# **Illicit Discharge Detection and Elimination Workshop for MS4s**

Case Study – Deteriorating Infrastructure

City of Seven Hills  
Mark K. Papke, P.E.  
City Engineer

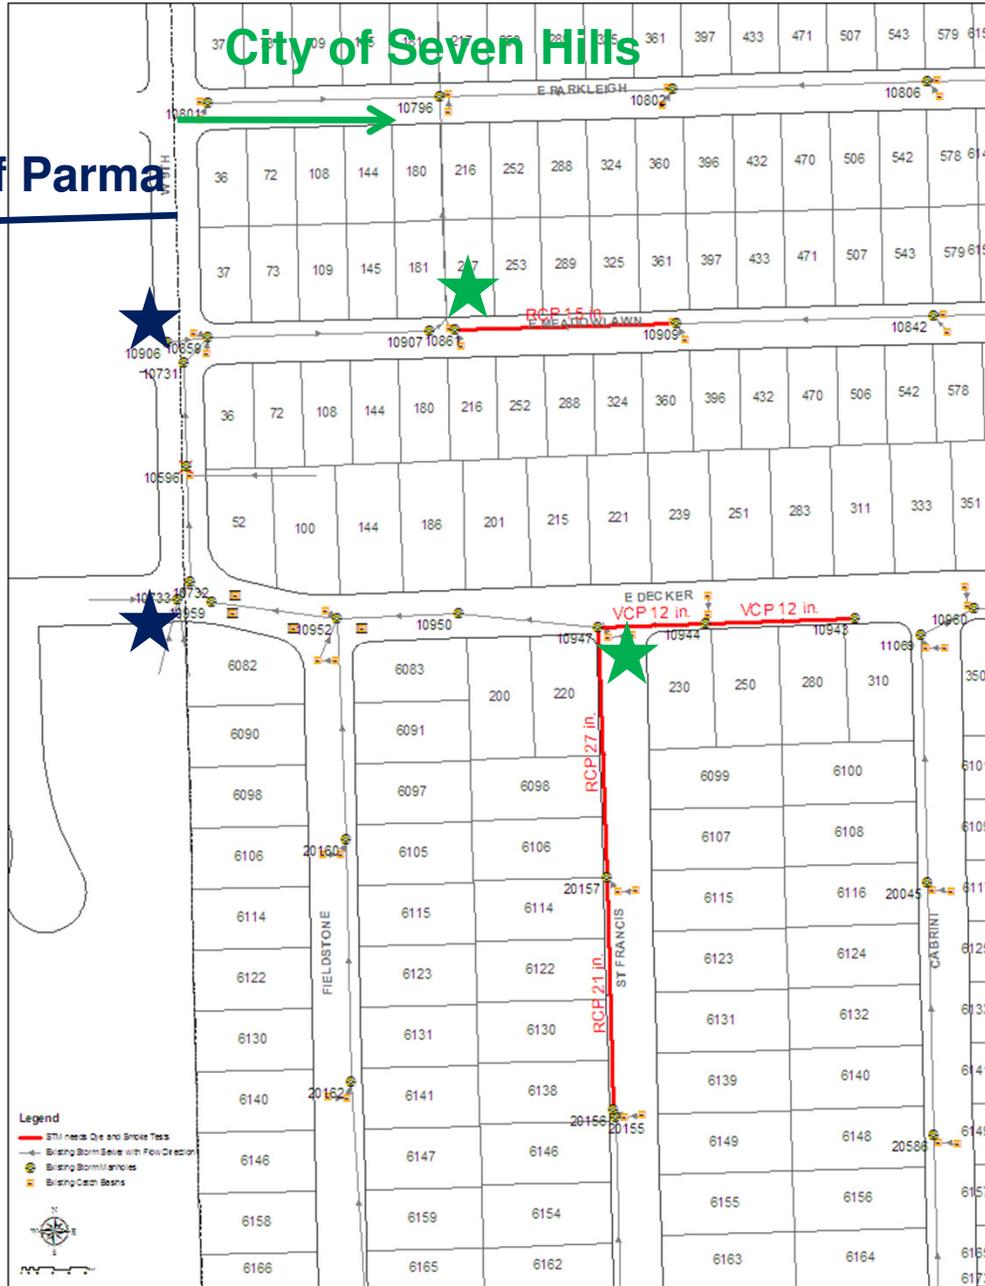
- Steady flow up to STM 10907
- STM 10907 had water pouring in through manhole walls – Probably Water main break (makes findings downstream inconclusive until repaired).
- Four (4) manholes identified flow during dry weather tracing.

★ Inflow detected  
Notify Parma

★ Inflow detected  
Lines scheduled to  
be televised, smoke  
& dye tested

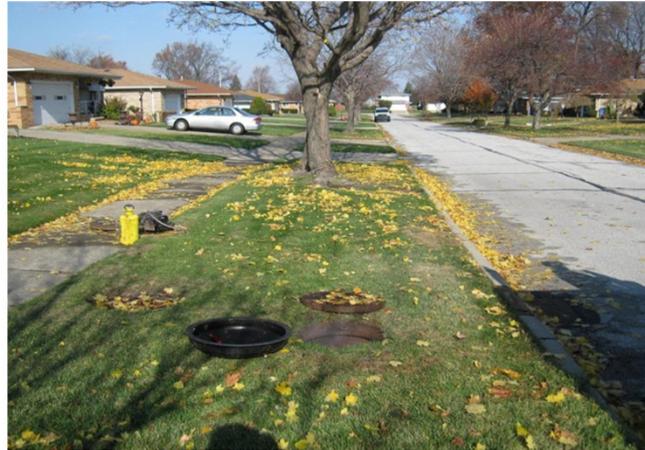
Smoke Test Results	
Smoke Induction Point:	STM1518
Source Description:	San-2-0110
Smoke Source Type:	Manhole
Test Date:	11/18/2010
Dye Test Results	
Dye Induction Point	SAN-2-0109 to San-2-0110
Source Description:	STM MH walls
Location of Observed Dye:	STM MH 1518
Estimated Flow:	1-3 gpm
CCTV Section Number:	2
Test Results:	Positive
Test Date:	11/18/2010

Photo: Photo below shows smoke from STM 1517 into SAN -2-0109

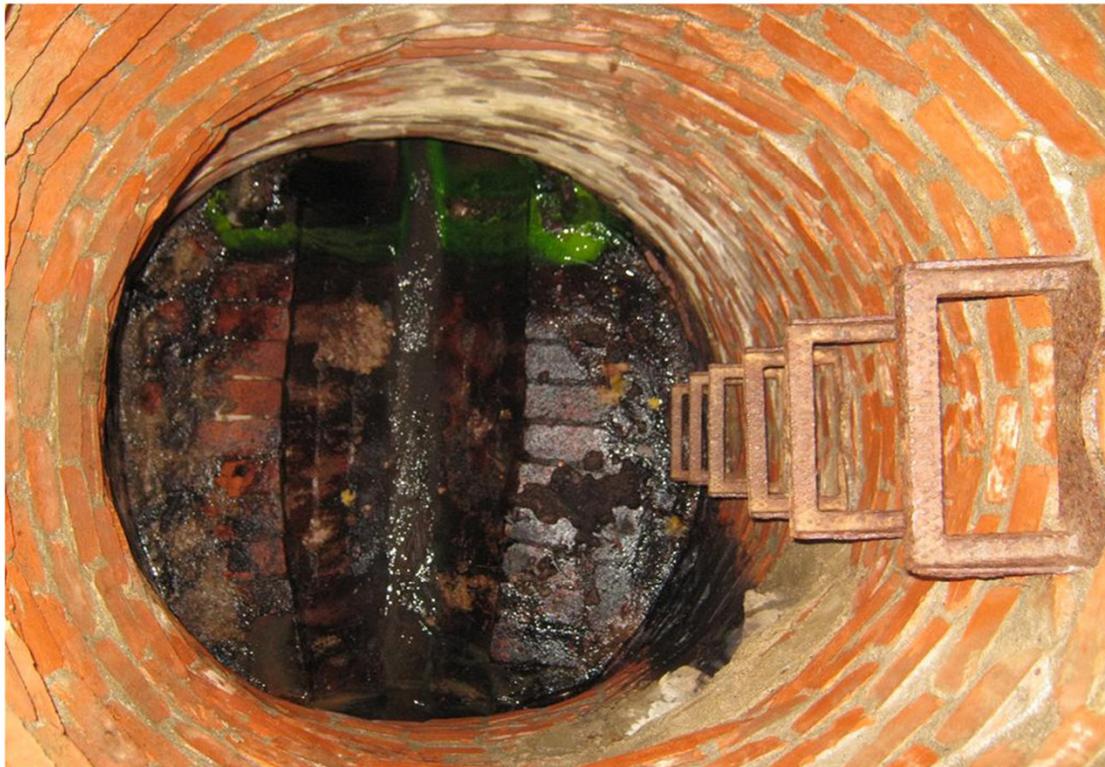
**Photo:** Photo below shows dye in STM-1518 from SAN-2-0109 to SAN-2-0110 DYE TEST

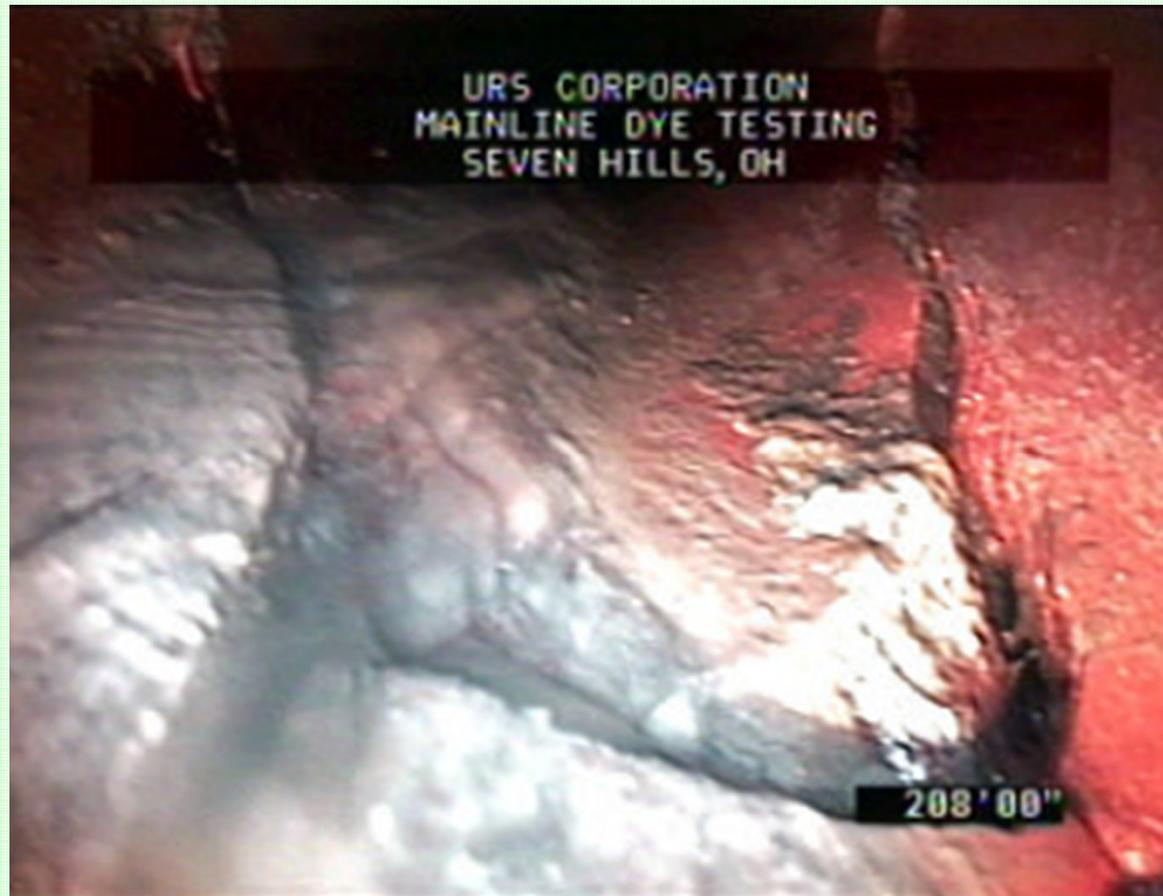
- Smoke tested the storm line
  - Results inconclusive but showed communication between storm and sanitary
- Dye test sanitary line
  - Results still inconclusive but showed sanitary is getting through via manholes.
- Televising sanitary line (CCTV)
  - Results indicate separations and tree roots.

## Broken Sections of Sanitary Sewer Pipe

- Sanitary infrastructure installed in 1950's requires rehabilitation and at some locations replacement
- Fix City issues first → mainline, manhole and laterals (in R-O-W) replacement or rehabilitation
- Selected Cured In-Place Pipe Lining and Manhole Lining
- Put together bid package for three (3) separate projects
  - 920' sanitary sewer CIPP lining
  - Two (2) manhole re-linings

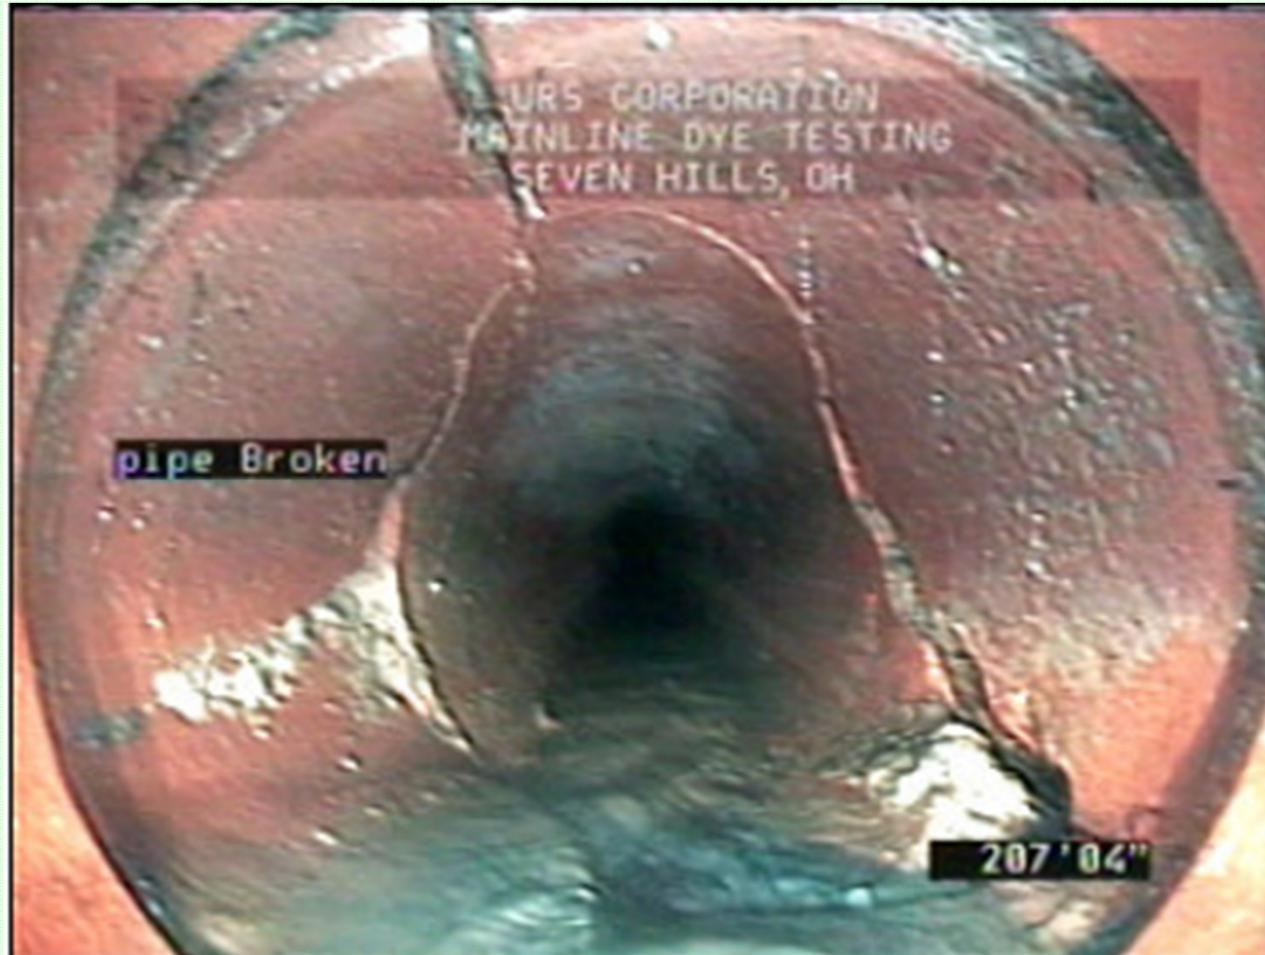
## Broken Sections of Sanitary Sewer Pipe

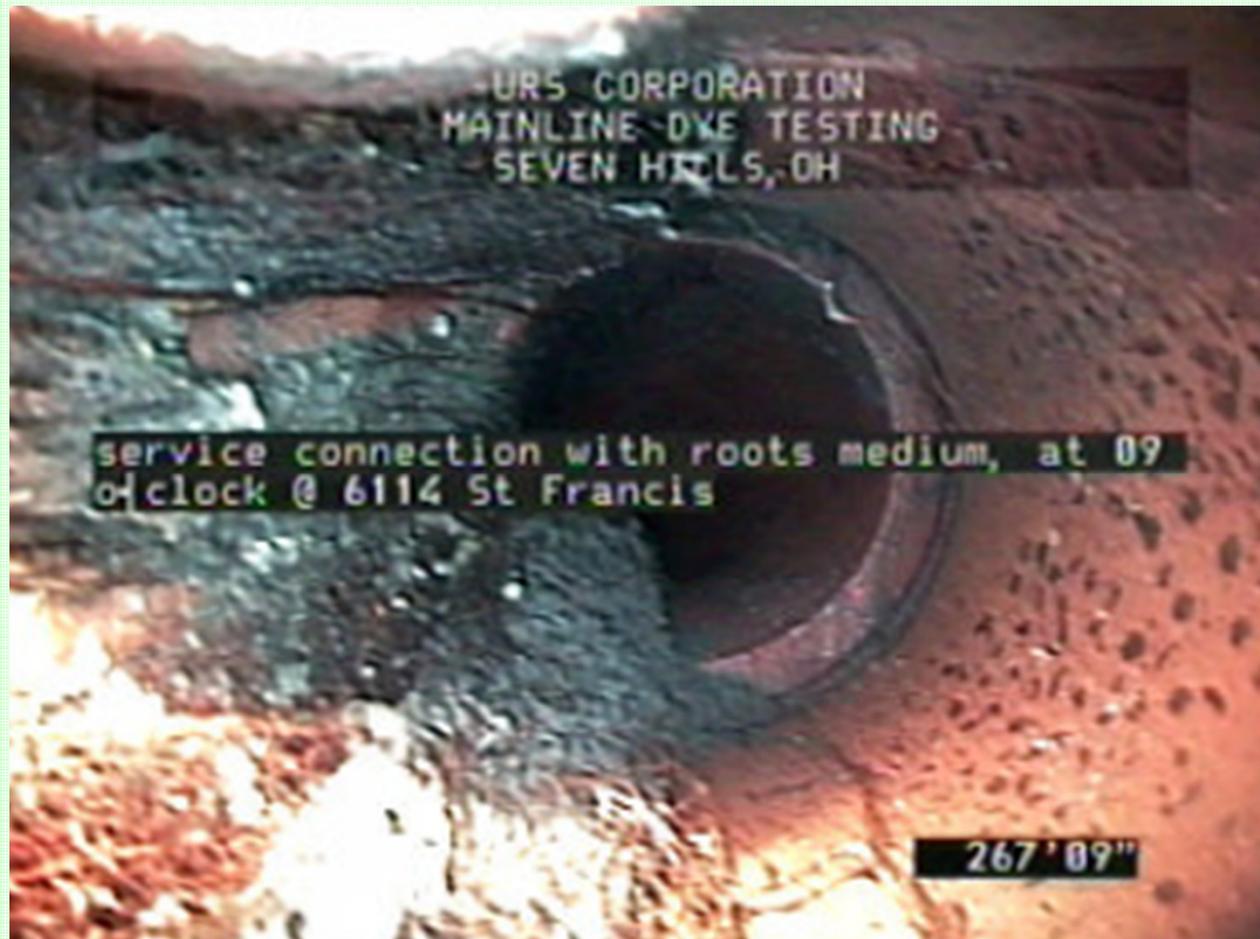
# Tree Roots
