## BROWNFIELD INVESTIGATION

Whittier Peninsula  
Columbus, Ohio

U.S. EPA ID: OHB000001706

November 6, 1998

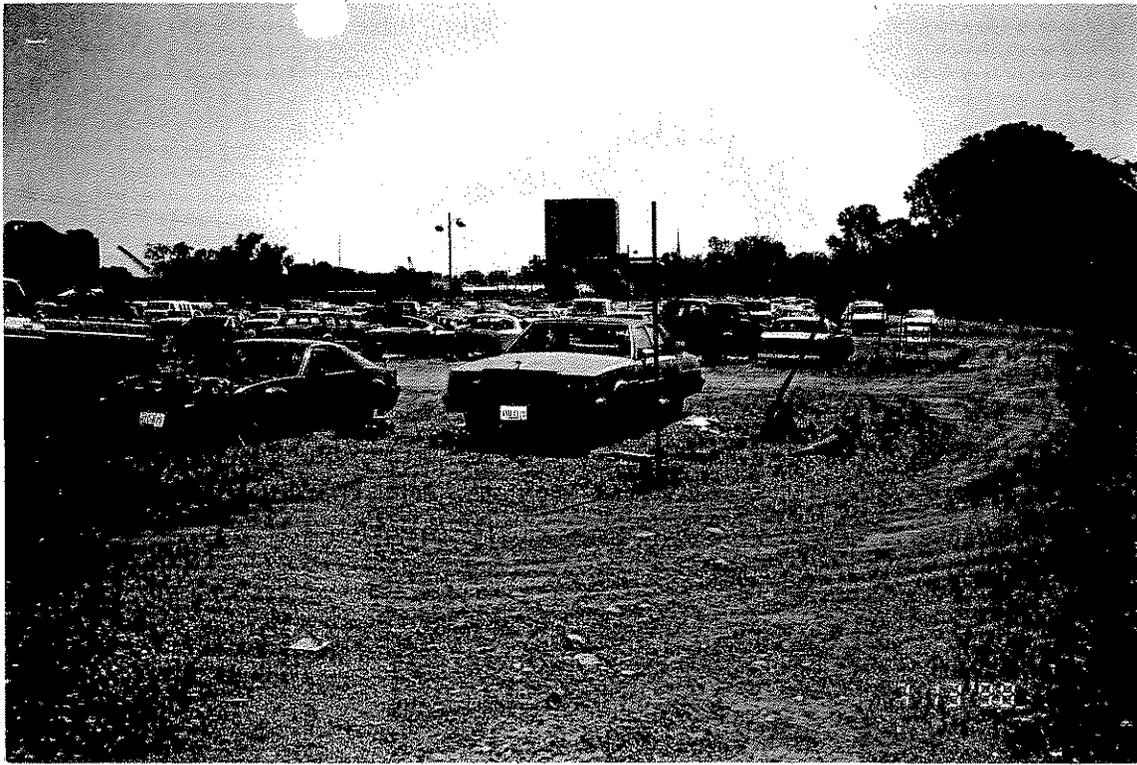
Photo No: 1  
Orientation: West  
Description: Impounded cars parked on upper impound lot.

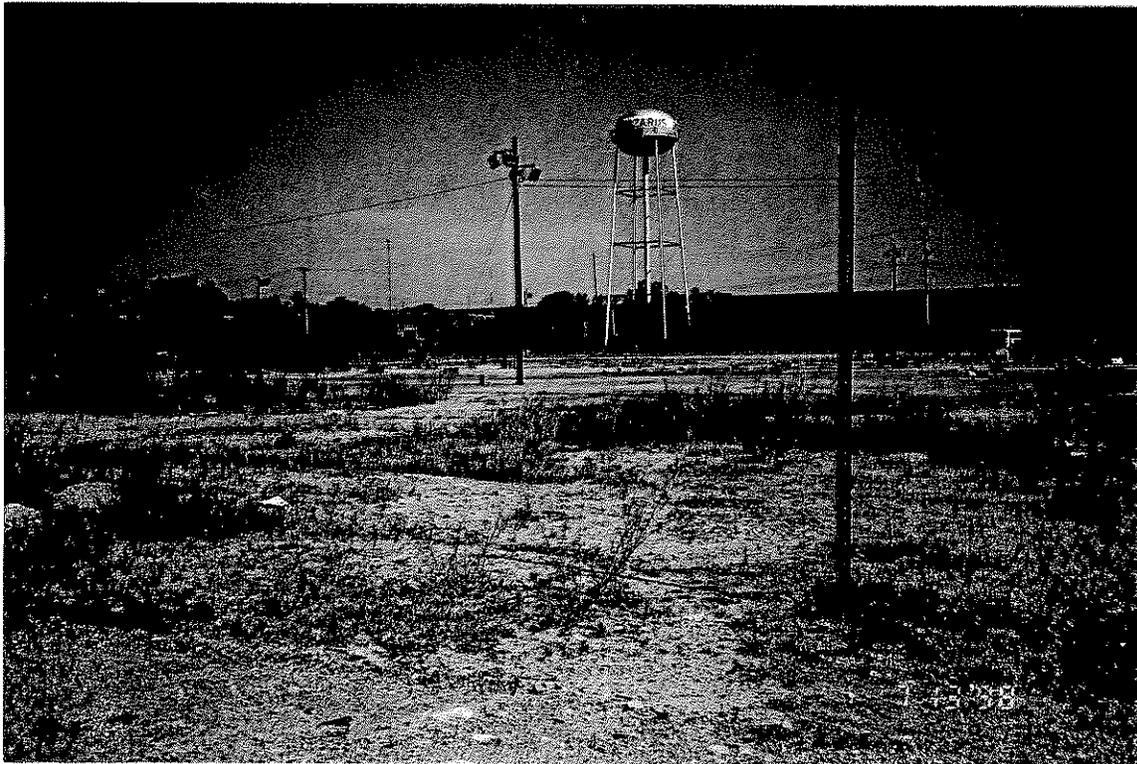
Photo No: 2  
Orientation: North  
Description: Lower Impound Lot. Former Location of Universal Concrete Building.

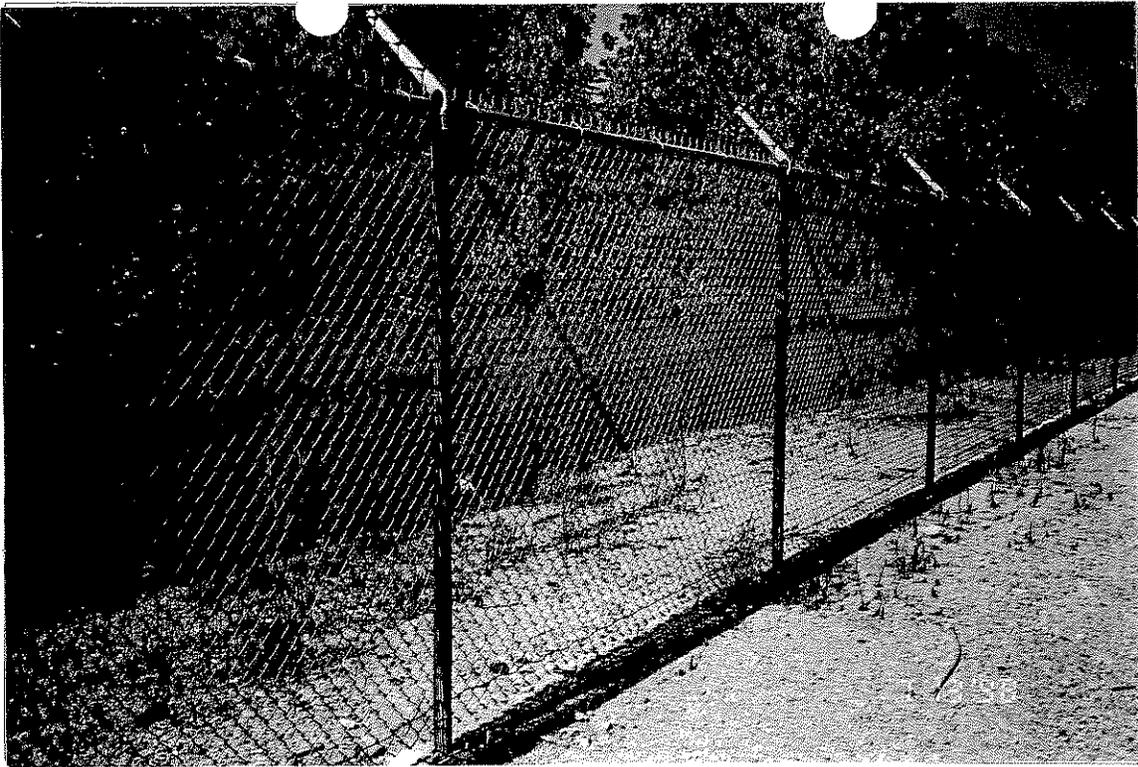
Photo No: 3  
Orientation: South  
Description: Universal Concrete MW2.

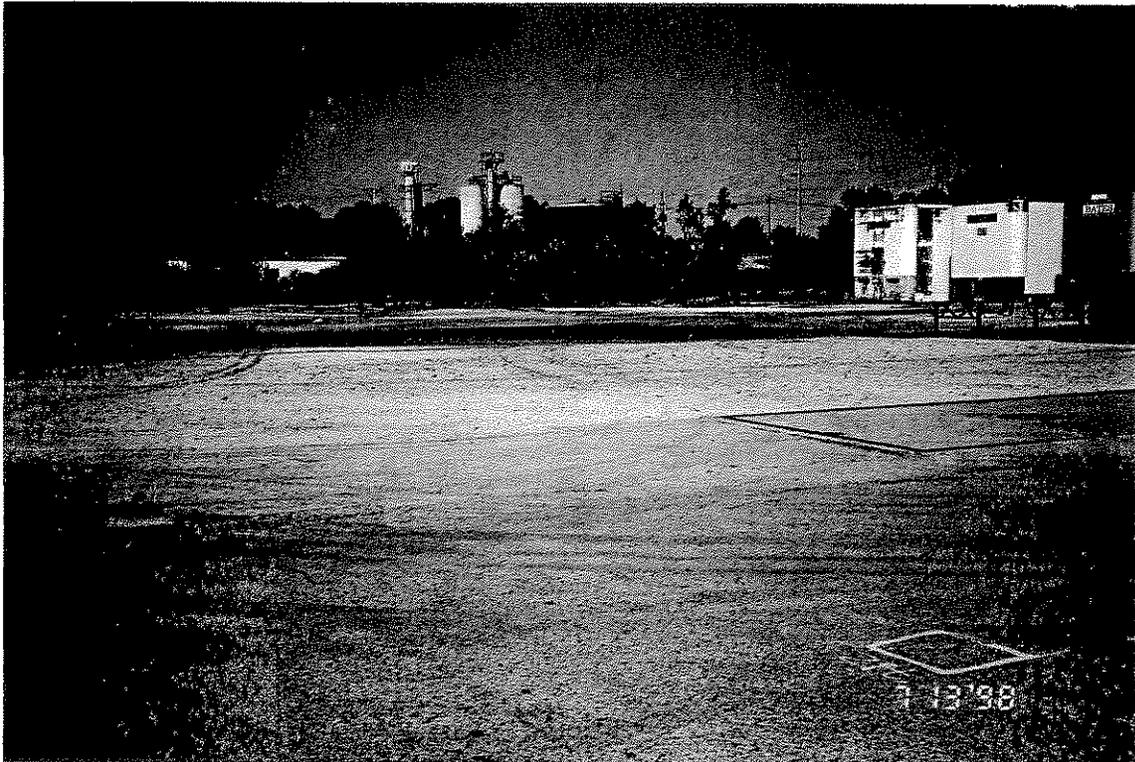
Photo No: 4  
Orientation: West  
Description: Maier Place gravel parking lot.

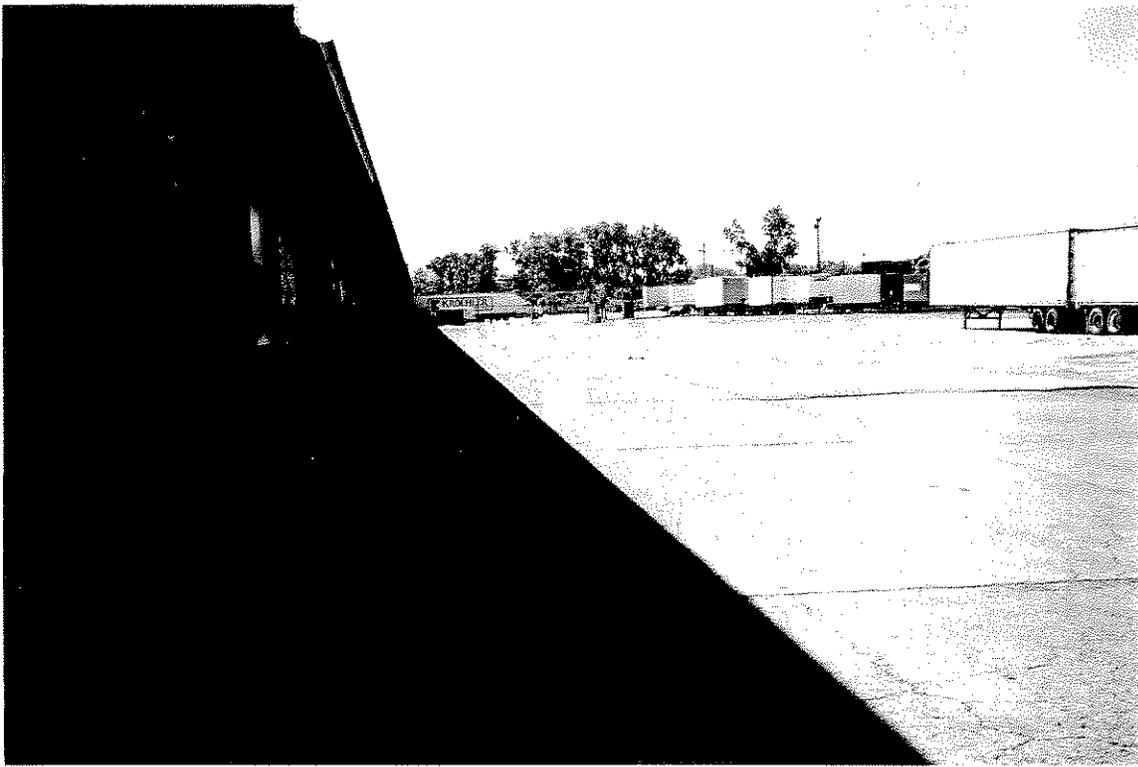
Photo No: 5

Description: Maier Place; view of west side of building.

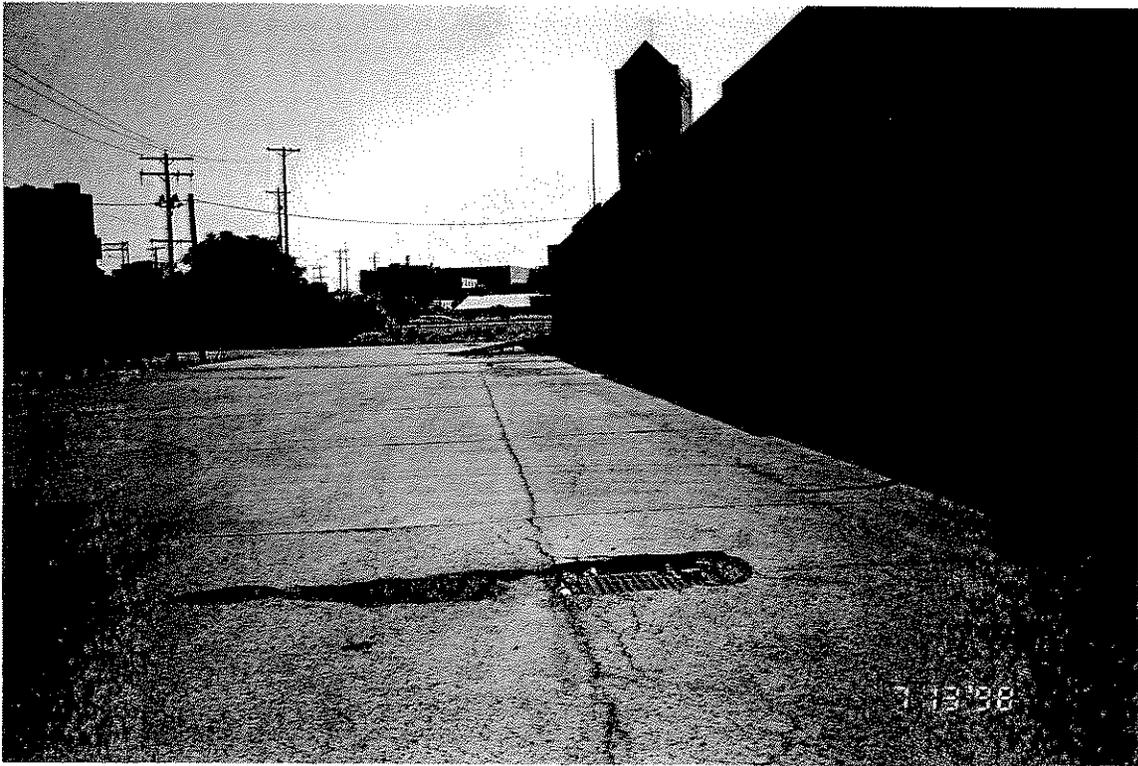
Photo No: 6

Description: Maier Place; north side of building.

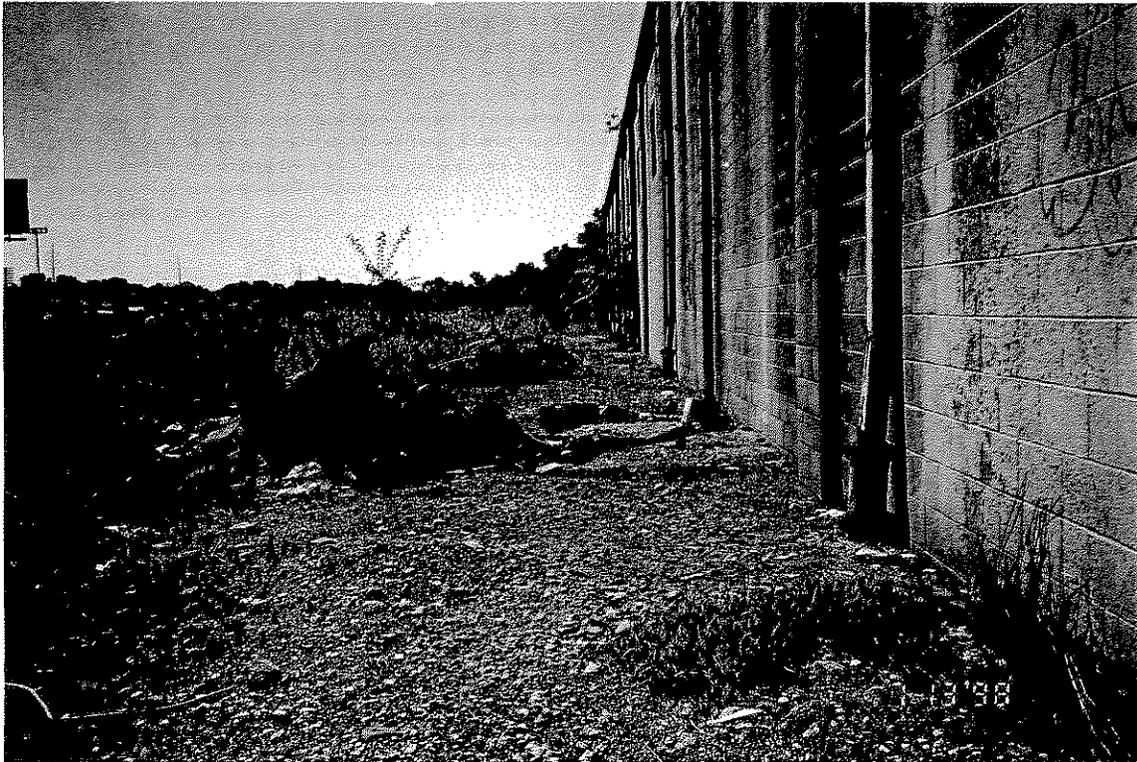
**Photo No: 8**

**Description: Back (east side) of building adjacent to railroad tracks.**

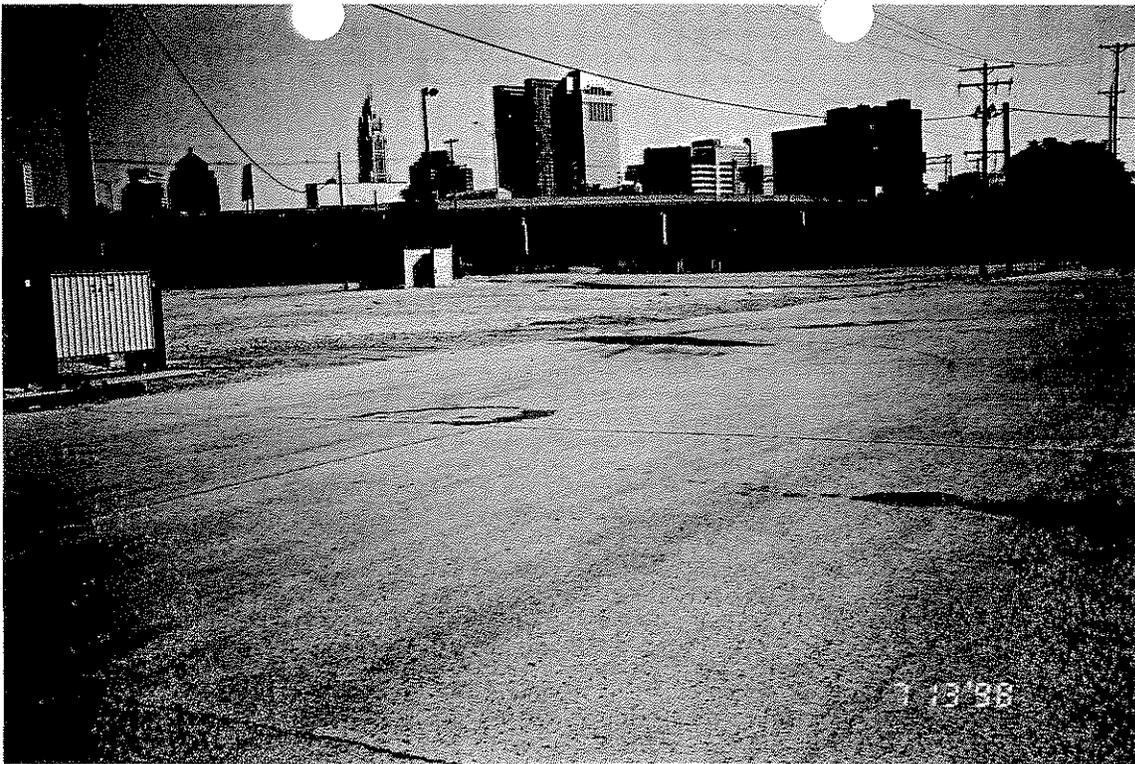
Photo No: 9

Description: Location of former hazardous waste storage pad.

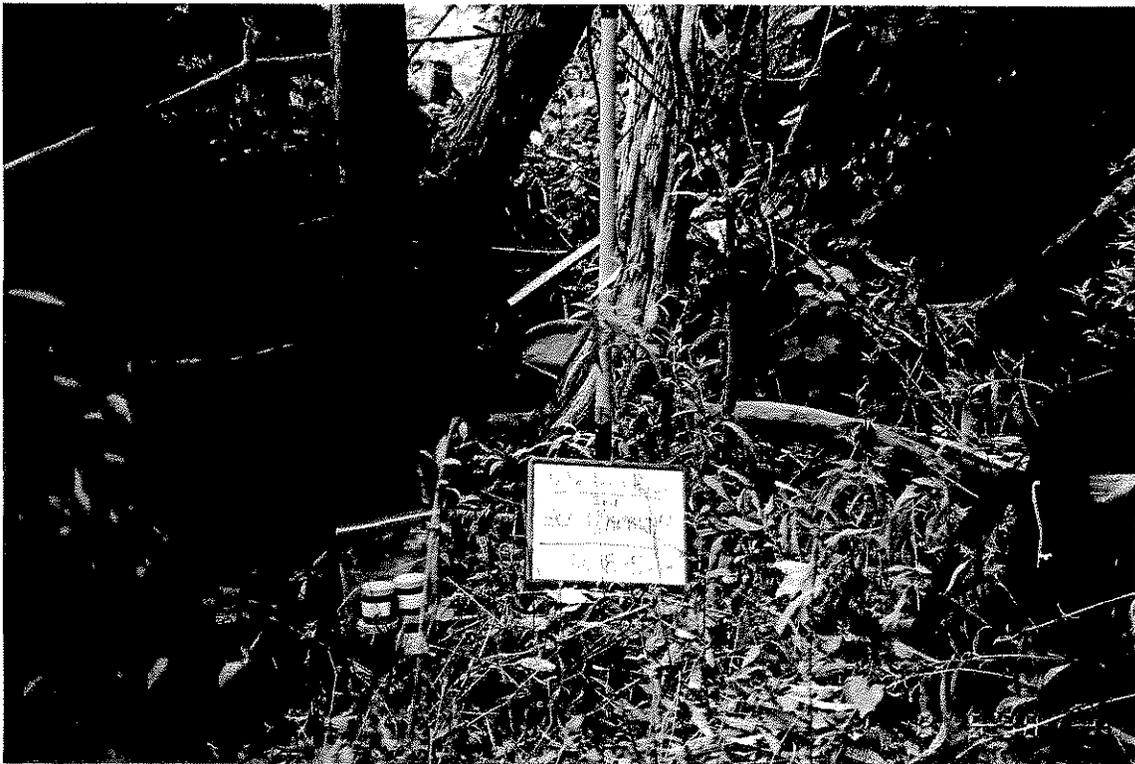
Photo No: 10

Description: Close up of soil sample "depression".

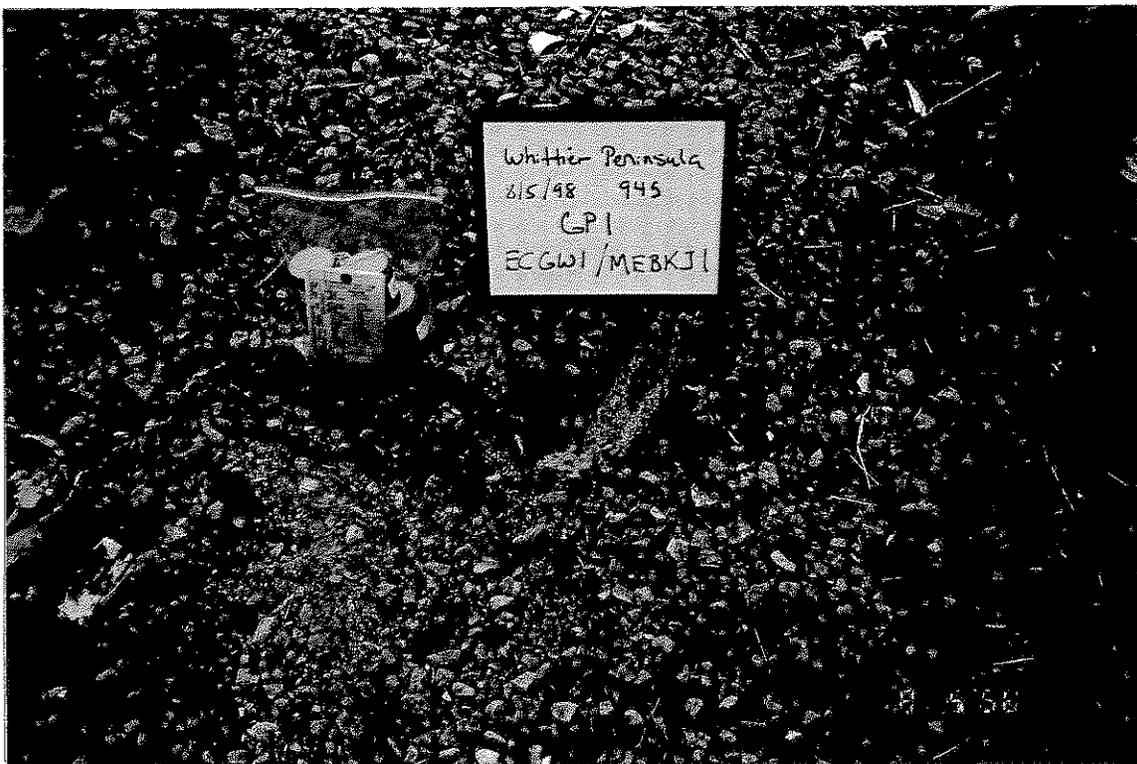
The soil sample obtained from GP2 had lead present at 1290 mg/kg. The OVAP standard is 400 mg/kg. As indicated earlier, this is considered elevated. GP2 was obtained from the western edge of the upper police impound lot and at a depth of 10 - 13 feet bgs. It is unclear as to the extent of the lead contamination at this location. In order to fully evaluate the extent of the contamination, further soil sampling should be done in this area. Remedial activities at this location may include spot removal of soil until sample results are below 400 mg/kg.

**Photo No: 14**  
**Sample No:** ECGW/MEBKJ 1  
**Date:** August 5, 1998  
**Orientation:** East  
**Description:** Close up of  
Geoprobe soil sample GP1  
collected in eastern corner of  
upper impound lot.

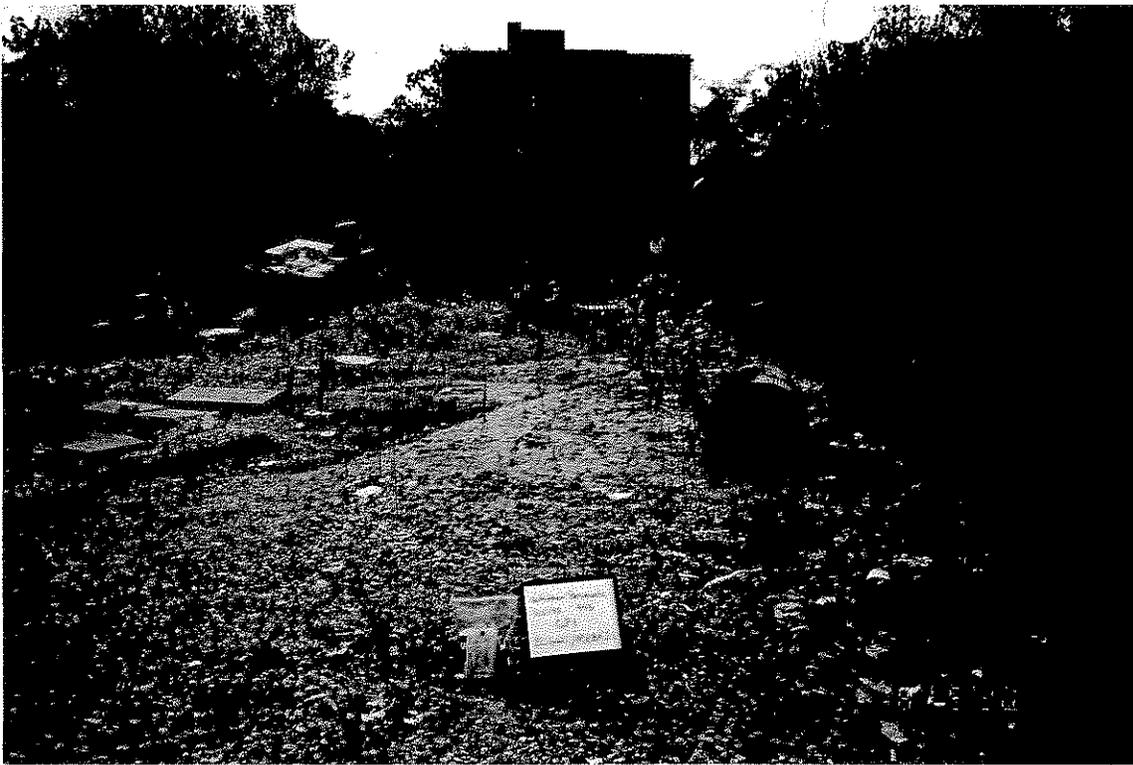
Photo No: 15

Description: Perspective of Geoprobe soil sample GP1 collected in the eastern corner of the upper impound lot.

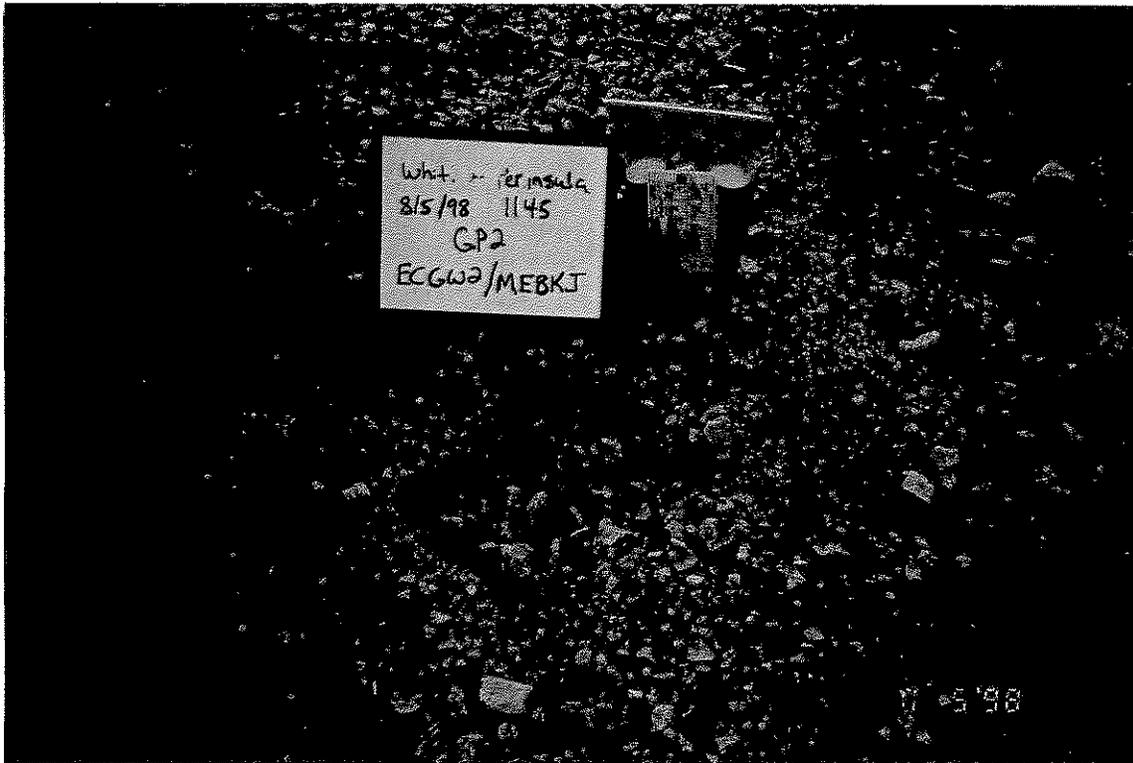
Photo No: 16

Description: Close up of Geoprobe soil sample GP2 collected in western corner of upper impound lot.

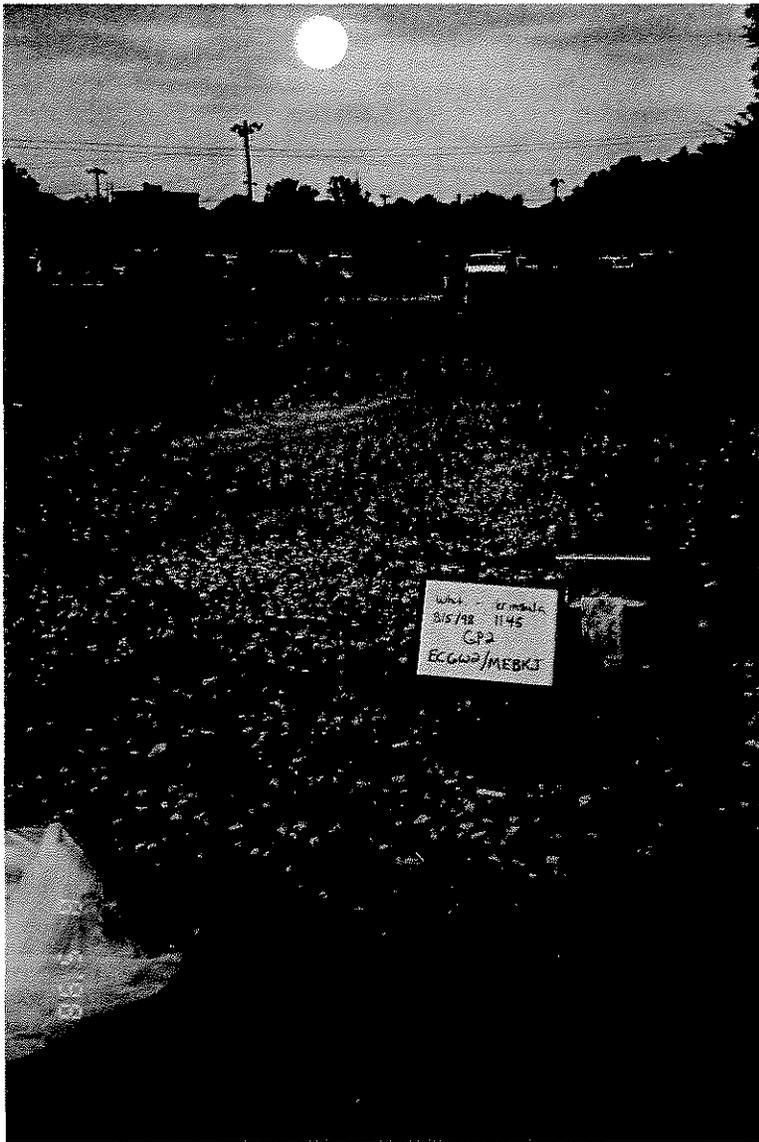
**Photo No: 17**  
**Sample No. ECGW/MEBKJ 2**  
**Date: August 5, 1998**  
**Orientation: South**  
**Description: Perspective of Geoprobe soil sample GP2 collected in western corner of upper impound lot.**

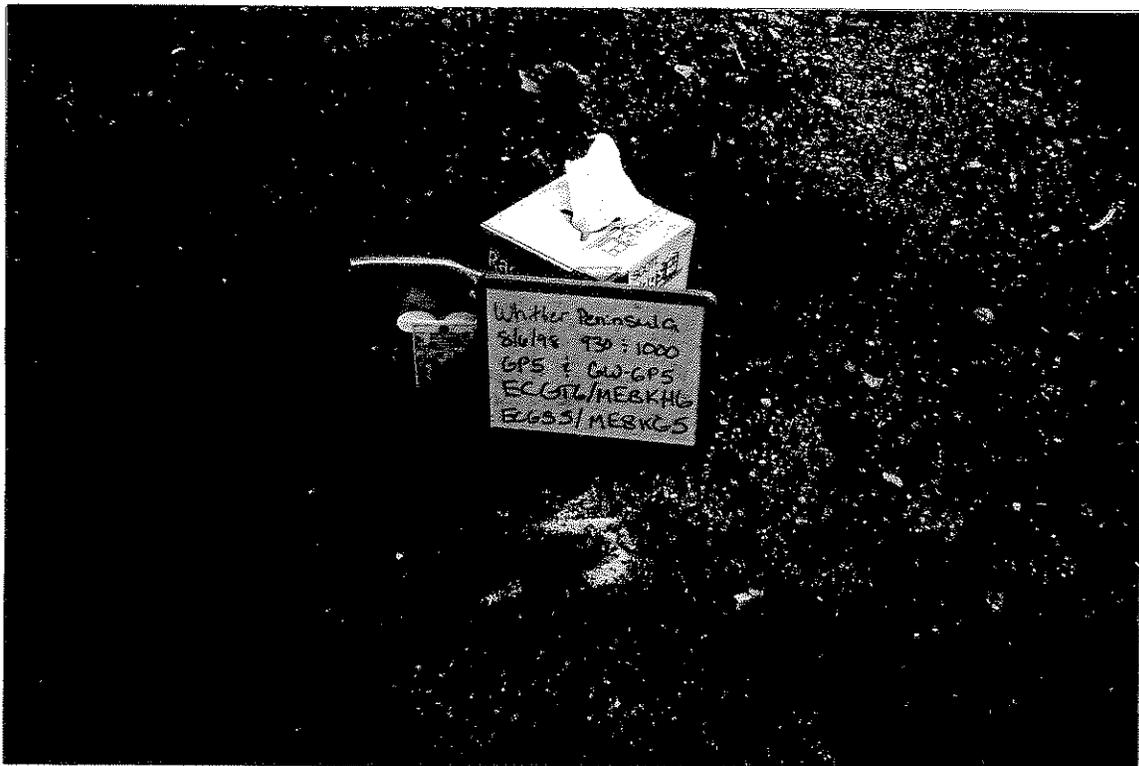
**Photo No: 20**  
**Sample No: ECGT/MEBKH 6**  
**& ECGS/MEBKG 5**  
**Date: August 5, 1998**  
**Orientation: Northeast**  
**Description: Close up of**  
**Geoprobe soil and groundwater**  
**samples GP5 and GW-GP5**  
**collected from stained area of**  
**parking lot at Maier Place.**

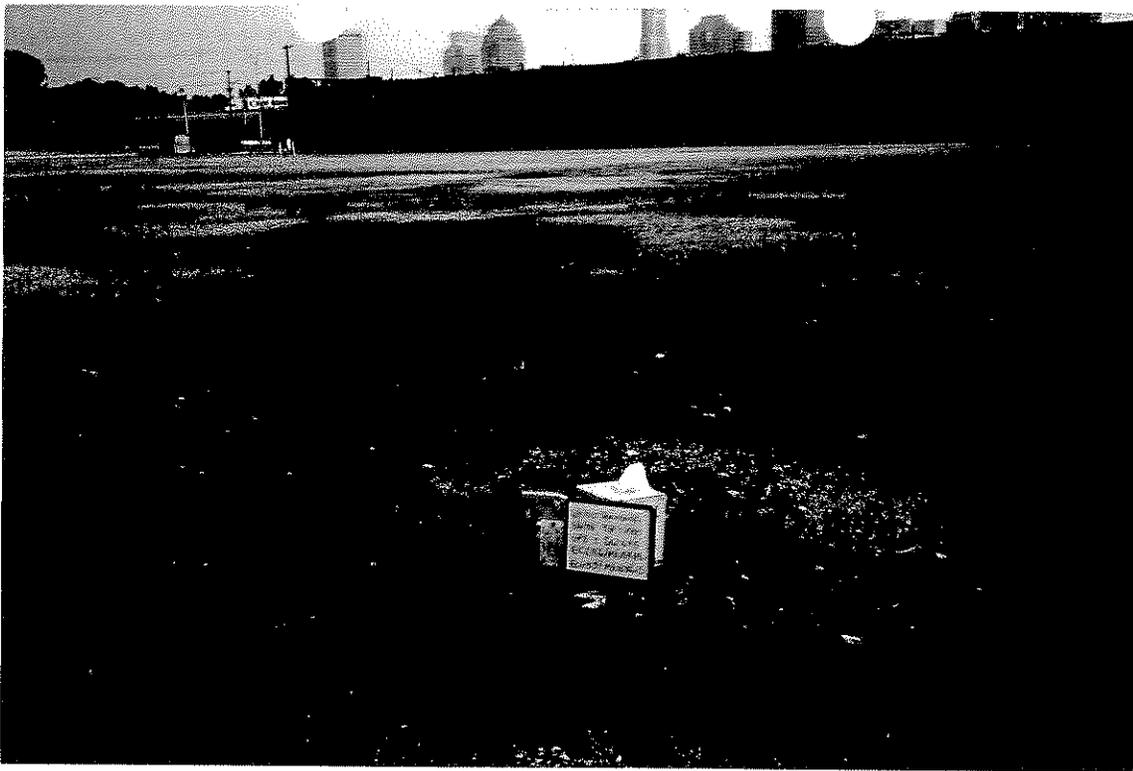
Photo No: 21                      Sample No:    ECGT/MEBKH 6                      Date: August 5, 1998  
 Orientation:    Northeast                      ECGS/MEBK 5  
 Description:    Perspective of Geoprobe soil and groundwater samples GP5 and GW-GP5 collected from stained area in parking lot of Maier Place.

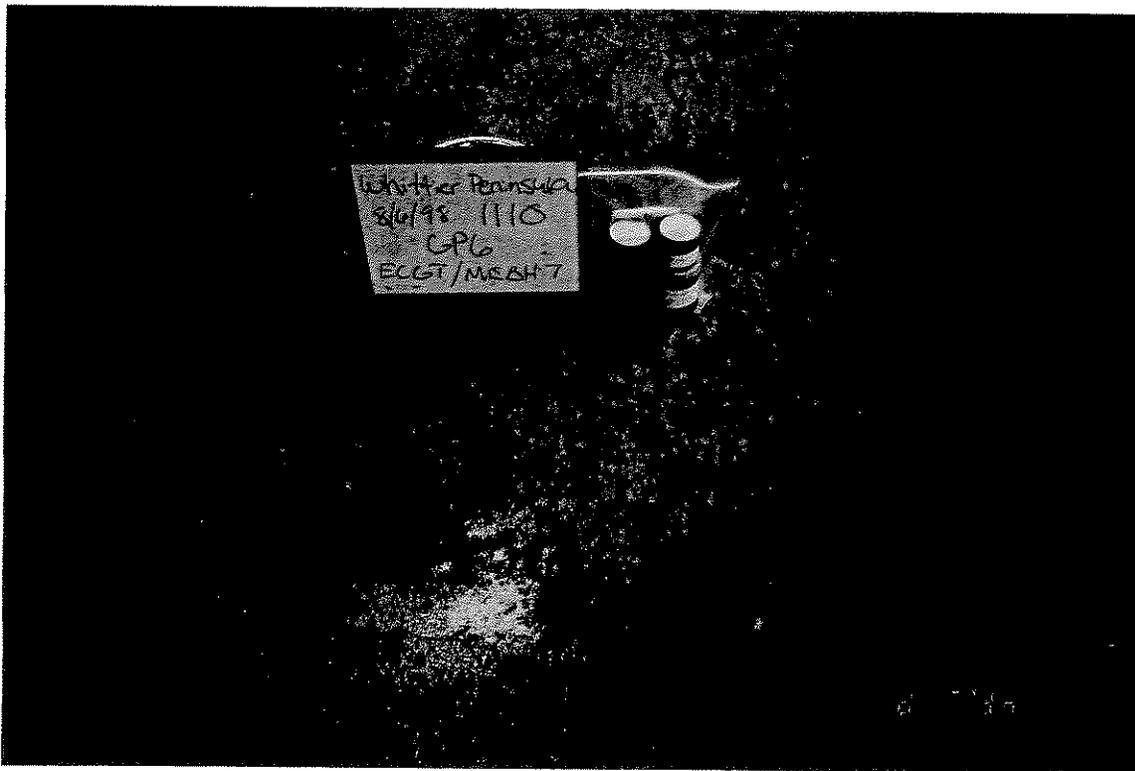
Photo No: 22                      Sample No:    ECGT/MEBKH 7                      Date: August 4, 1998  
 Orientation:    East  
 Description:    Close up of Geoprobe soil sample GP6 collected from unpaved area of parking lot at Maier Place.

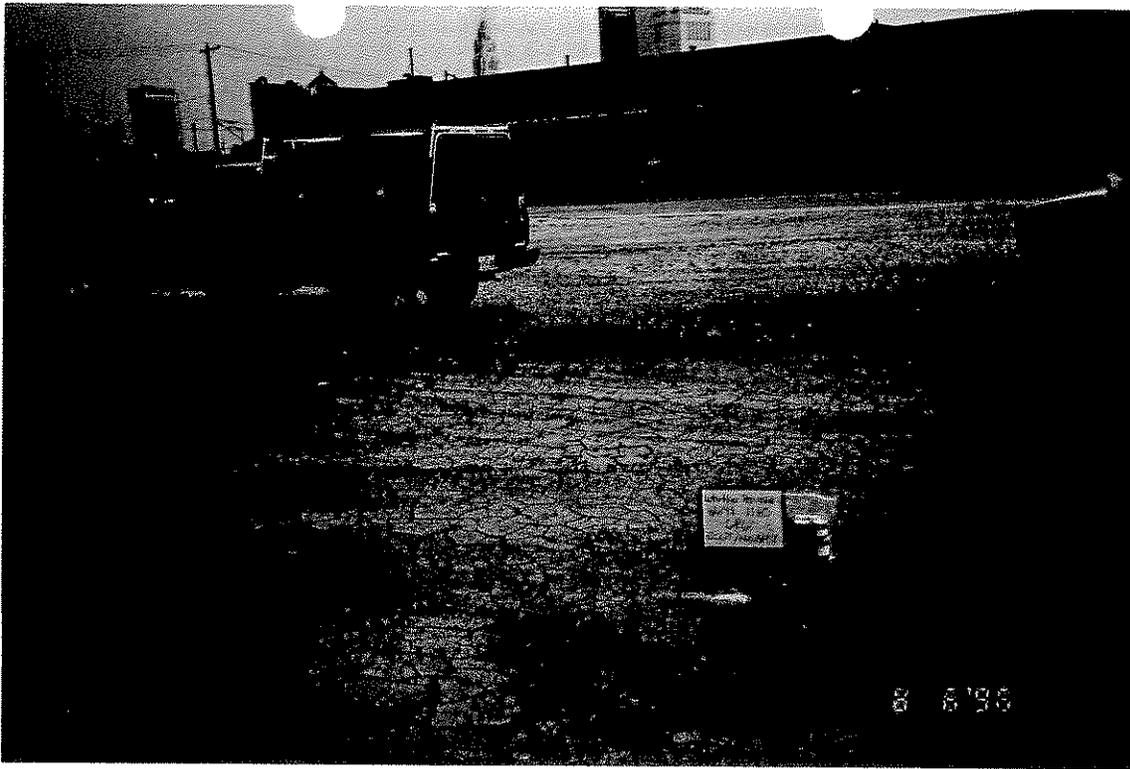
Photo No: 23                      Sample No:    ECGT/MEBKH 7                      Date: August 5, 1998  
Orientation:                      East  
Description:                      Perspective of Geoprobe soil sample GP6 collected from unpaved area of parking lot at Maier Place.

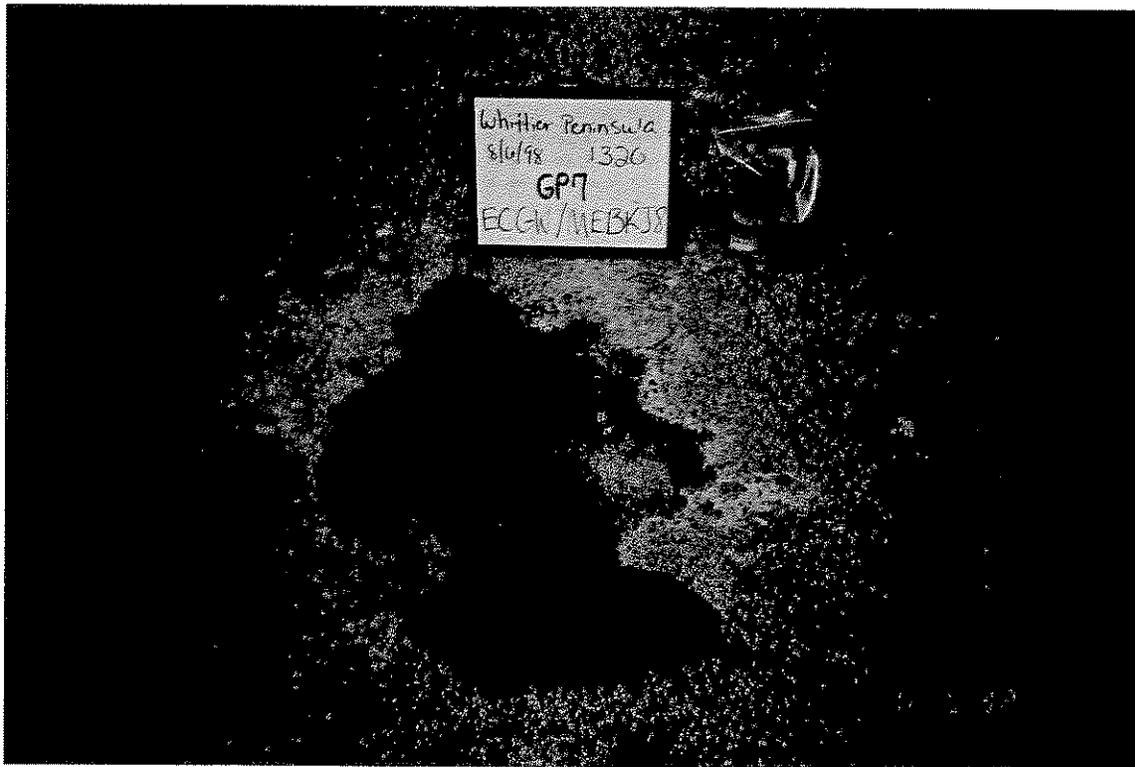
Photo No: 24                      Sample No:    ECGW/MEBKJ 8                      Date: August 4, 1998  
Orientation:                      Northwest  
Description:                      Close up of Geoprobe GP7 collected on the west side of the Maier building.

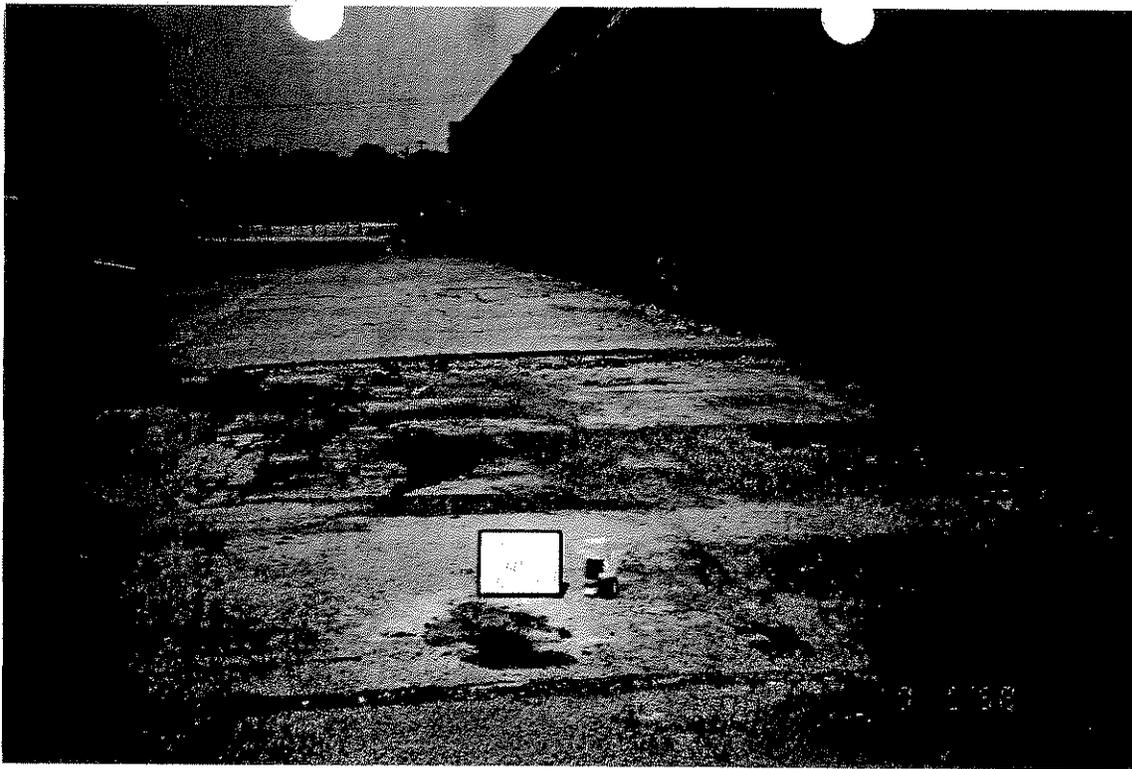
Photo No: 25                      Sample No:    ECGW/MEBKJ 8                      Date: August 5, 1998  
Orientation:    Northwest  
Description:    Perspective of Geoprobe soil sample GP7 collected on the west side of the Maier building.

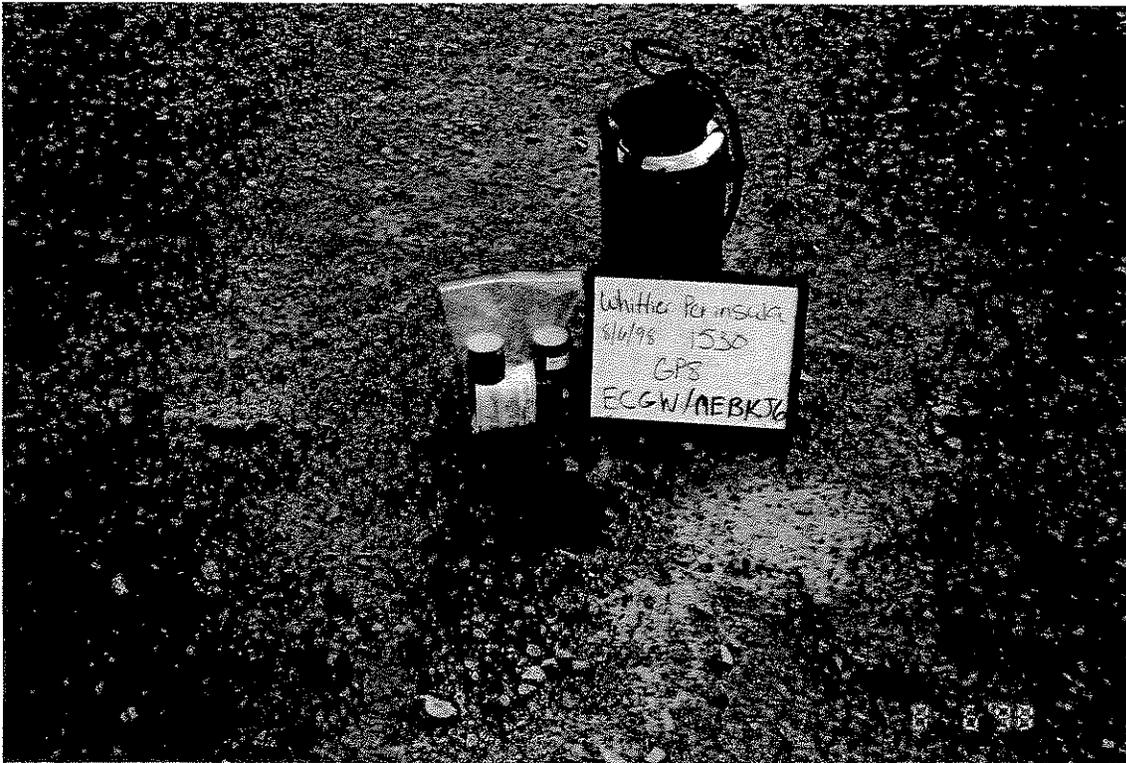
Photo No: 26                      Sample No:    ECGW/MEBKJ 6                      Date: August 5, 1998  
Orientation:    Southeast  
Description:    Close up of Geoprobe soil sample GP8 collected on north side of the Maier building between the substation and railroad tracks leading to the building.

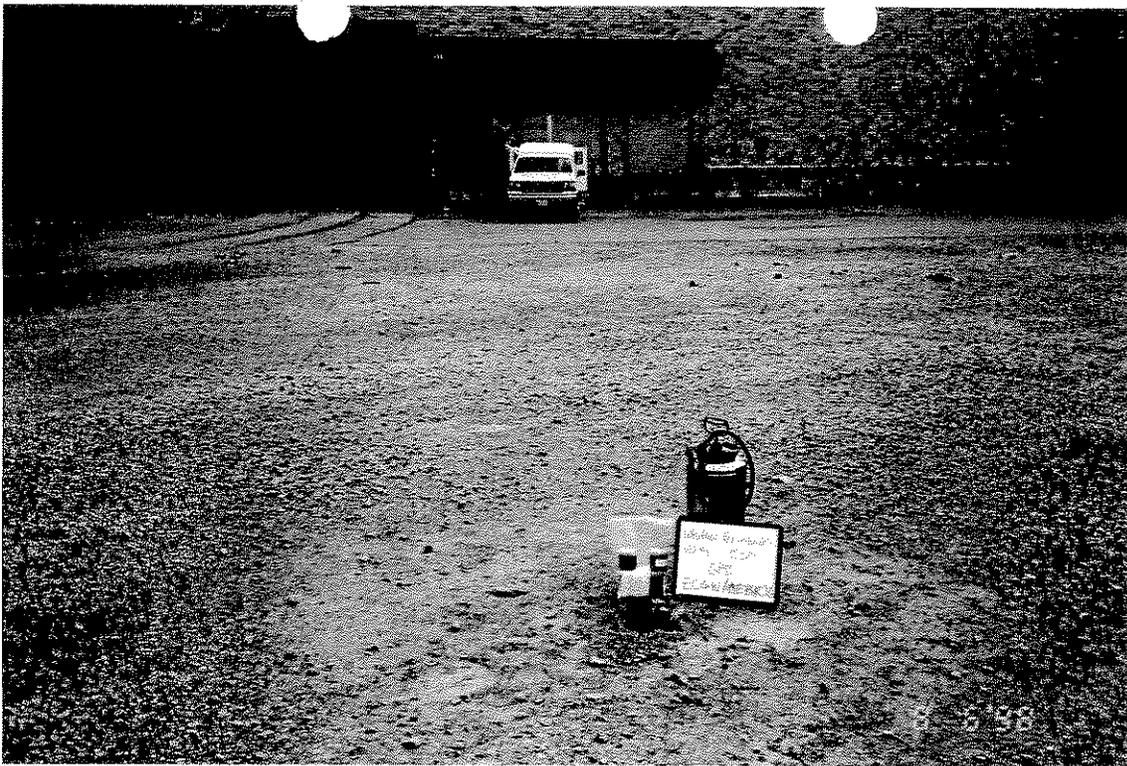
Photo No: 27                      Sample No:    ECGW/MEBKJ 6                      Date: August 5, 1998  
Orientation:                      Southeast  
Description:                      Perspective of Geoprobe soil sample GP8 collected on the north side of the Maier building between the substation and railroad tracks leading to the building.

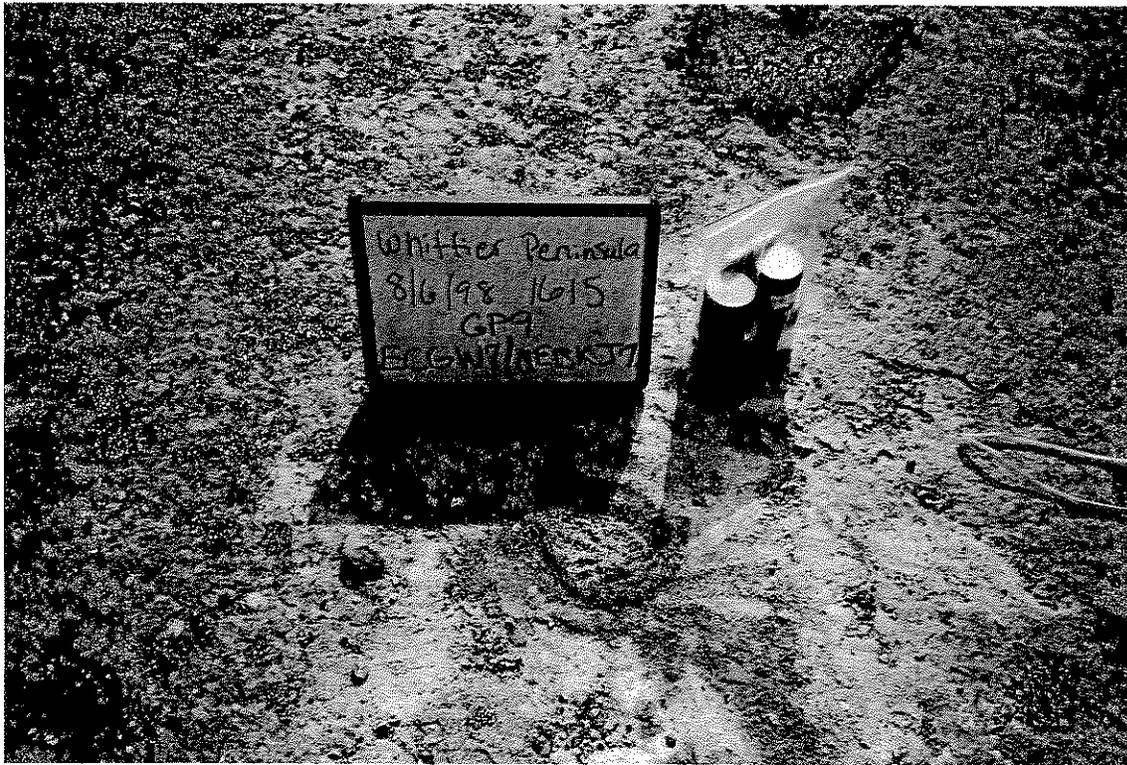
Photo No: 28                      Sample No:    ECGW/MEBKJ 7                      Date: August 5, 1998  
Orientation:                      West  
Description:                      Close up of Geoprobe soil sample GP9 collected close to the Maier building on the north side.

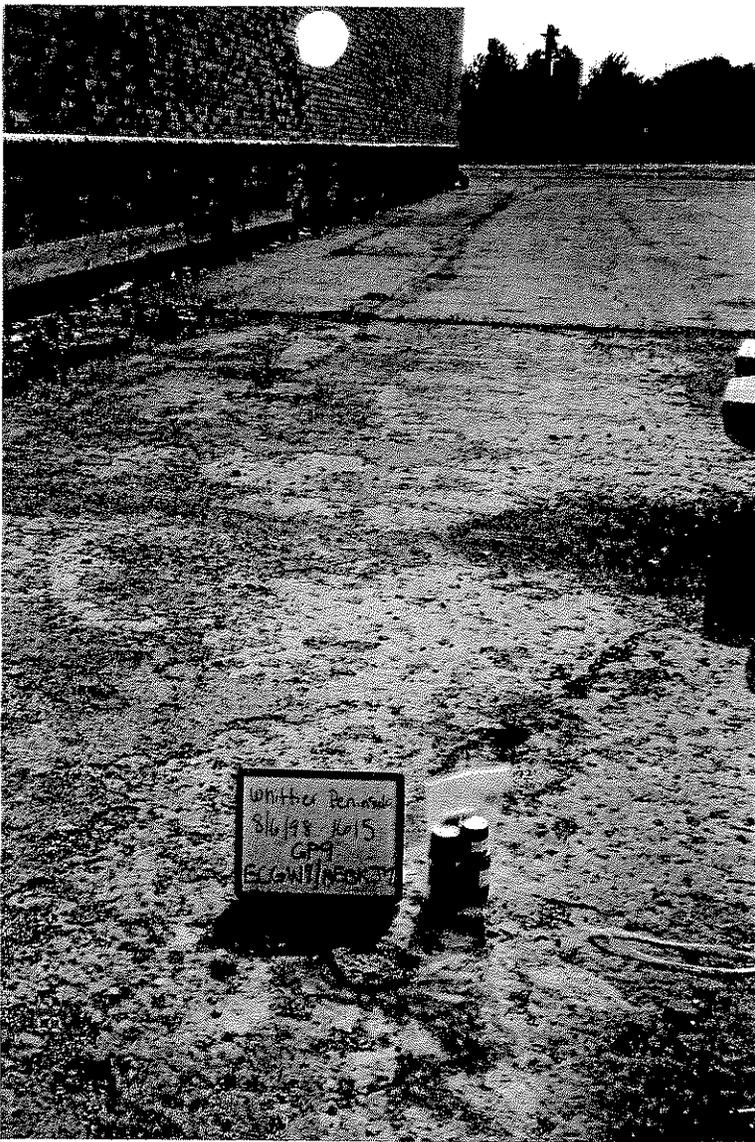
**Photo No:** 29  
**Sample No.** ECGW/MEBKJ 7  
**Date:** August 5, 1998  
**Orientation:** West  
**Description:** Perspective of Geoprobe soil sample GP9 collected close to Maier building on the north side.
