**Integrated Assessment Report- Combined Preliminary Assessment Site Inspection**

**Town Run**

**Marysville, Union County, Ohio**

EPA I.D. No. : OHN000508114

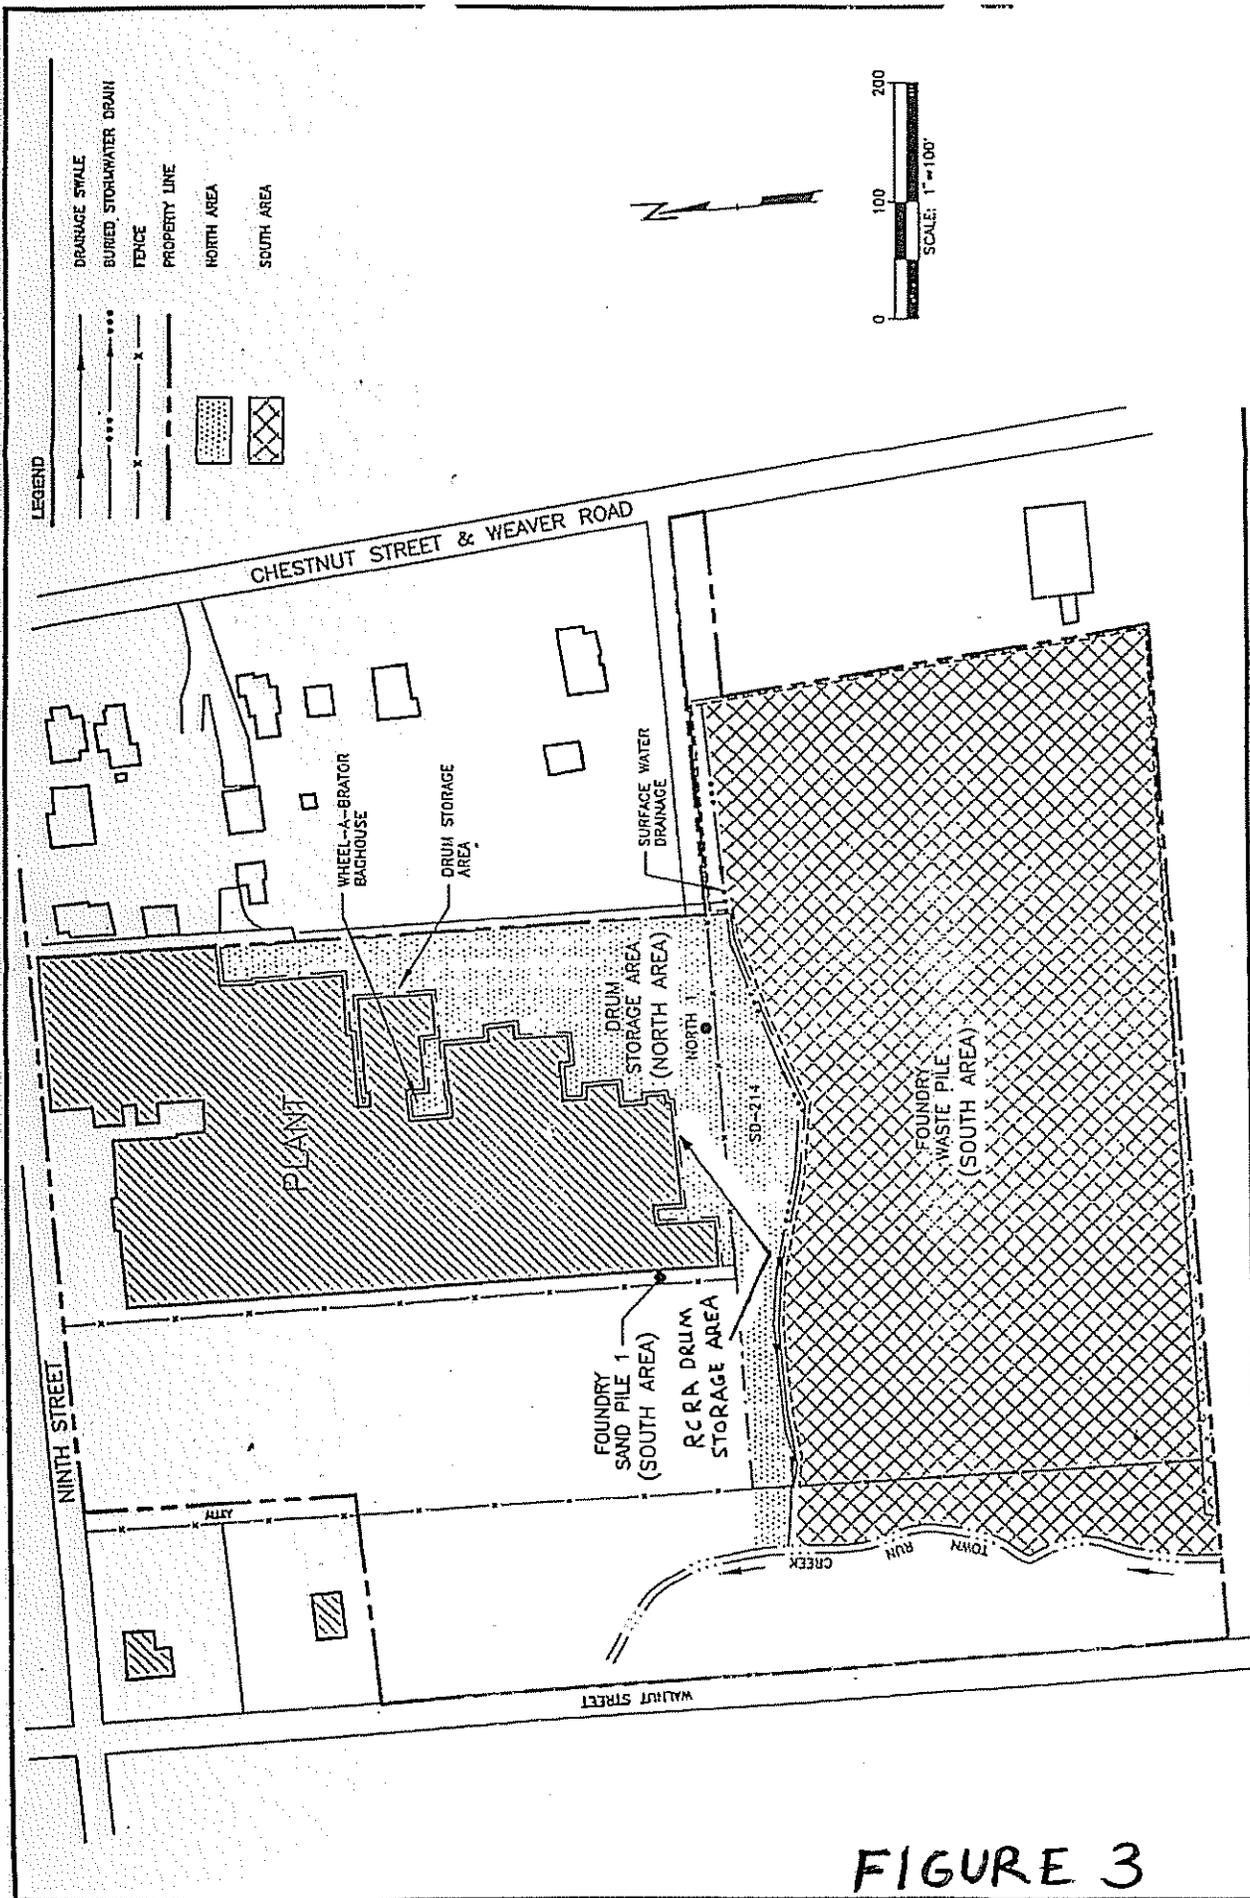
FIGURE 3

The Ohio EPA DHWM finalized consensual DFFOs with Eljer on May 21, 1993, requiring Eljer to submit a revised RCRA Closure Plan addressing the waste foundry sand, the drainage ditch, the container storage area, the wheel-a-brator baghouse area, the existing landfill, and the hazardous waste pile. The majority of the waste foundry sand was located at the southern part of the site with the western border adjacent to Town Run, covering approximately six acres (including the 3.5 acre landfill) with approximately 9,000 cubic yards of chromium and lead contaminated sand up to eight feet deep in places. Before 1951, Eljer also used their waste foundry sand as fill material for their building expansion on the northern part of their property on approximately 2.5 acres as shown in **Figure 3**.

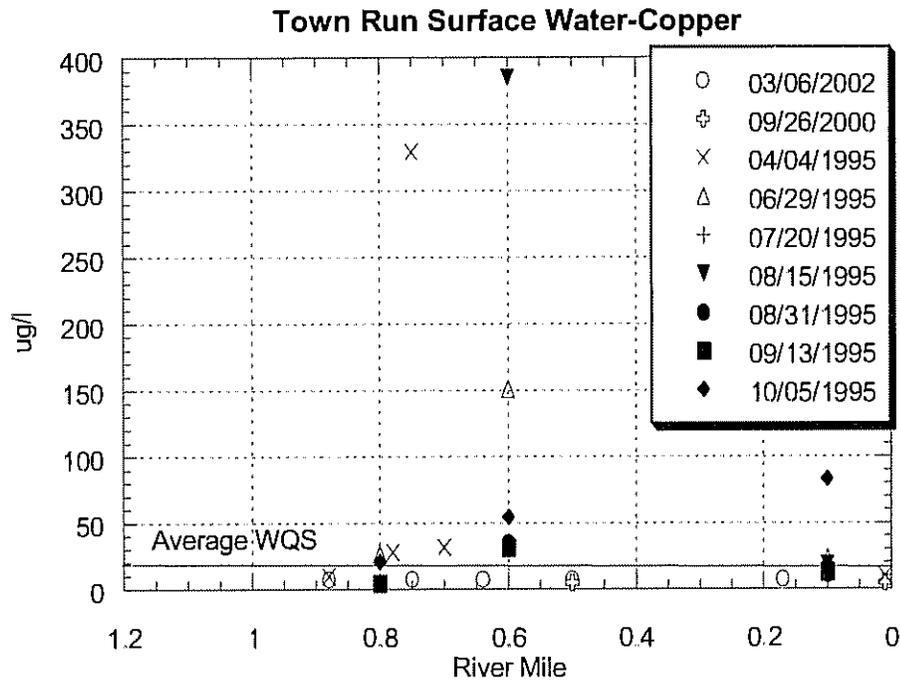
Figure 1. Town Run surface water sampling results for copper in relation to water quality criteria.

Scatter plots for copper, lead, and zinc raw data for all sampling dates and locations in relation to the water quality criteria is presented in Figures 1,2, and 3. None of the figures show any violations of water quality criteria since remediation of contaminated sediments in Town Run. While this may be the result of sediment removal and capping it is also possibly the result of limited sampling conditions. If sampling is only done under low flow conditions, low stream velocity reduces scour of sediments and the introduction of sediment into the water column.

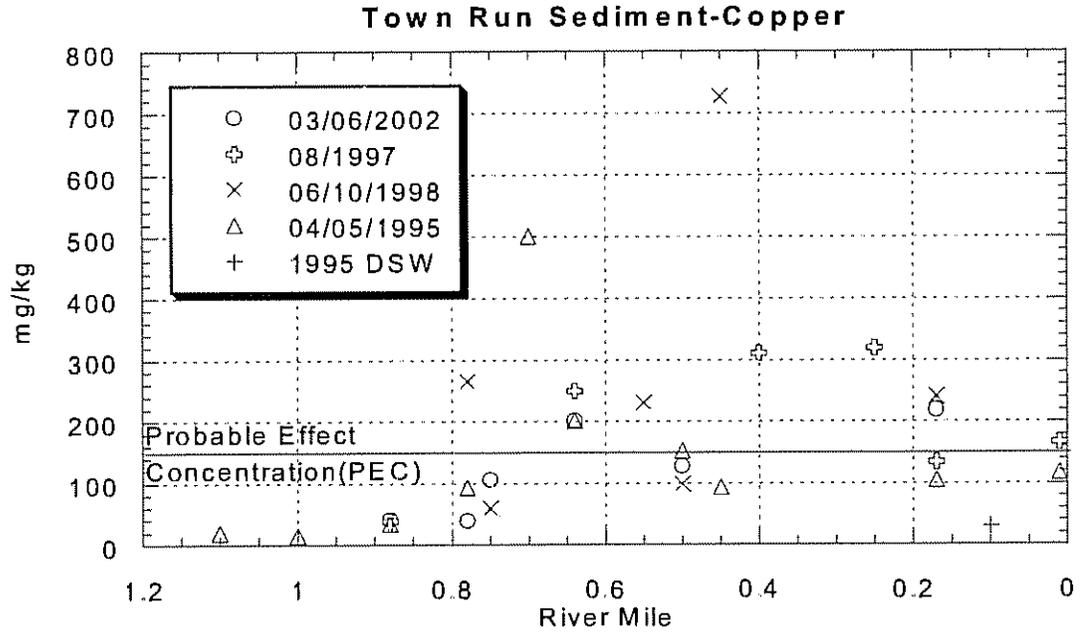
Figure 4. Town Run sediment sampling results for copper in relation to PEC.

Sediment sampling data for copper, lead, and zinc are shown in Figures 4, 5 and 6. Scatter plots of

the raw data for all sampling dates and locations are shown in relation to the probable effect concentrations (PEC). The PEC is the level of a contaminant above which adverse effects are expected to occur more often than not (MacDonald *et al.*, 2000). The PEC levels were consensus based from a review of the sediment quality guideline literature. Data from 2002 shows a reduction, below PEC levels, in copper, lead and zinc sediment concentrations in the vicinity of the Eljer Plumbingware facility following remediation efforts in late 1998 and early 1999 (Figure 4,5, and 6). The remediation efforts consisted of sediment removal from 220 feet of stream bed between the Eljer facility and Walnut Street. The 2002 sampling results indicate that sediment samples from river mile 0.64 and 0.17 still exceed the PEC for copper and lead.
