Remediation of a Skeet Shooting Range

Craig A. Cox, CPG, CP

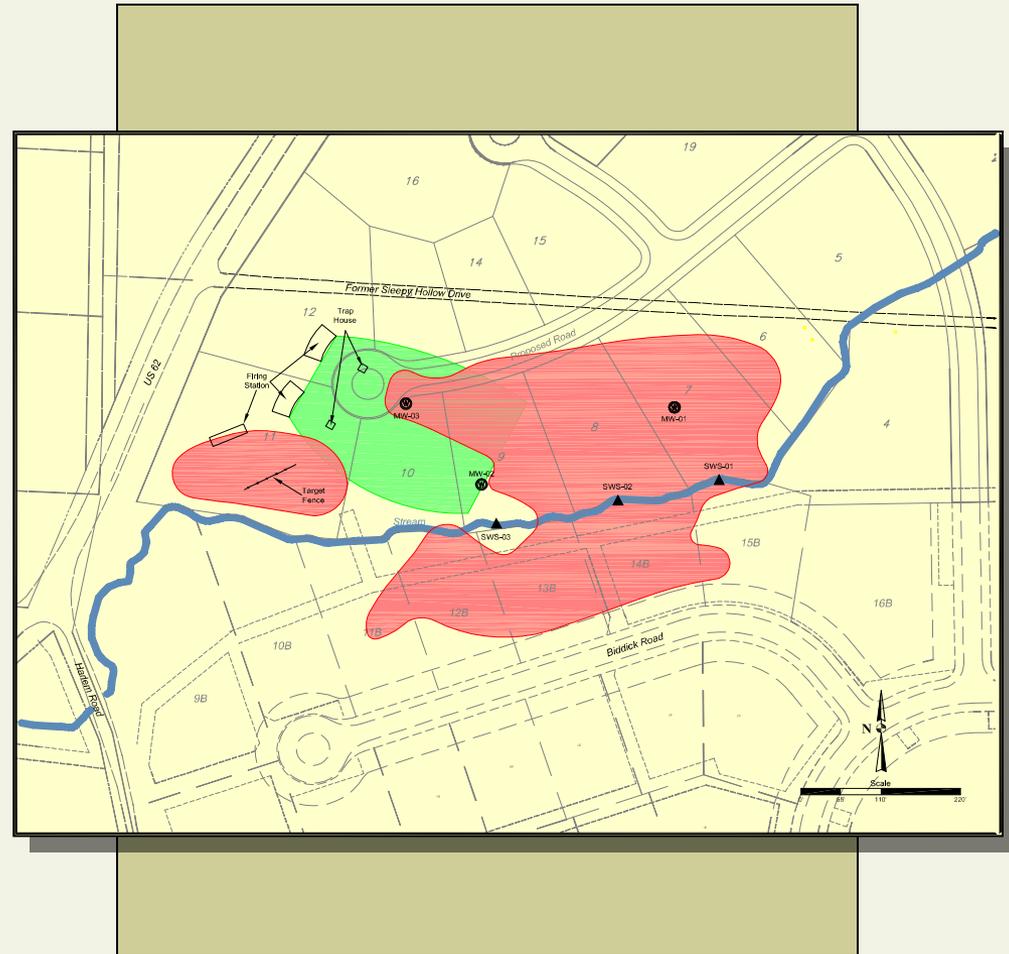
- Range appeared to be used for shot guns only.
- The range had two trap houses and associates firing stations.
- The range also had a fence used for targets.
- Clay targets and spent shell casings were abundant, but lead shot only seen in the stream.

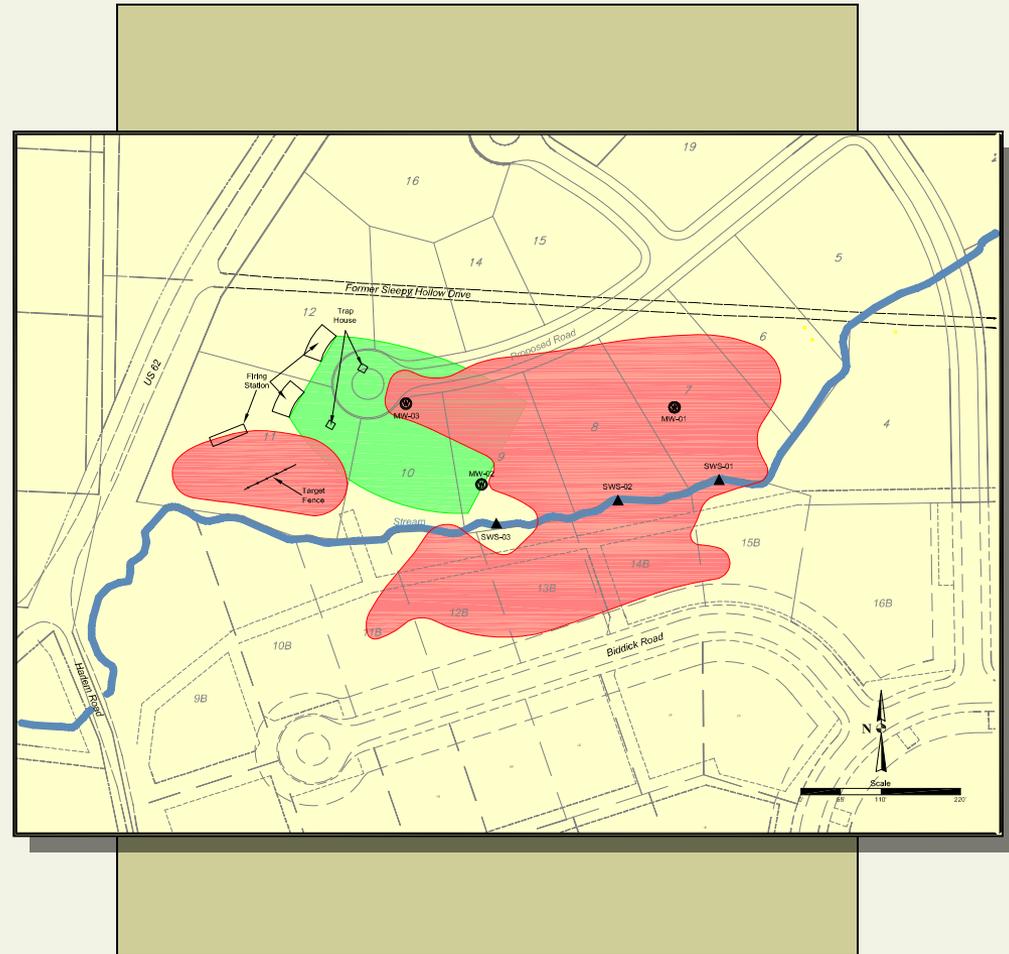
- Approximately 2-acres of the site was hazardous for lead.
- PAHs only in surface soils.
- Groundwater not affected.
- A 350-foot stretch of the stream contained lead shot as much as a foot thick.
- Surface water not affected, but vulnerable to effects of remediation of the sediment.
