Biological and Water Quality Study of the Bokes Creek Basin, 2013

Logan, Union and Delaware Counties

OHIO EPA Technical Report EAS/2015-04-03

May 1, 2015

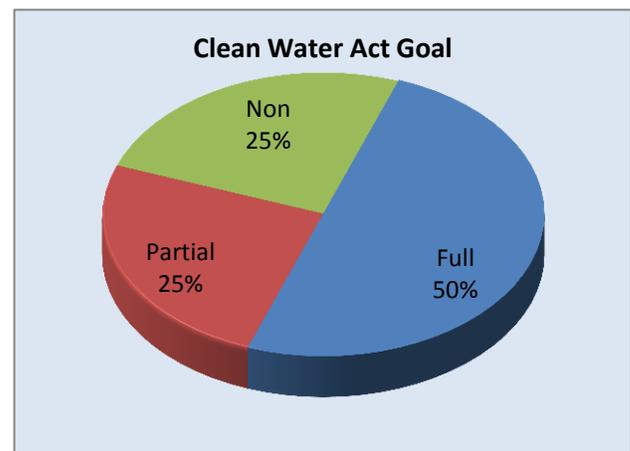
Figure 2. 50% of the sites sampled in the Bokes Creek study area met their designated aquatic life use biocriteria.

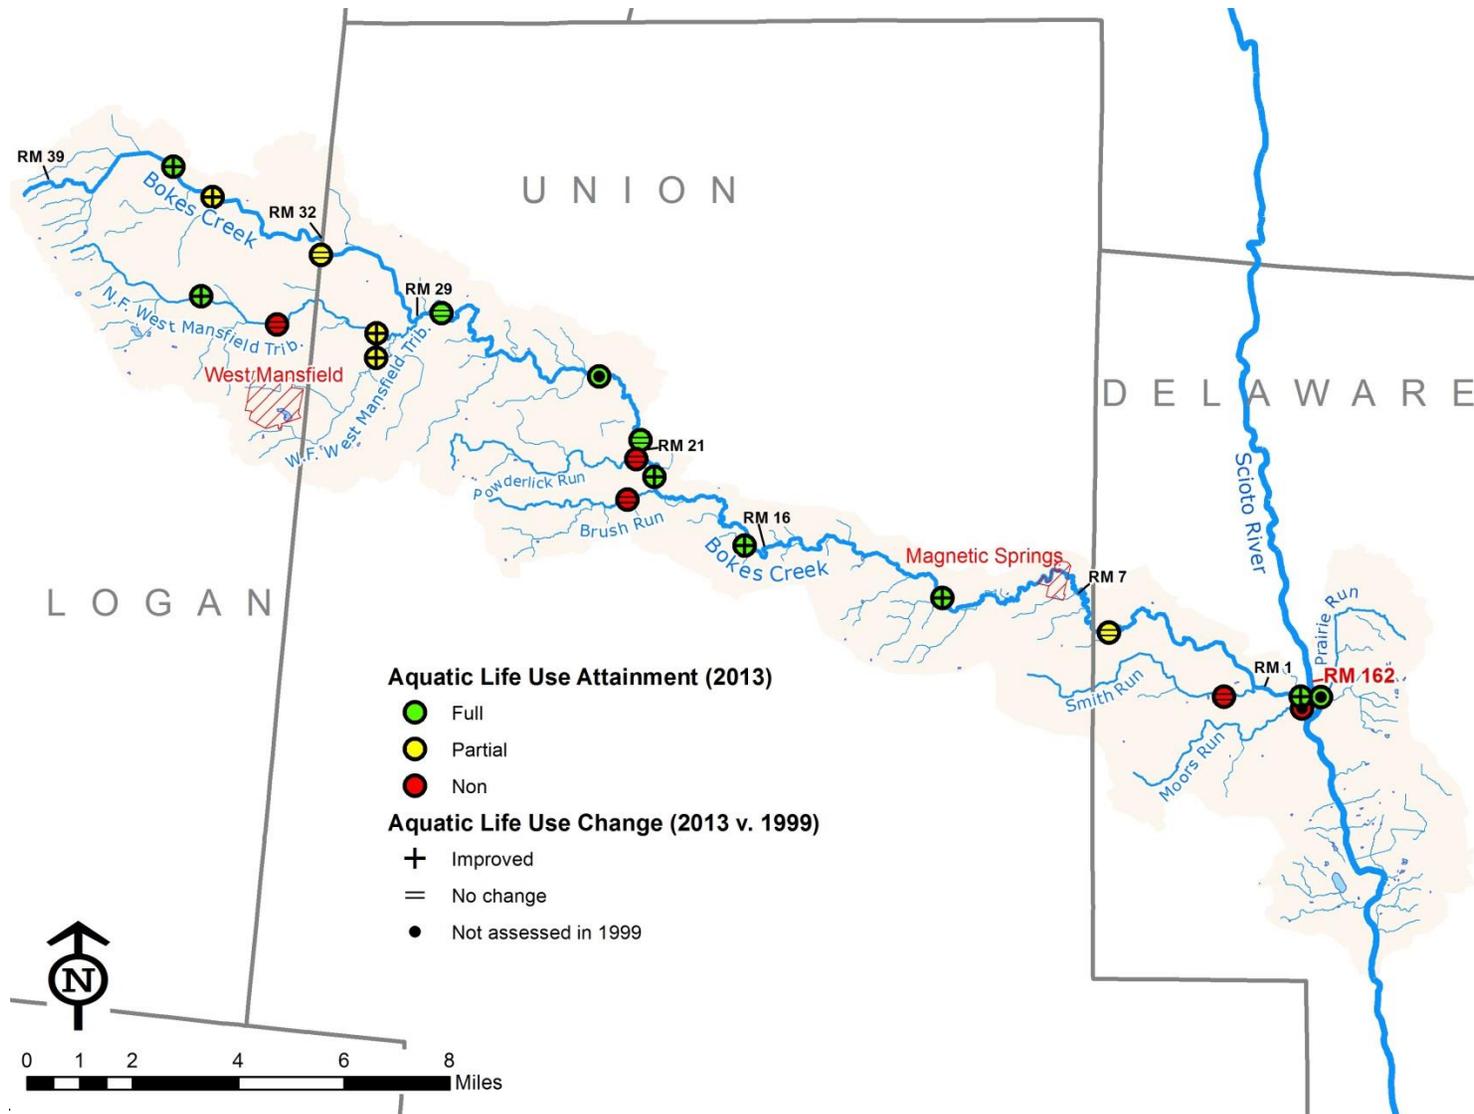
*The color of the site number corresponds to the narrative biological score (blue is exceptional to very good (meets EWH goals), green is good to marginally good (meets WWH goals) yellow is fair, orange is poor and red is very poor (fair, poor and very poor do not meet the goals of WWH).

Figure 3. Aquatic life use attainment status of sites in the Bokes Creek study area, 2013 and applicable changes in attainment status versus conditions encountered in 1999.

In 2013, fourteen years after the last comprehensive assessment of Bokes Creek, modest ecological improvement was documented in the watershed. Of the 20 biological stations assessed, 10 sites (50%) were fully meeting the designated ALU, 5 (25%) were partially attaining, and 5 (25%) were not attaining (Figure 3; Table 2).

Repeat sampling of fifteen sites allowed for a direct comparison of contemporary conditions with those of the earlier survey (Figure 3). In 1999, none of nine headwater sites (<20 mi.² drainage) met aquatic life use expectations. The 2013 survey produced one site in full attainment of the designated ALU. Five sites partially met and three headwater sites did not meet

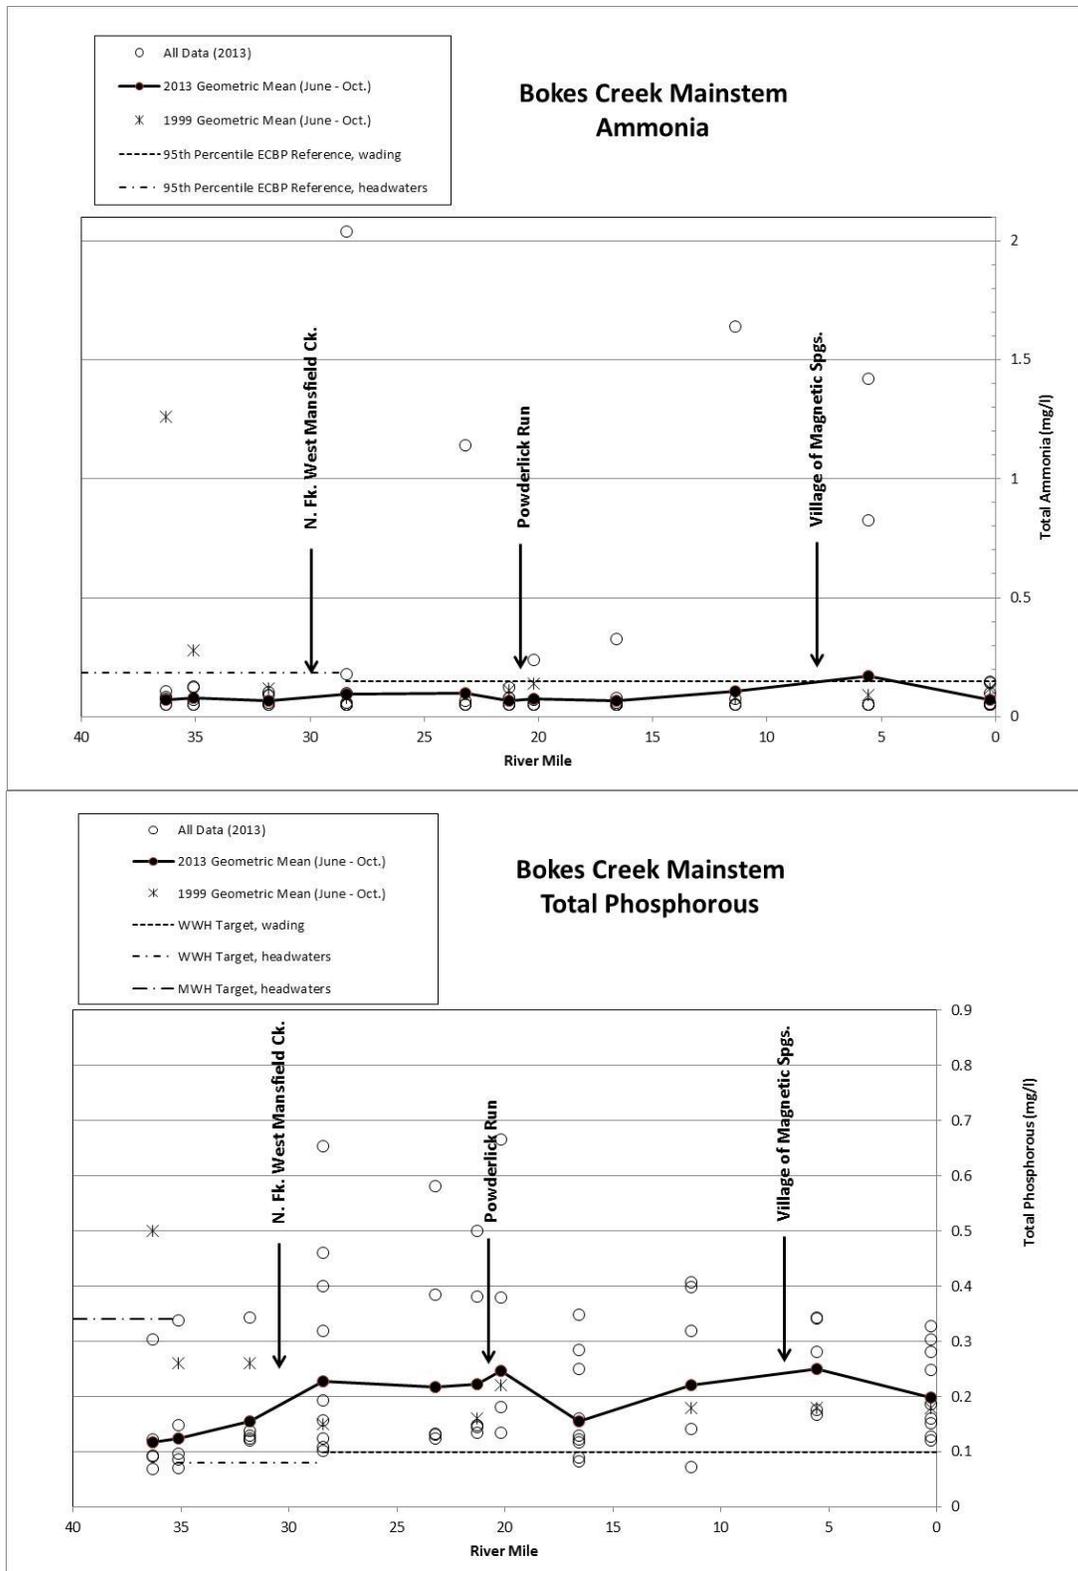
Figure 4. Longitudinal trend of ammonia (mg/l) and total phosphorus (mg/l) concentrations for the Bokes Creek mainstem, 1999 and 2013.

A comparison of 2013 and 1999 sampling results for nutrients that have been linked in the past to the degradation of Bokes Creek biological communities, are presented in Figure 4 and Figure 5. Chemical concentration data is plotted by river mile for total ammonia, total phosphorous (TP), nitrate (NO₃+NO₂) and total Kjeldahl nitrogen (TKN). Individual sampling events are shown as open circles and the 2013 geomean from each site is plotted as a darkened circle. For trend comparison purposes, 1999 geomean concentrations (where available) are shown as an asterisk. Insufficient nitrate data were collected in 1999 for a meaningful trend comparison; therefore 1999 nitrate data are not displayed. Tributary data of the same chemical parameters are presented in a similar fashion in Figure 6 and Figure 7, with each tributary sampling location plotted individually.

The chemical concentration plots illustrate several important spatial and temporal trends in Bokes Creek. Lowered concentrations of nutrients (ammonia, TP, and TKN) were the most evident among the Bokes Creek headwaters sites and in all of the North Fork West Mansfield Tributary sampling locations. Conversely, the downstream-most third of the Bokes Creek mainstem, particularly RMs 11.37 and 5.55, had consistently higher nutrient concentrations in 2013 than in 1999. These two sampling locations are the only Bokes Creek mainstem sites with increased ammonia geomeans in 2013 vs. 1999. In 2013, phosphorous concentrations were higher than those in the 1999 study from RM 28.4 to the mouth.

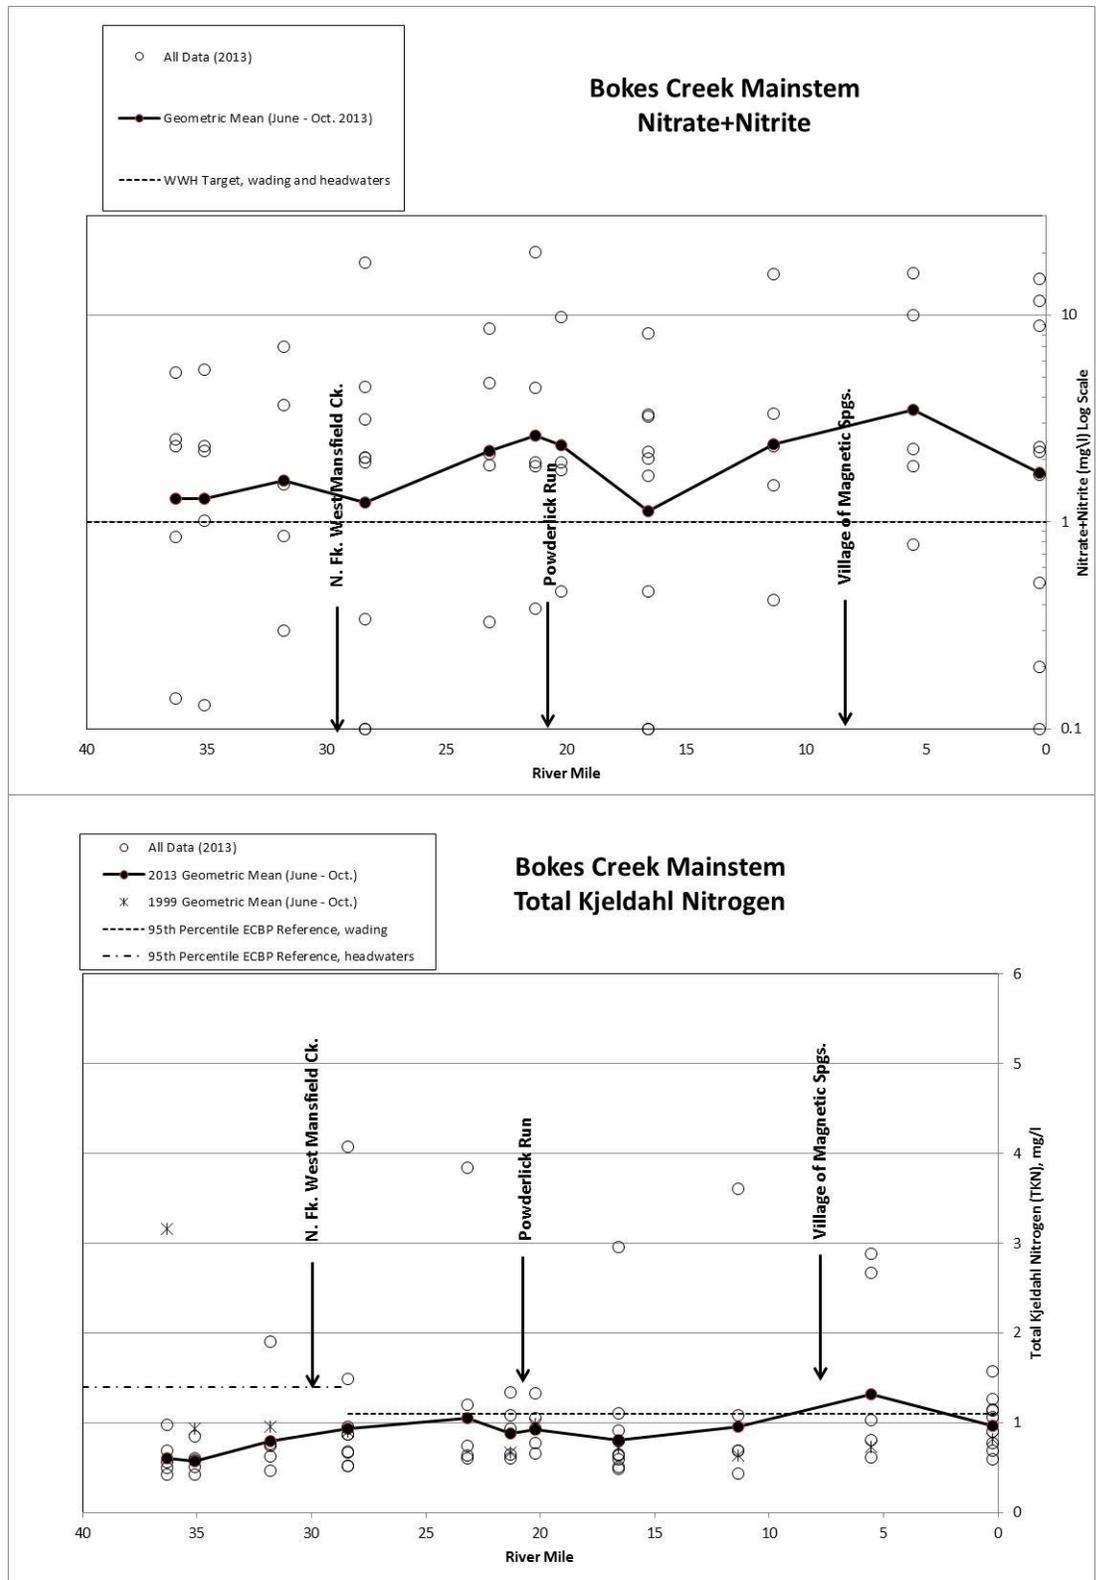
Figure 5. Longitudinal trend of nitrate+nitrite (mg/l) and total Kjeldahl nitrogen (mg/l) concentrations for the Bokes Creek mainstem, 1999 (where available) and 2013.

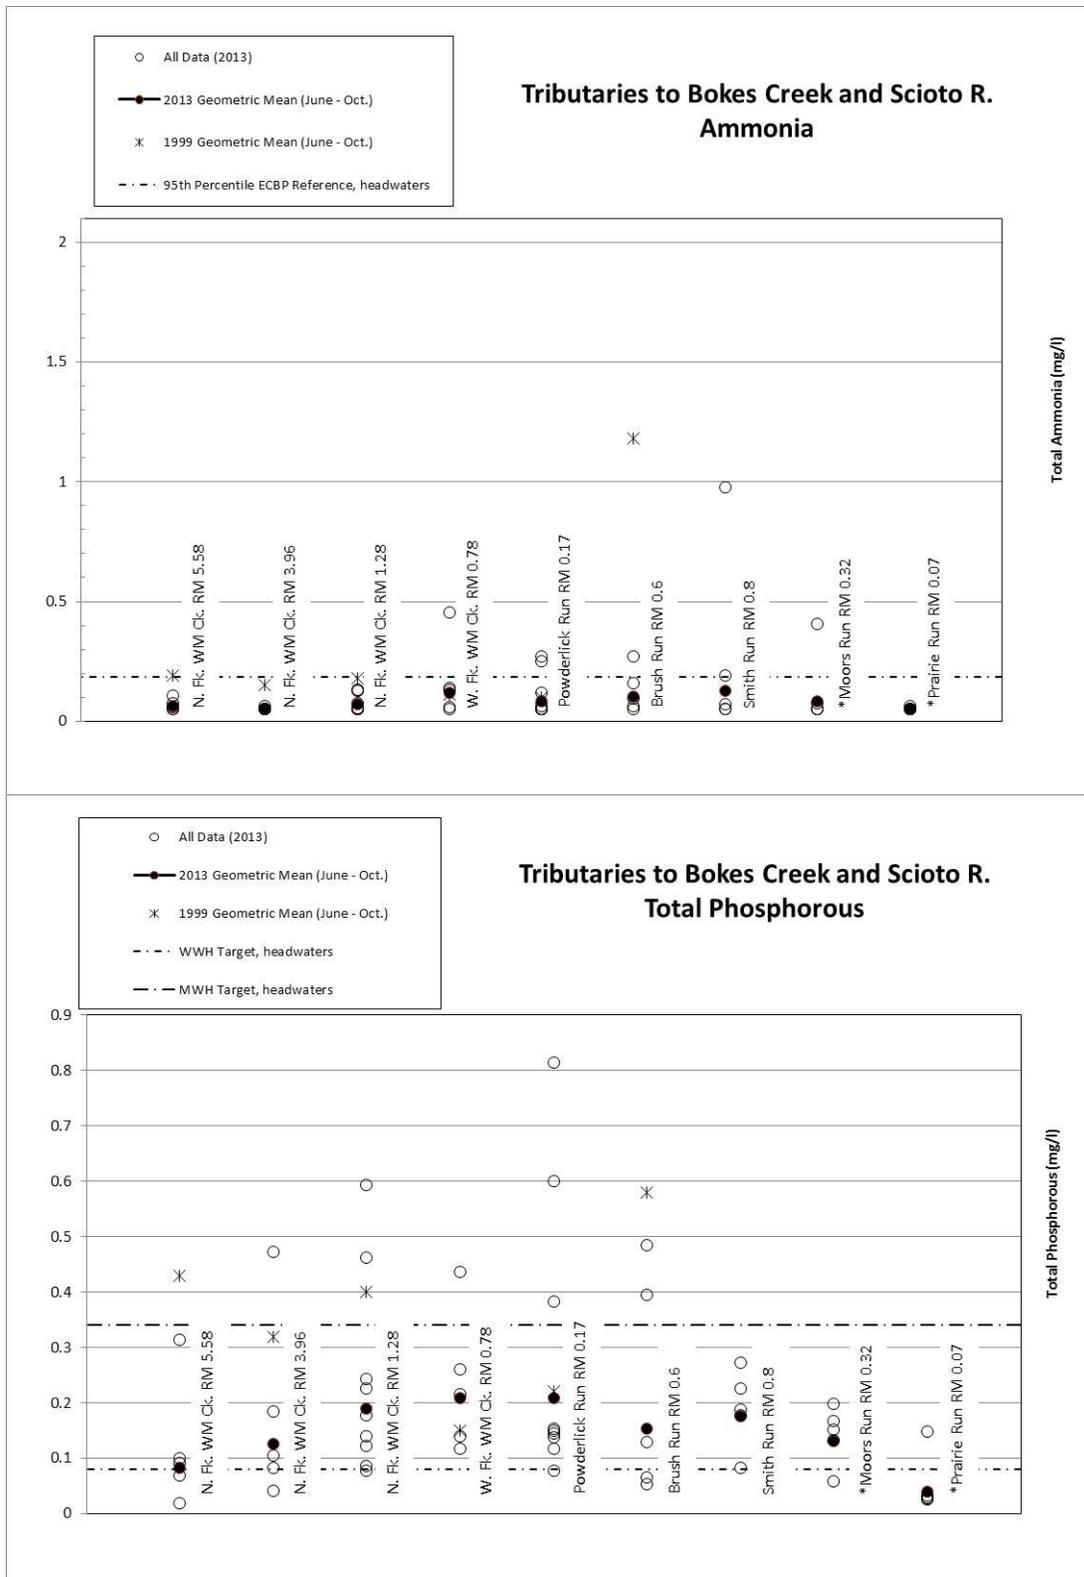
Figure 6. Ammonia (mg/l) and total phosphorus (mg/l) concentrations for tributaries in the Bokes Creek study area listed by sampling location, 2009 (where available) and 2013.

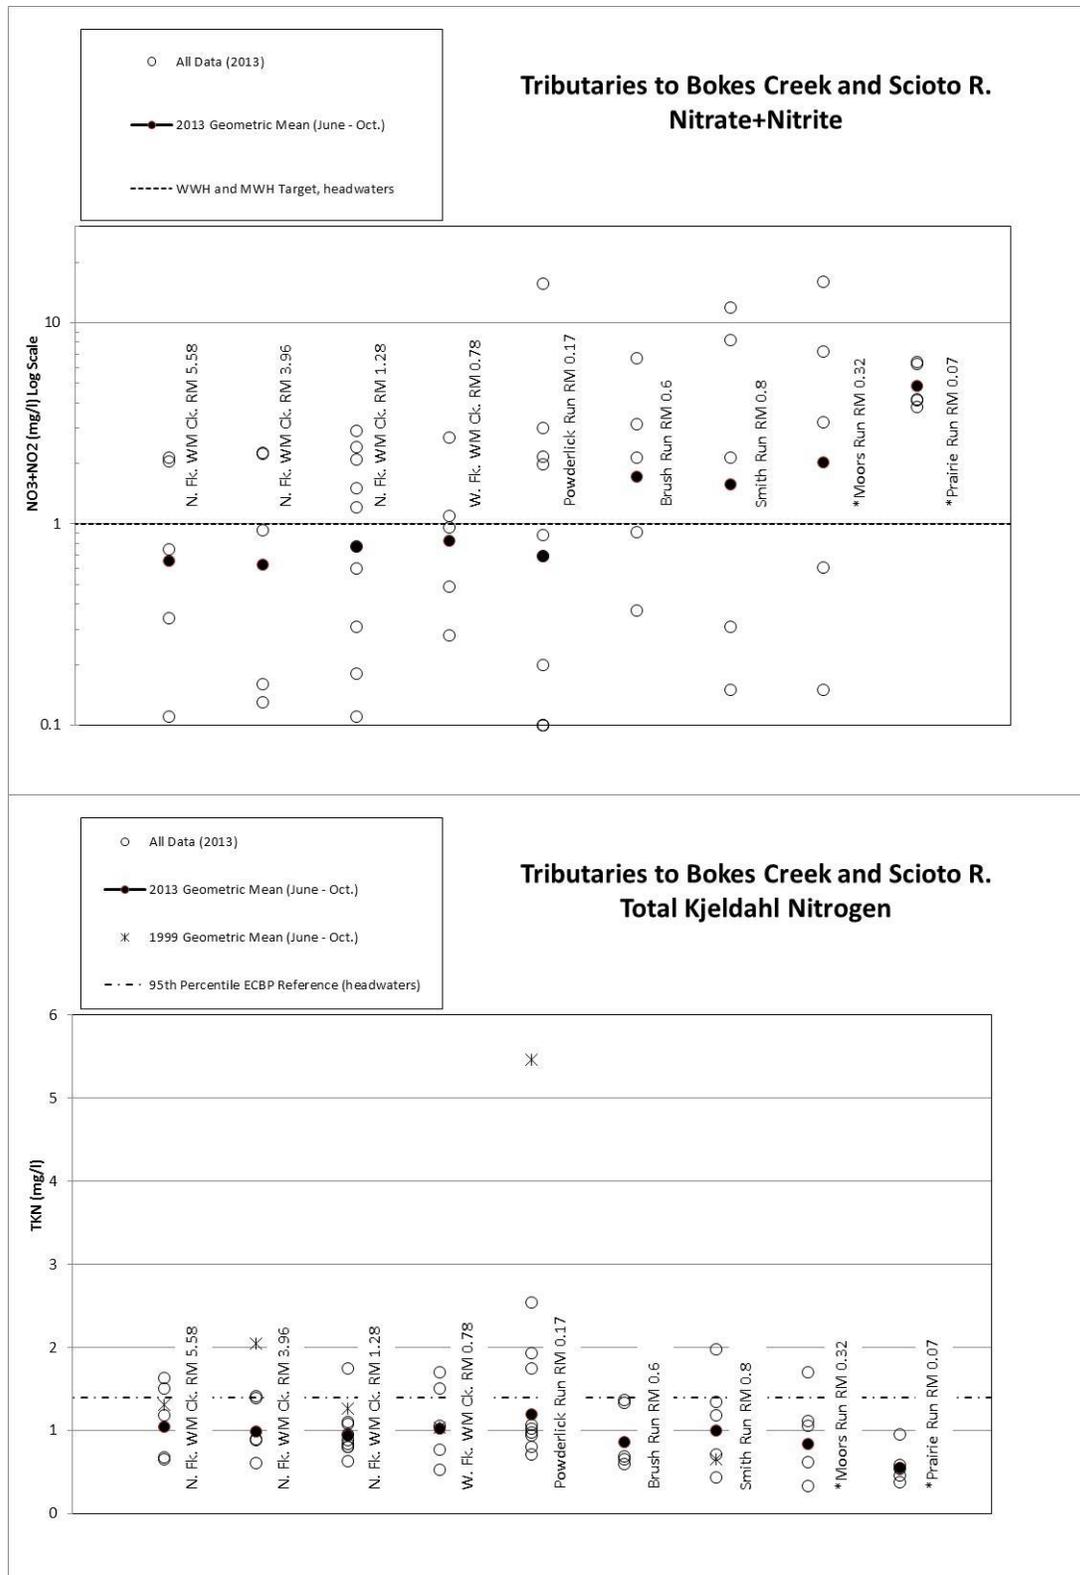
Figure 7. Nitrate+nitrite (mg/l) and total Kjeldahl nitrogen (mg/l) concentrations for tributaries in the Bokes Creek study area listed by sampling location, 2009 (where available) and 2013.

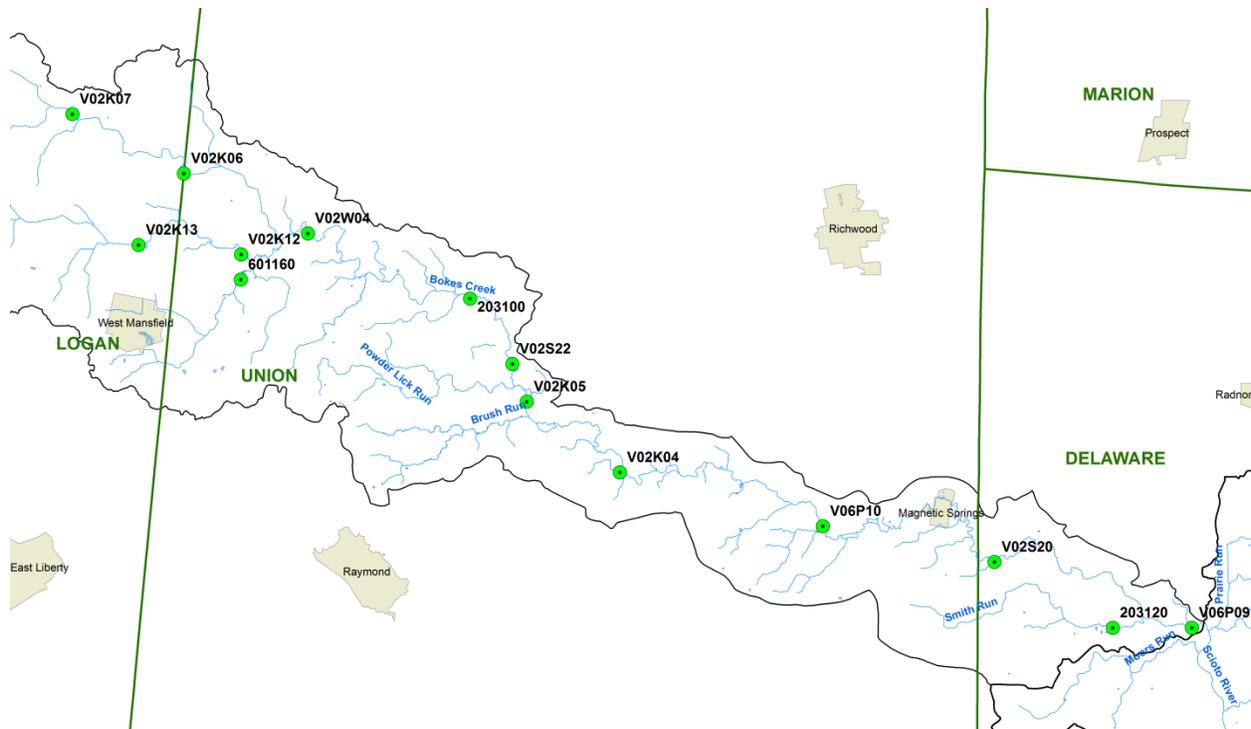
Figure 8. Map showing locations and station codes of sondes deployed in the Bokes Creek watershed.

Magnetic Springs. Fourteen sites were sampled with water quality sondes to represent the general watershed area as well as target areas of concern. Critical conditions for temperature and dissolved oxygen are times when flows are low, temperatures are high, and daylight is long. These are the times that streams are most sensitive to organic and nutrient enrichment. To capture these conditions, sondes are typically deployed in low flow conditions from June to September. Sondes were deployed September 4-6, 2013 primarily in the Bokes Creek mainstem. Three sondes were deployed in the North Fork West Mansfield Tributary near the town of West Mansfield, and one sonde was placed in Smith Run near the confluence of the Scioto River (Figure 8).

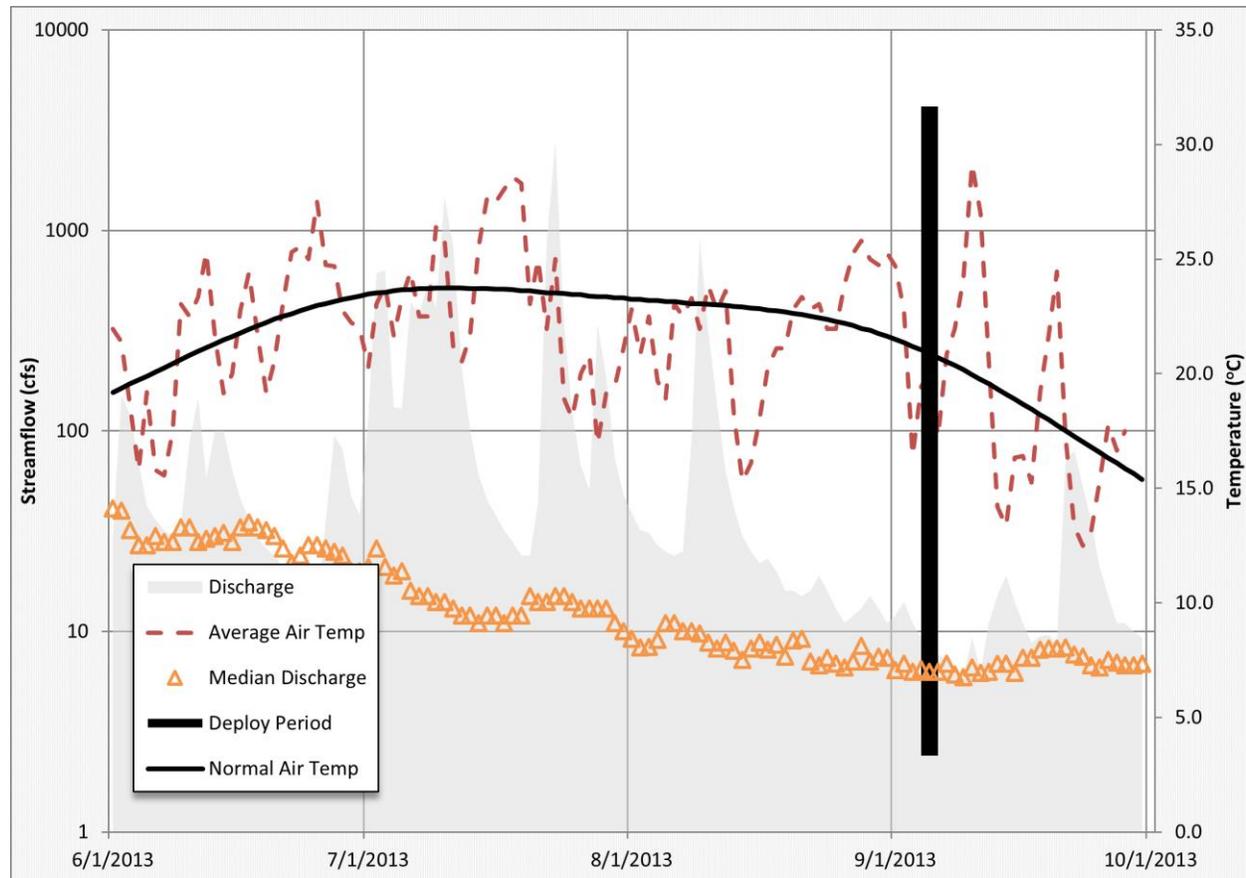
Figure 9. Graph of average daily stream flow relative to long term daily median stream flow for Mill Creek near Bellepoint, Ohio (USGS 03220000) including the average and normal daily air temperature (NOAA - GHCND:USC00334979) for the sampling season. No active gage was present in the study area; however, this nearby gage represents general hydrological conditions for the region.

Summer 2013 weather conditions were generally wetter than normal, though flows in nearby Mill Creek were close to median during the deployment period (Figure 9). Summary plots and tables of all data collected are included in Appendix I of this document. The plots are of hourly readings taken for temperature, dissolved oxygen, pH, and specific conductance.

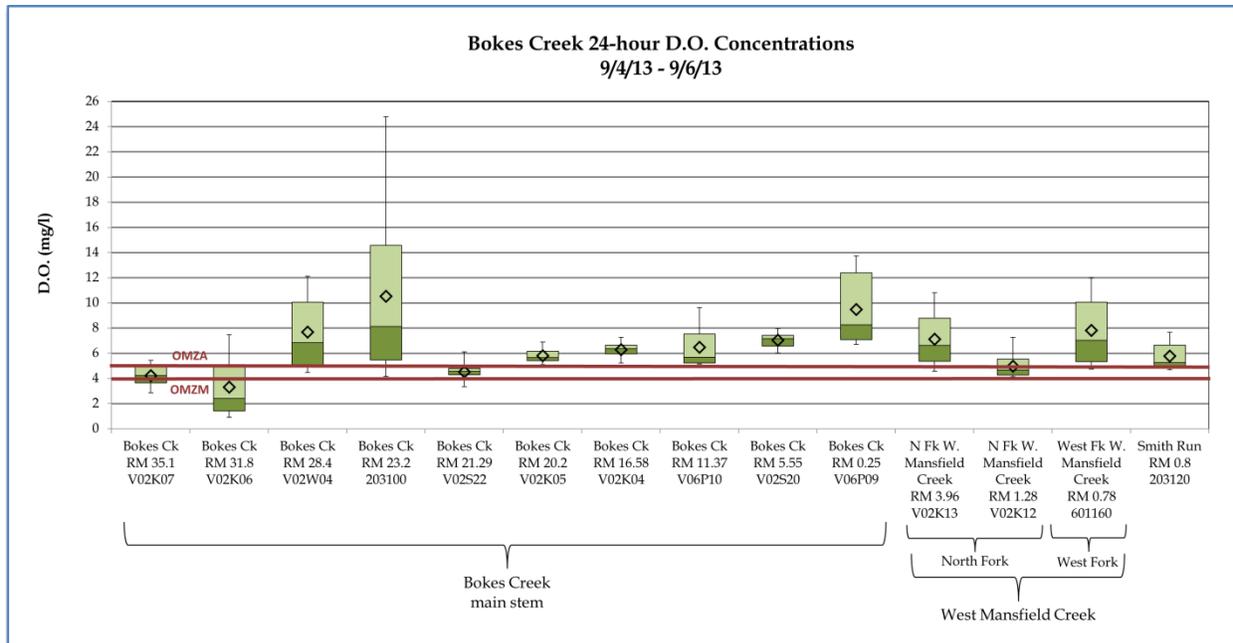
Figure 10. Box-and-whisker plots of daily D.O. at each sonde site, Bokes Creek watershed, 2013.

A summary of the exceedances is presented in Table 10. Exceedances of Ohio Water Quality Standards criteria (OAC 3745-1) for chemical and physical parameters derived from diel monitoring, 2013. Sondes collected 42-47 hours of data at 14 sites. Sonde water quality monitors record hourly readings for the duration of the deployment. Consequently, exceedances can be presented as both a measure of magnitude and duration. Rolling 24-hour averages were calculated using the hourly readings for comparison against the average criteria. The magnitude of an exceedance is presented as the most extreme value measured that exceeds the criteria. The duration is the count of consecutive hours that exceeded the criteria and is presented in parenthesis after the measure of magnitude. Applicable water quality criteria include: minimum D.O., average D.O., maximum temperature, pH and specific conductance. Of these criteria, only D.O. was not met. Figure 10 shows box-and-whisker plots of the D.O. for each site.

Four of the fourteen sondes deployed in the Bokes Creek watershed recorded exceedances. Bokes Creek at RMs 35.1 and 31.8 failed to meet both minimum and average D.O. criteria. At these two sites, biological indicators point to excessive nutrients. The source of nutrients is believed to be from the surrounding agricultural landscape. Geometric means for both nitrate-nitrite and total phosphorus exceeded established targets.

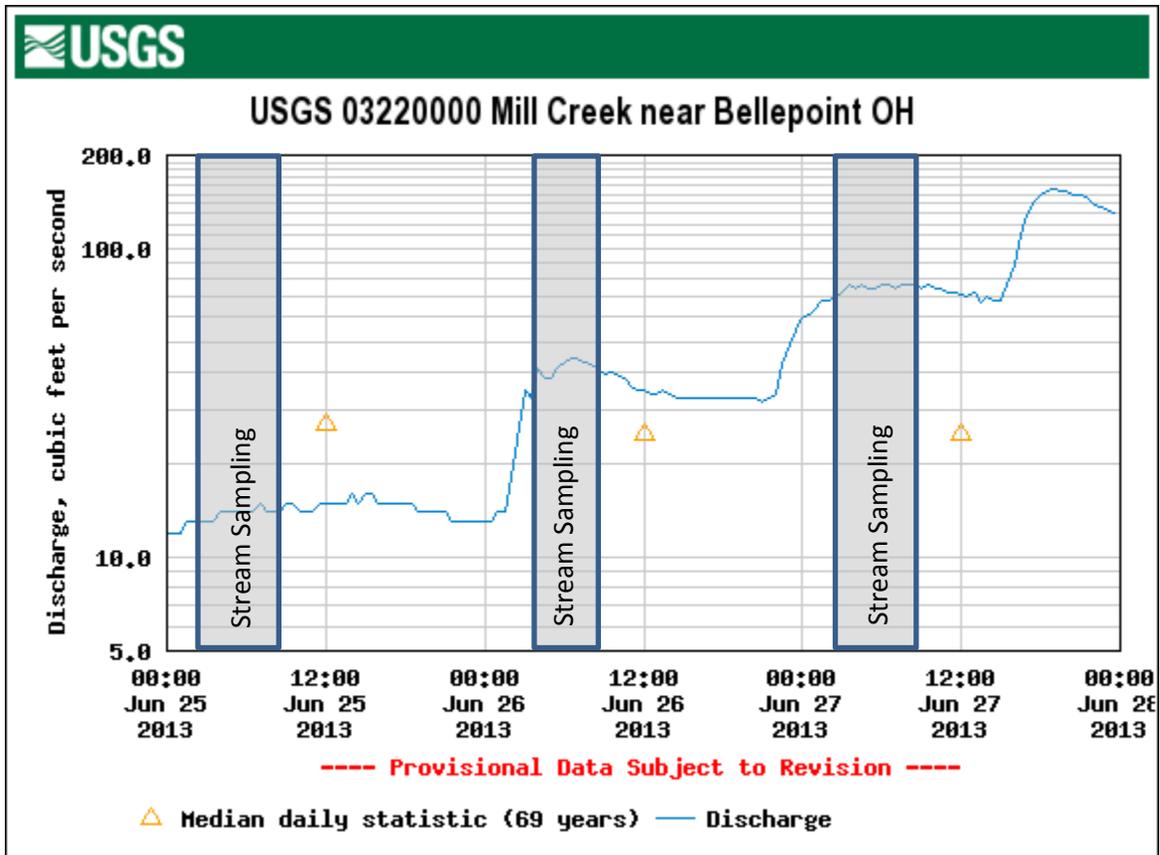
Figure 11. Stream flow on nearby Mill Creek, June 25-27 2013.

The precipitation and stream flow trend when a set of *E. coli* samples was collected can provide important information about potential bacteria sources. For instance, one of the sampling events in the Bokes Creek watershed took place on three consecutive days at the end of June 2013, and local weather patterns strongly influenced runoff and stream flow during that period.

Isolated thunderstorms began moving through the region late in the evening on June 25 and continued overnight into the early morning on June 26. The resulting surface runoff caused stream flows to rise. On the following two days when stream sites were sampled, small logs, leaves and other debris were observed floating downstream in turbid water. Stream flow quantity is monitored continuously by the US Geological Survey at a gaging station on Mill Creek, the adjacent watershed to the south, which likely experienced similar weather conditions. The increased flows in Mill Creek after the June 25-26 storm are depicted in Figure 11. *E. coli* concentrations were elevated following this storm at most sampling sites in Bokes Creek, but extraordinarily high *E. coli* was measured at Bokes Creek at Hoover-Moffitt Rd, RM 28.4, (32,000 cfu/100 ml) and Powderlick Run at Yearsley Rd, RM 0.17, (28,000 cfu/100 ml).

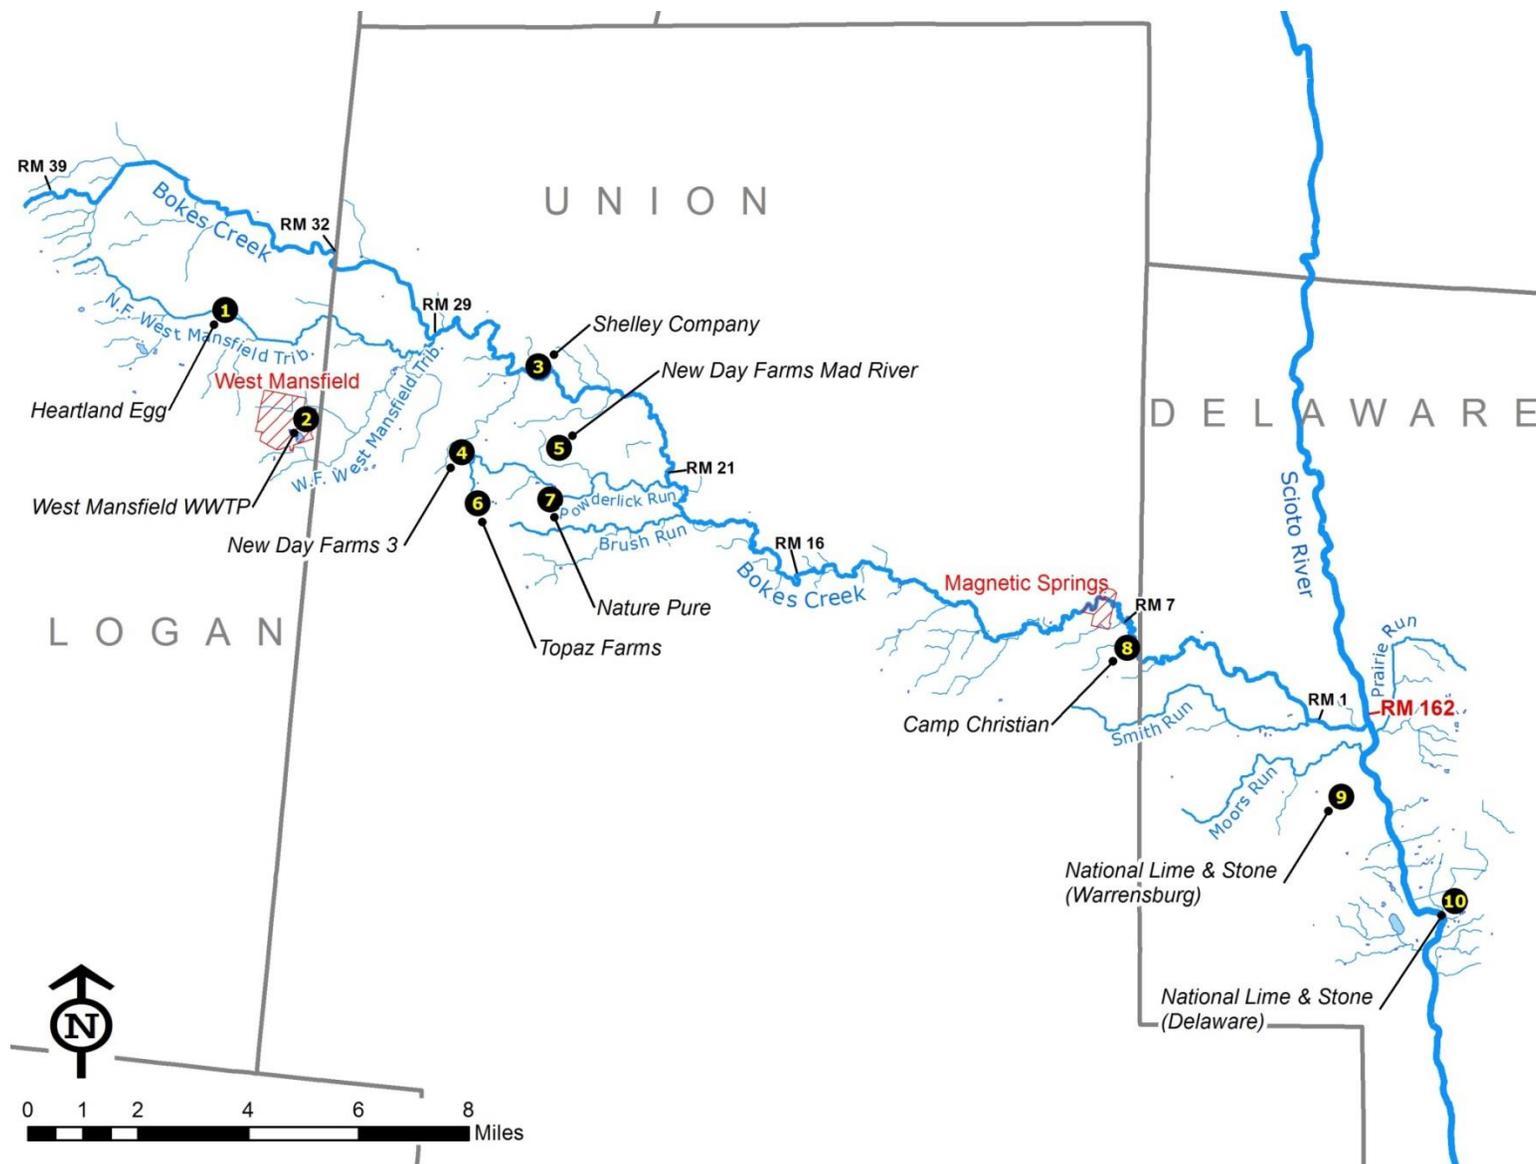
Figure 12. Regulated facilities in the Bokes Creek watershed, 2013.

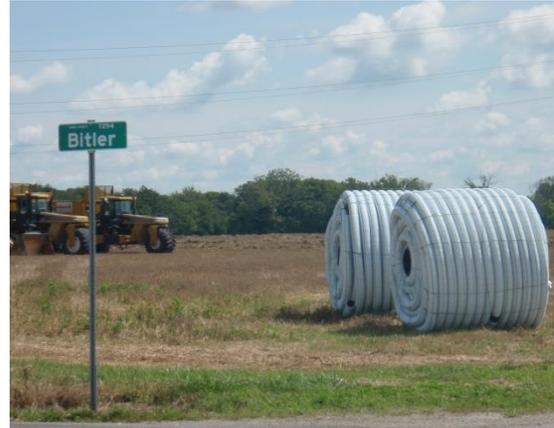
Figure 13. Installation of tile drainage in agricultural fields adjacent to Bokes Creek, 2013.

The 2002 Bokes Creek TMDL noted that tile drainage speeds the delivery of excess nutrients to Bokes Creek. Additionally, the contribution of subsurface moisture to the summer streamflows is reduced. As a result, the 2013 quantitative macroinvertebrate sampling results were compromised by a lack of surface flows and velocities and the concurrent effects on the efficacy of the artificial substrate collections. It appears that the total acreage of tiled agricultural fields will only increase in the future. One recent project was adjacent Bokes Creek near Bitler Rd. (Figure 13).

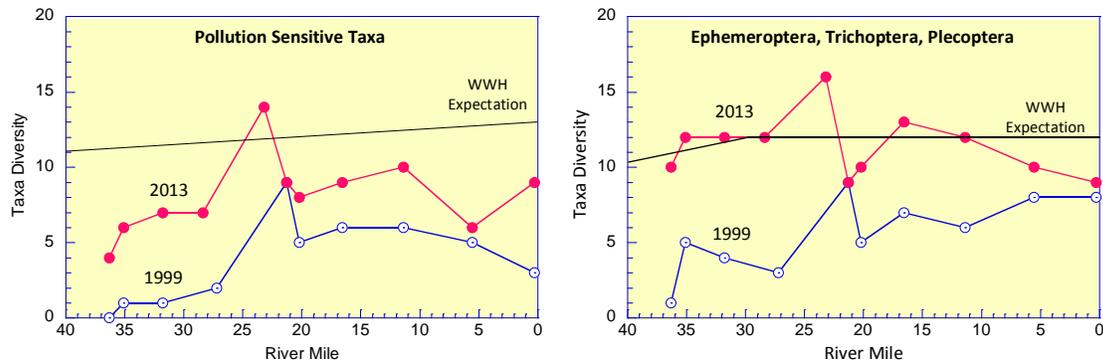
Figure 14. Longitudinal trend of the number of pollution sensitive and EPT taxa collected from the natural substrates plotted by river mile in Bokes Creek from 1999 and 2013.

In 1999, seven Bokes Creek sites were sampled from the headwaters (RM 36.30) to near the confluence with the Scioto River (RM 0.25). Comparable ICI scores between 1999 and 2013 were limited but qualitative sampling results allowed assessment of changes in community condition. Overall, the Bokes Creek macroinvertebrate results showed modest improvement over the past 14 years. Pollution sensitive taxa diversity was higher in 2013, but 10 of the 11 macroinvertebrate collections remained suppressed below the level expected from typical WWH sites of similar drainage area (Figure 14). EPT taxa collected from the natural substrates demonstrated similar modest improvement and met WWH expectations at six locations. One site where both pollution sensitive taxa and EPT diversity was unchanged (RM 21.29, Yearsley Rd.) was affected by the slow current and limited microhabitats within the sampled reach.

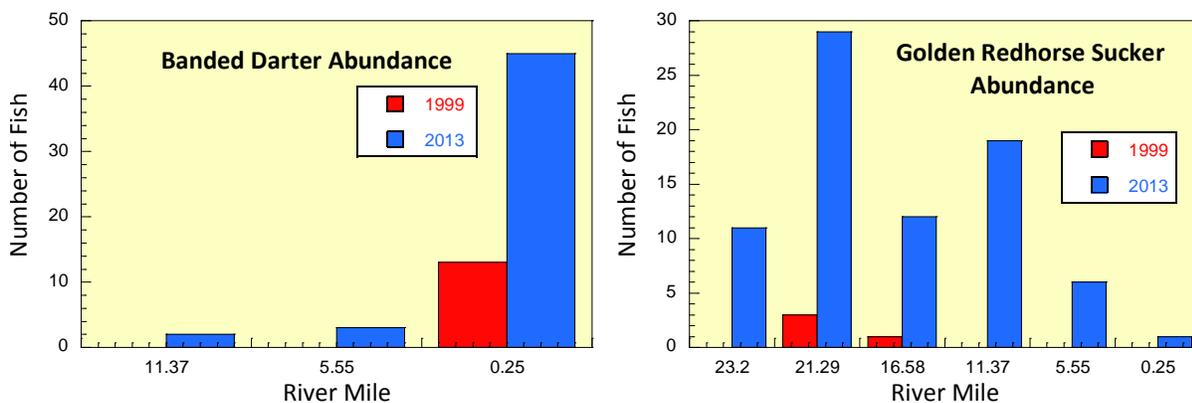
Figure 15. Increased longitudinal distribution and average abundance of banded darters (*Etheostoma zonale*) and golden redhorse suckers (*Moxostoma erythrurum*) in Bokes Creek in 2013 versus 1999.

Pollution sensitive fish species demonstrated significant increases in abundance between 1999 and 2013 and are evidence of improved water quality in Bokes Creek (Figure 15). Banded darters (*Etheostoma zonale*) have gradually increased their number and distribution in Bokes Creek. In 1999, a total of 13 individuals were collected at a single site near the mouth of Bokes Creek (RM 0.25), likely originating from the Scioto River. Separate sampling events at the same site produced 34 and 56 individuals in 2013 and this species was also recorded, in low numbers, upstream at RMs 5.55 and 11.37. Golden redhorse (*Moxostoma erythrurum*) distribution and frequency has similarly expanded. Six individuals were collected from two sites in 1999; 126 golden redhorse were collected from six locations in 2013.

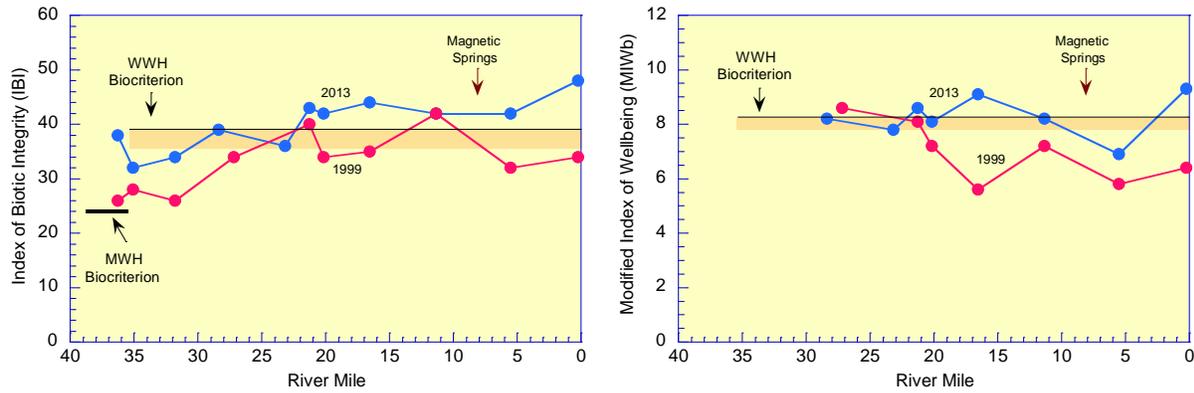
Figure 16. Longitudinal trend of IBI and MIwb scores plotted by river mile in 1999 and 2013.

Overall the fish community of Bokes Creek was modestly improved at nine comparable sites in 2013. Seven sites failed to meet ALU expectations in 1999 versus two sites in 2013 (Figure 16). Average number of native fishes increased from 13.9 in 1999 to 22.0 in 2013. Among the sites that had impaired

fish communities in 1999, both RMs 16.58 and 0.25 saw the largest improvements in MIwb scores resulting from increases in both diversity and abundance. However, the MIwb score, while somewhat higher than in 1999, decreased below the criterion downstream from Magnetic Springs at RM 5.55 and ten fewer species were recorded than at the next upstream site.

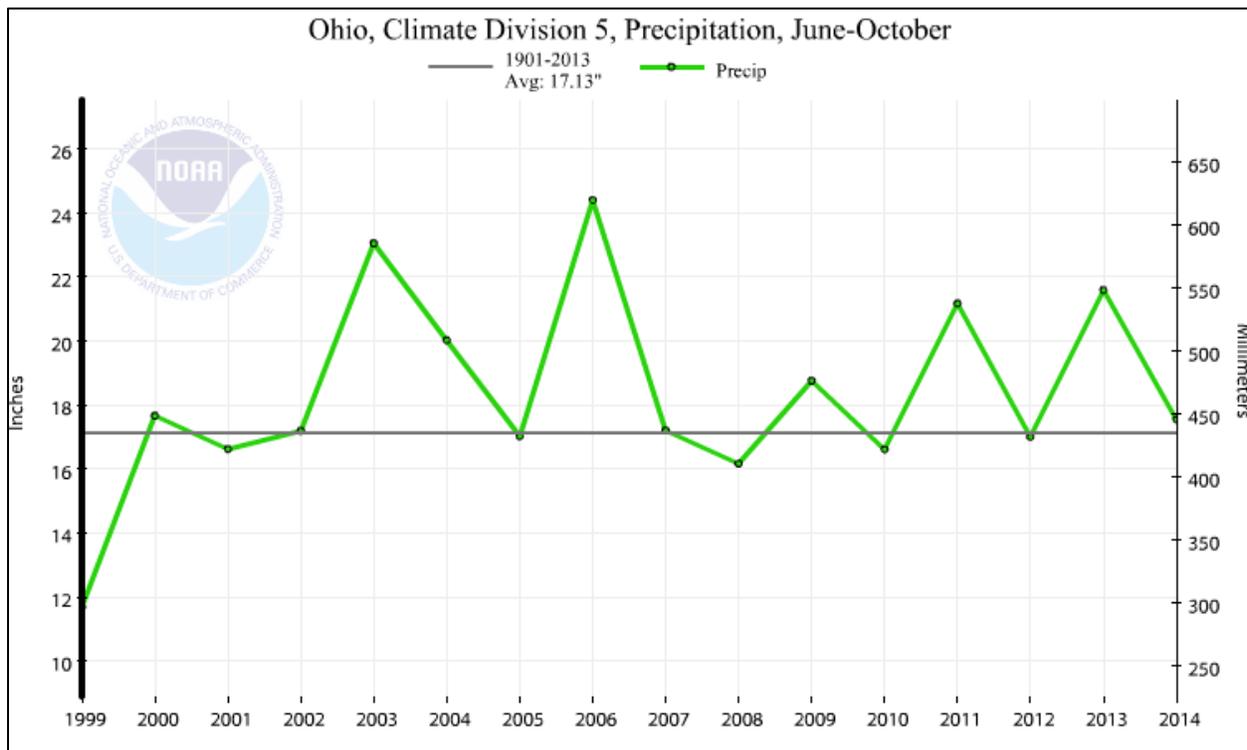
Figure 17. Precipitation totals for the five month period, June- October, recorded in central Ohio, 1999-2014. <http://www.ncdc.noaa.gov/cag/time-series/us>.

Overall, QHEI scoring in the Bokes Creek watershed increased compared to conditions documented in 1999. It is likely that the improved QHEI scores were at least partially attributable to increased precipitation throughout the watershed along with the establishment of a vegetated riparian buffer in the headwaters. Stream conditions were desiccated during the 1999 summer with much lower pool and riffle depths compared to those noted on the 2013 QHEI data sheets (Figure 18 and Appendix A). Many WWH attributes such as undercut banks, rootwads, rootmats, and boulders may have been left high and dry during the 1999 summer. However, natural recovery of past physical alterations and improved quality of riparian corridors may also be contributing to the improved habitat scores.

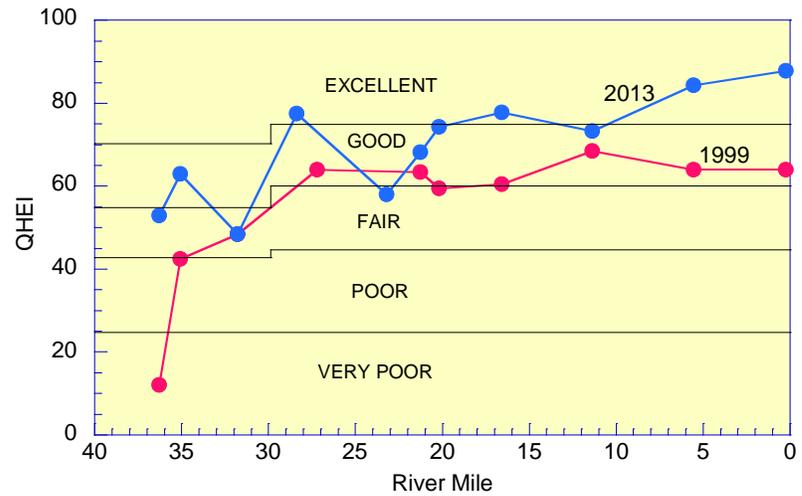
Figure 18. Longitudinal trend of Qualitative Habitat Evaluation Index (QHEI) scoring for Bokes Creek, 1999 and 2013.

The six sites which scored fair to poor quality habitat were Bokes Creek (RMs 36.3, 31.8 and 23.2), Powderlick Run, and North Fork West Mansfield Tributary (RMs 5.58 and 3.96) (Table 16). Despite the fair quality habitat score in the Bokes Creek headwaters (RM 36.3, QHEI=53.0), ongoing recovery from previous channel modifications has occurred since 1999 (Figure 20). The improved fish community at this location clearly demonstrated the link between the stream's improved habitat conditions compared to the 1999 survey (Figure 19). It can be surmised that the silt and sediment has reduced throughout the downstream

reaches in Bokes Creek due to the formation of a more stable headwater channel. Bokes Creek at RM 31.8 showed signs of recovery from instream livestock, during the 1999 survey this area had broken down banks with cattle in the stream. During the 2013 sampling a vegetated riparian buffer was present and no signs of instream livestock were encountered. Stream banks at RM 23.3 appeared to be actively eroding (Figure 19). A very narrow riparian corridor in this reach was comprised mostly of grass with just a few trees. Localized affects from erosion and downstream sedimentation could be lessened with the establishment of a wider treed riparian buffer.

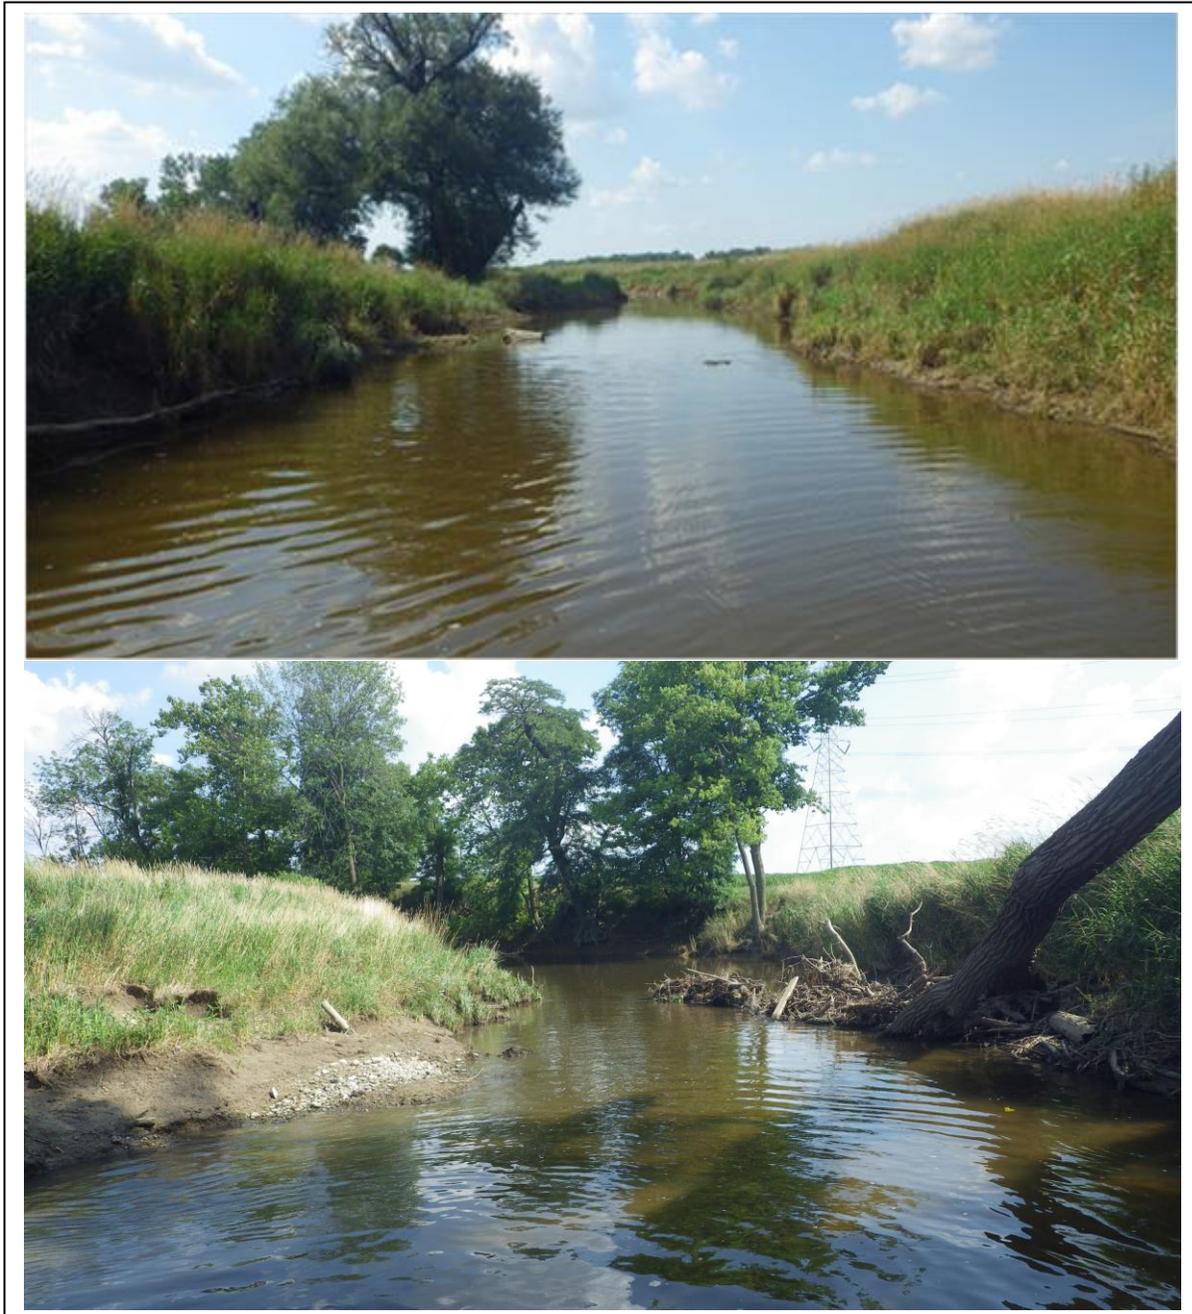
Figure 19. Pictured above looking upstream and looking downstream below, a very narrow riparian buffer with row crops planted less than 5m from Bokes Creek at RM 23.32. Further erosion and loss of farm land could be reduced by allowing the establishment of or actively planting a wider riparian buffer.
