Biological and Water Quality Study of the Bokes Creek Basin, 2013

Logan, Union and Delaware Counties

OHIO EPA Technical Report EAS/2015-04-03

May 1, 2015

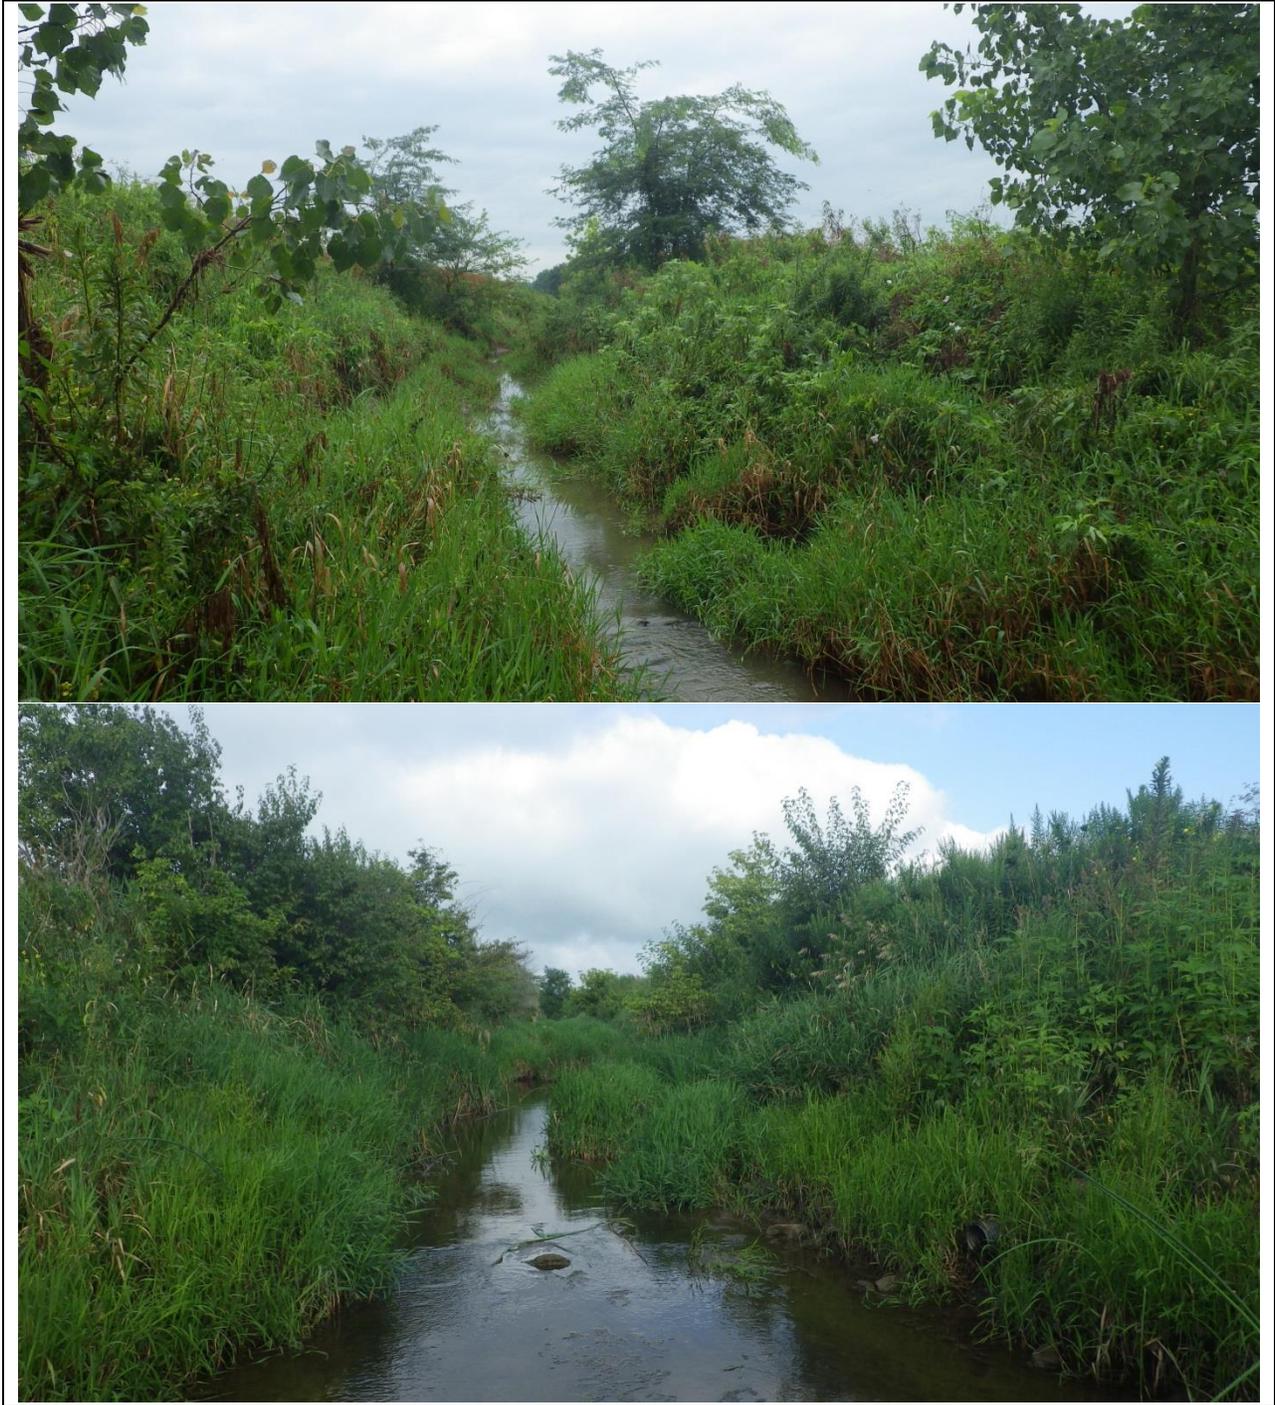
Figure 20. Ongoing recovery from channelization at sites in the Bokes Creek headwaters RM 36.3 pictured above and the North Fork Mansfield Tributary RM 3.96 pictured below has resulted in improved fish communities.

reaches in Bokes Creek due to the formation of a more stable headwater channel. Bokes Creek at RM 31.8 showed signs of recovery from instream livestock, during the 1999 survey this area had broken down banks with cattle in the stream. During the 2013 sampling a vegetated riparian buffer was present and no signs of instream livestock were encountered. Stream banks at RM 23.3 appeared to be actively eroding (Figure 19). A very narrow riparian corridor in this reach was comprised mostly of grass with just a few trees. Localized affects from erosion and downstream sedimentation could be lessened with the establishment of a wider treed riparian buffer.
