OHIO EPA Technical Report EAS/2015-03-02

**Biological and Water Quality Study of the Brandywine Creek-
Broken Sword Creek (Sandusky River) Study Area
2013**

**Hydrologic Unit Code (HUC)
04100011 01 03**

Crawford County, Ohio

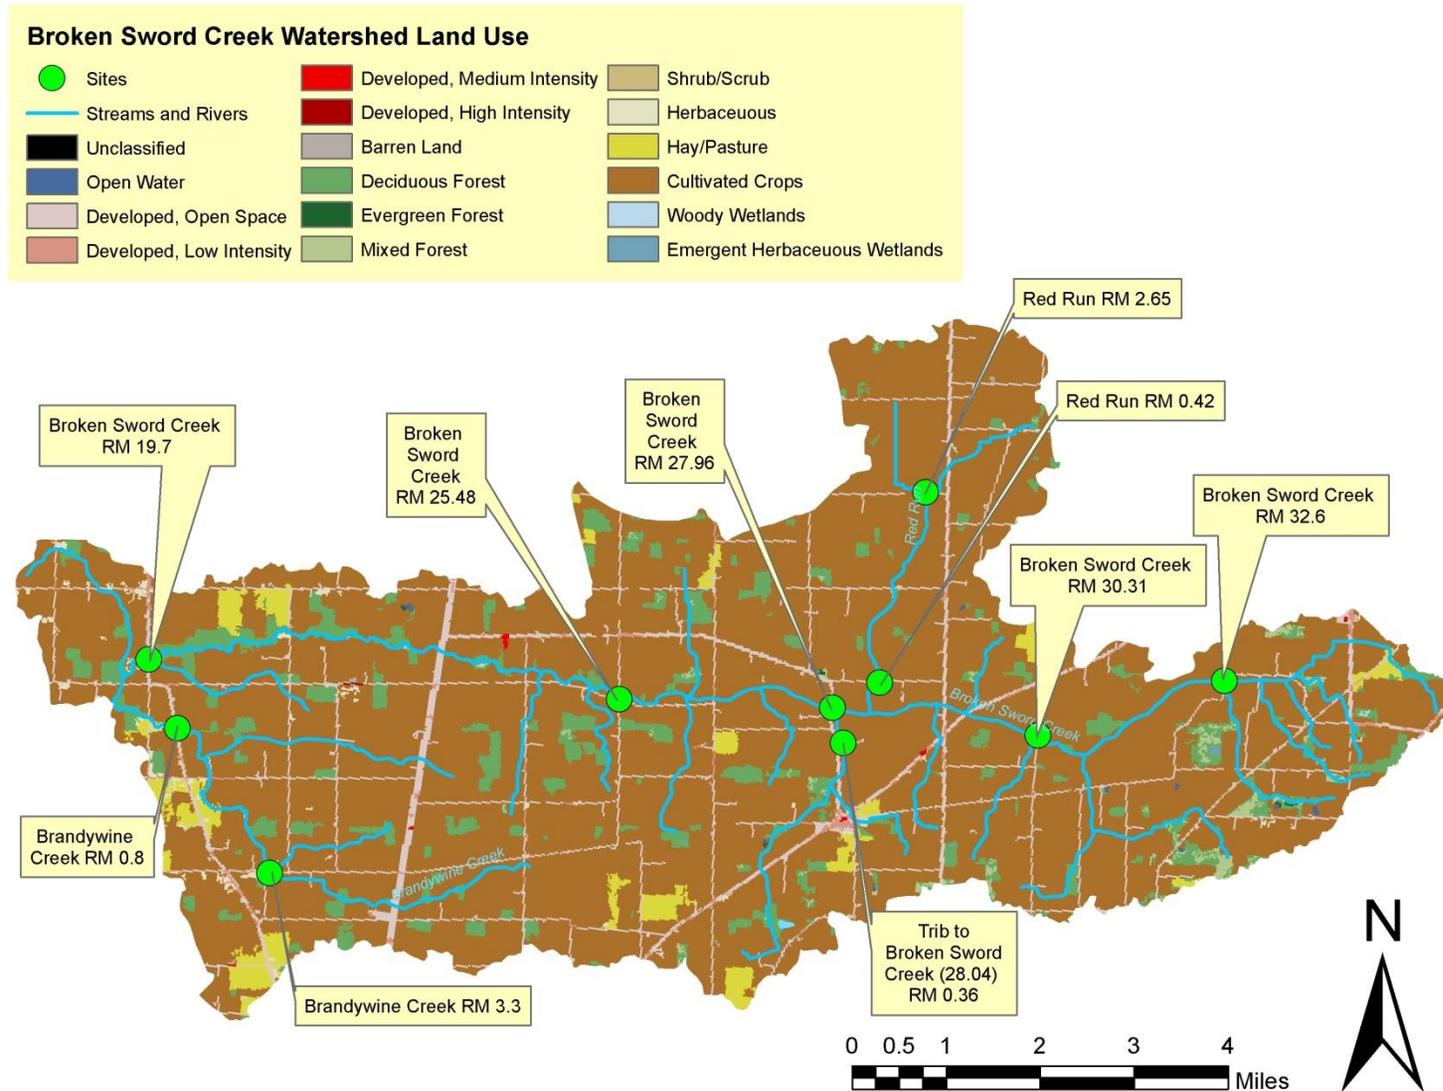
Figure 1. Sampling locations (biological, physical habitat, and stream chemistry) and current land uses in the Brandywine Creek-Broken Sword Creek HUC-12 watershed study area, 2013.

The entire watershed is located within the Eastern Corn Belt Plains (ECBP) ecoregion and there are no permitted point source dischargers present. Aquatic life use attainment conditions are presented in Table 1, and sampling locations are detailed in Table 2 and graphically presented in Figure 1. Stream samples, including sample type, drainage area and location information are listed in Table 2 and represented graphically in Figure 1.

watershed size at each sampling zone (Figure 1 and Table 2). Fish were processed in the field which included identifying each individual to species, counting individuals at all sites, weighing individuals at wading sites, and recording any external abnormalities. Discussion of the fish community assessment methodology used in this report is detailed in Biological Criteria for the Protection of Aquatic Life: Volume III, Standardized Biological Field Sampling and Laboratory Methods for Assessing Fish and Macroinvertebrate Communities (Ohio Environmental Protection Agency 1989a, 2014b).

Aquatic habitat at sites in the Broken Sword Creek watershed study area was evaluated using the Qualitative Habitat Evaluation Index (QHEI) developed by the Ohio EPA for streams and rivers in Ohio (Rankin 1989; Ohio Environmental Protection Agency 2006). Various attributes of the available habitat are scored based on their overall importance to the establishment of viable, diverse aquatic faunas. Evaluations of type and quality of substrate, amount of instream cover, channel morphology, extent of riparian canopy, pool and riffle development and quality, and stream gradient are among the metrics used to evaluate the characteristics of a stream segment, not just the characteristics of a single sampling site. As such, individual sites may have much poorer physical habitat due to a localized disturbance yet still support aquatic communities closely resembling those sampled at adjacent sites with better habitat, provided water quality conditions are similar. QHEI scores from hundreds of segments around the state have indicated that values higher than 60 are generally conducive to the establishment of warm water faunas while those which score in excess of 75 often typify habitat conditions which have the ability to support exceptional faunas. Habitat assessments using QHEI protocols were completed at each fish sampling reach in the Broken Sword Creek watershed study area (Figure 1).

A minimum of four surface water chemistry grab samples were collected from each of seven Broken Sword Creek watershed sampling locations between July 10, 2013 and June 23, 2014 (Figure 1 and Table 2). Stations were established in free-flowing sections of the streams and were primarily collected from bridge crossings. Surface water samples were collected directly into appropriate containers, preserved and delivered to Ohio EPA's Environmental Services laboratory. Collected water was preserved using appropriate methods, as outlined in the Surface Water Field Sampling Manual for Water Column Chemistry, Bacteria and Flows (Ohio Environmental Protection Agency 2013).

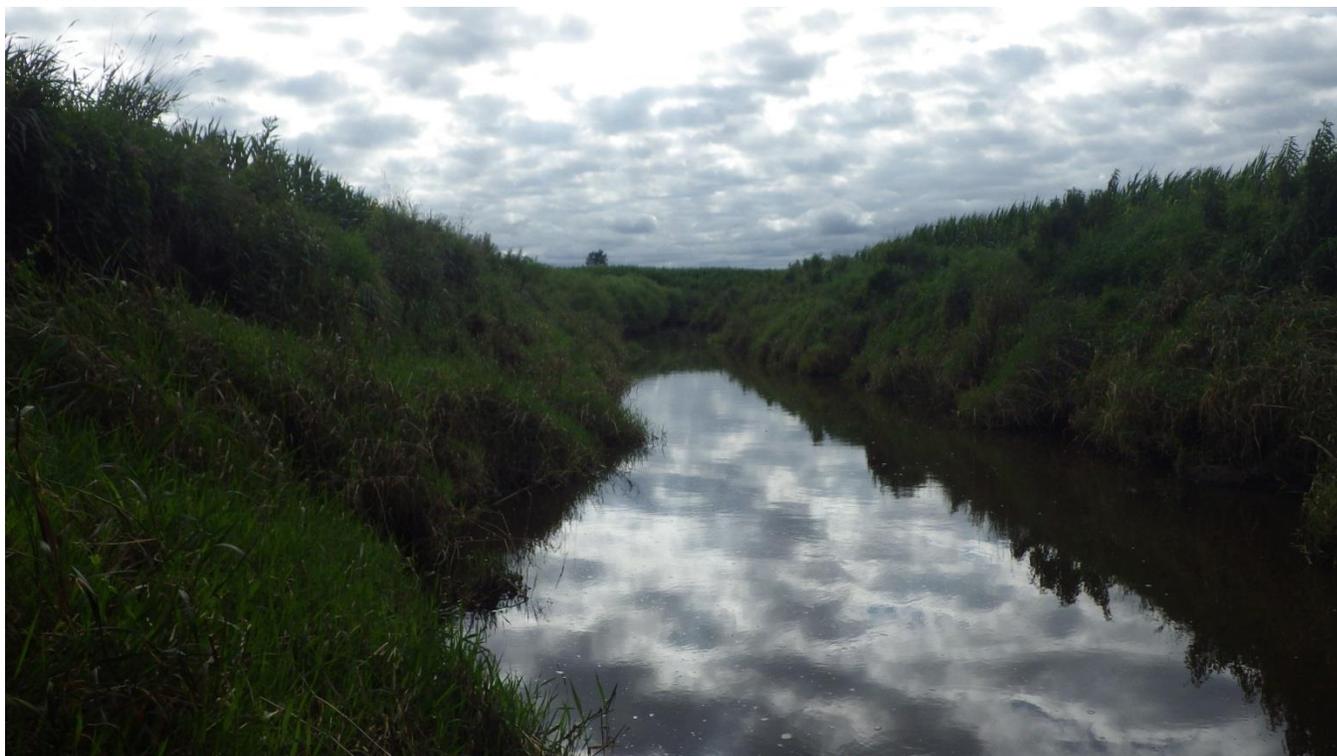
Figure 2. The narrow and incised stream channel in Broken Sword Creek at Schwemley Road (RM 32.6) pictured above is designed for the quick transport of storm water. The increase in water transport exacerbates downstream flooding and also means increased sediment and nutrient transport from the adjacent tiled fields.

Physical habitat in the Broken Sword Creek watershed study area ranged from good to very poor quality due to the extensive amount of channel modification throughout (Figure 2). It is recommended that drainage maintenance activities in these streams be as minimal as practical which should allow more natural stream habitat to recover, increasing the pollutant assimilative capacity and lessening downstream erosion and flooding in the watershed.

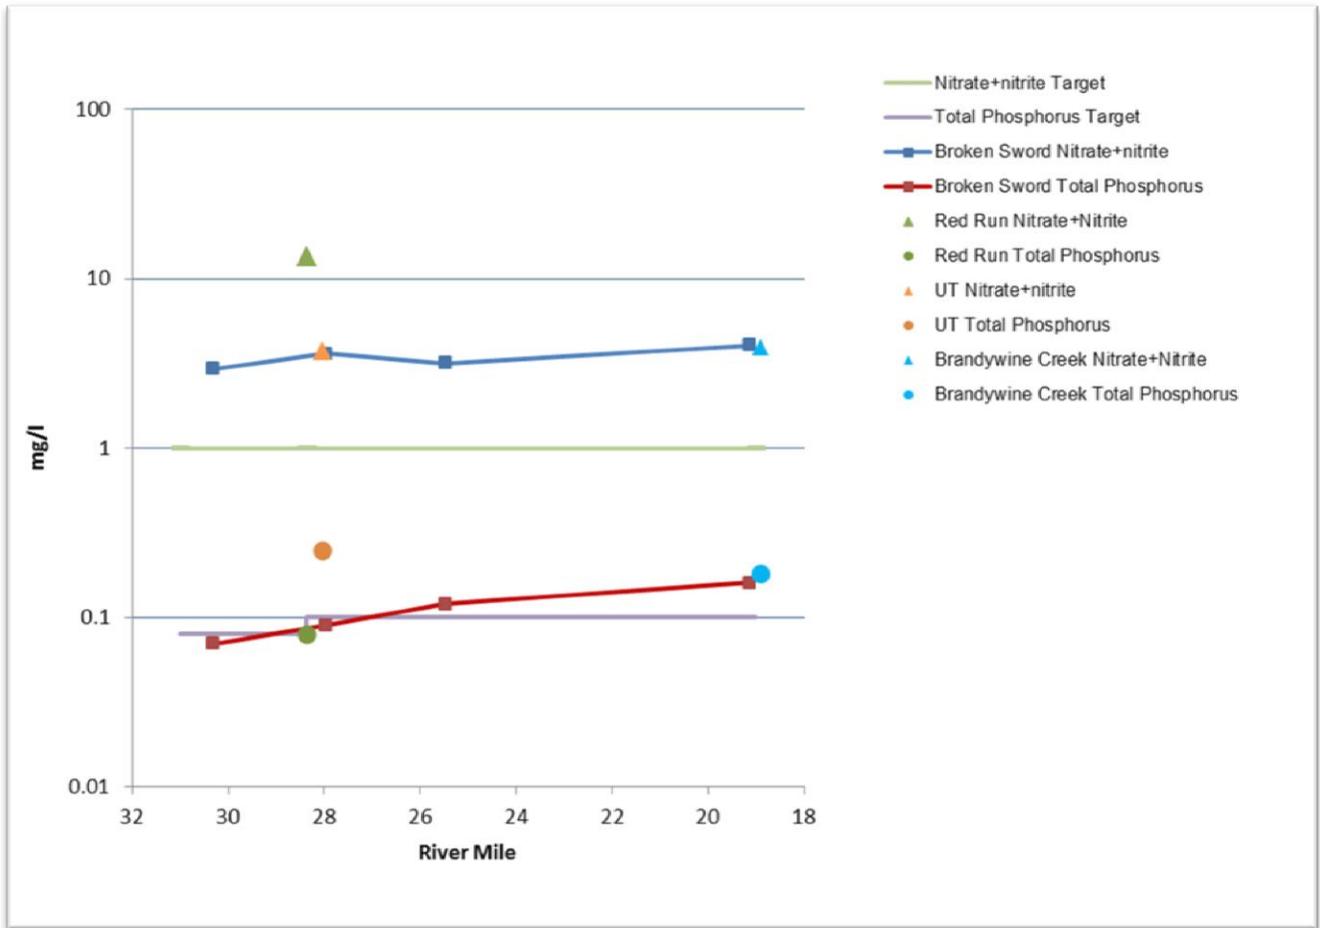
Figure 3. Geometric means for total phosphorus and nitrate+nitrite in the Brandywine Creek-Broken Sword Creek HUC-12 watershed study area, 2013-2014.

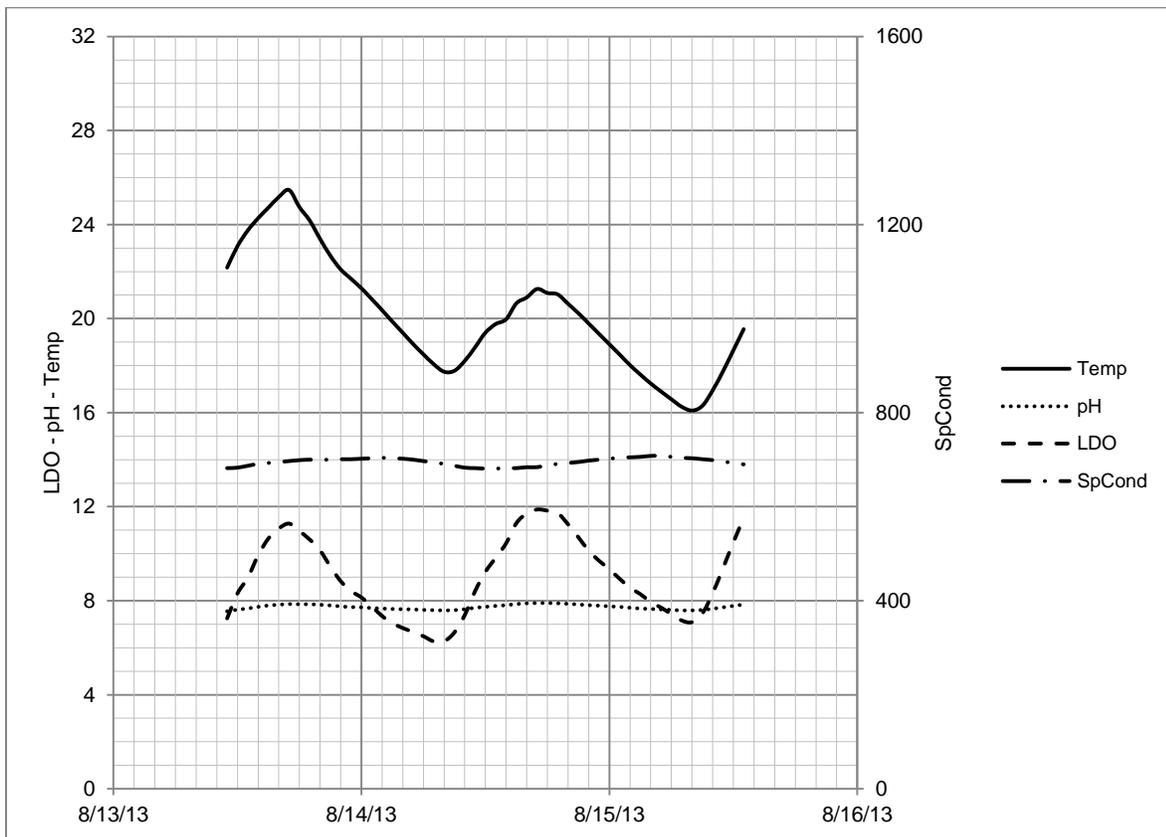
Figure 4. Plot of continuous field parameters collected with a submersible water quality sonde at Brokenword Creek (RM 25.48), August 13-15, 2013, with sensors taking hourly readings of temperature (Temp - °C), dissolved oxygen (LDO - mg/L), pH (S.U.), and specific conductivity (SpCond - µS/cm).

Water quality sondes were deployed to take hourly measurements of temperature, dissolved oxygen (DO), pH and specific conductivity. The sondes were deployed at four of the locations; Brokenword Creek at RM 25.48, Brokenword Creek at RM 23.0, Brokenword Creek at RM 19.7, and Brandywine Creek at RM 0.20. No exceedances of Ohio WQS criteria were captured during this time period. The measurement of DO throughout the 24-hour diel cycle is a strong indicator of primary production and therefore eutrophication. The sonde deployment generally represented low levels of primary production with the highest diel DO range being around 5 mg/L. Dissolved oxygen ranges decreased from upstream to downstream (Figures 4-7). The most likely reason for this phenomenon is decreased photosynthesis and the increasingly dense riparian canopy offered to the stream. However, the cool and cloudy conditions during the survey were not ideal for assessing the potential for eutrophication. There is some expectation that if temperatures were warmer and cloud cover reduced that eutrophic conditions would have been expressed at the most upstream Brokenword Creek site. The dominantly agricultural landscape serves as an ample supply of nutrients and the lack of a woody riparian in these upstream reaches do little to stymie eutrophication.

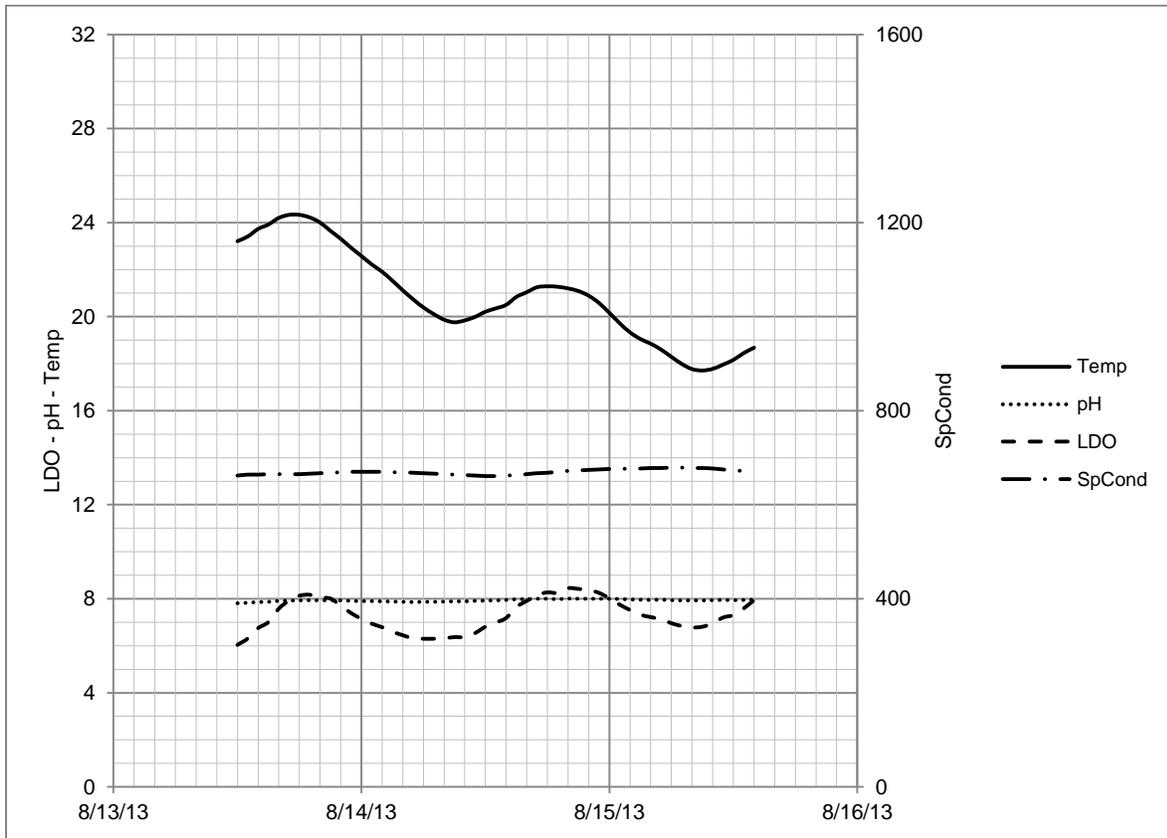
Figure 5. Plot of continuous field parameters collected with a submersible water quality sonde at Brokenword Creek (RM 23.0), August 13-15, 2013, with sensors taking hourly readings of temperature (Temp - °C), dissolved oxygen (LDO - mg/L), pH (S.U.), and specific conductivity (SpCond - µS/cm).

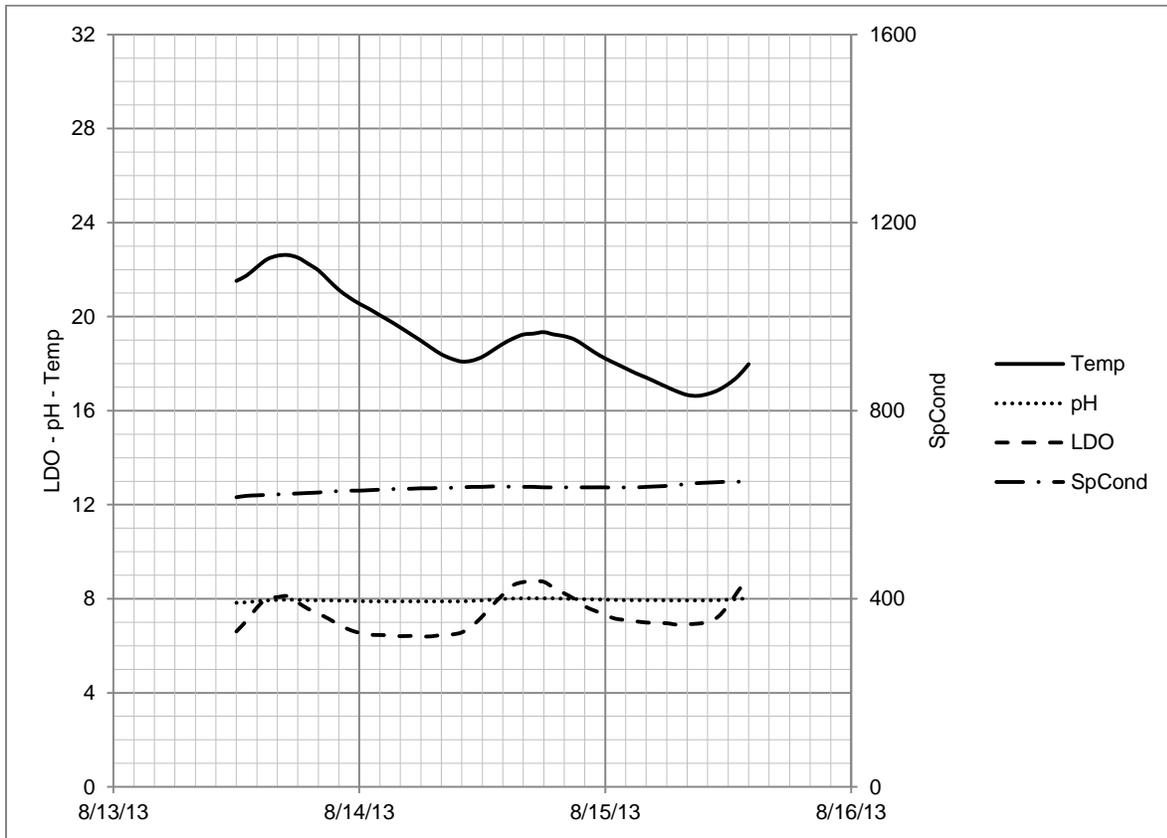
Figure 6. Plot of continuous field parameters collected with a submersible water quality sonde at Brokenword Creek (RM 19.7), August 13- 15, 2013, with sensors taking hourly readings of temperature (Temp - °C), dissolved oxygen (LDO - mg/L), pH (S.U.), and specific conductivity (SpCond - µS/cm).

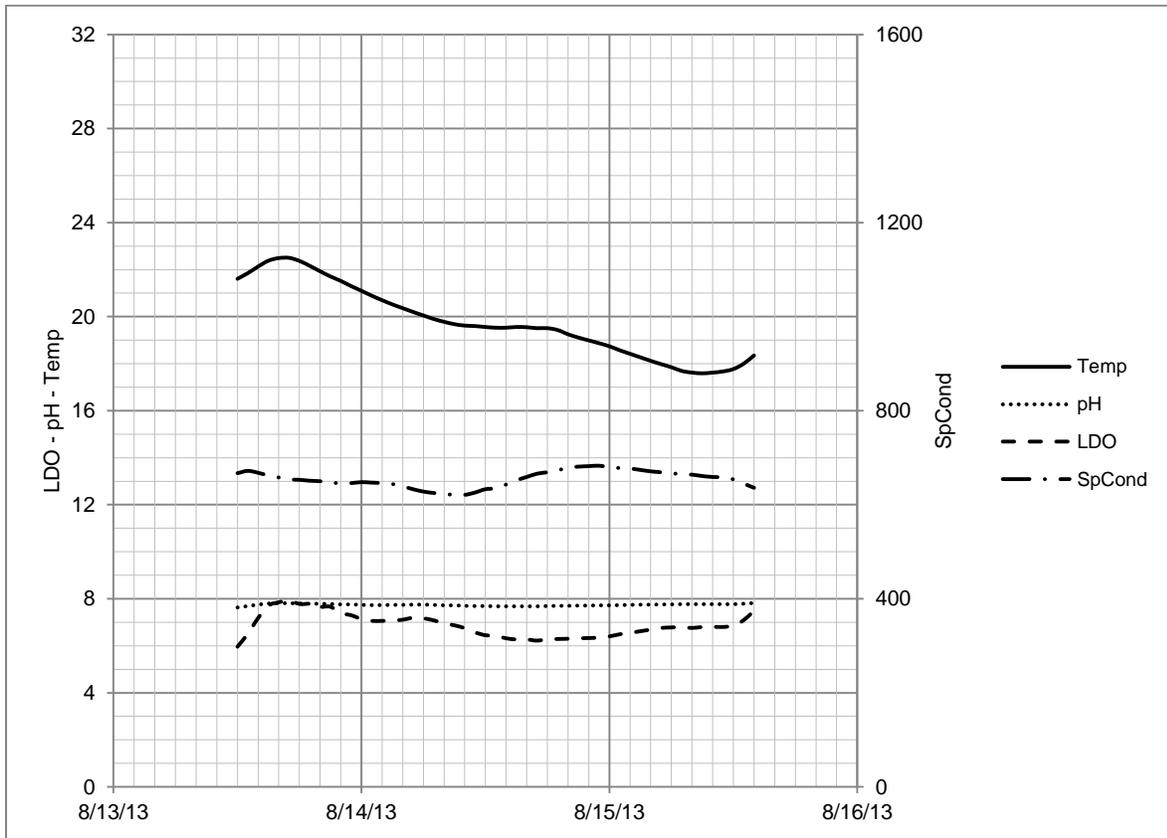
Figure 7. Plot of continuous field parameters collected with a submersible water quality sonde at Brandywine Creek (RM 0.2), August 13- 15, 2013, with sensors taking hourly readings of temperature (Temp - °C), dissolved oxygen (LDO - mg/L), pH (S.U.), and specific conductivity (SpCond - μS/cm).
