Results: Visual Inspection

Results: Soil Profile Inspection

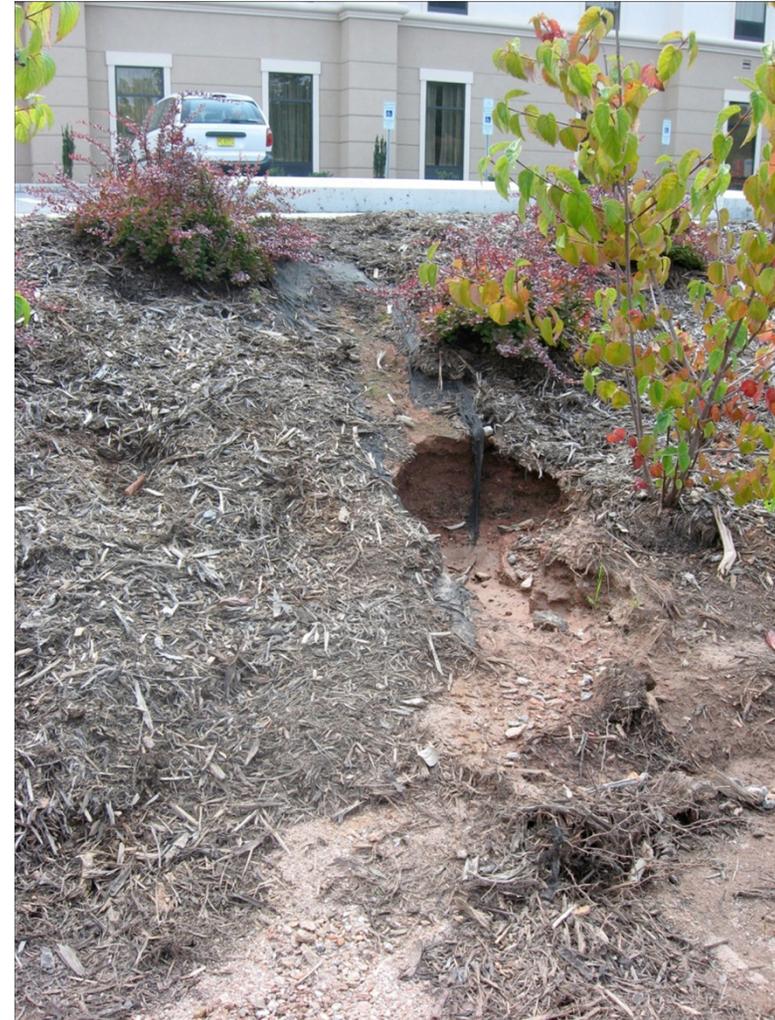
- 53% of cells need maintenance
- Most common issues:
 - 44%: Sediment deposition on mulch surface... pretreatment is critical!
 - 30%: Internal erosion anywhere “sheet flow” enters cell

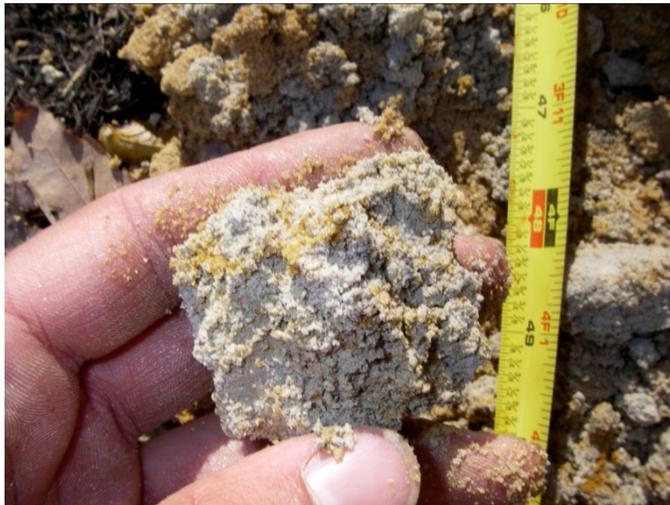
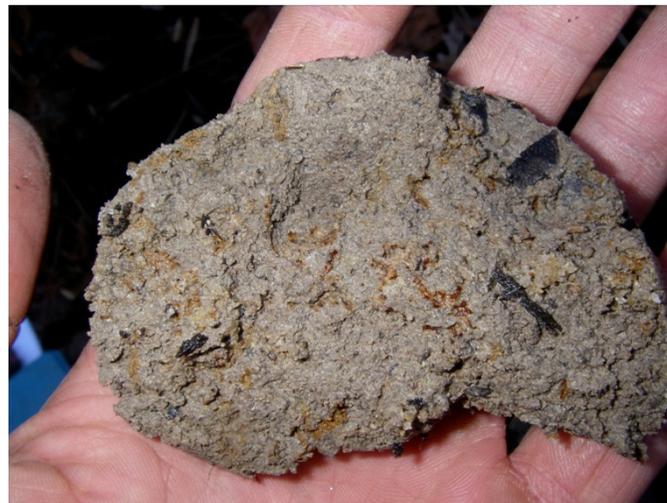
Characteristic	Frequency
Hydric Soil	6% (2)
Redox Features	36% (14)

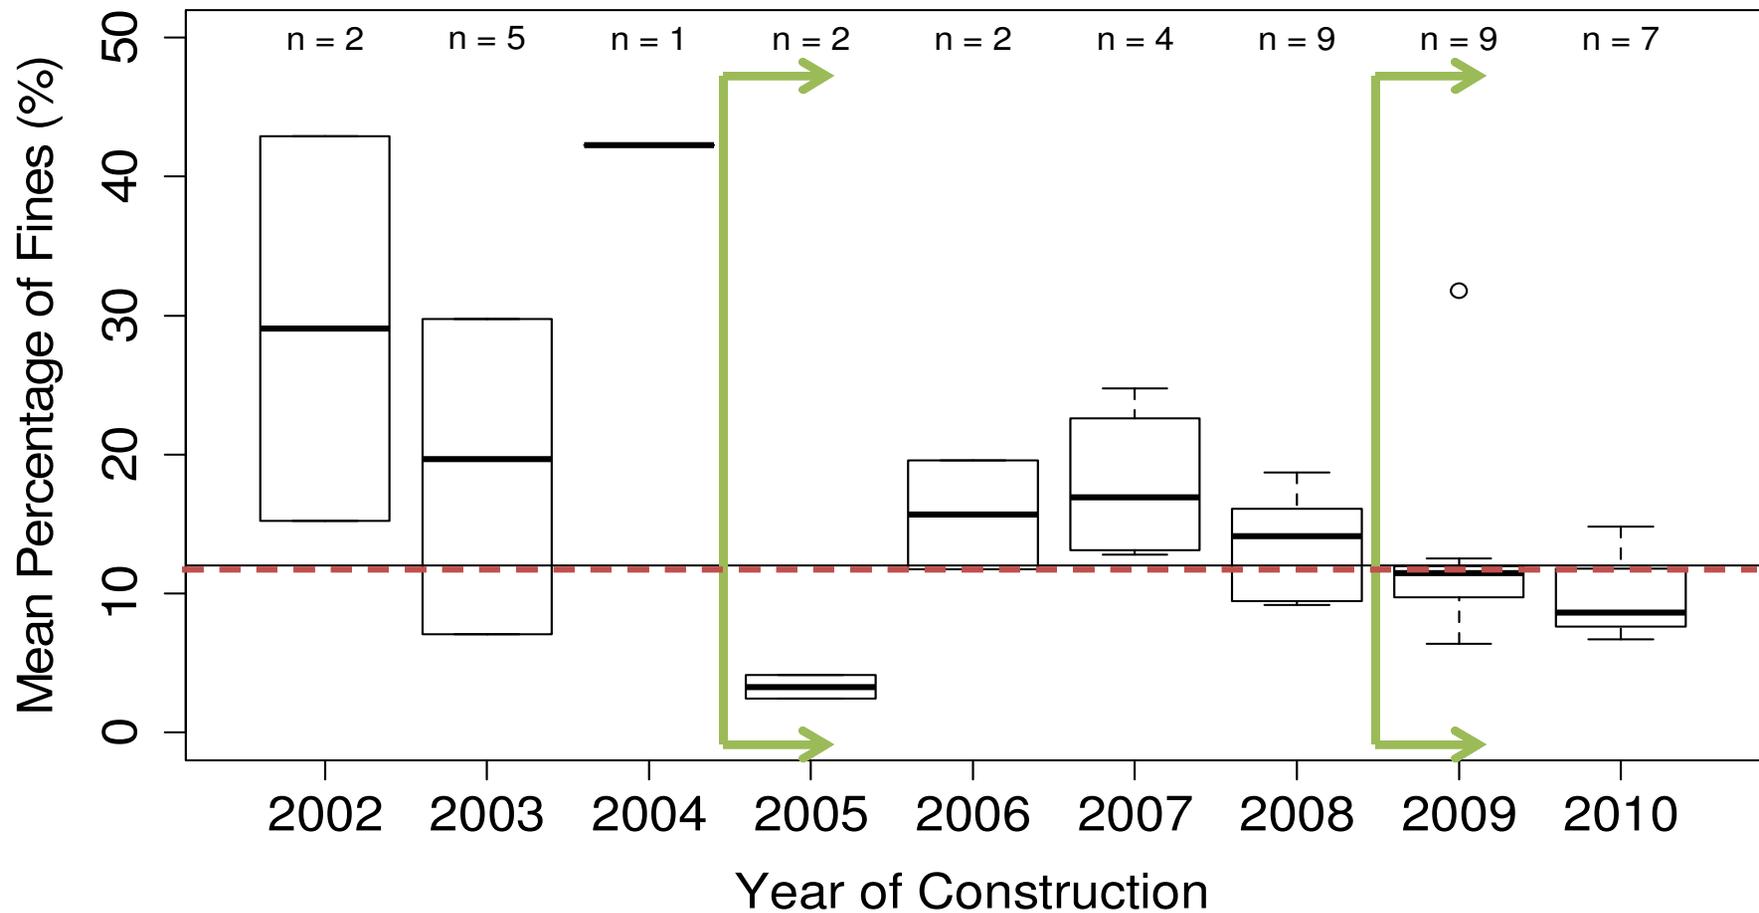
Results: Soil Media Analysis

In this Study, Particle Size has
No Significant Effect on Mean Permeability
($p=0.147$)

- Biological Activity in Fine Soils Create Macropores
- Compaction of Coarse Sand Restricts Flow
- Conductivity Test Overpredicts for Fine Soil

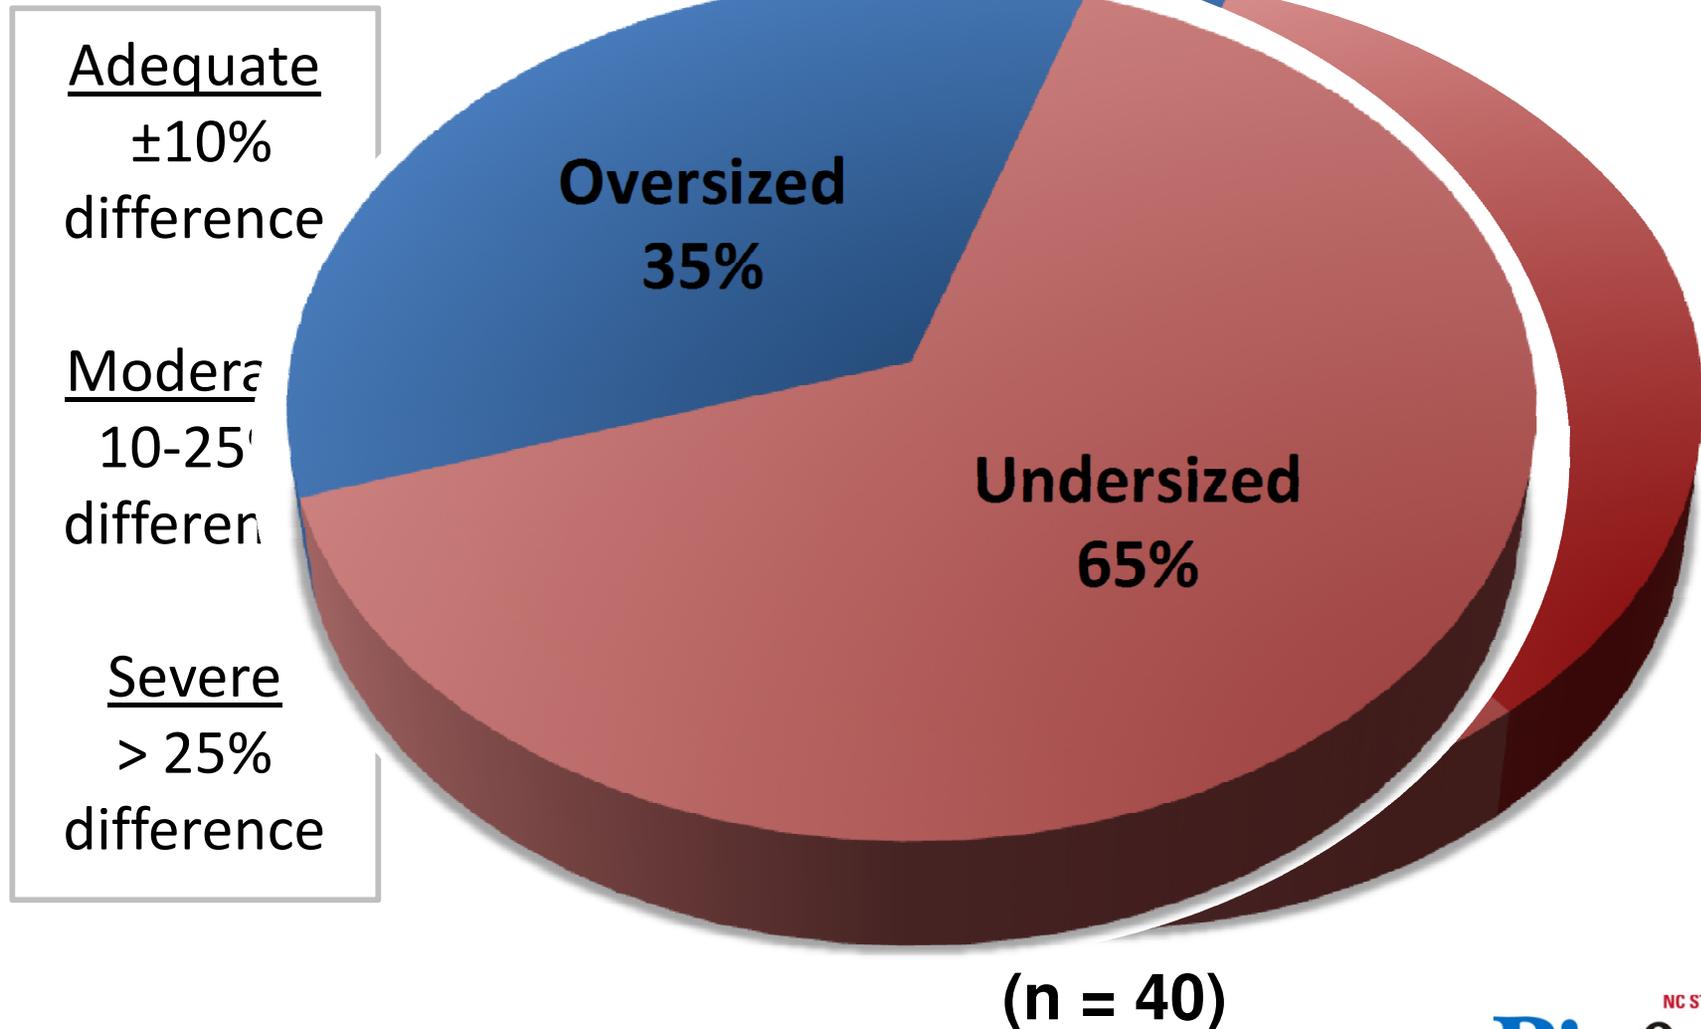
Results: Storage Volume

Total Intended Storage	2378 m³ (1.93 acre-ft)
Total Storage Provided	2284 m³ (1.85 acre-ft)
Percent of Intended Storage	96%

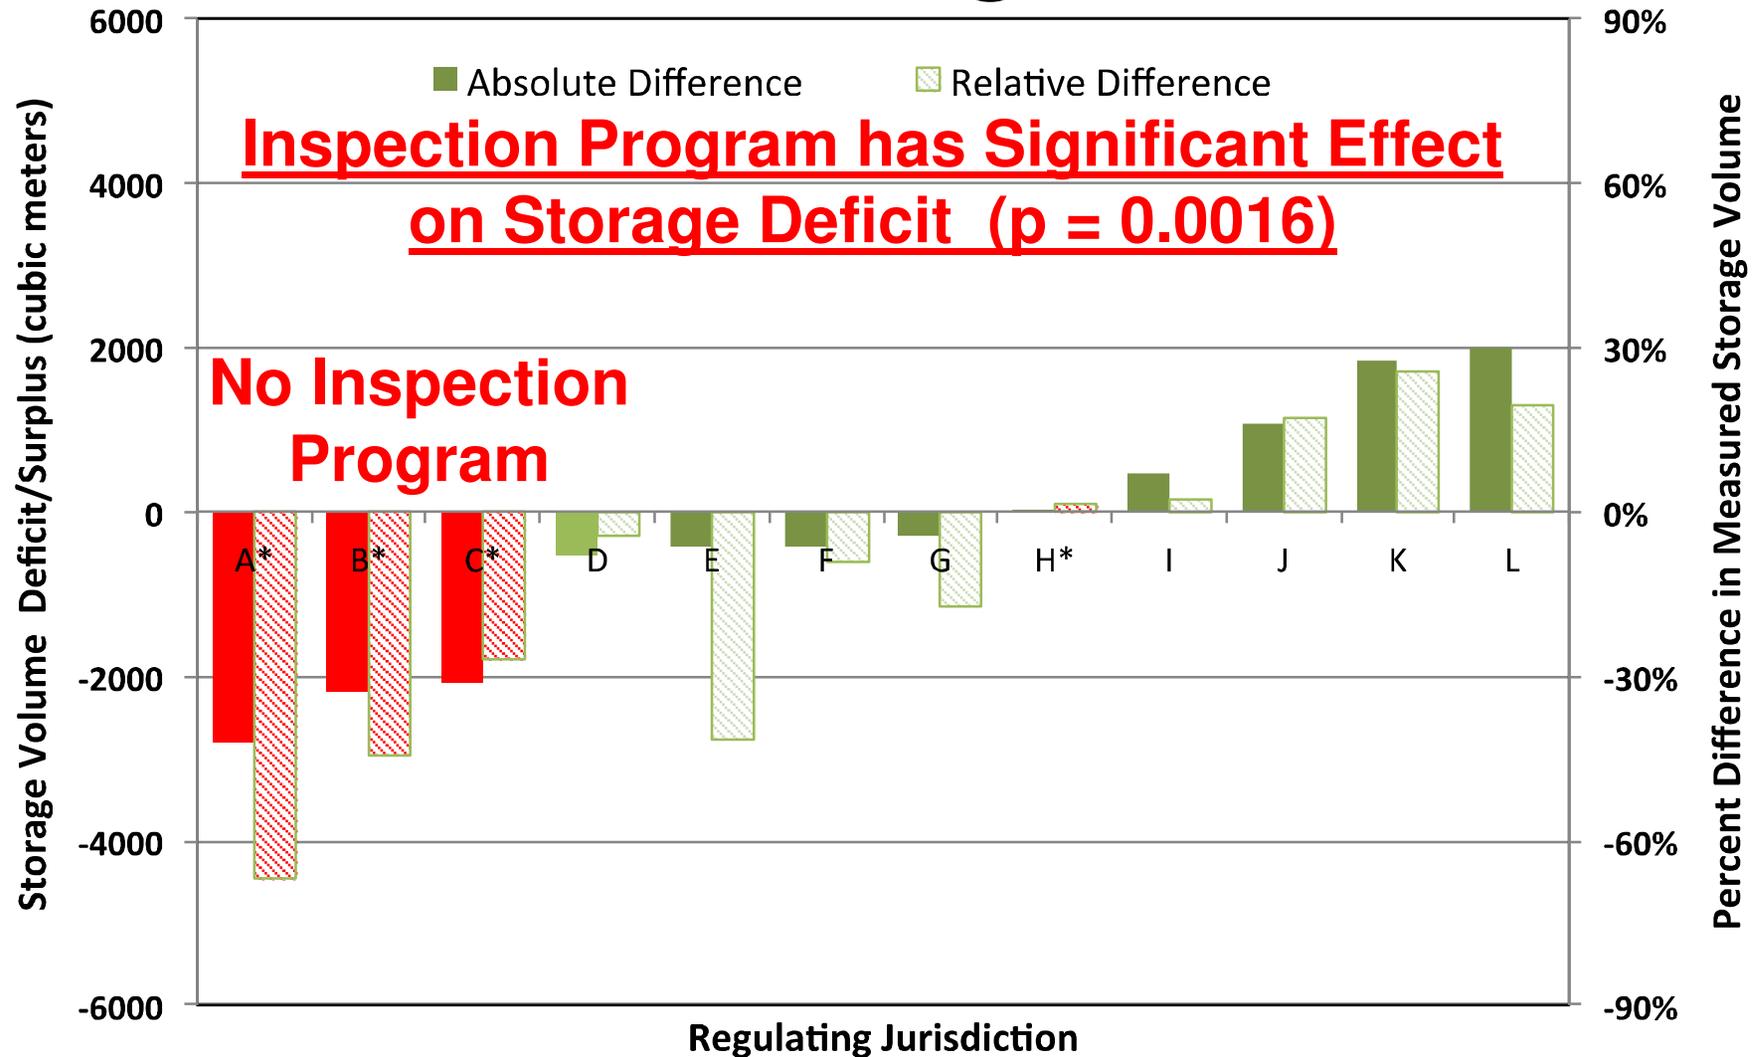
Results: Storage Volume

Factor	P-value	Significant Effect?
<u>Age</u>	0.0128	✓
Jurisdiction	0.205	
<u>Inspection/Maintenance Program</u>	0.0016	✓
Design Cell Size	0.351	
Design Ponding Depth	0.978	
Outlet Structure Height Discrepancy	0.392	
<u>Average Ponding Depth Discrepancy</u>	0.0160	✓

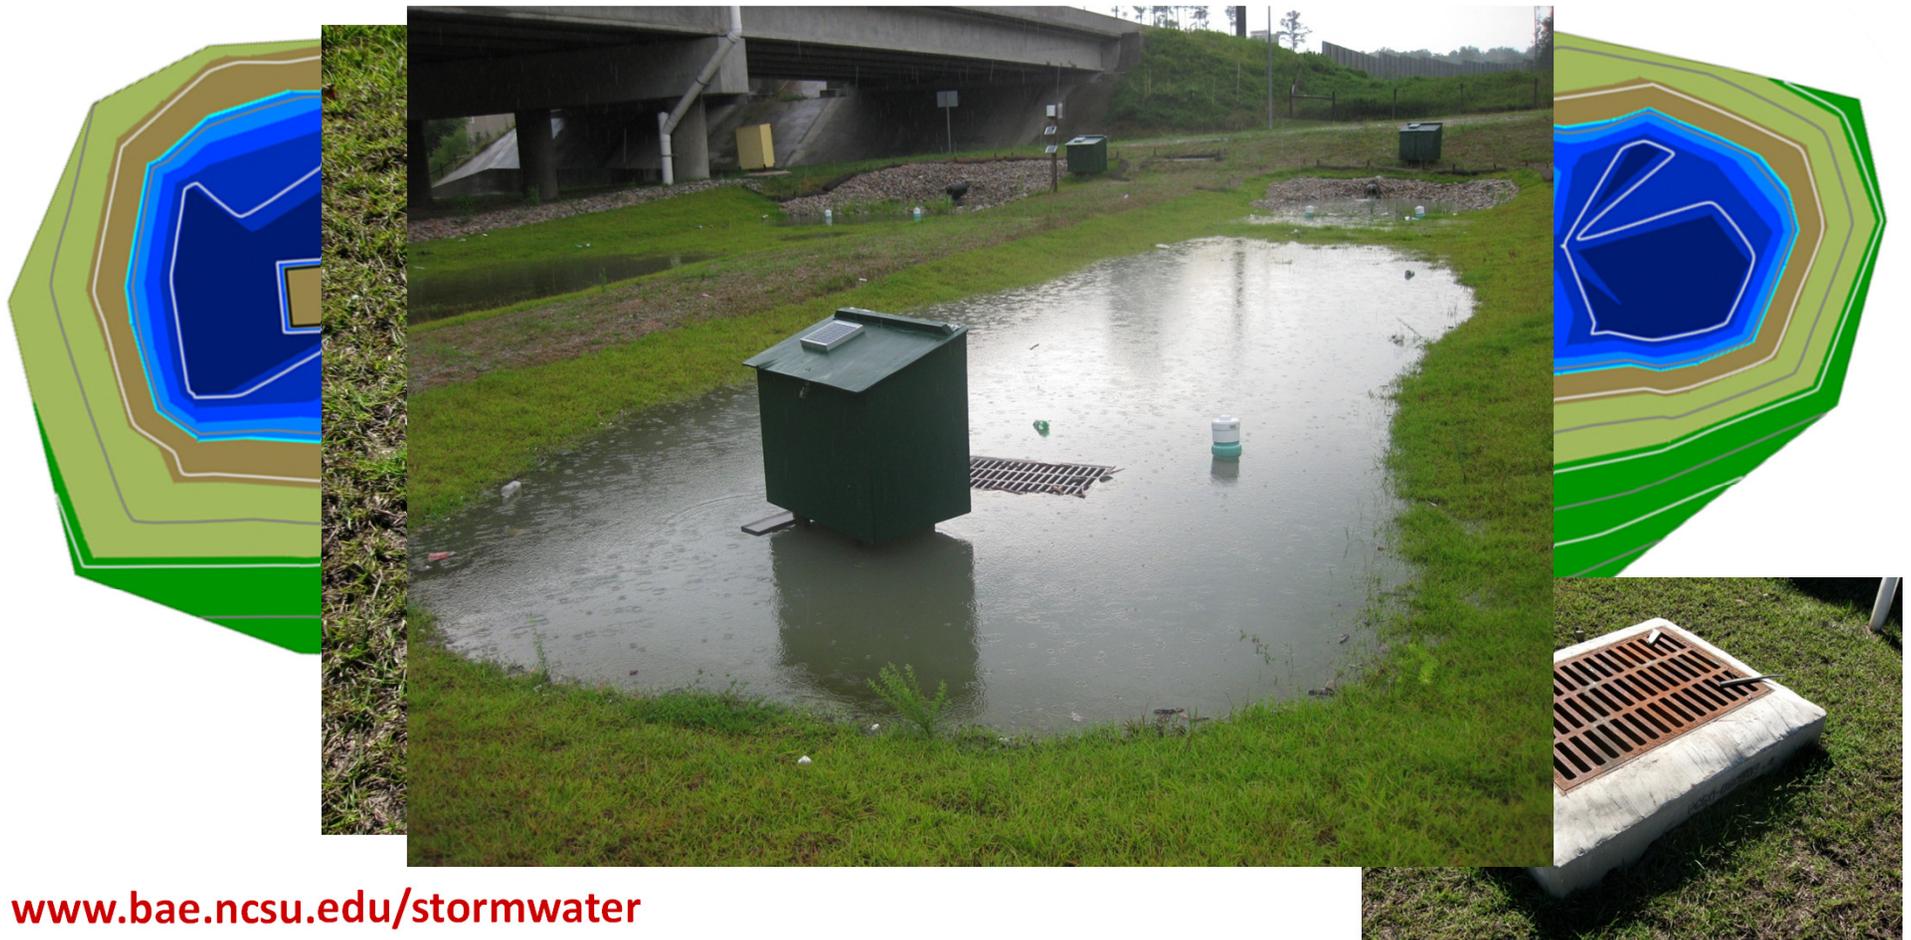
Results: Storage Volume

Need to inspect average ponding depth
(*not* height of outlet structure)

- **Maintenance is key!**
 - Stabilize watershed
 - Remove sediment
- Soil media is adequate
- Over half of cells are moderately/severely undersized
 - Inspect and maintain
 - Accurately grade average ponding depth
