PHASE I PROPERTY ASSESSMENT
OTTERBEIN COLLEGE EQUINE FACILITY

Prepared for
Otterbein College, Westerville, Ohio
June 15, 2007

Ohio Voluntary Action Program
OAC 3745-300-06

BROWN AND CALDWELL

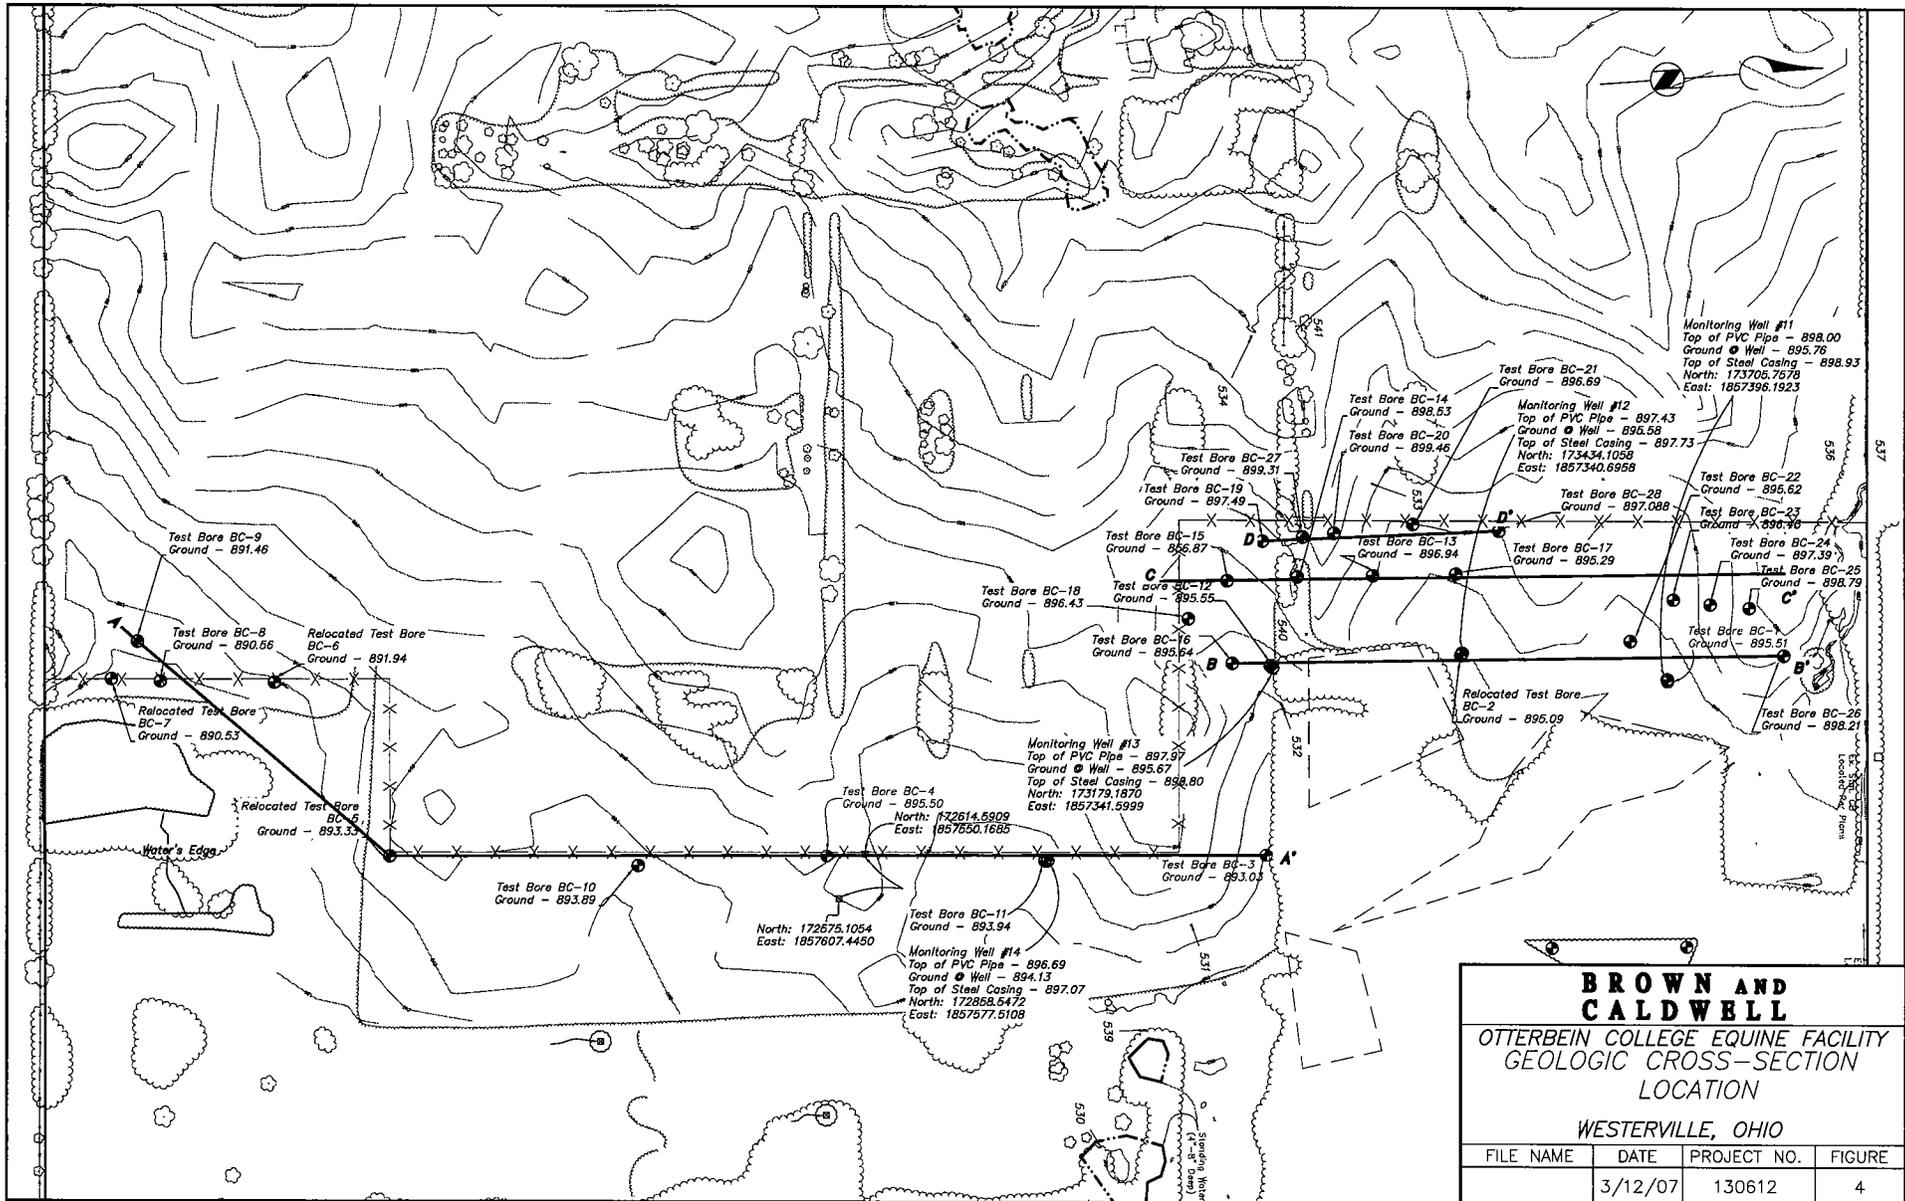
FIGURE 3

Test Bore BC-9
Ground - 891.46

Test Bore BC-8
Ground - 890.66

Test Bore BC-3
Ground - 893.03

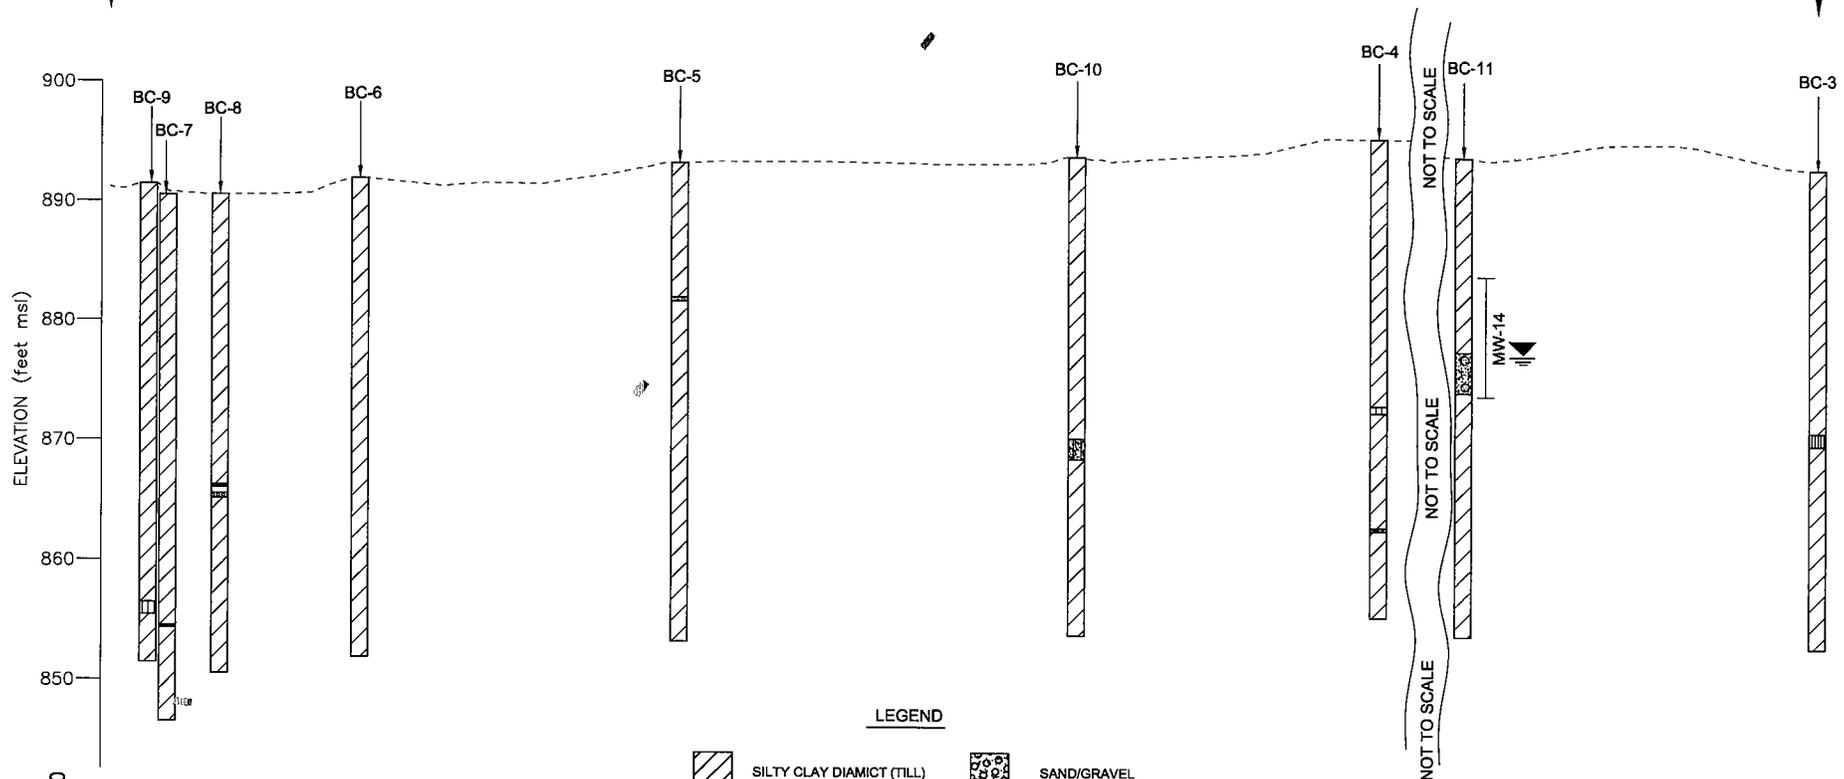
BROWN AND CALDWELL			
OTTERBEIN COLLEGE EQUINE FACILITY GEOLOGIC CROSS-SECTION A-A'			
WESTERVILLE, OHIO			
FILE NAME	DATE	PROJECT NO.	FIGURE
	3/12/07	130612	5

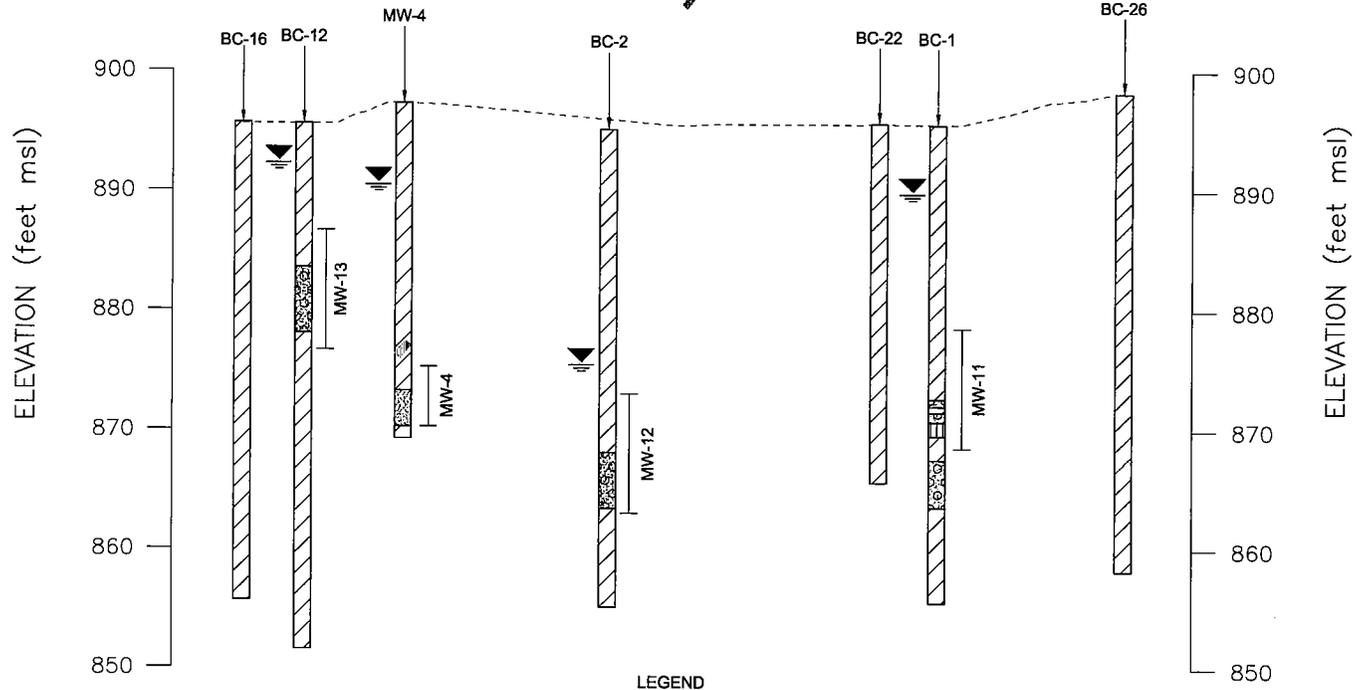
BROWN AND CALDWELL			
OTTERBEIN COLLEGE EQUINE FACILITY GEOLOGIC CROSS-SECTION B-B'			
WESTERVILLE, OHIO			
FILE NAME	DATE	PROJECT NO.	FIGURE
	3/12/07	130612	6

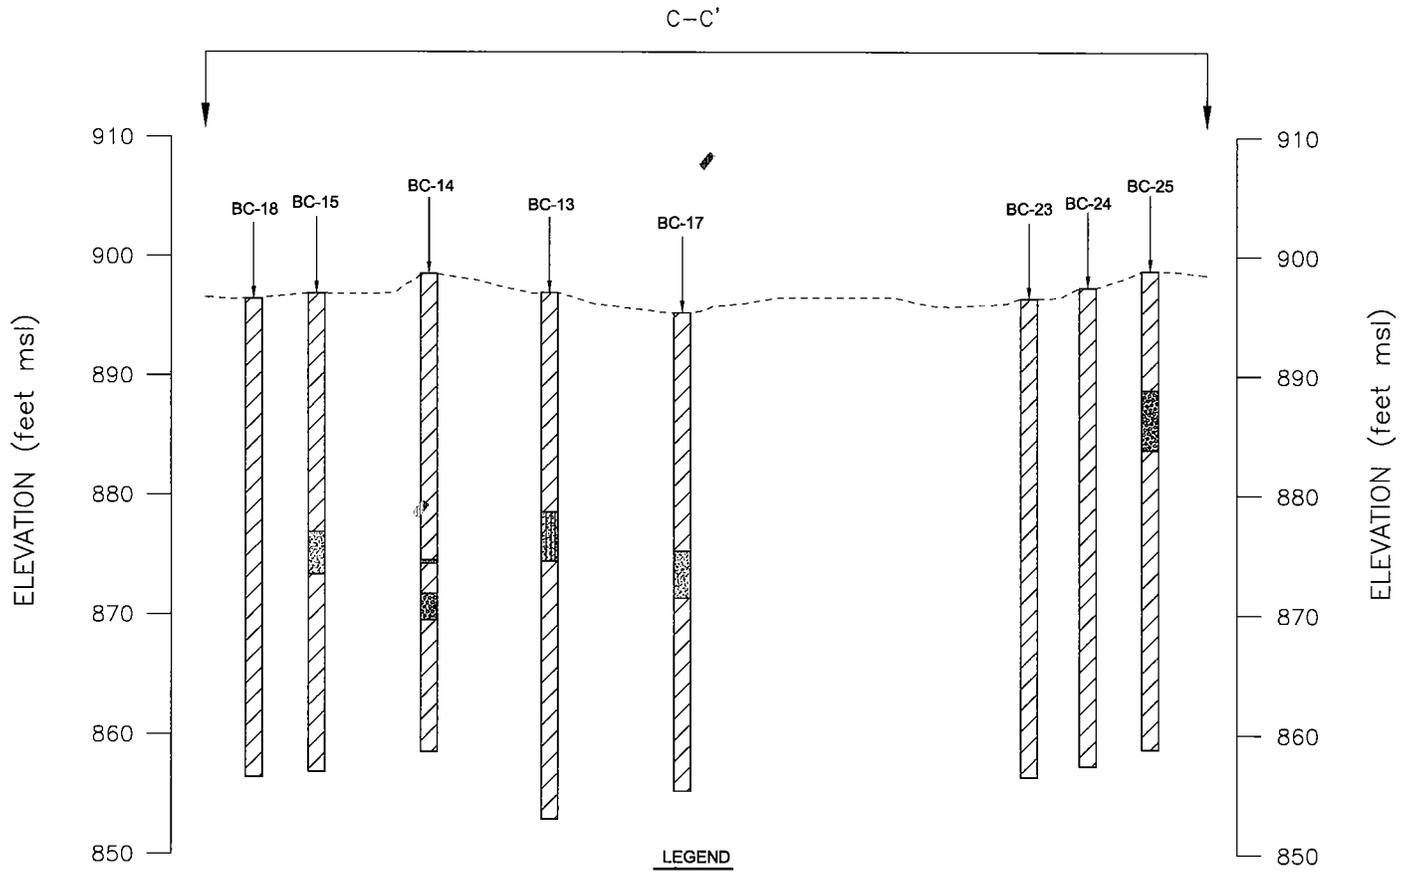
VERTICAL EXAGERATION = 10X

- SILTY CLAY DIAMICT (TILL)
- SAND
- SILT
- CURRENT TOPOGRAPHY (200X)
- POTENTIOMETRIC SURFACE ON 4/9/07
- SAND/GRAVEL
- SANDY SILT
- MW-7 SCREENED INTERVAL
- BREAKLINE SECTION 200 FEET FROM CROSS-SECTION

BROWN AND CALDWELL			
OTTERBEIN COLLEGE EQUINE FACILITY GEOLOGIC CROSS-SECTION C-C'			
WESTERVILLE, OHIO			
FILE NAME	DATE	PROJECT NO.	FIGURE
	3/12/07	130612	7

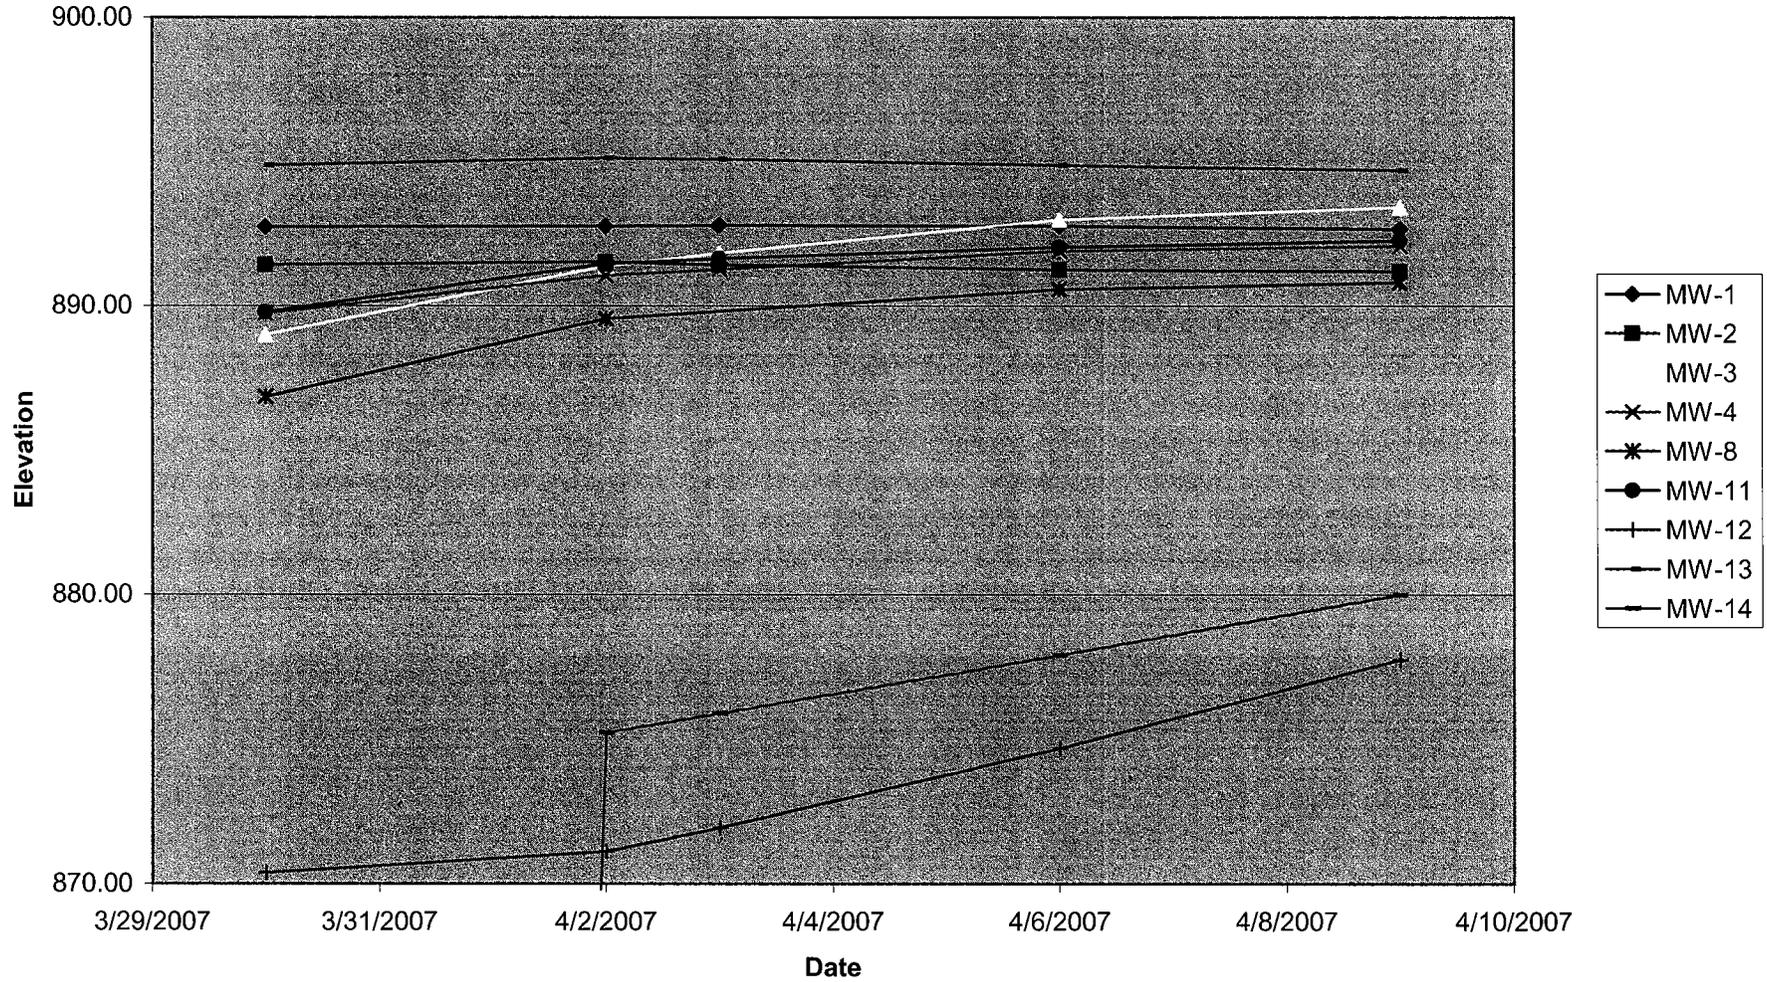
Figure 9
Site Potentiometric Data
Otterbein College - Equine Science Facility

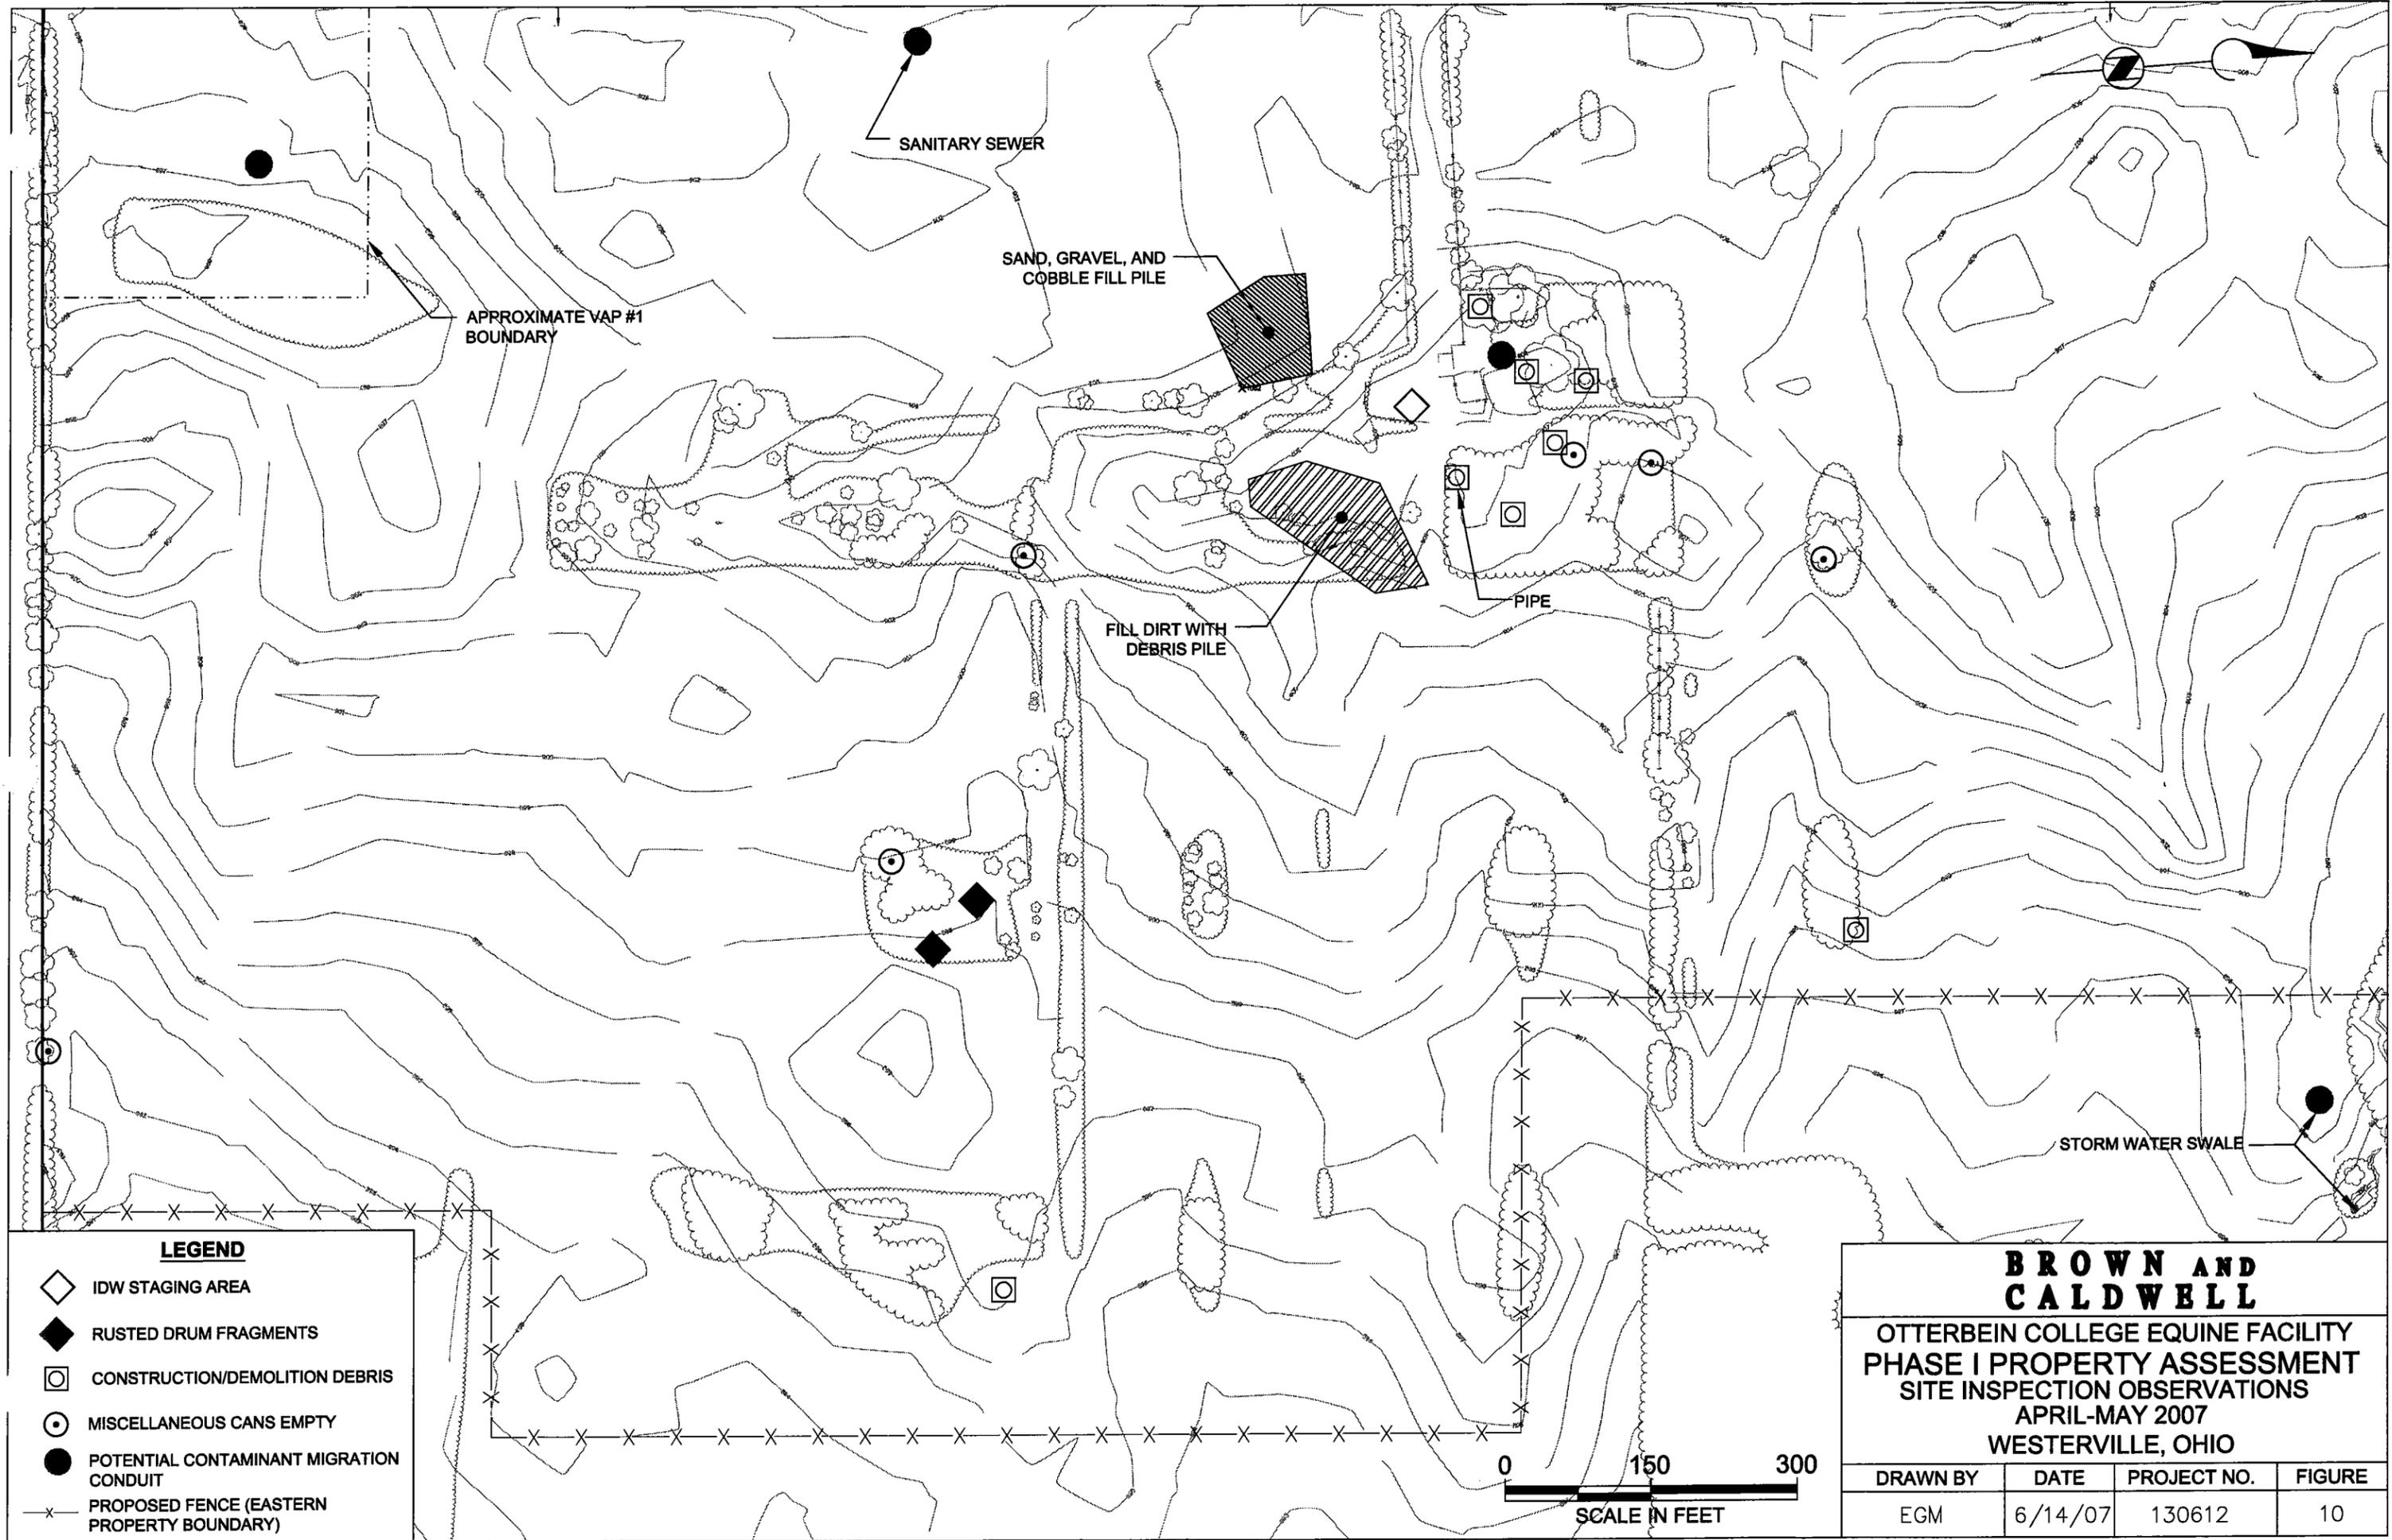
- ◇ IDW STAGING AREA
- ◆ RUSTED DRUM FRAGMENTS
- CONSTRUCTION/DEMOLITION DEBRIS
- MISCELLANEOUS CANS EMPTY
- POTENTIAL CONTAMINANT MIGRATION CONDUIT
- x- PROPOSED FENCE (EASTERN PROPERTY BOUNDARY)
