**KILGORE FARM PROPERTY  
800 TUSSIC STREET  
WESTERVILLE, OHIO**

**VOLUNTARY ACTION PROGRAM  
0AC 3745-300-06  
PHASE I PROPERTY ASSESSMENT AMENDMENT**

**CERTIFIED ENVIRONMENTAL PROFESSIONAL  
GERALD R. MYERS, C.E.P. 131**

**May, 1998**

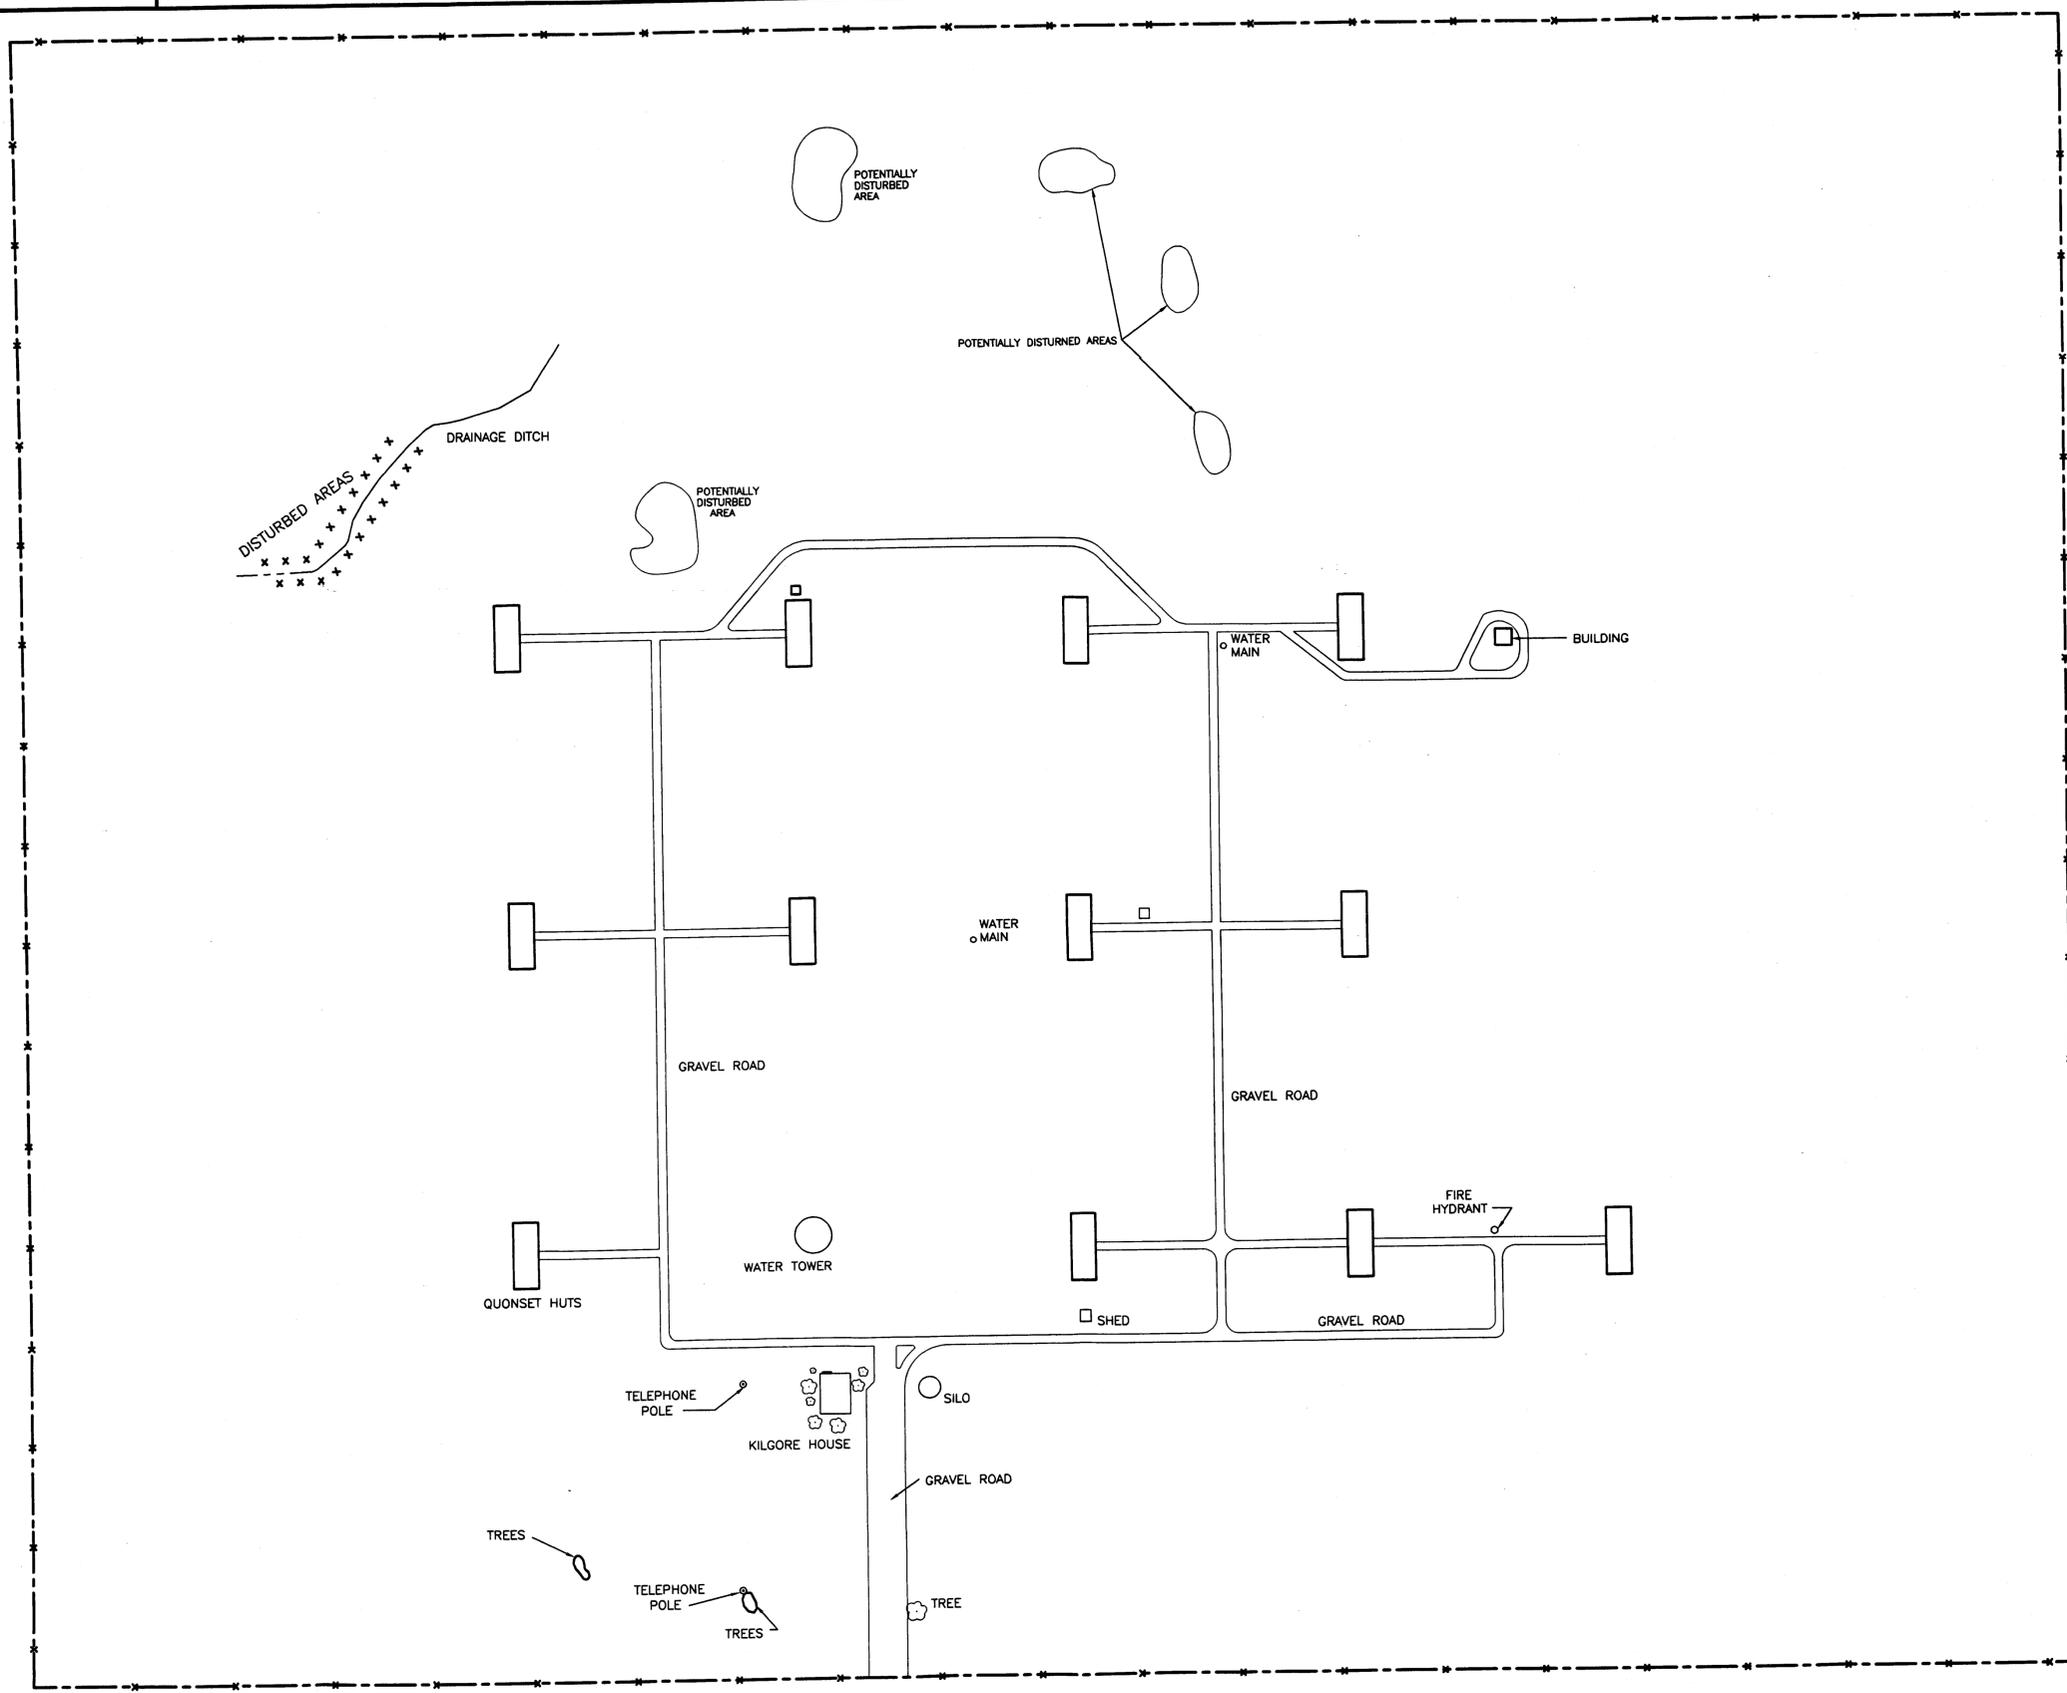
\* MAP BASED ON A 1950 AERIAL PHOTOGRAPH

An aerial photograph from 1950 shows the location of the farm house, the Quonset huts, a possible manufacturing building and several roads on the site. In addition to the huts, there are several areas of ground surface along the eastern side of the property that appear to have been disturbed. The 1950 aerial photo does not show any evidence of manufacturing buildings located in the northeast portion of the site, disposal trenches or the burn pit. There is evidence of disturbed soils adjacent to the small drainage area located in the northeast section of the property. The property located along the western, northwestern and southwestern border of the property line was farmed. Portions of the farmed land extended to the Quonset huts. Mr. Day further stated that while he lived on the property from 1945 to 1949, livestock grazed over the unfarmed portions of the property.

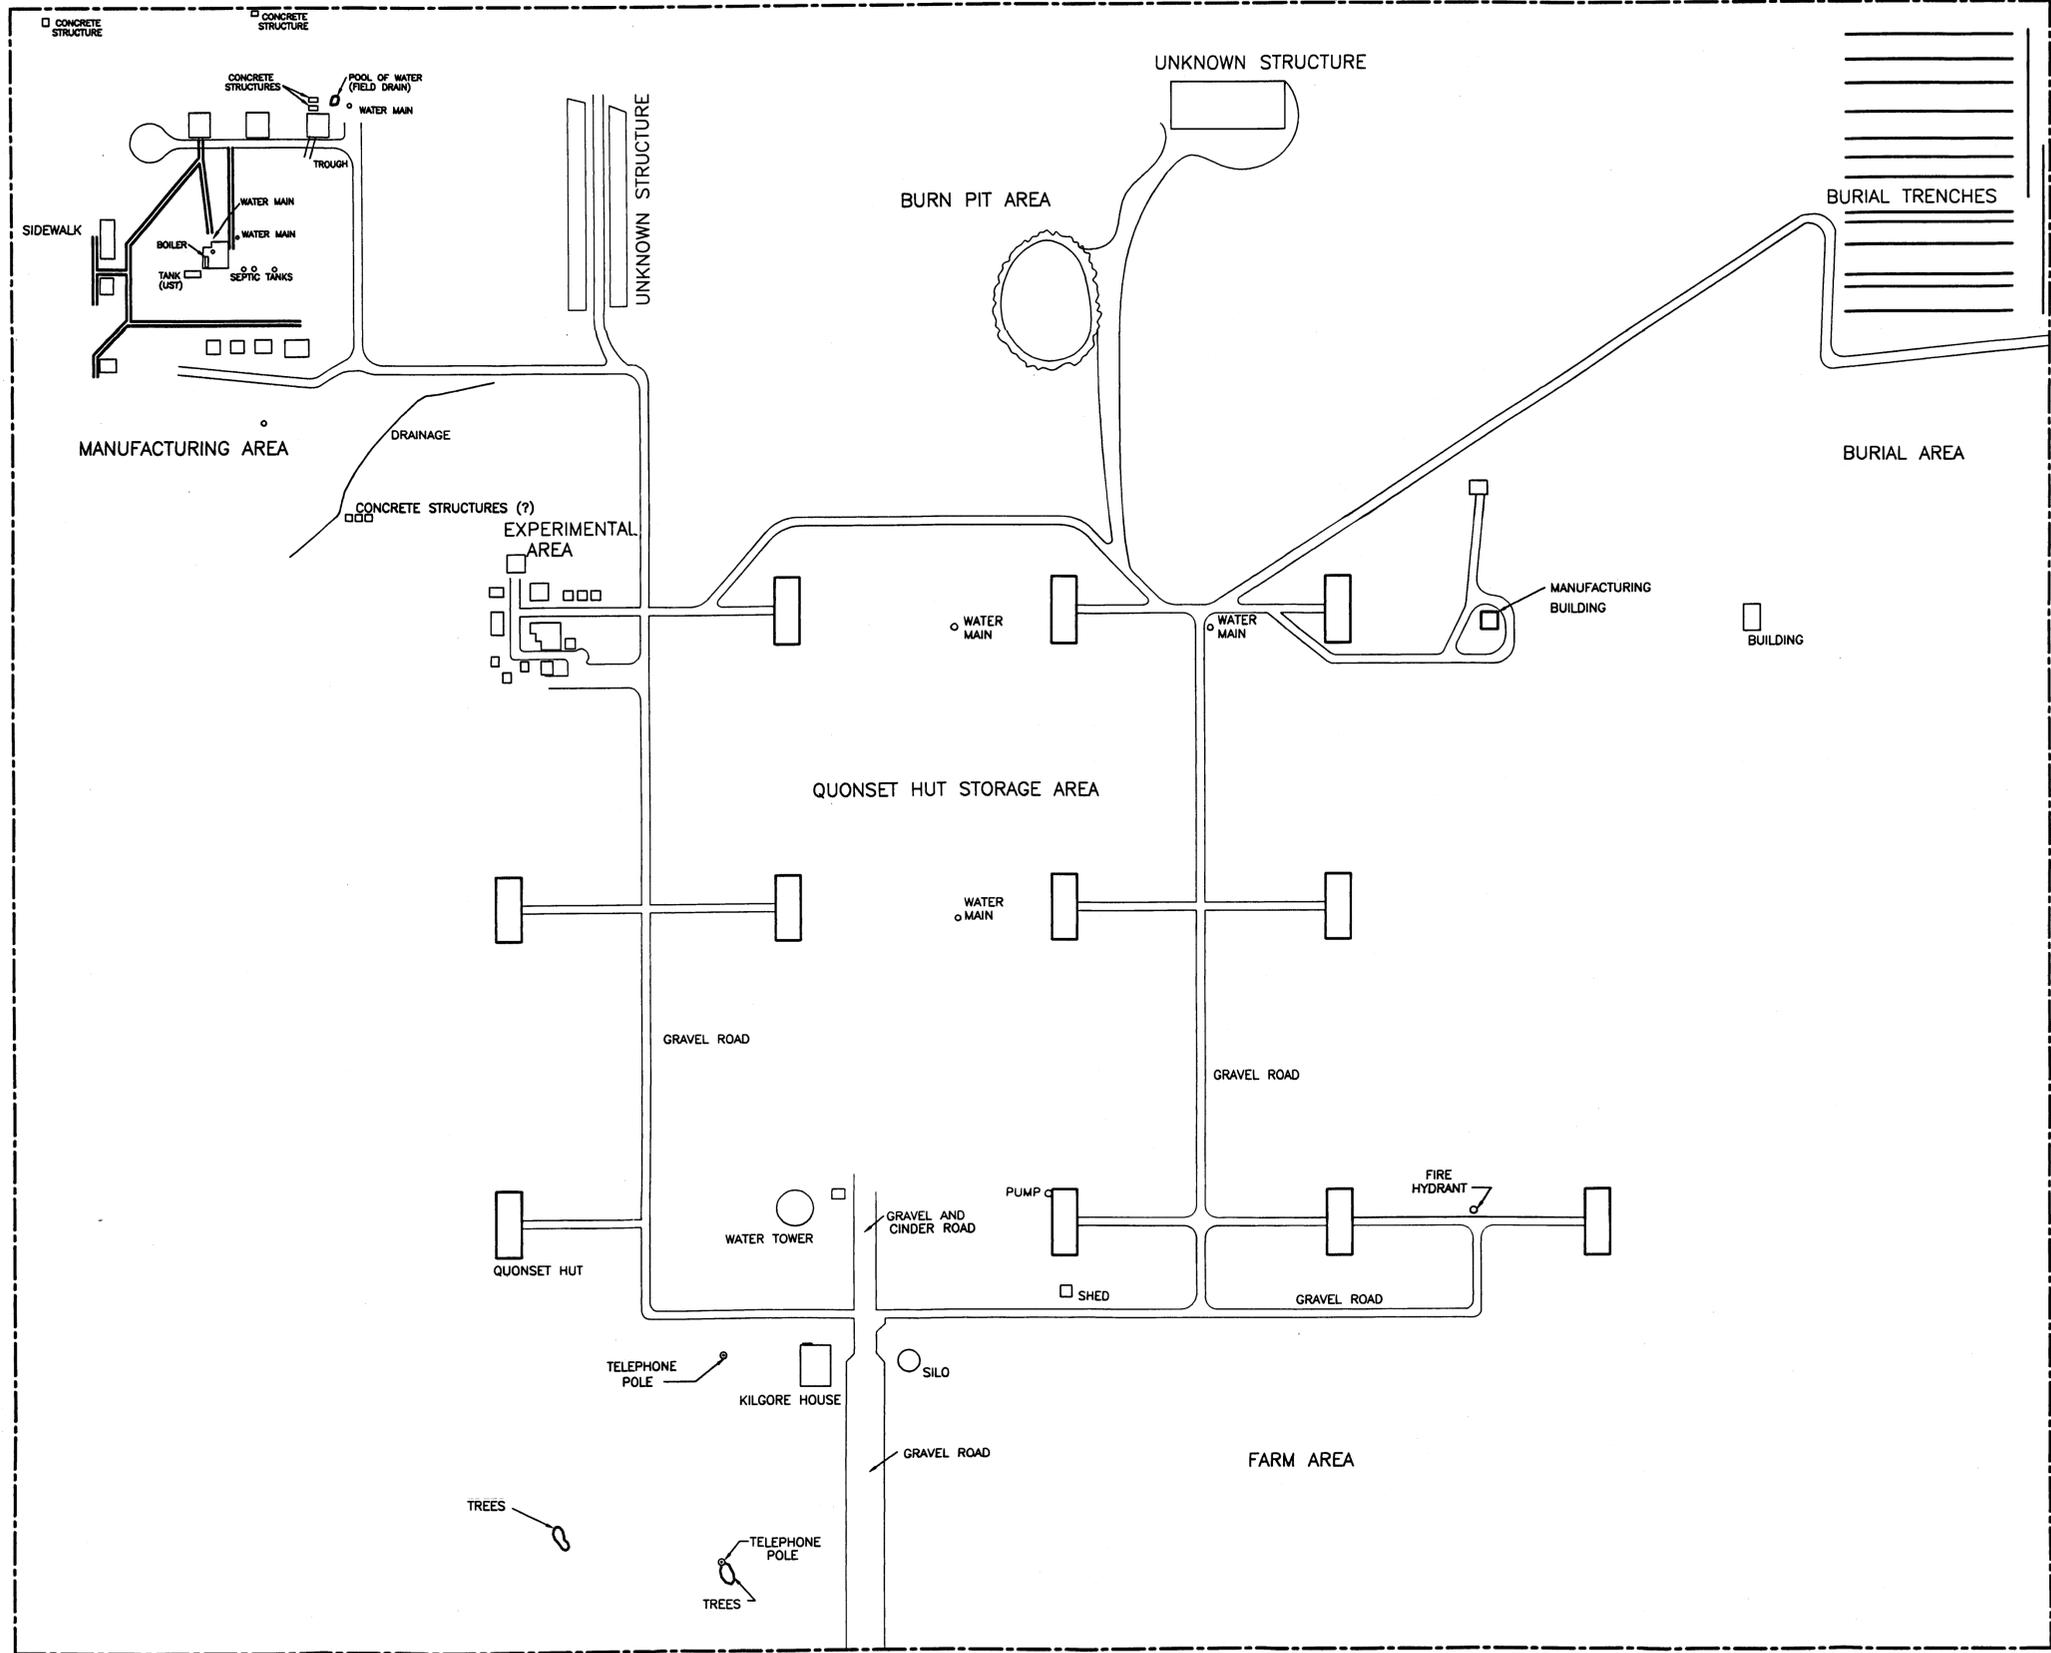
\* MAP BASED ON A 1957 AERIAL PHOTOGRAPH

Two rectangular shaped features are shown on the 1956 and 1957 aerial photographs located south of the manufacturing area. M&E has not been able to ascertain the identity or use of these features. West of the burn pit, a disturbed area is visible on the aerial photographs. Mr. Skip Day recalled that there was a building located in that area of the property where work was conducted related to the development of "shaped" charges. He recalled that an explosion occurred in the area where shaped charges were being formulated and that the building was destroyed. He believes that the area southeast of the burn pit was this area. No other areas of soil disturbance are evident on the 1956 or 1957 aerial photos. Figure 4 shows the facility layout in 1957 and identifies the items described above.

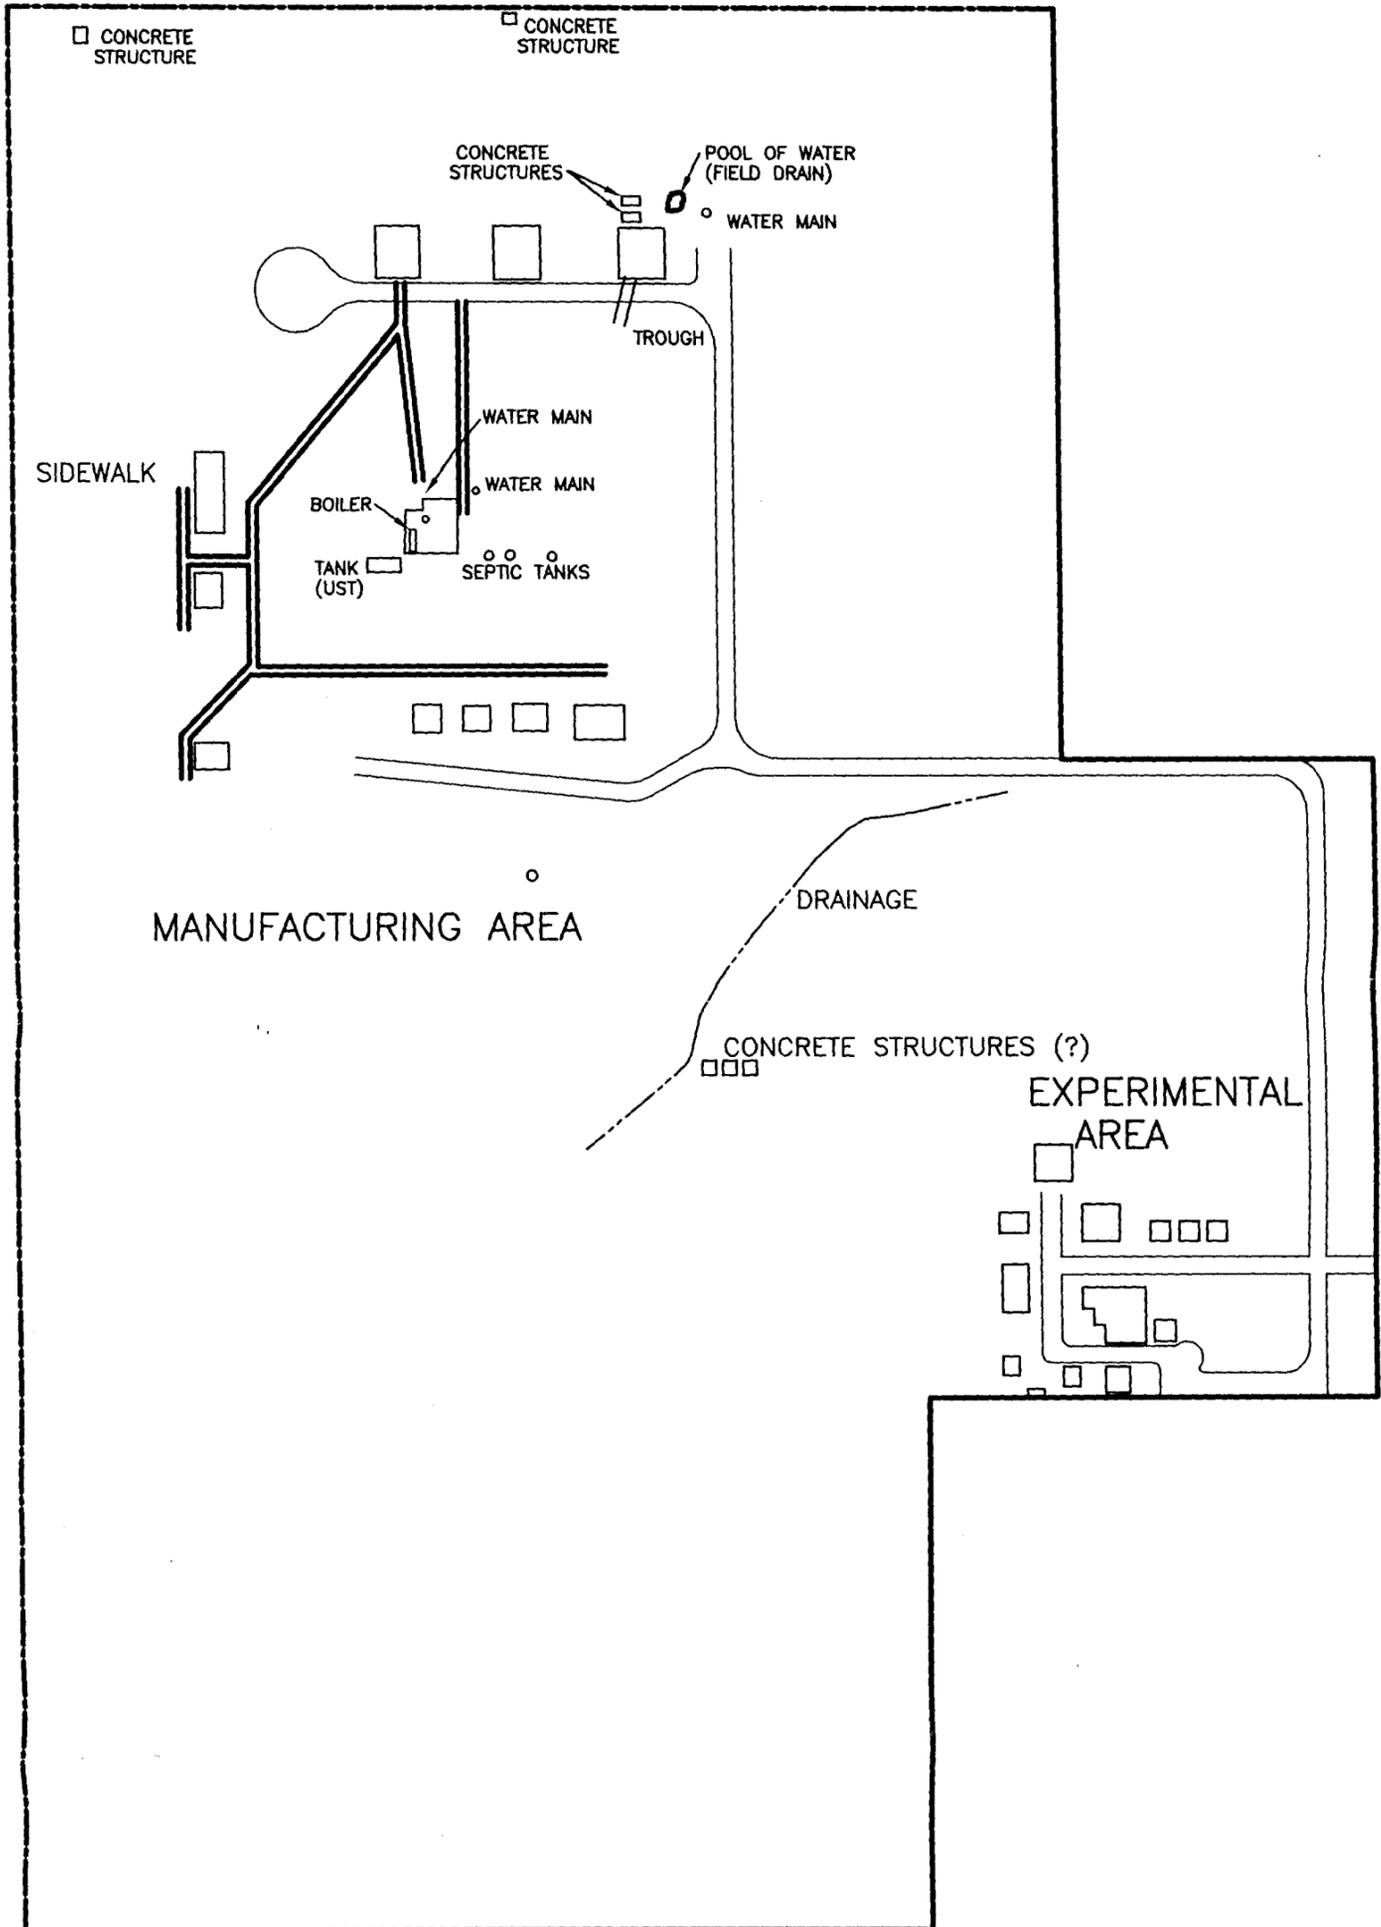
Figure 6 - Subdivided Kilgore Property Map

Based on interviews conducted with former Kilgore employees, the manufacturing area of the Kilgore Farm Property was constructed in the early 1950s. By 1956, at least 24 buildings were constructed in this area and are clearly visible on historical aerial photographs. Building activities were centered in two separate areas. The larger of the areas (located adjacent to the northeastern property line) was where manufacturing, assembly and maintenance facilities were located. The buildings were constructed in a square pattern with a large building located in the center of the other buildings. This building housed a boiler that supplied steam heat to the other buildings. The boiler was fired using diesel fuel which was stored in a 2,500-gallon underground storage tank located on the north side of the building. Major activities conducted in this area would have included assembly of products and pelletization of black powder.

NOTE: BASED ON 1957 AERIAL PHOTOGRAPH

In the tract of property located south of the former manufacturing area and east of the Quonset storage huts, a burn pit historically operated to destroy off-specification materials. This tract of land, approximately 18 acres in area, which includes the former burn pit shall be referred to hereafter as the "Burn Pit Area". The exact location of the Burn Pit Area is shown on the 1956 and 1957 aerial photographs and was positively identified by Mr. Adams (See Figure 6).

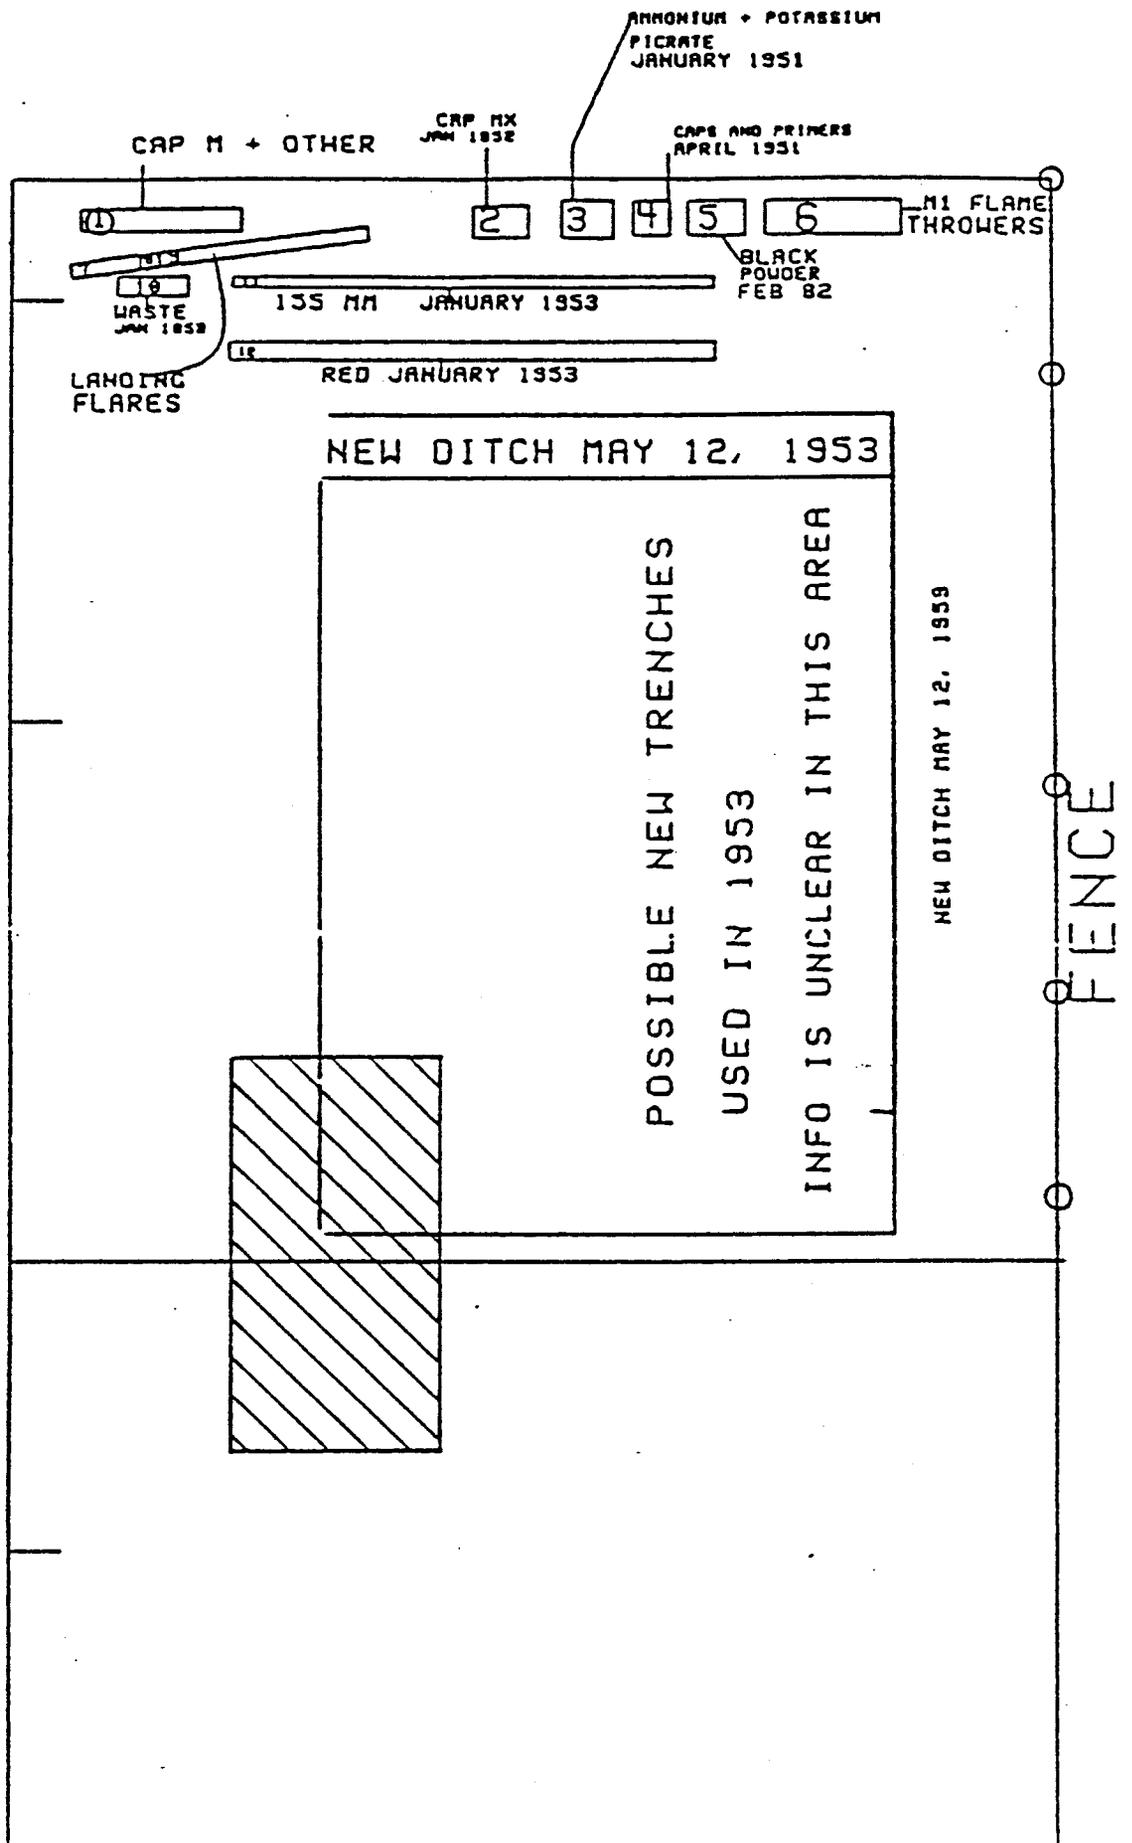
FIGURE 7: Nonscaled drawing of Otterbein property. Rectangle with diagonal lines indicates concentration of metal objects.
