Countywide Recycling & Disposal Facility

Remediation Unit

**Monthly Progress Report
Of
Operations, Monitoring & Maintenance Activities**

November 2010

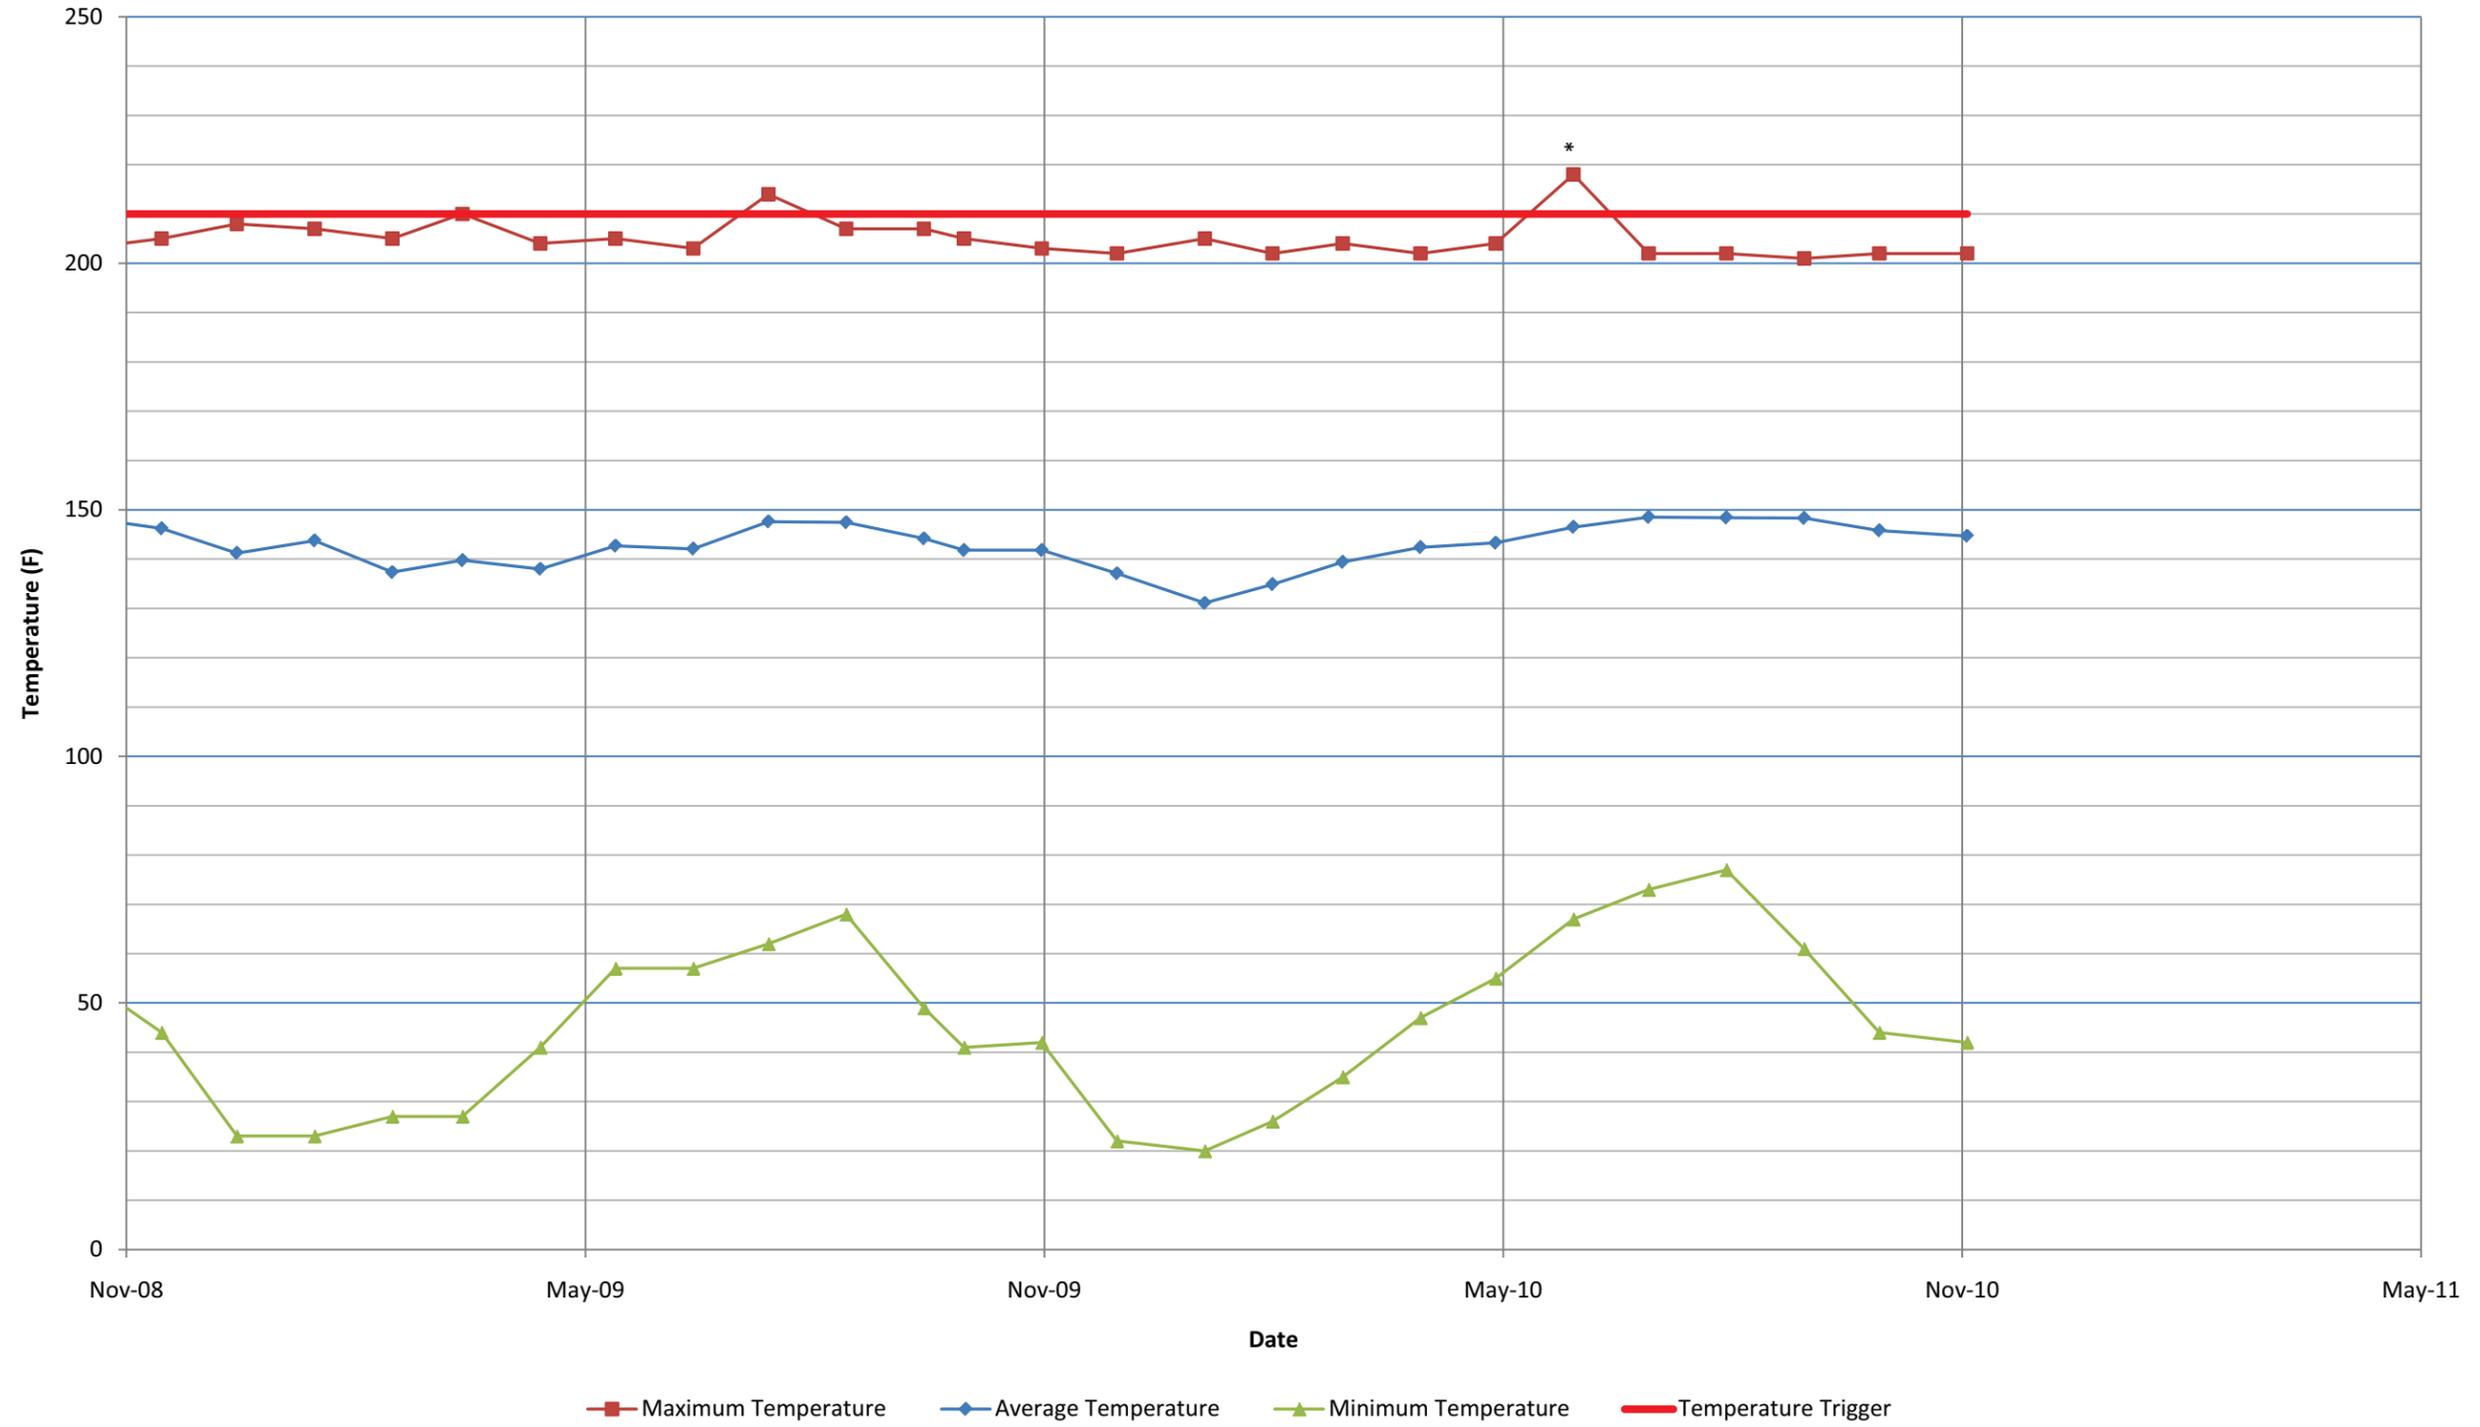
Graph 1 Wellhead Temperature

1. Maximum temperature depicted for June 2010 represents a single occurrence of a wellhead temperature over 210 degrees at a single well, caused by wellhead pressure. It does not represent a sustained temperature. Upon vacuum adjustment at the well, temperature returned to normal trend, below 210 degrees

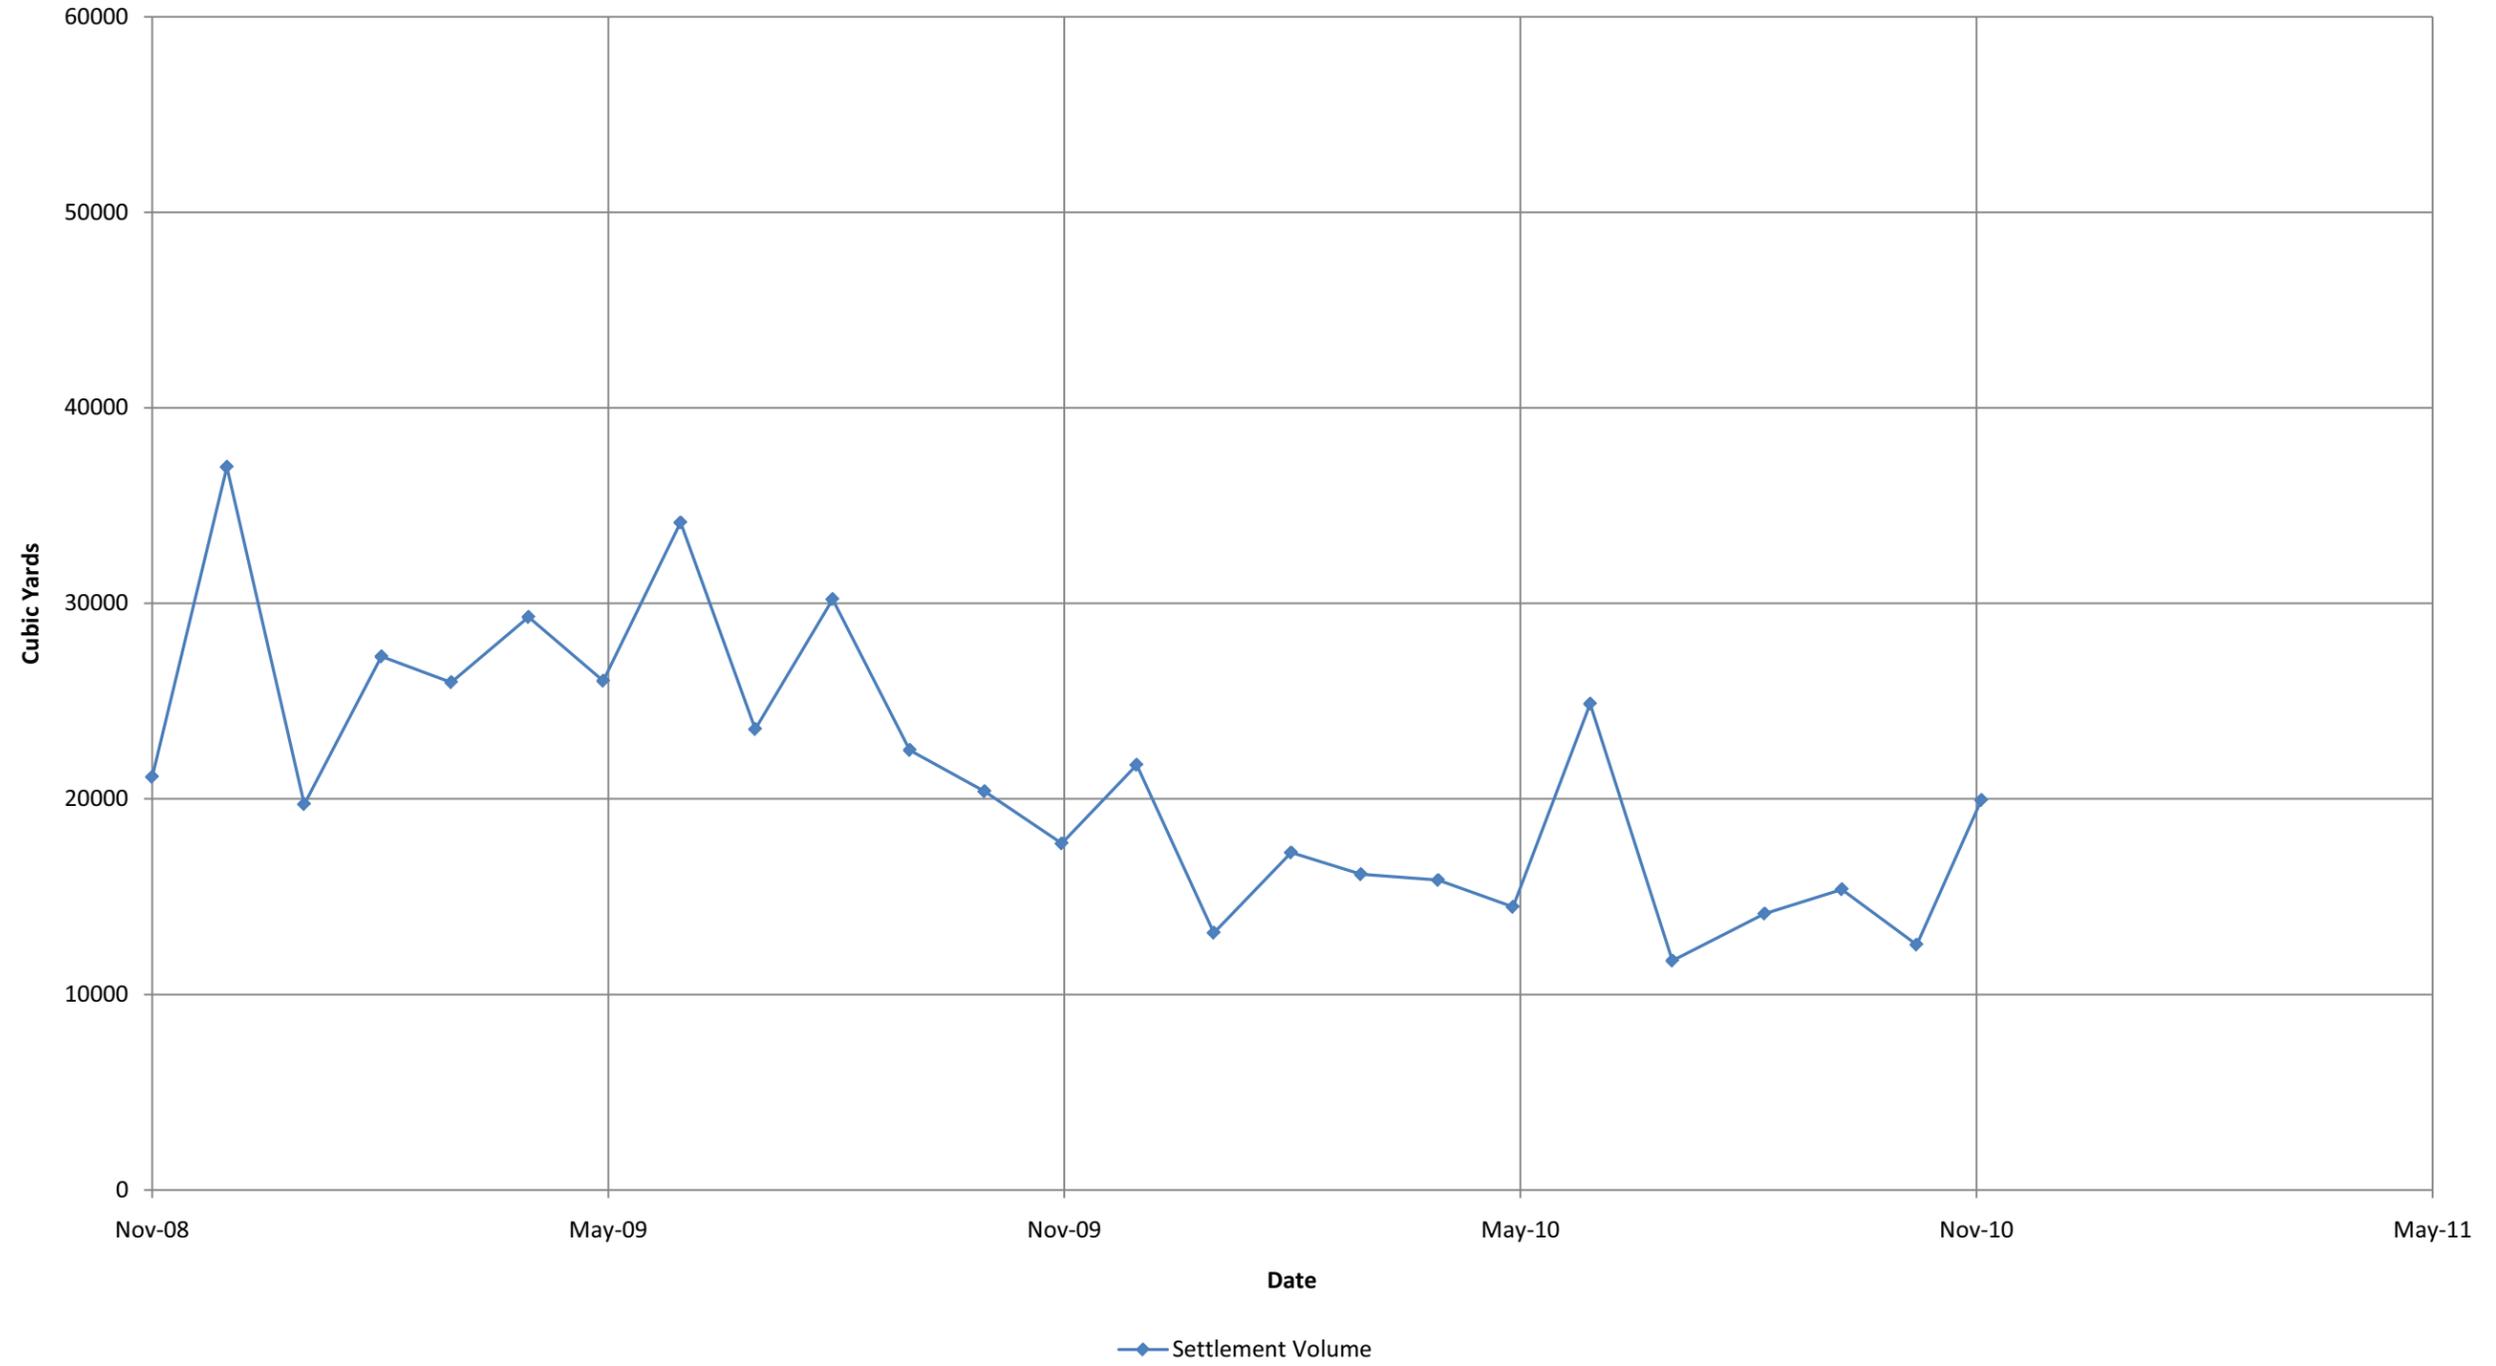
Graph 2 Settlement Volume

1. Information presented prior to October 2009 was compiled from data prepared and presented by SCS Engineers for Countywide Recycling and Disposal Facility.
2. Data presented on monthly basis.
3. Settlement volume reported prior to the 4th quarter of 2009 is for a limited area of the 88-acre reaction area.

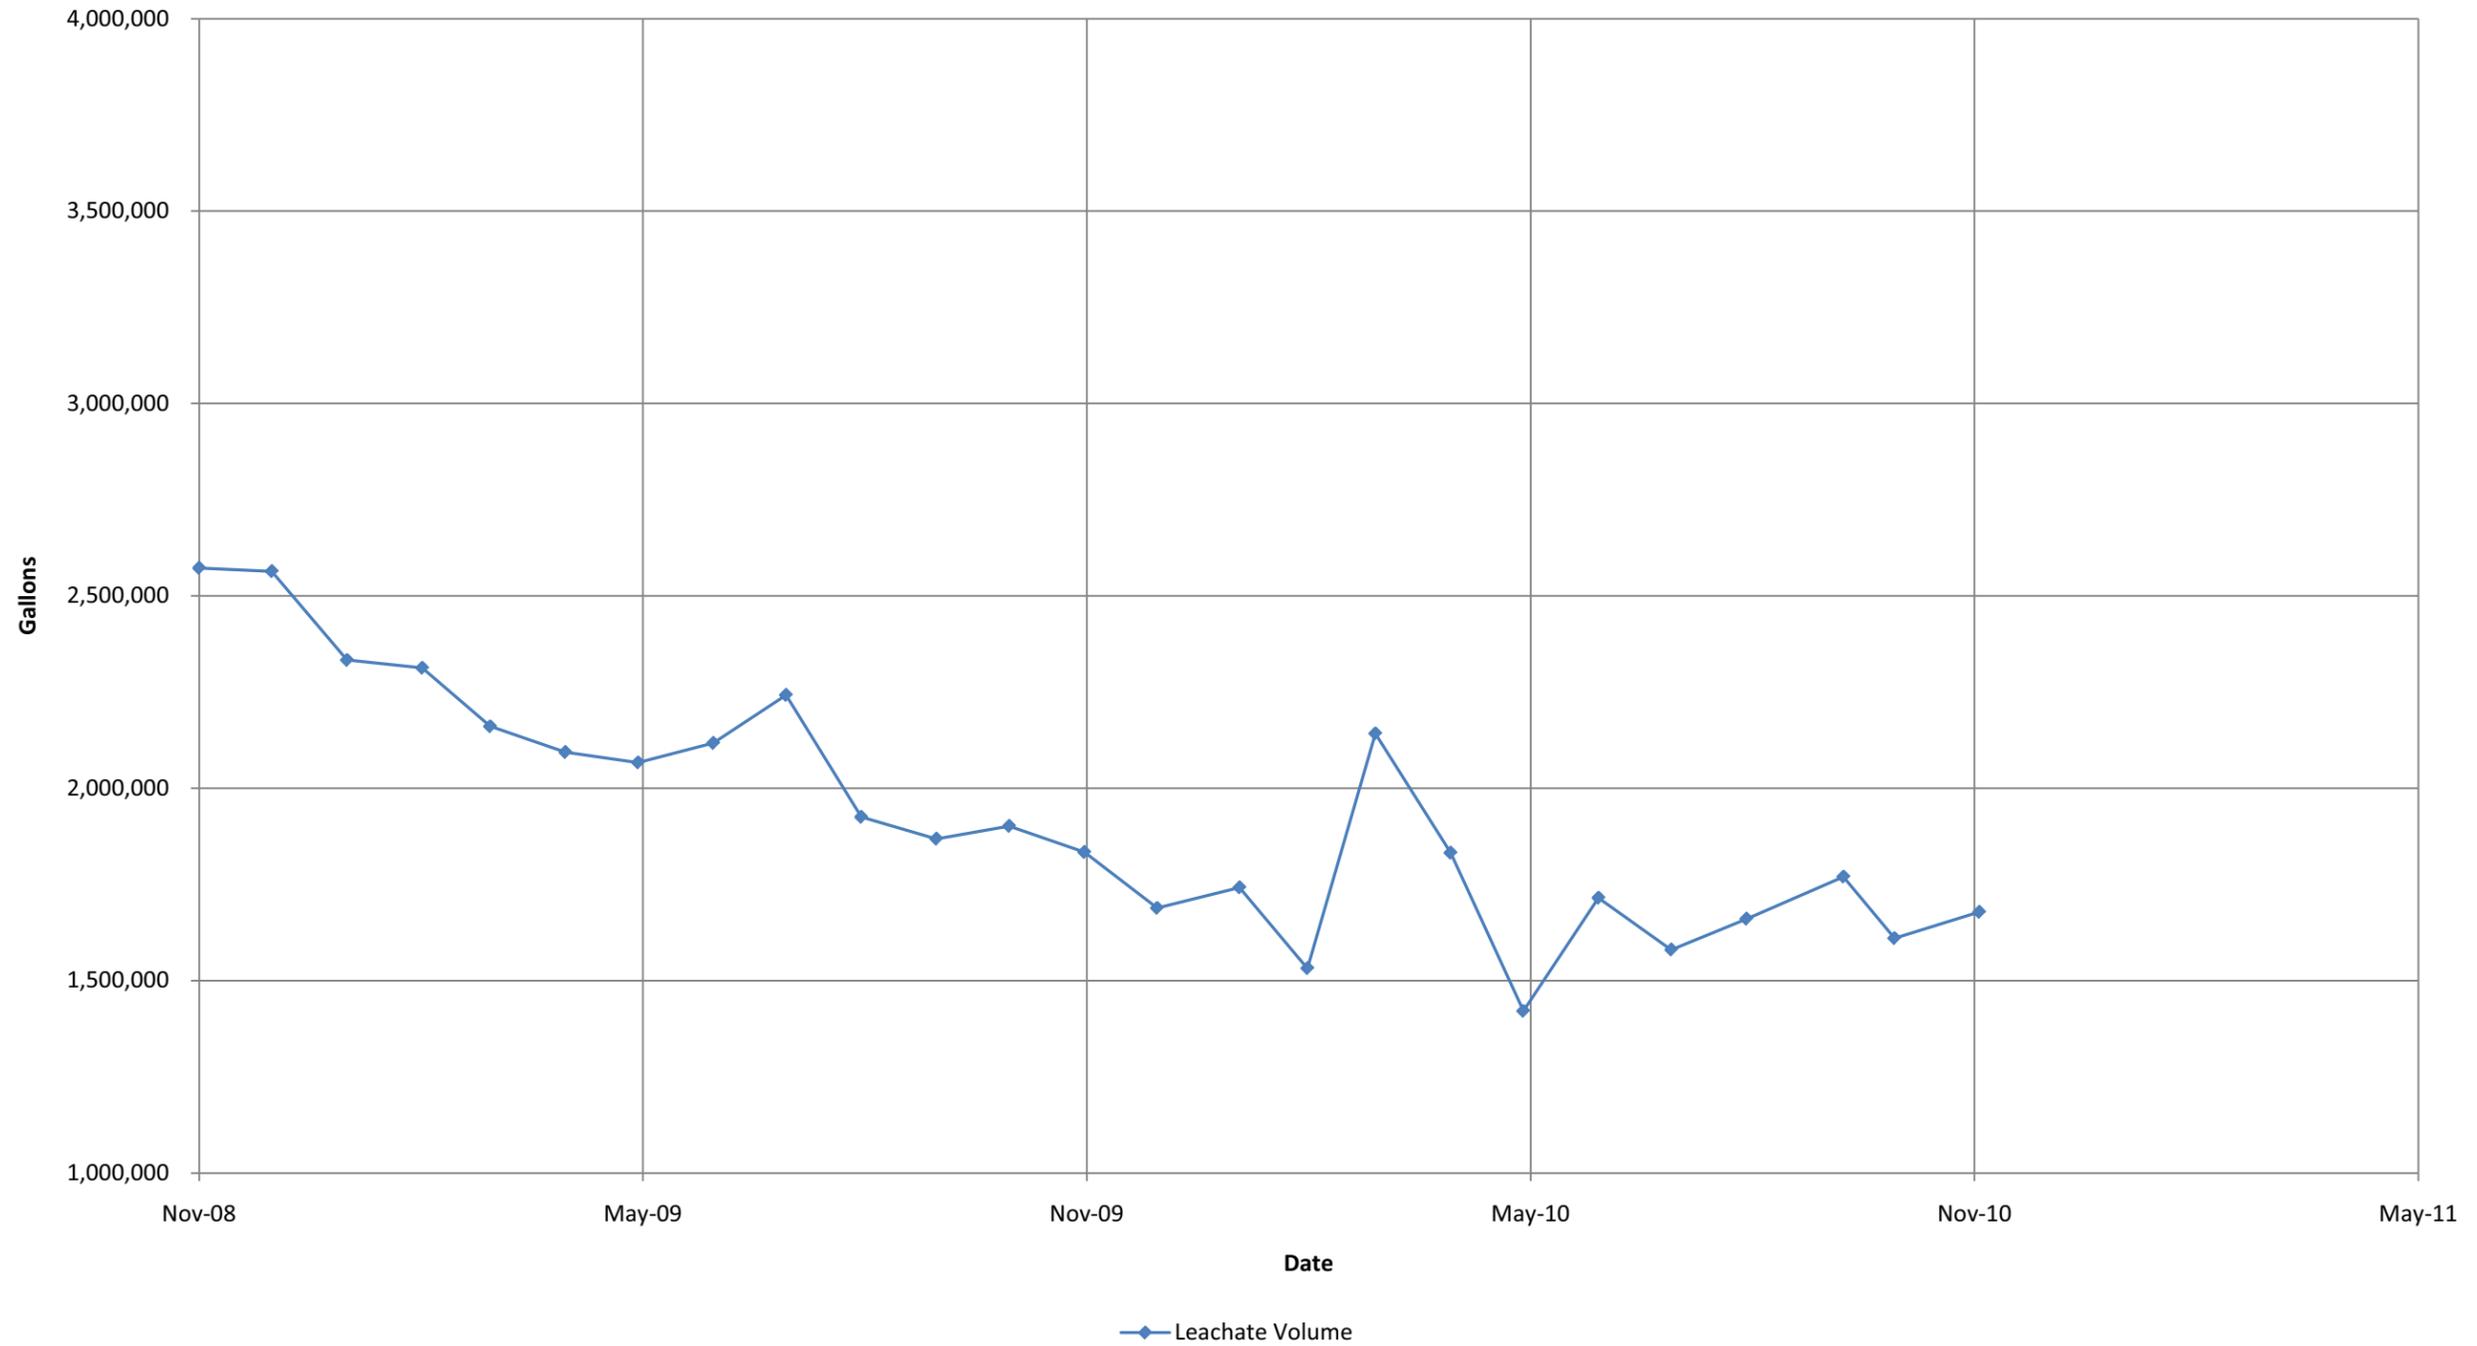
Graph 3 Leachate Volume

1. A freeboard of approximately 6 feet, approximately 90,000-gallons, is typically maintained at the 500,000-gallon tank. This freeboard volume was removed in July for tank cleaning and inspection. As such, the July 2010 leachate volume is elevated due to removal of this liquid.

2. Leachate generated from the Remediation Unit was stored in the same storage tank as that generated from the Operational Unit during the period July 19, 2010 through August 9, 2010 due to cleaning and maintenance to the Remediation storage tank. As such, the volume of leachate generated from the Remediation Unit was estimated for that period based upon typical daily averages.

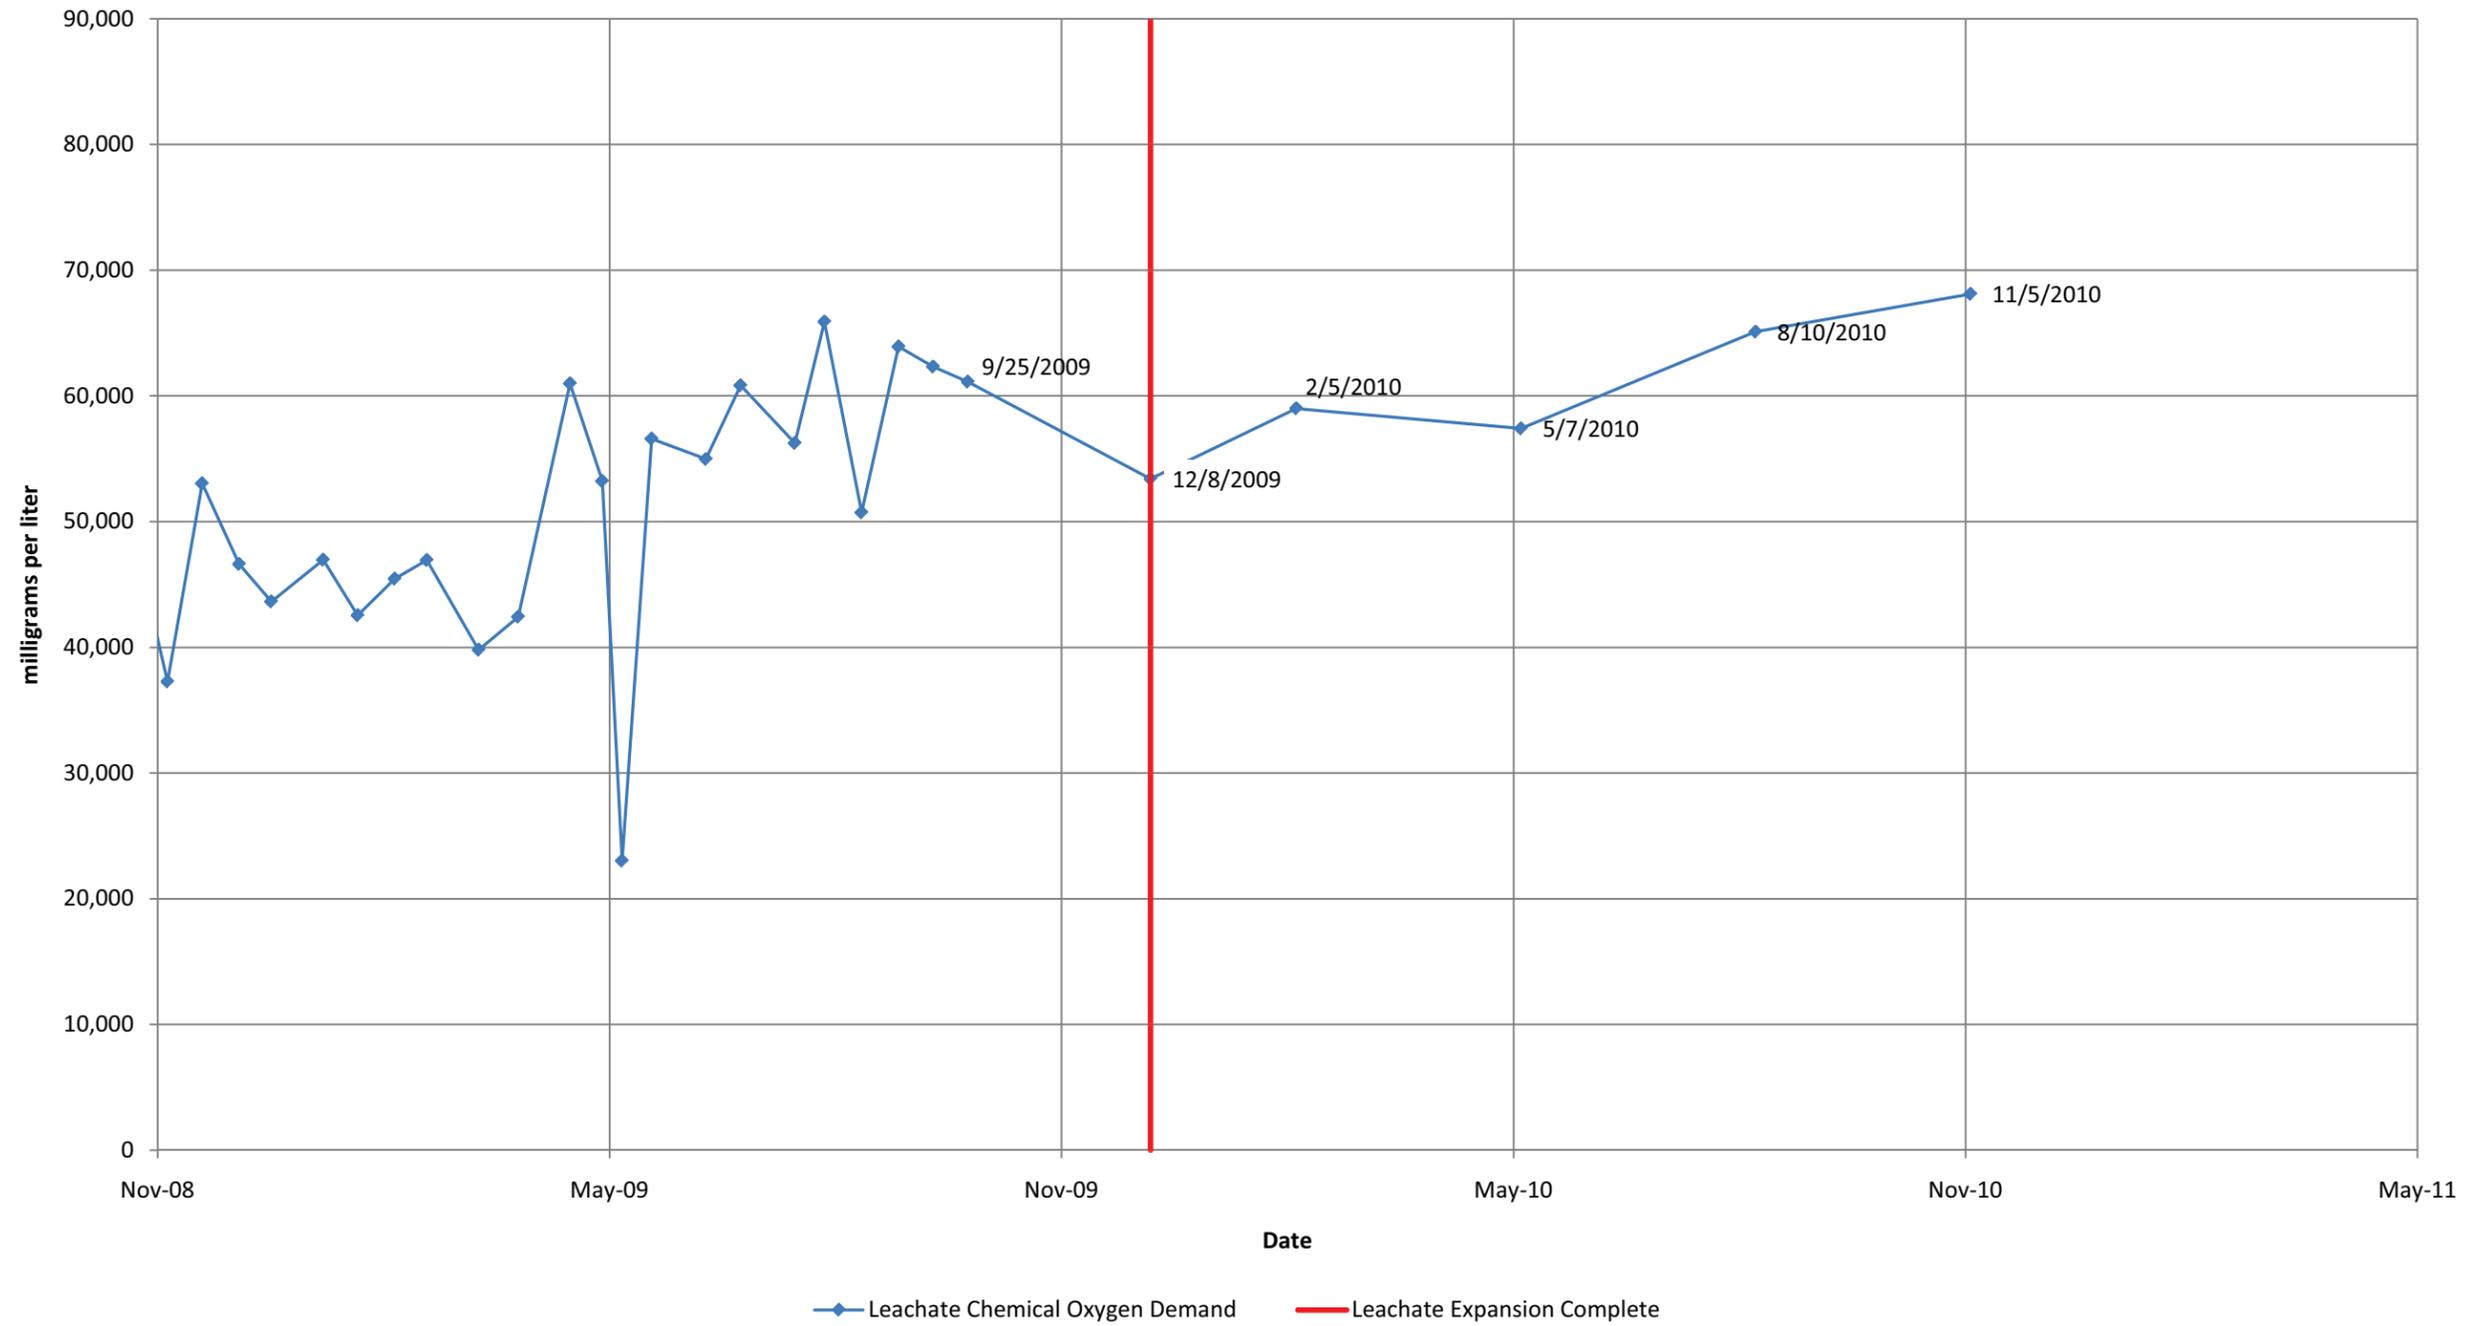
Graph 6 Leachate Chemical Oxygen Demand

1. Information presented prior to October 2009 was compiled from data prepared and presented by AECOM for Countywide Recycling and Disposal Facility.
2. Data shown prior to October 2009 are flow-weighted averages of data from the East, North and South leachate collection tanks. Data from December 2009 is from combined Tank East 500.
3. Data shown prior to October 2009 comprises data from the leachate collection system only, and excludes certain leachate toe drains, sumps and gas collection wells.
4. Data labels beginning in October 2009 indicate date of quarterly analytical sampling.

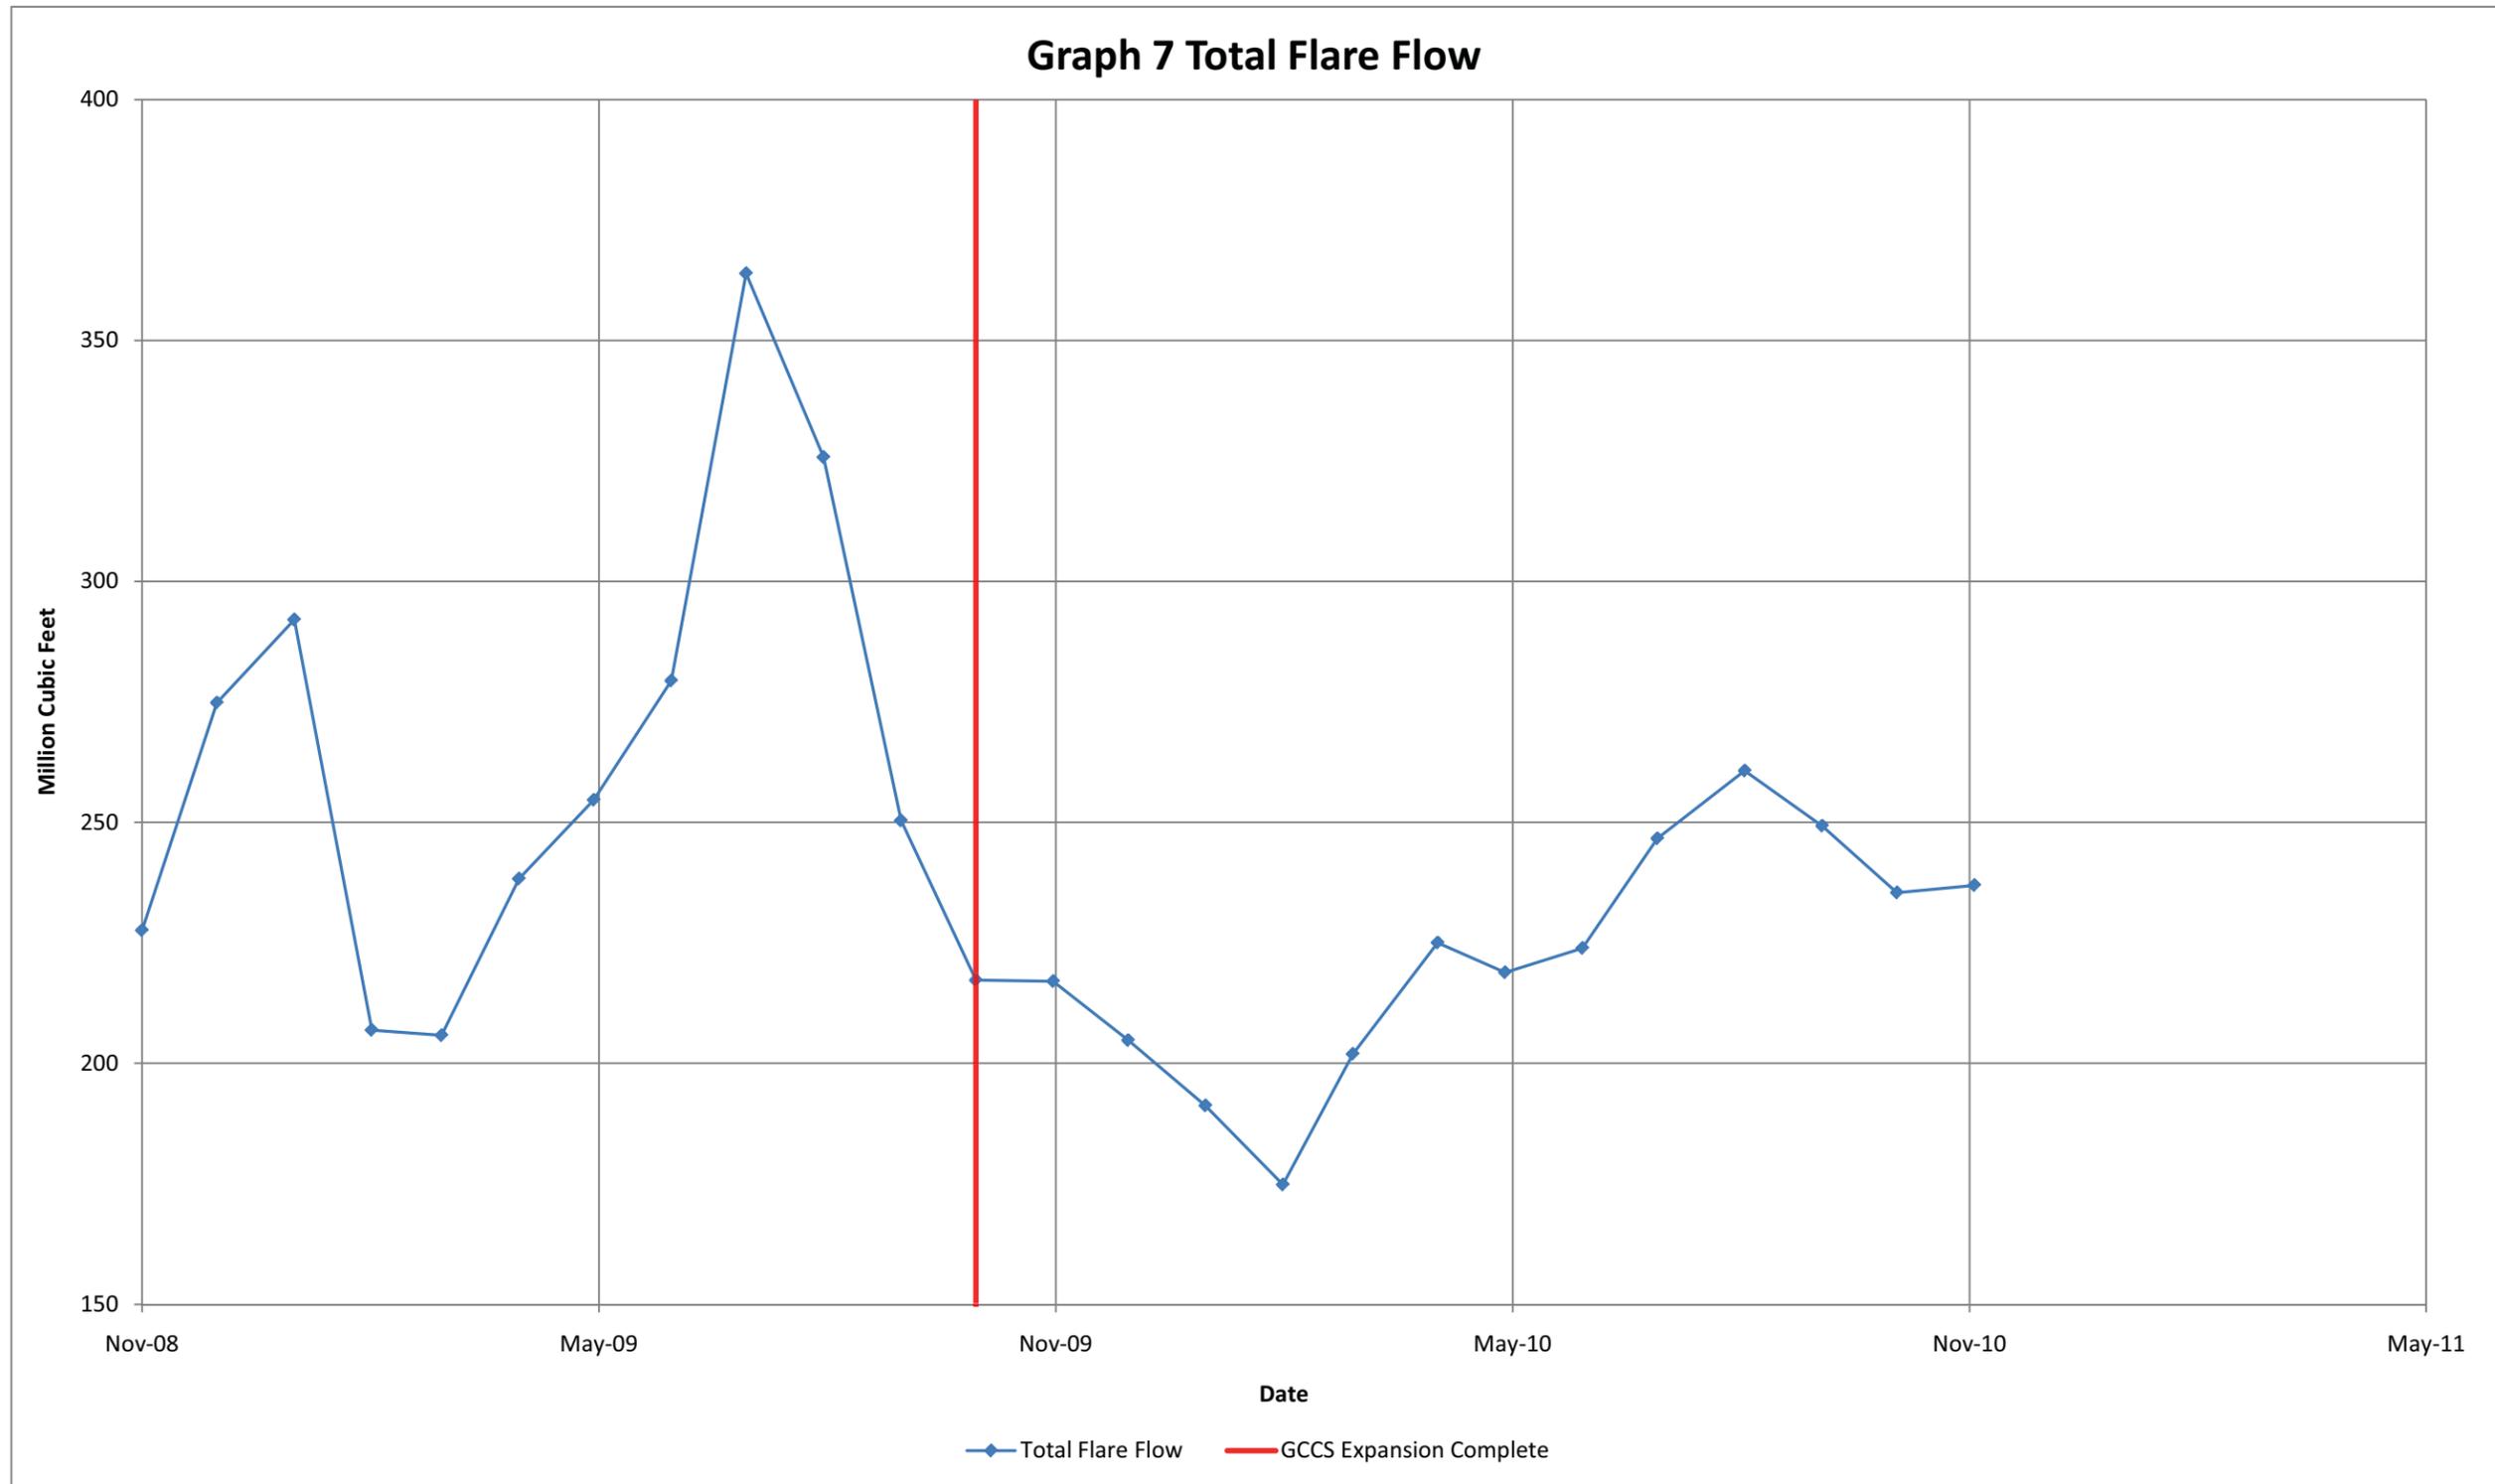
1. Increased flare flow in August 2010 is at least partially due to recalibration of flow meters during the reporting period.

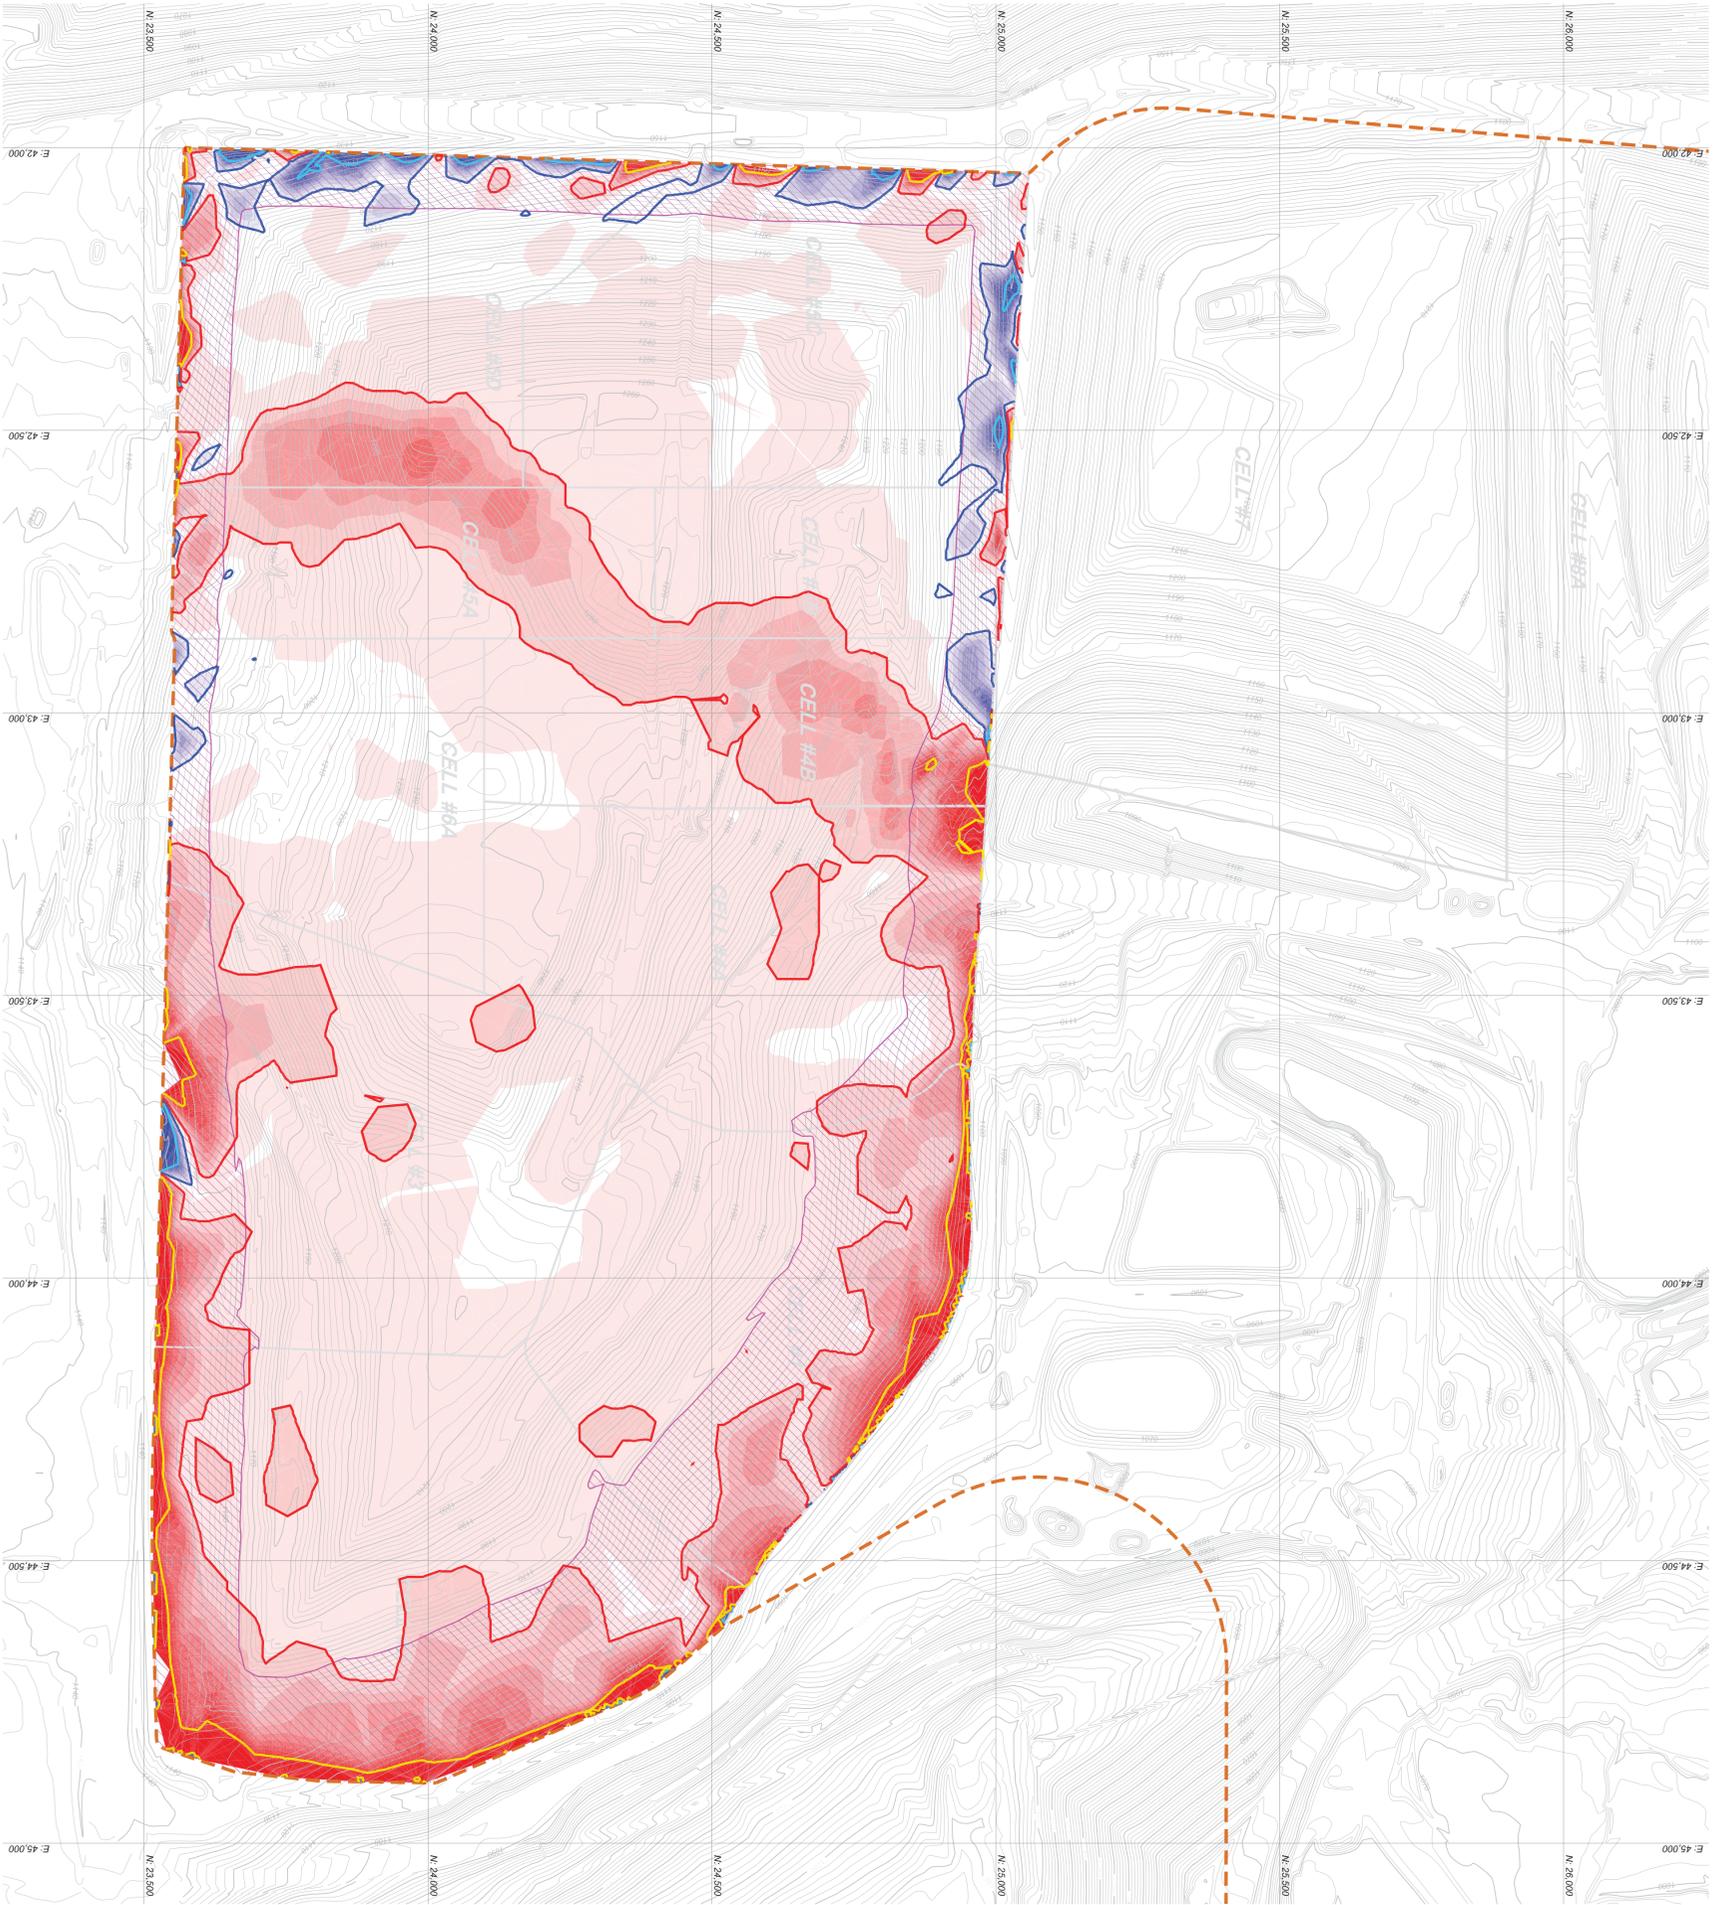
GENERAL NOTE:
THIS MAP REPRESENTS THE AVERAGE ANNUALIZED MONTHLY SETTLEMENT FOR THE TIME PERIOD FROM OCTOBER 2010 THRU NOVEMBER 2010.
