Countywide Recycling & Disposal Facility

Remediation Unit

**Monthly Progress Report
Of
Operations, Monitoring & Maintenance Activities**

November 2010

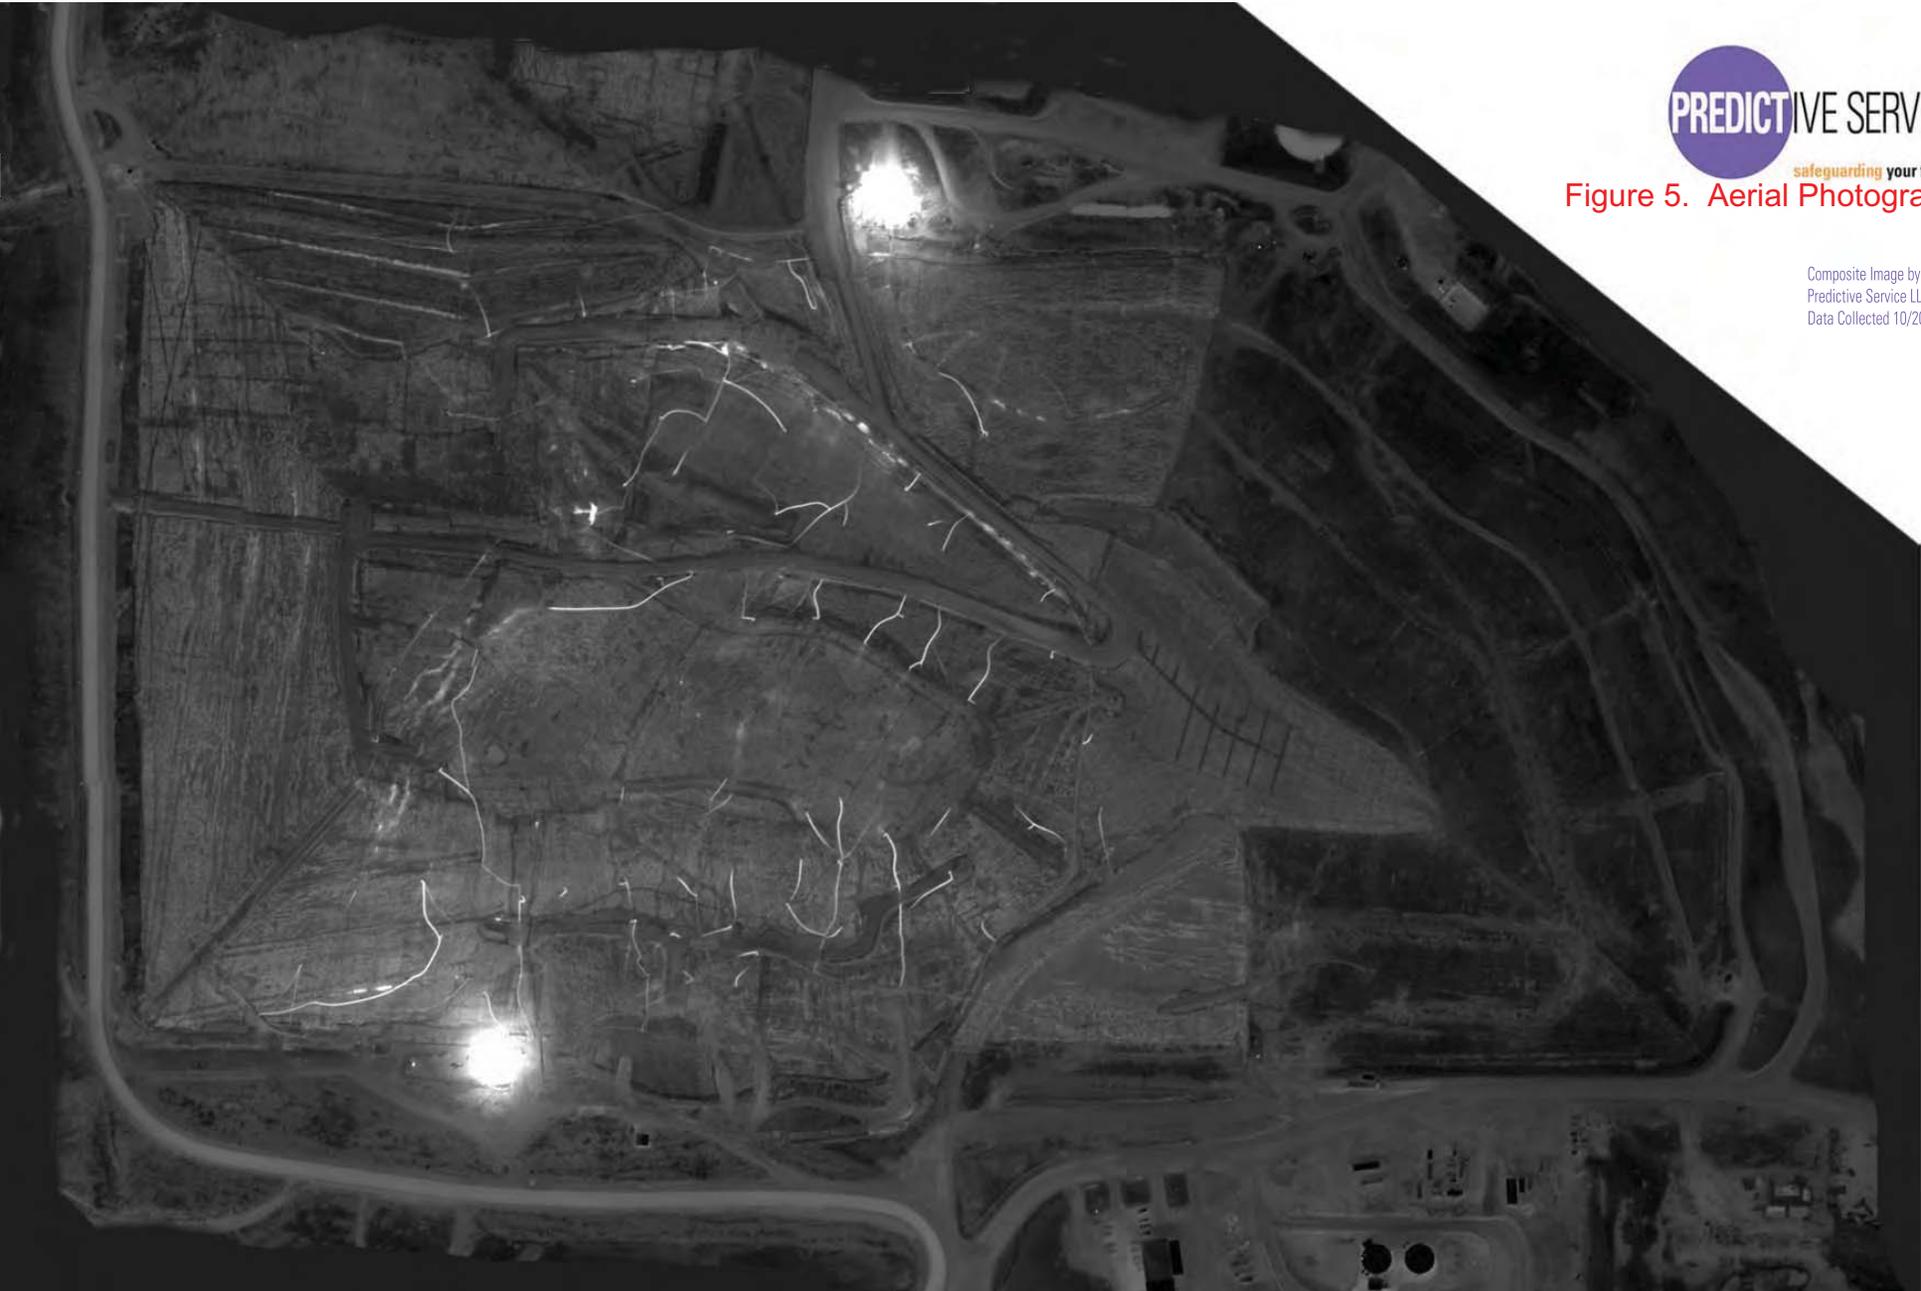
Figure 5. Aerial Photograph

Composite Image by
Predictive Service LLC, 216.378.3500
Data Collected 10/20/2010

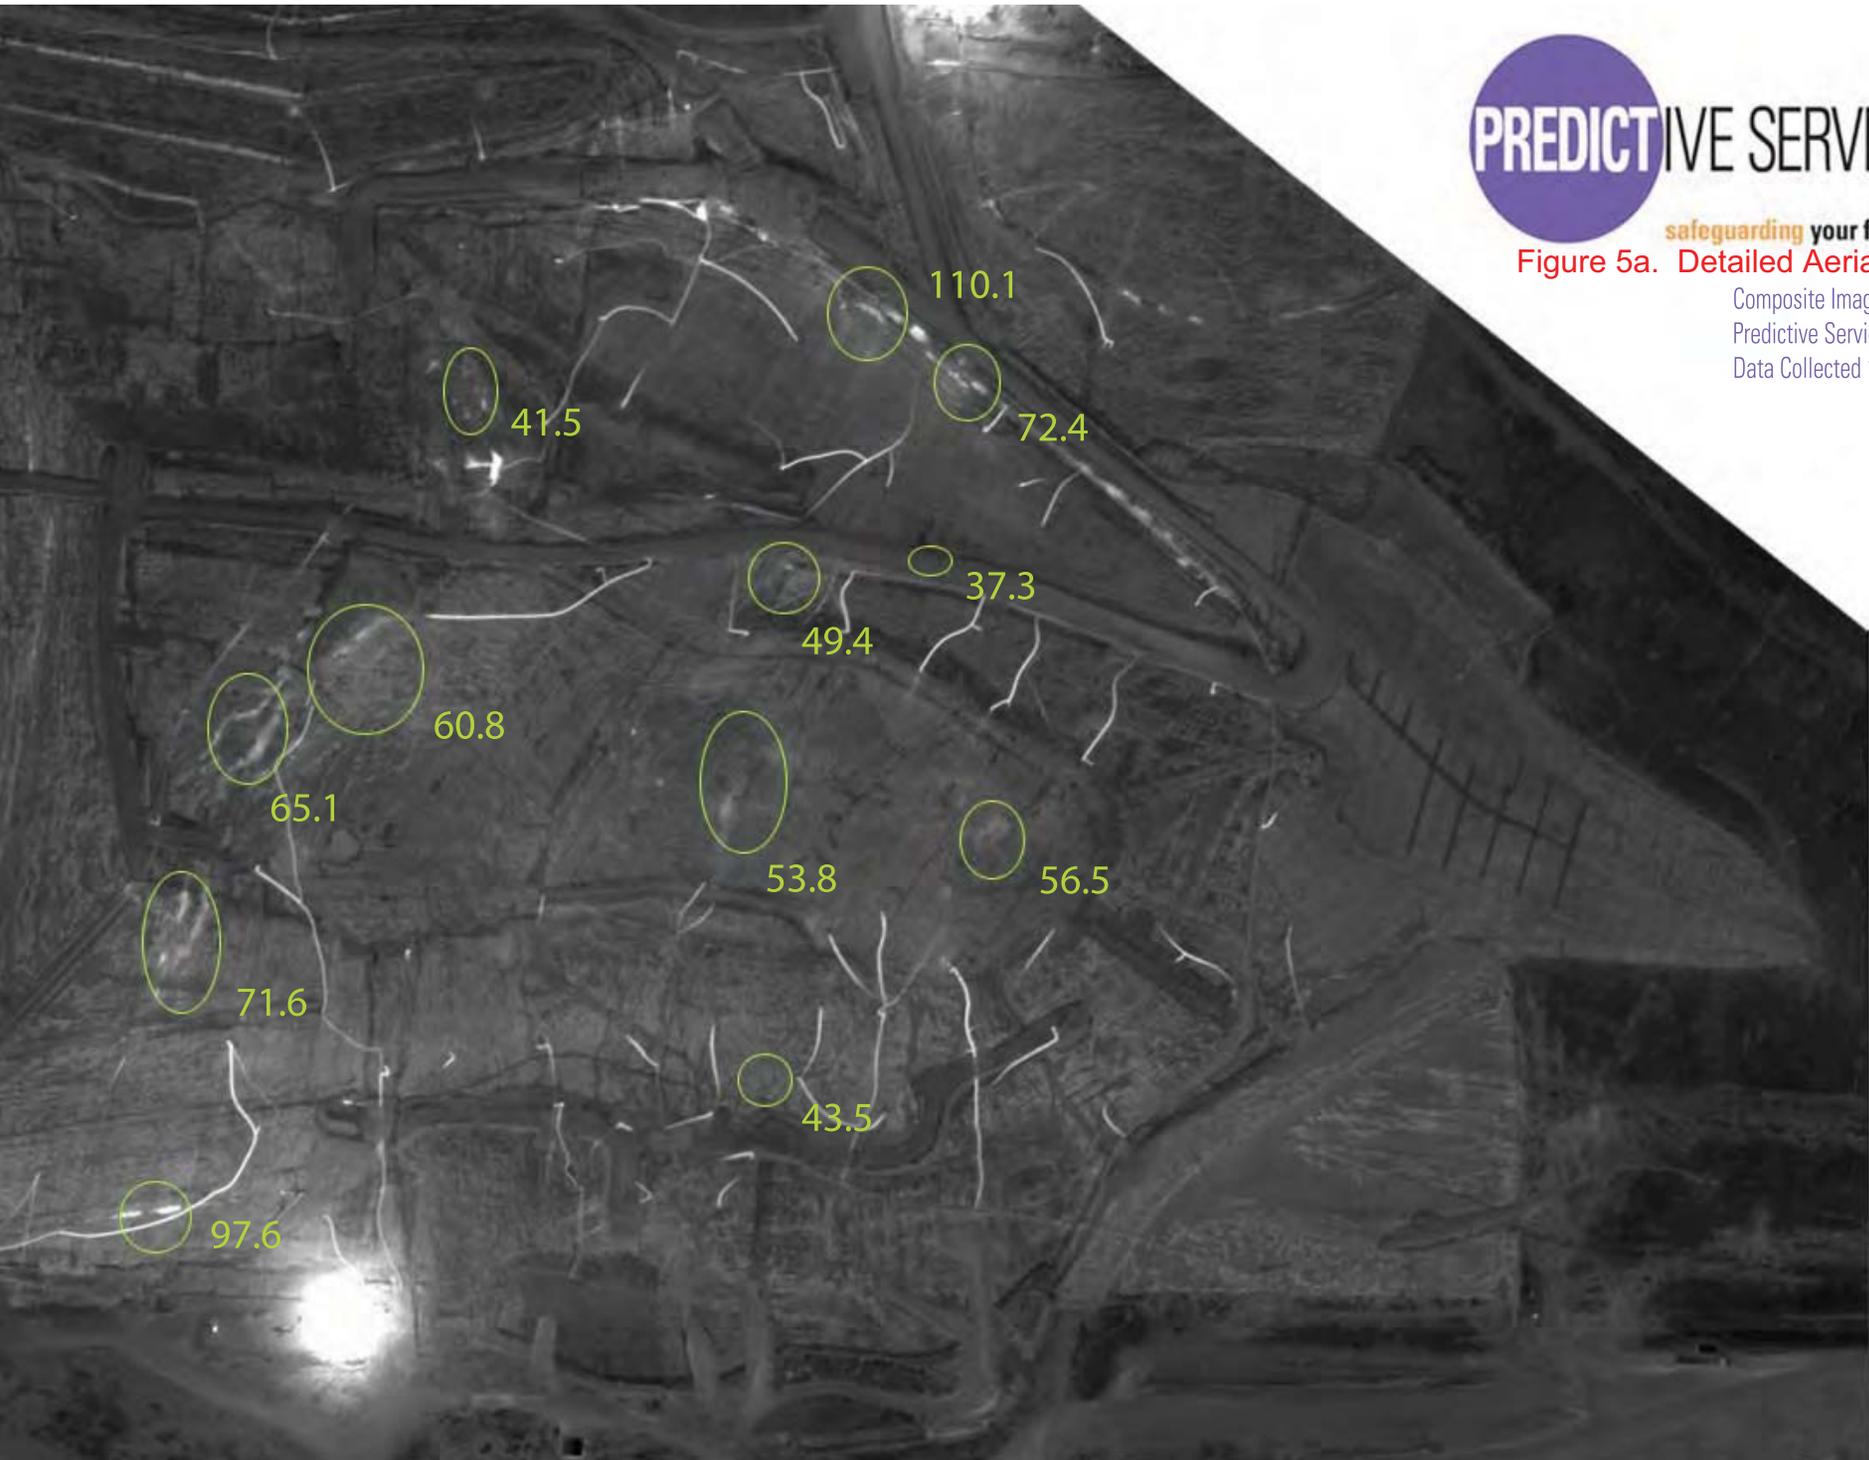
Figure 5a. Detailed Aerial Photograph

Composite Image by
Predictive Service LLC. 216.378.3500
Data Collected 10/20/2010

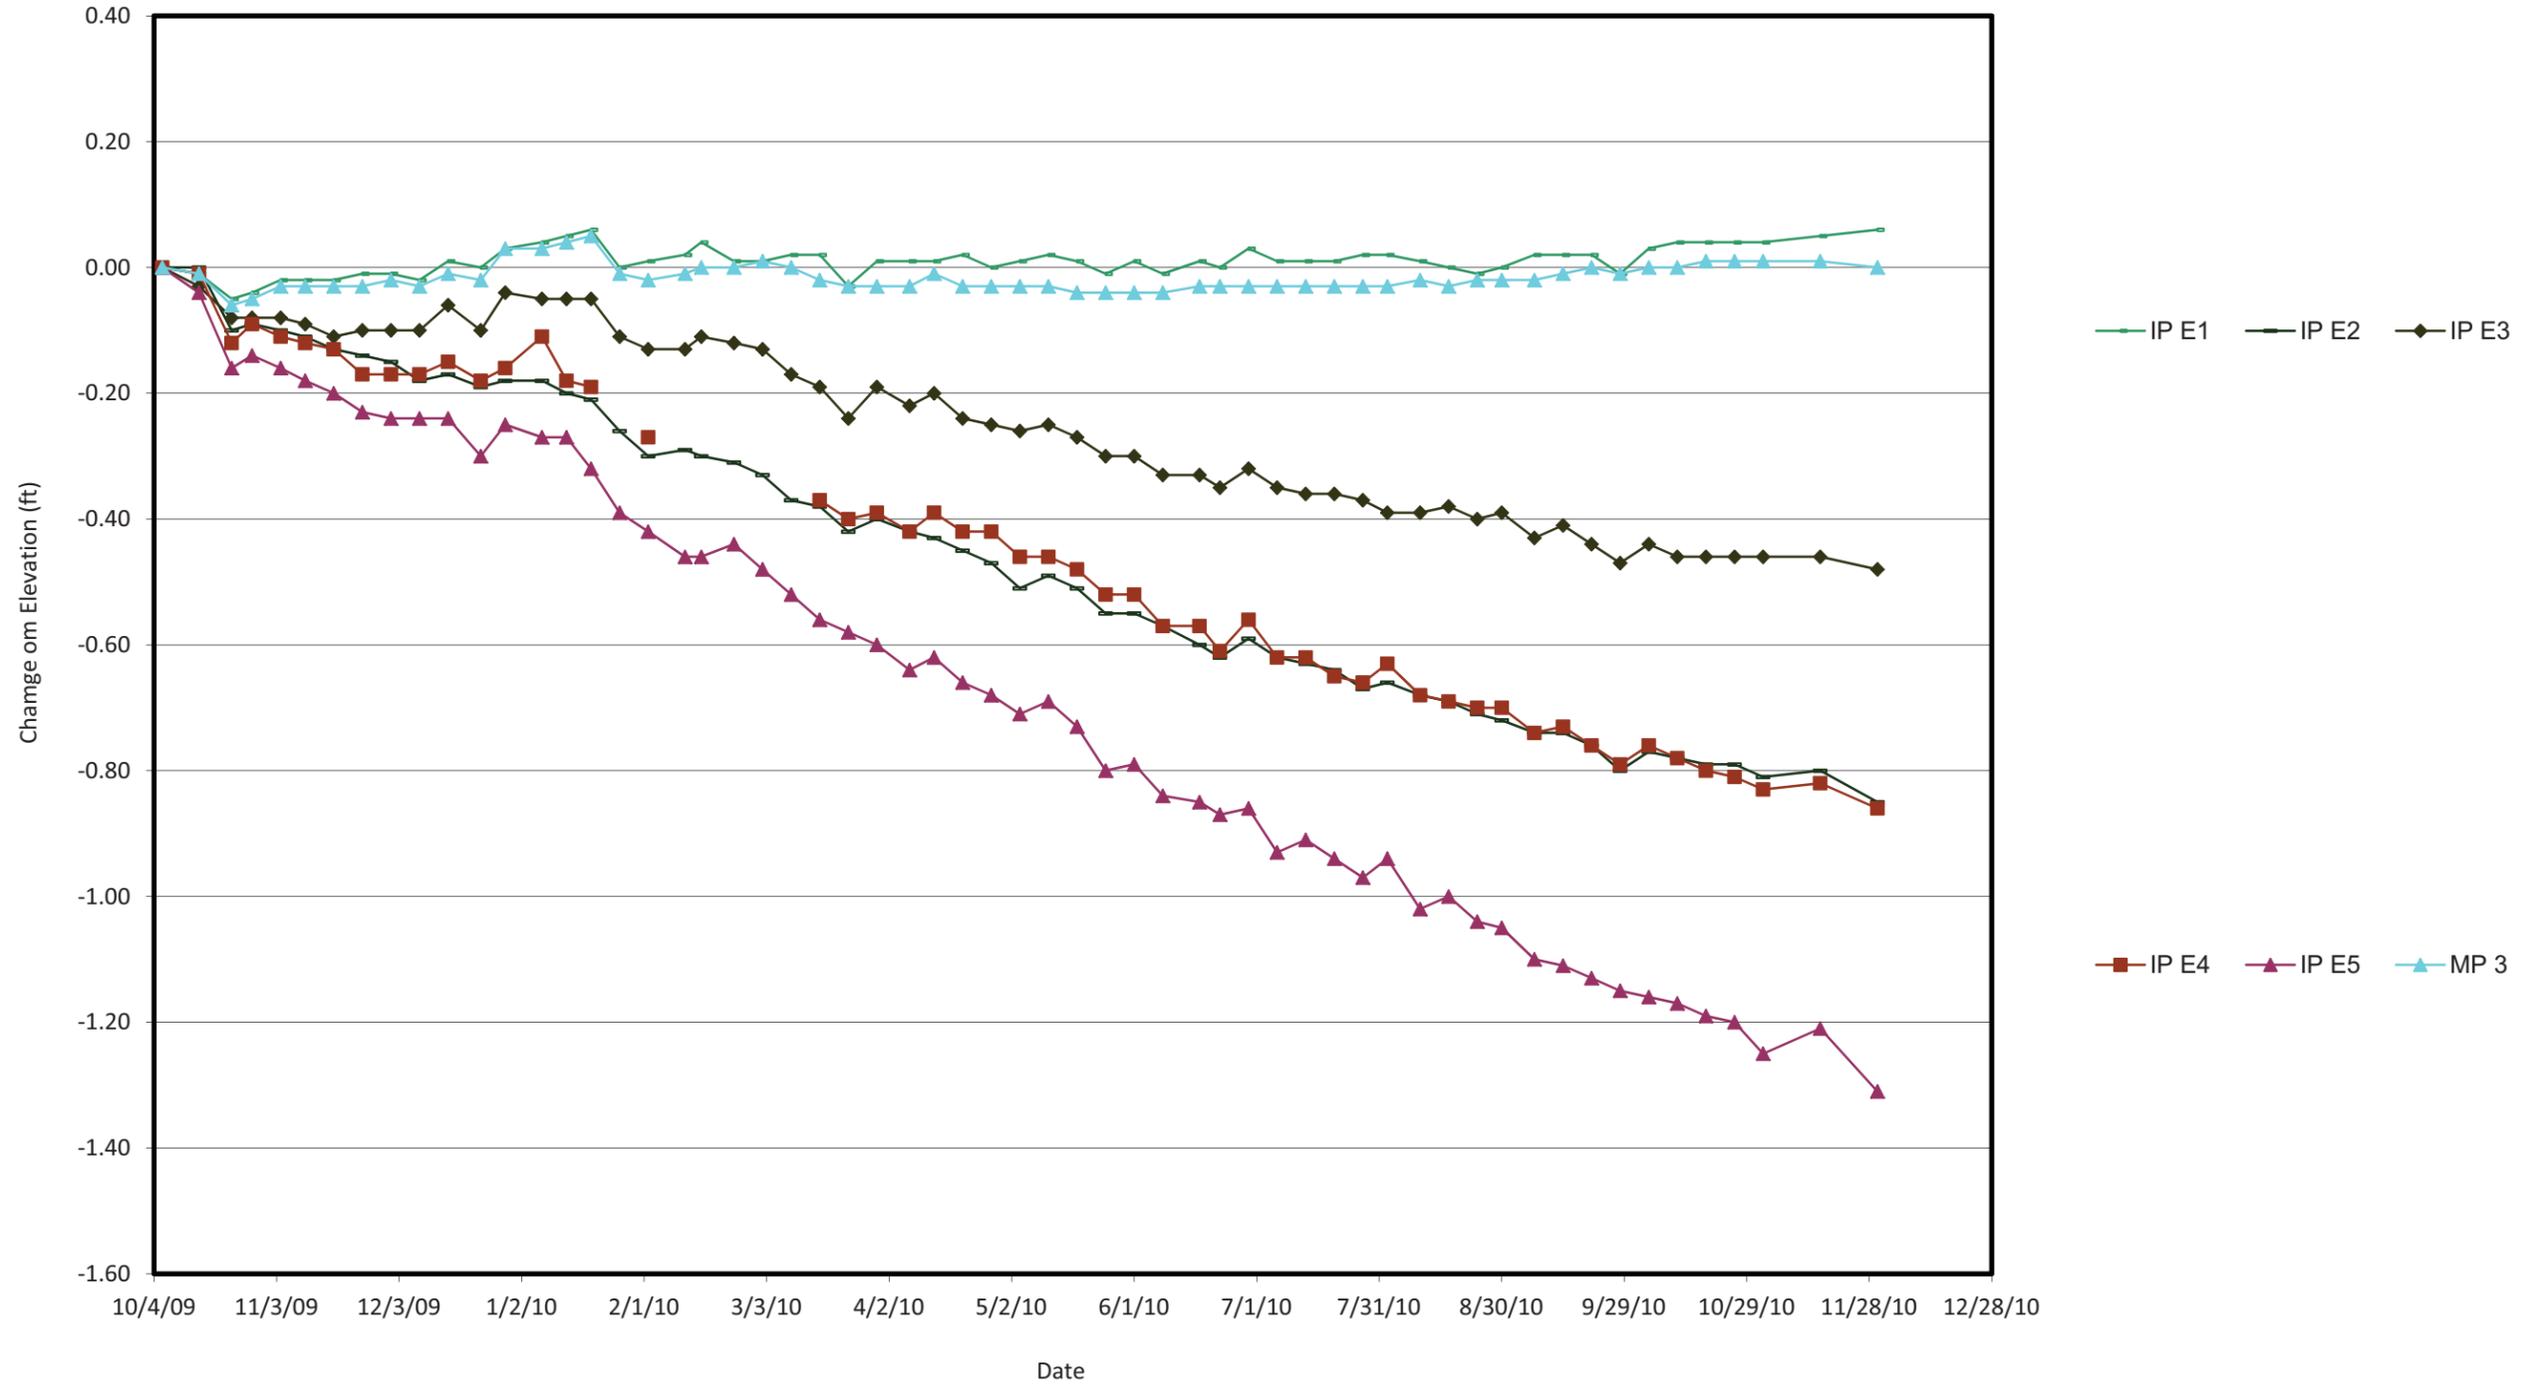
Graph 16 - West Slope Pin Movement
 For Pins that Exceeded a Trigger During Reporting Month
 Elevation Change

1. Data compiled by PJ Carey Associates, PC.
 2. Survey provided by DEI beginning on October 5, 2009.

CHANGE IN ELEVATION (FT)
CALCULATED BASED ON ORIGINAL SURVEY DATE OF 10-06-09

During the last week of November, monitoring pin IP-E1 also exceeded the vertical trigger. Elevation change for this pin does not necessarily represent a pattern, nor does it represent a deviation from prior trends that would indicate slope instability. Countywide does not believe that the analysis of these triggers should prompt any additional measures beyond the requirements of the OM&M Plan and ongoing activities. Further analysis of this data is presented in Attachment 4.

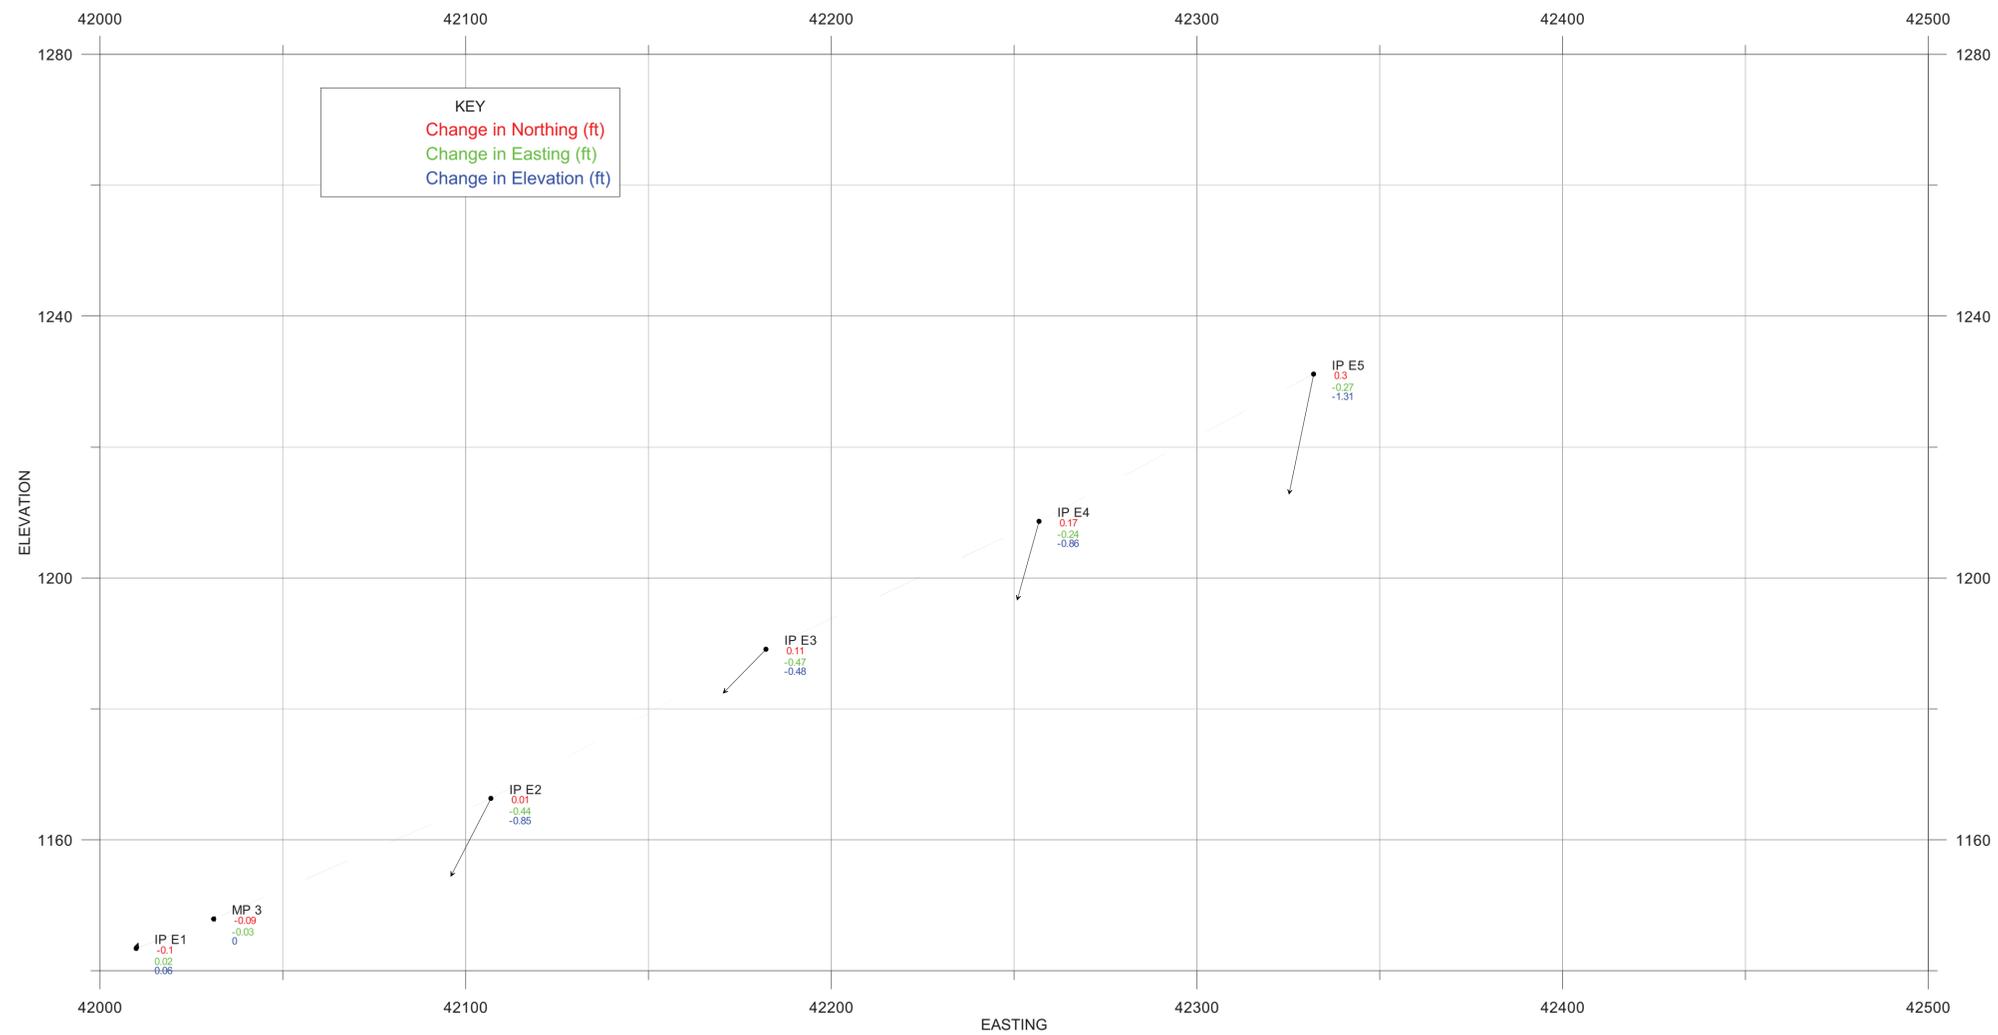
PROFILE MOVEMENT FOR ROW 'E'
BETWEEN 10/06/09 & 11/30/10

1. PROFILE IS APPROXIMATED USING POINTS SHOWN AS PROVIDED BY DIVERSIFIED ENGINEERING INC.

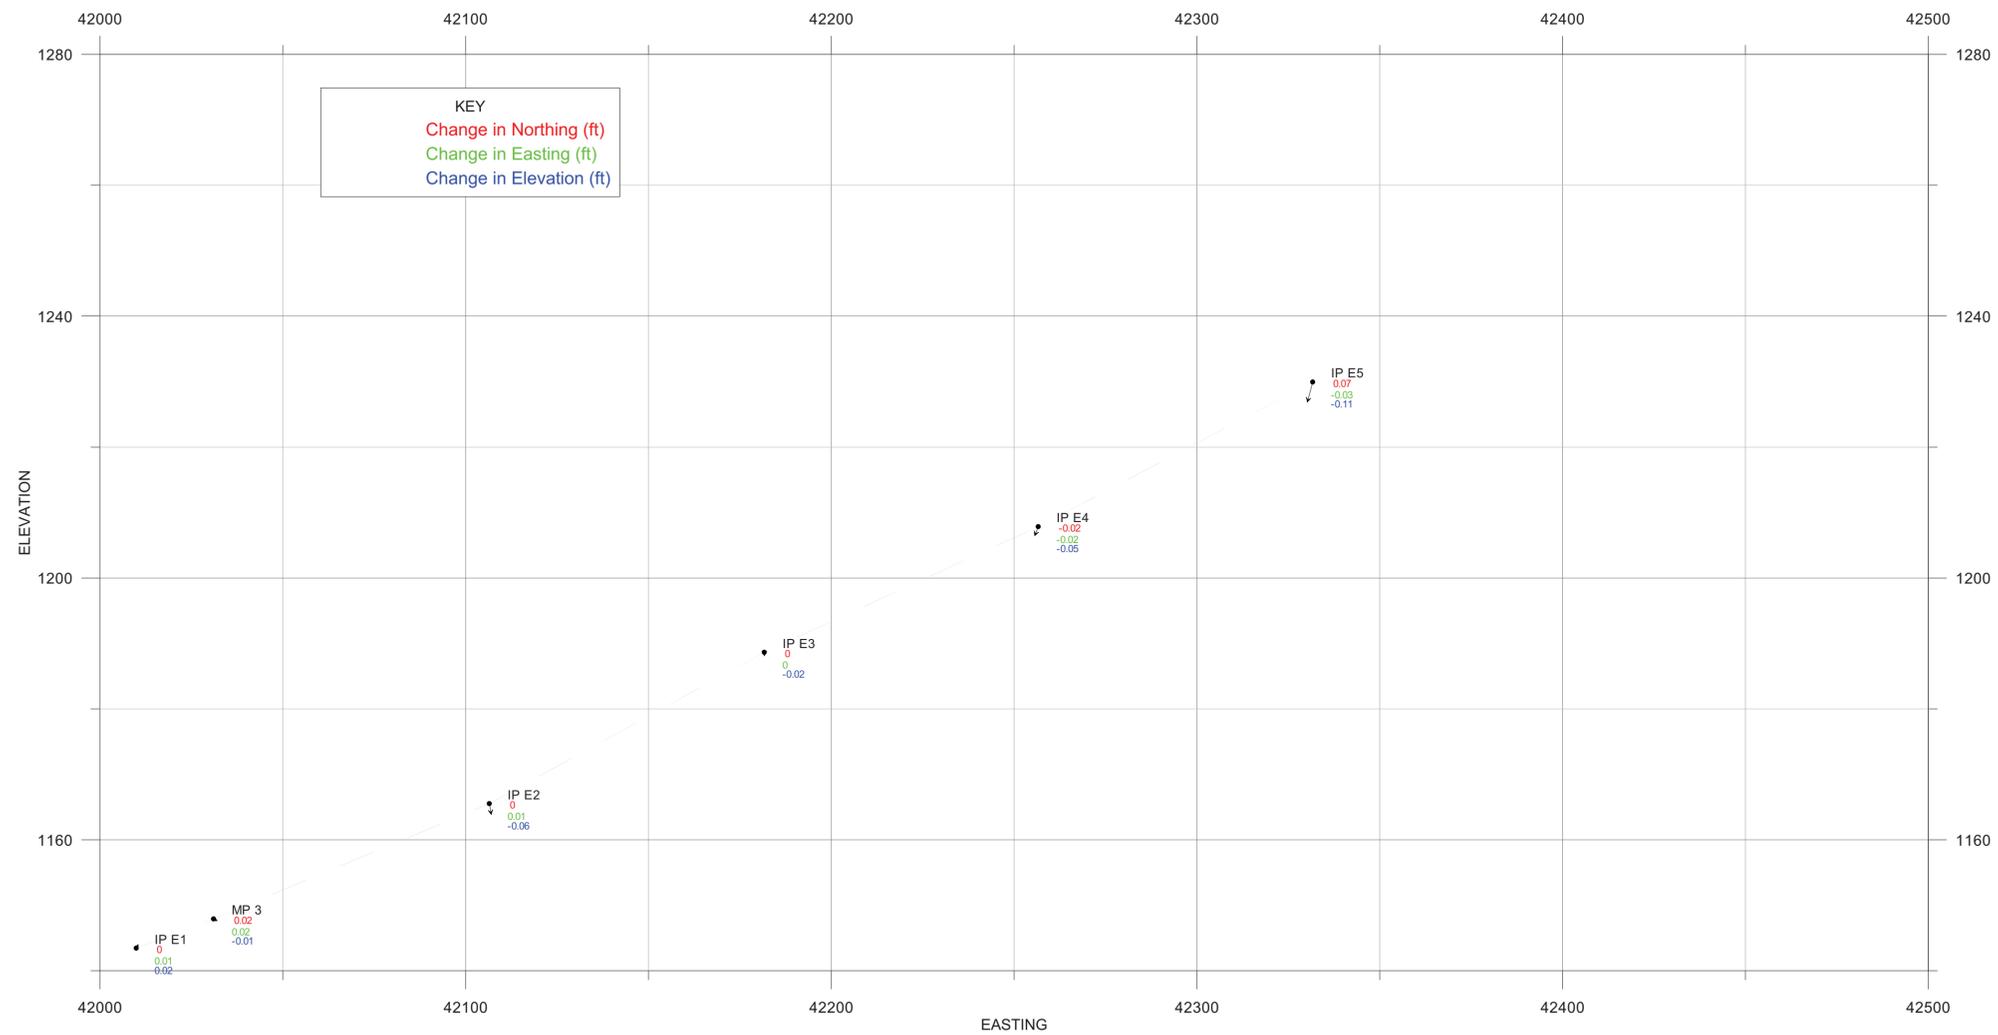
PROFILE MOVEMENT FOR ROW 'E'
BETWEEN 10/26/10 & 11/30/10

1. PROFILE IS APPROXIMATED USING POINTS SHOWN AS PROVIDED BY DIVERSIFIED ENGINEERING INC.

2. HORIZONTAL MOVEMENT VECTORS ARE PLOTTED TO A 1 INCH = 0.5 FEET SCALE. \longrightarrow 0.5 FEET

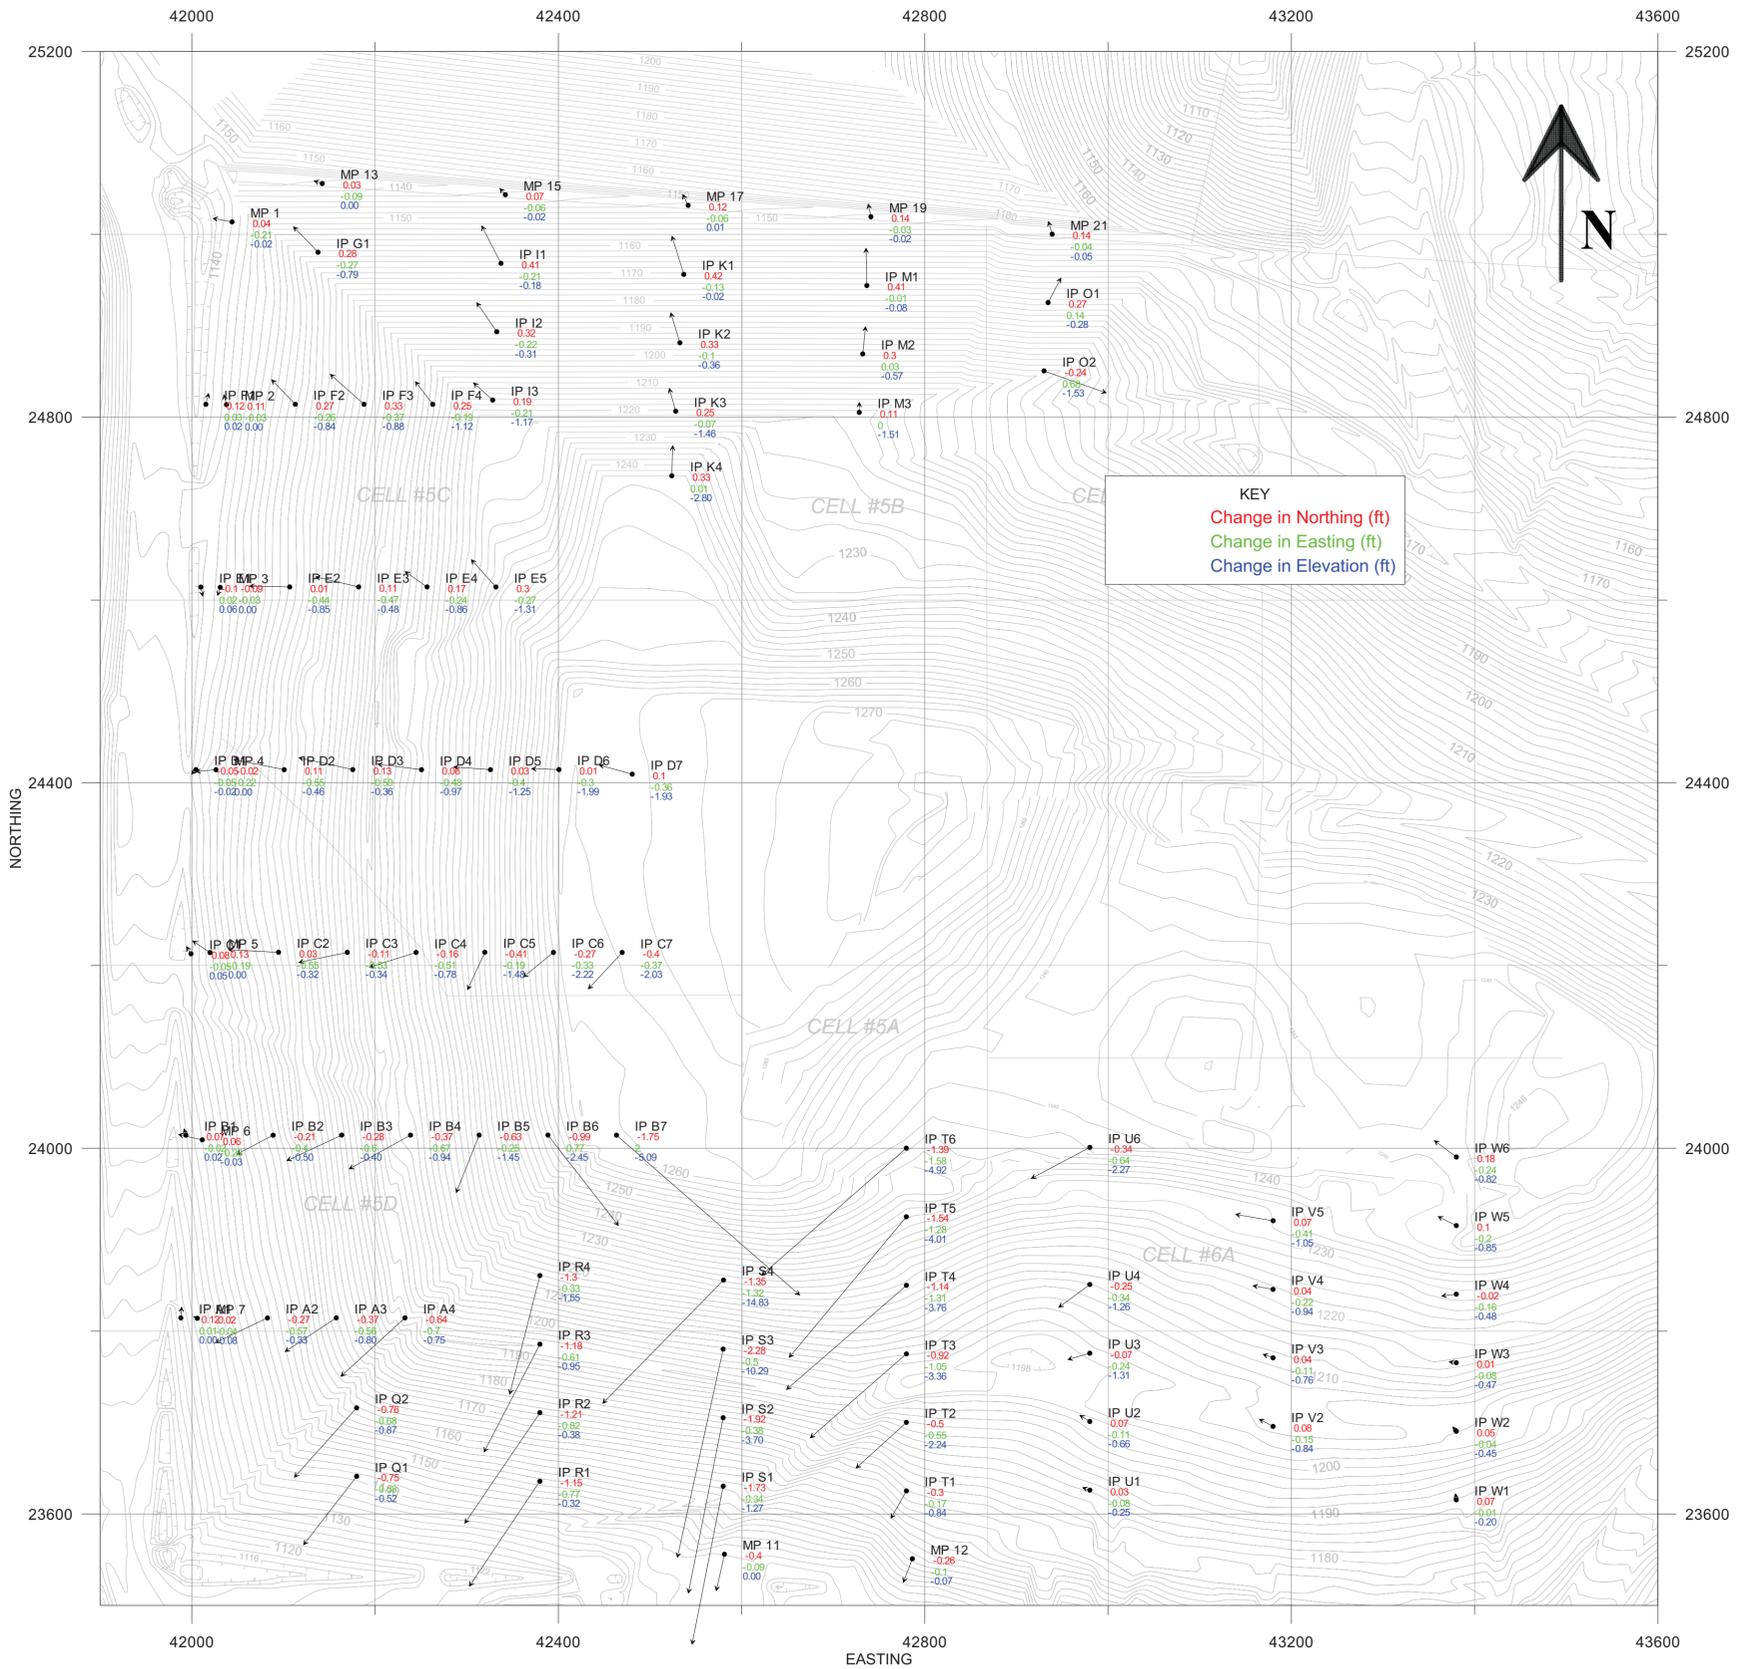
1. TOPOGRAPHY PROVIDED BY DIVERSIFIED ENGINEERING INC AS PART OF THE "88 REMEDIATION UNIT SLOPE PINS AND MONITORING PLATES LOCATION" PROJECT, DRAWING DATED 7/21/2009.
2. HORIZONTAL MOVEMENT VECTORS ARE PLOTTED TO A 1 INCH = 1 FOOT SCALE.

3. ON MAY 10, 2010, OHIO EPA APPROVED AN INCREASE OF THE BASELINE ELEVATION OF IRON PIN F1 FROM THE ORIGINAL ELEVATION OF 1141.06', ESTABLISHED ON OCTOBER 6, 2009, TO 1141.15' DUE TO THE EFFECTS OF FROST HEAVE.
4. ON NOVEMBER 22, 2010, OHIO EPA APPROVED AN INCREASE THE BASELINE ELEVATION OF MONITORING POINTS MP-4 AND MP-5 FROM THE ORIGINAL ELEVATION OF 1154.82' AND 1152.34', ESTABLISHED ON OCTOBER 6, 2009, TO 1154.88' AND 1152.39', SURVEYED ON NOVEMBER 30, 2010, RESPECTIVELY.
5. VERTICAL MOVEMENT TRIGGERS WAS EXCEEDED AT IP E1 DURING MONITORING PERIOD.

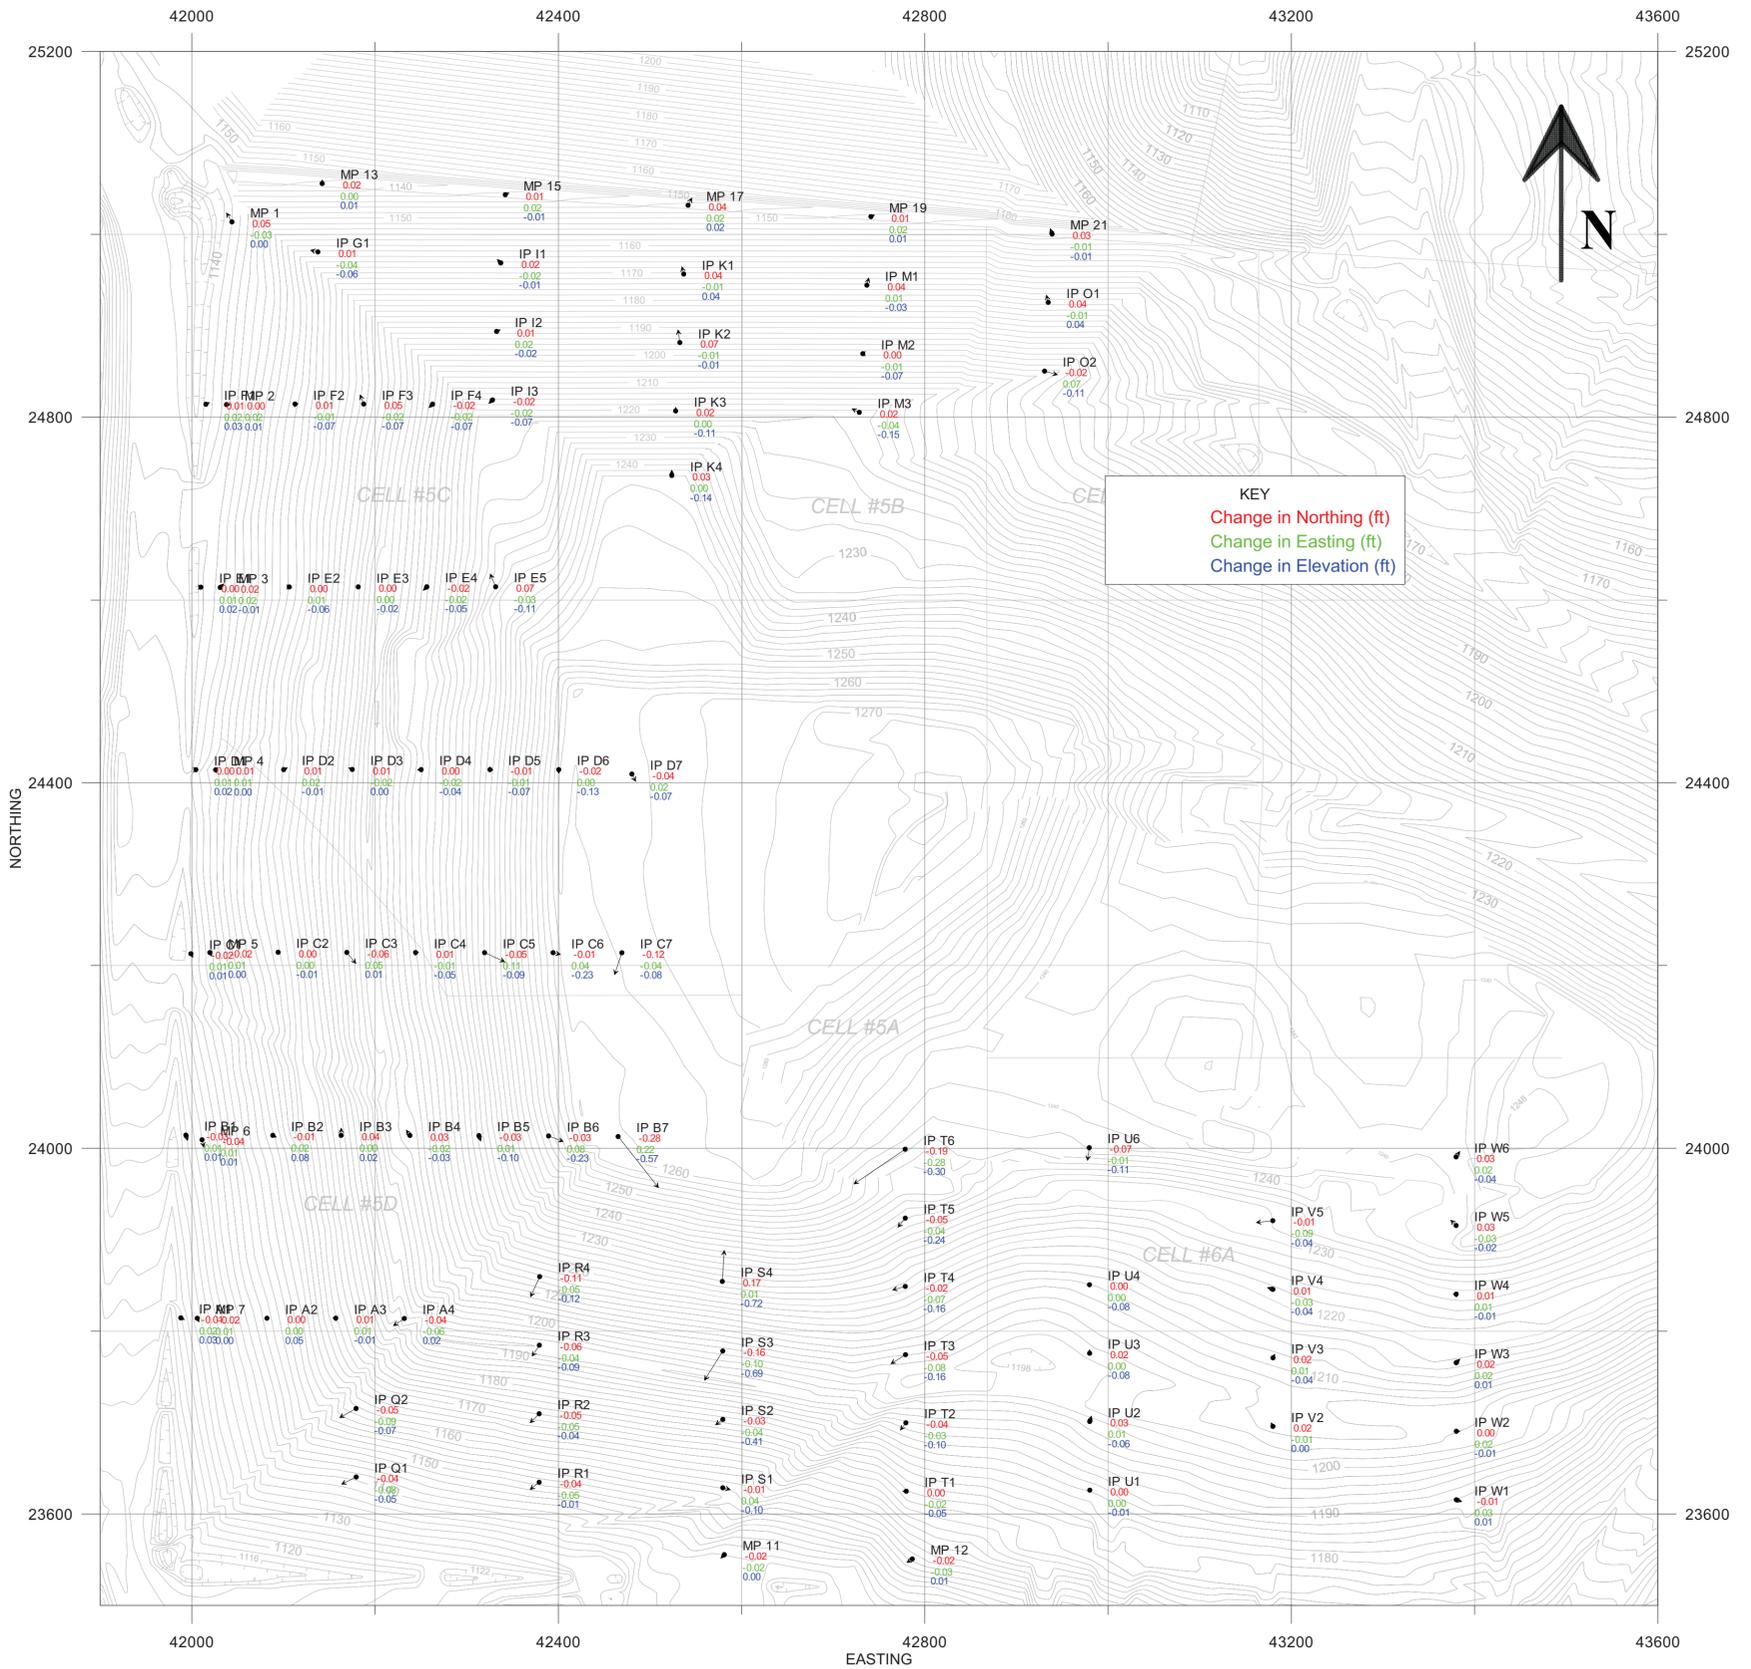
**HORIZONTAL MOVEMENTS
BETWEEN 10/26/10 & 11/30/2010**

- NOTE:
1. TOPOGRAPHY PROVIDED BY DIVERSIFIED ENGINEERING INC AS PART OF THE "88 REMEDIATION UNIT SLOPE PINS AND MONITORING PLATES LOCATION" PROJECT, DRAWING DATED 7/21/2009.
 2. HORIZONTAL MOVEMENT VECTORS ARE PLOTTED TO A 1 INCH = 0.5 FEET SCALE.
 3. HORIZONTAL MOVEMENT TRIGGER WAS NOT EXCEEDED DURING REPORTING PERIOD.
 4. VERTICAL MOVEMENT TRIGGER WAS EXCEEDED AT IP E1 DURING THE REPORTING PERIOD.
