## **Figures**

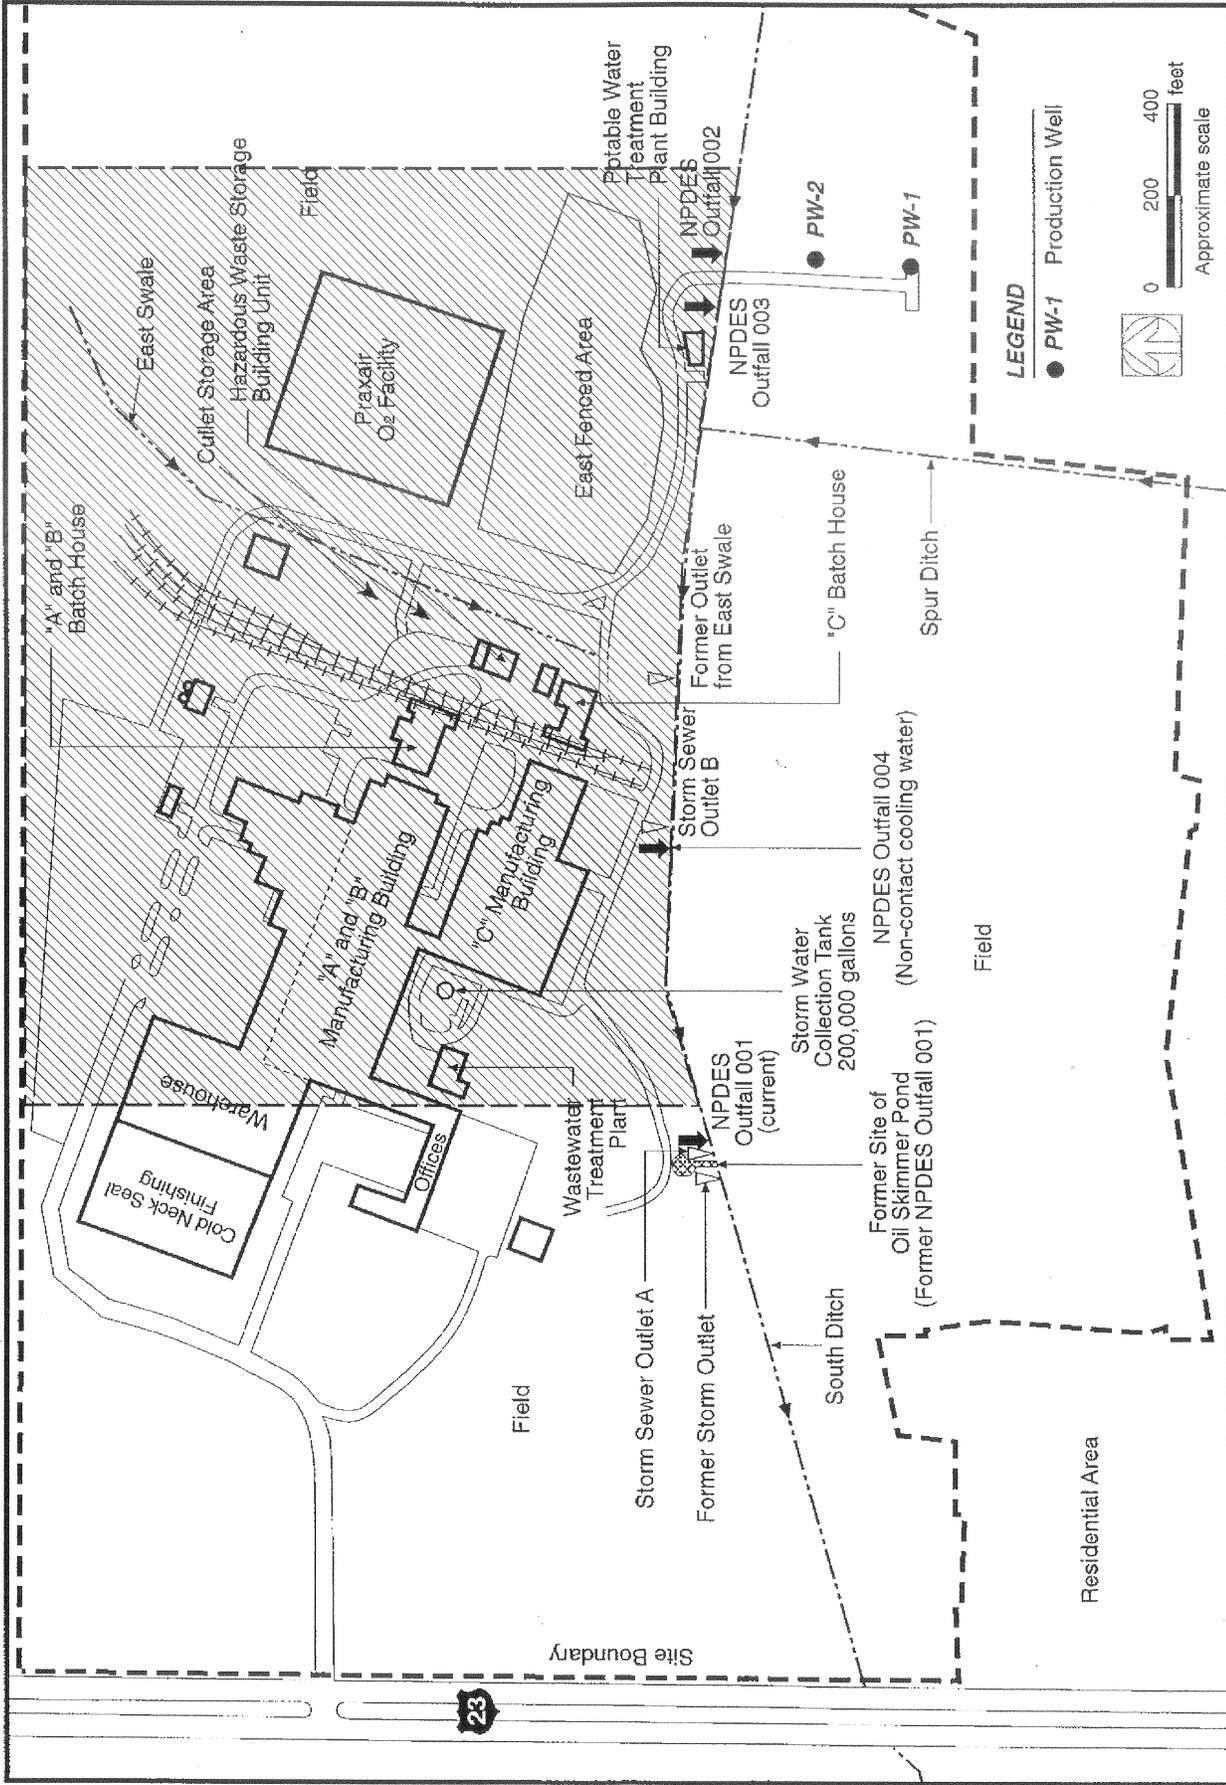
Figure 1-2. Site features.

= Approximate limits of proposed Environmental Restrictive Covenant.  
 (Southern boundary on south bank of South Ditch; other boundaries as shown.)

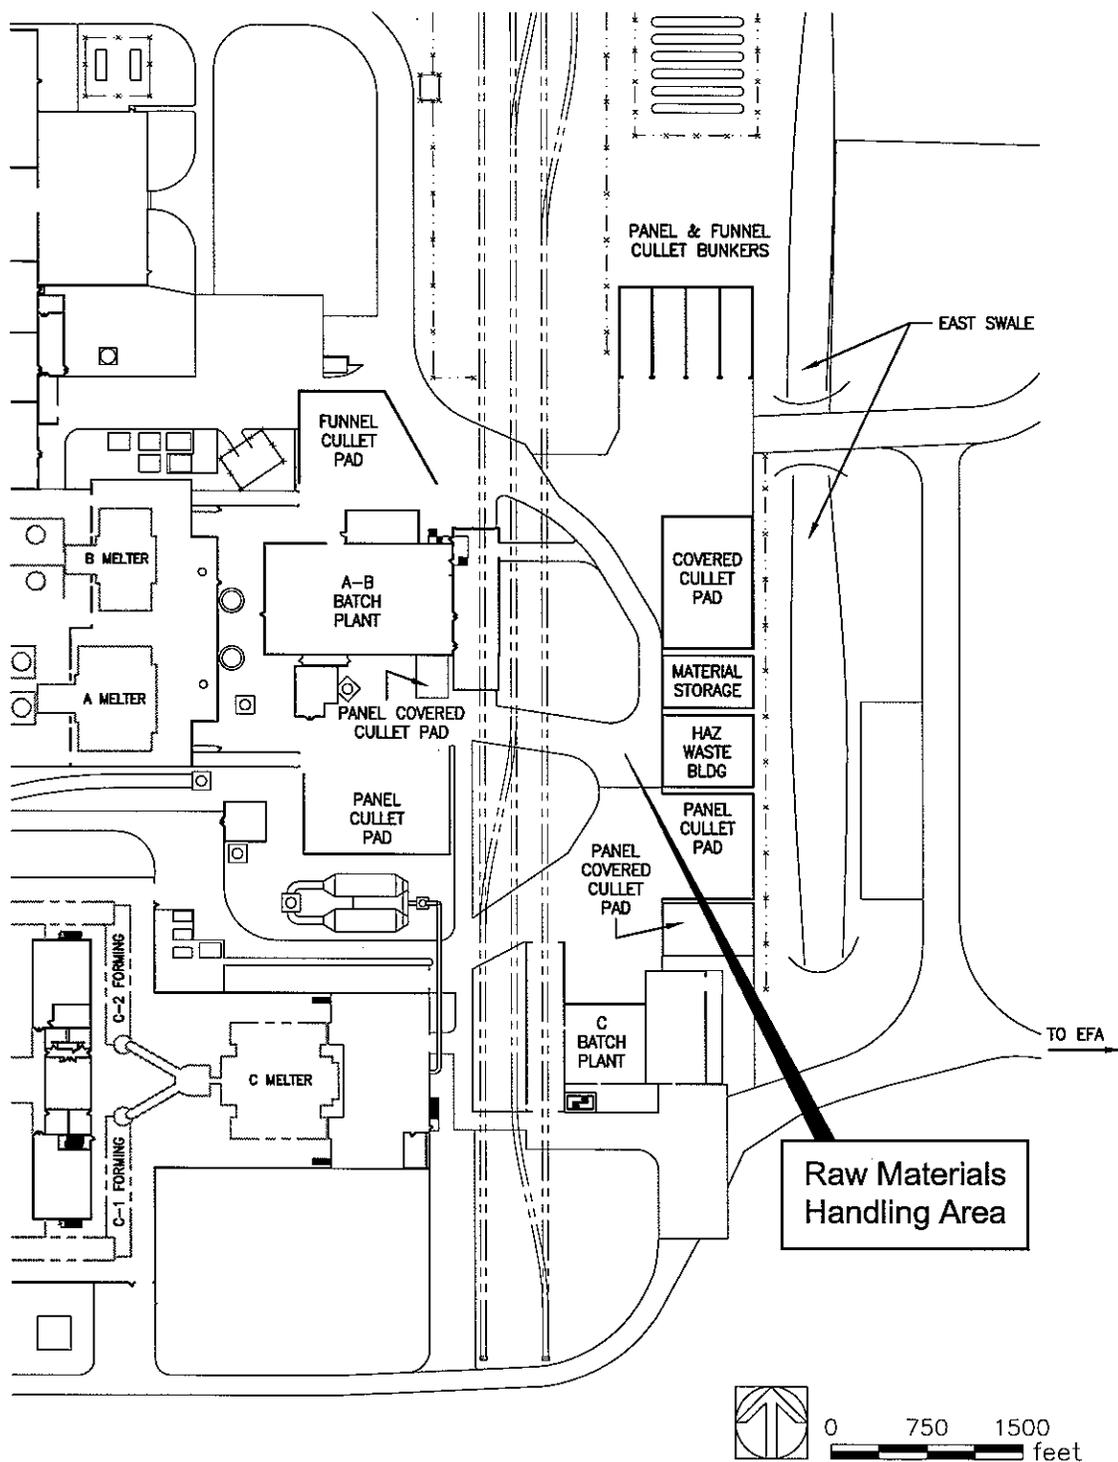
Figure 1-3. Raw Materials Handling Area.

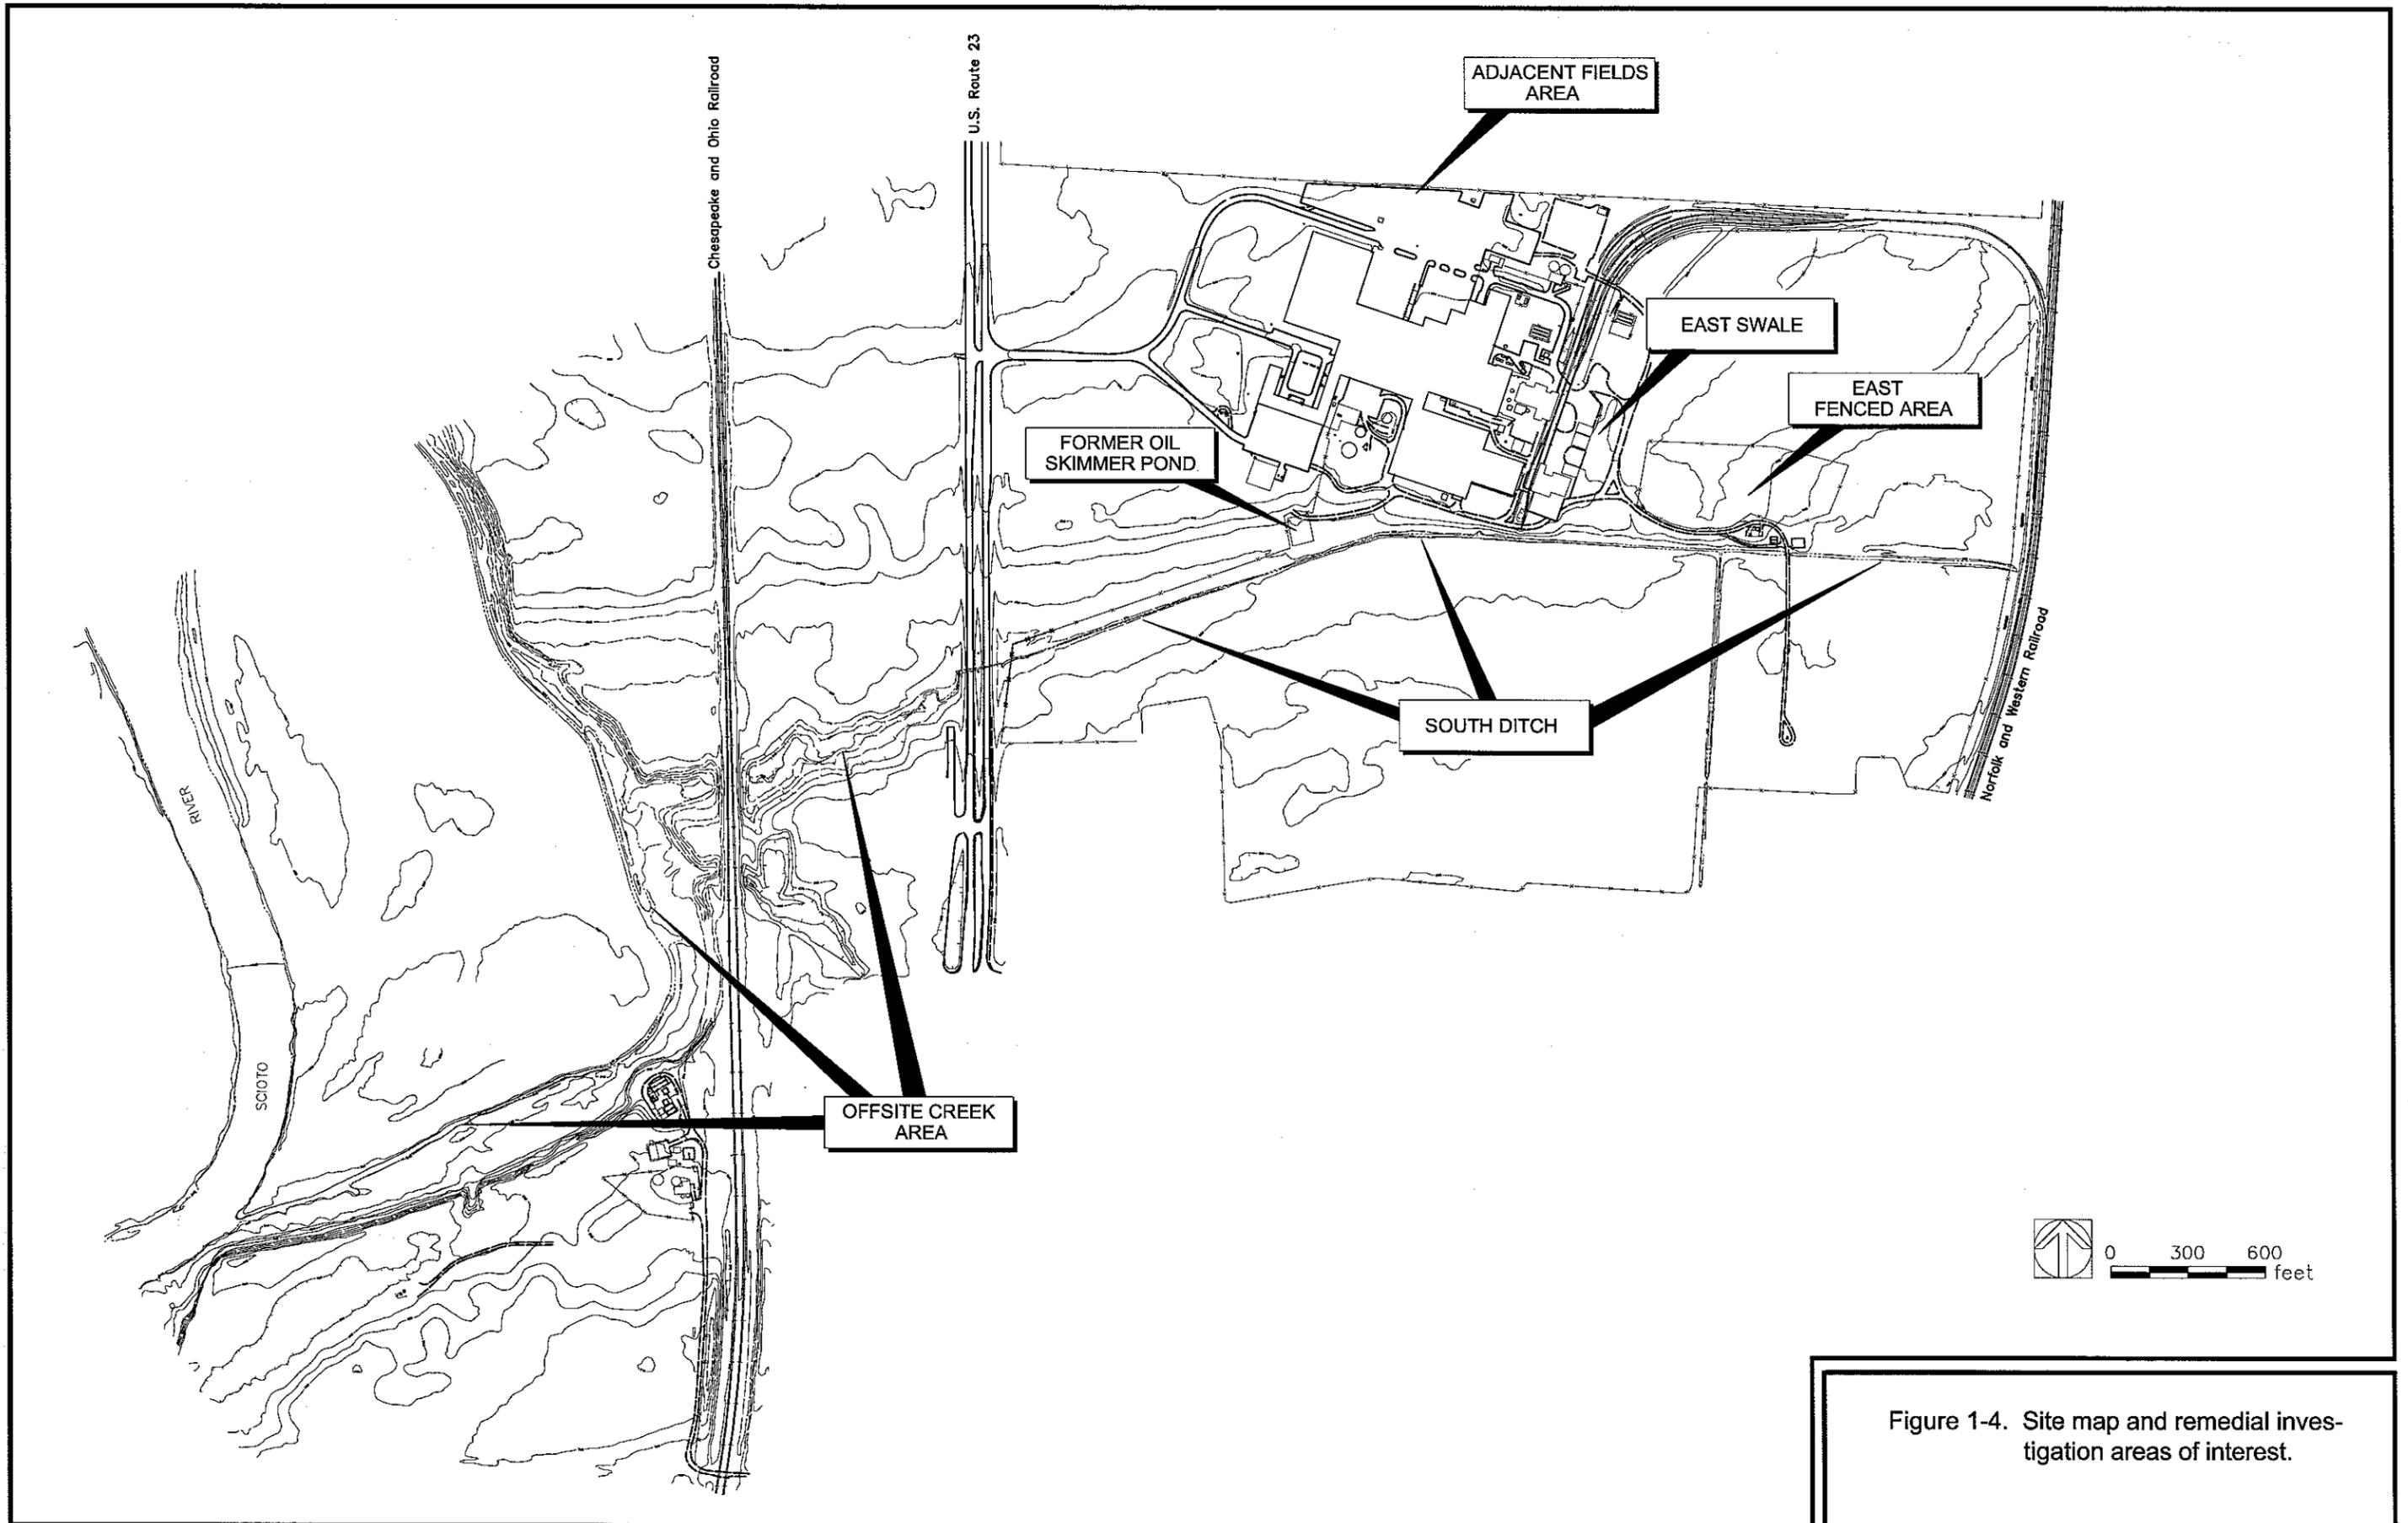
Figure 1-4. Site map and remedial investigation areas of interest.

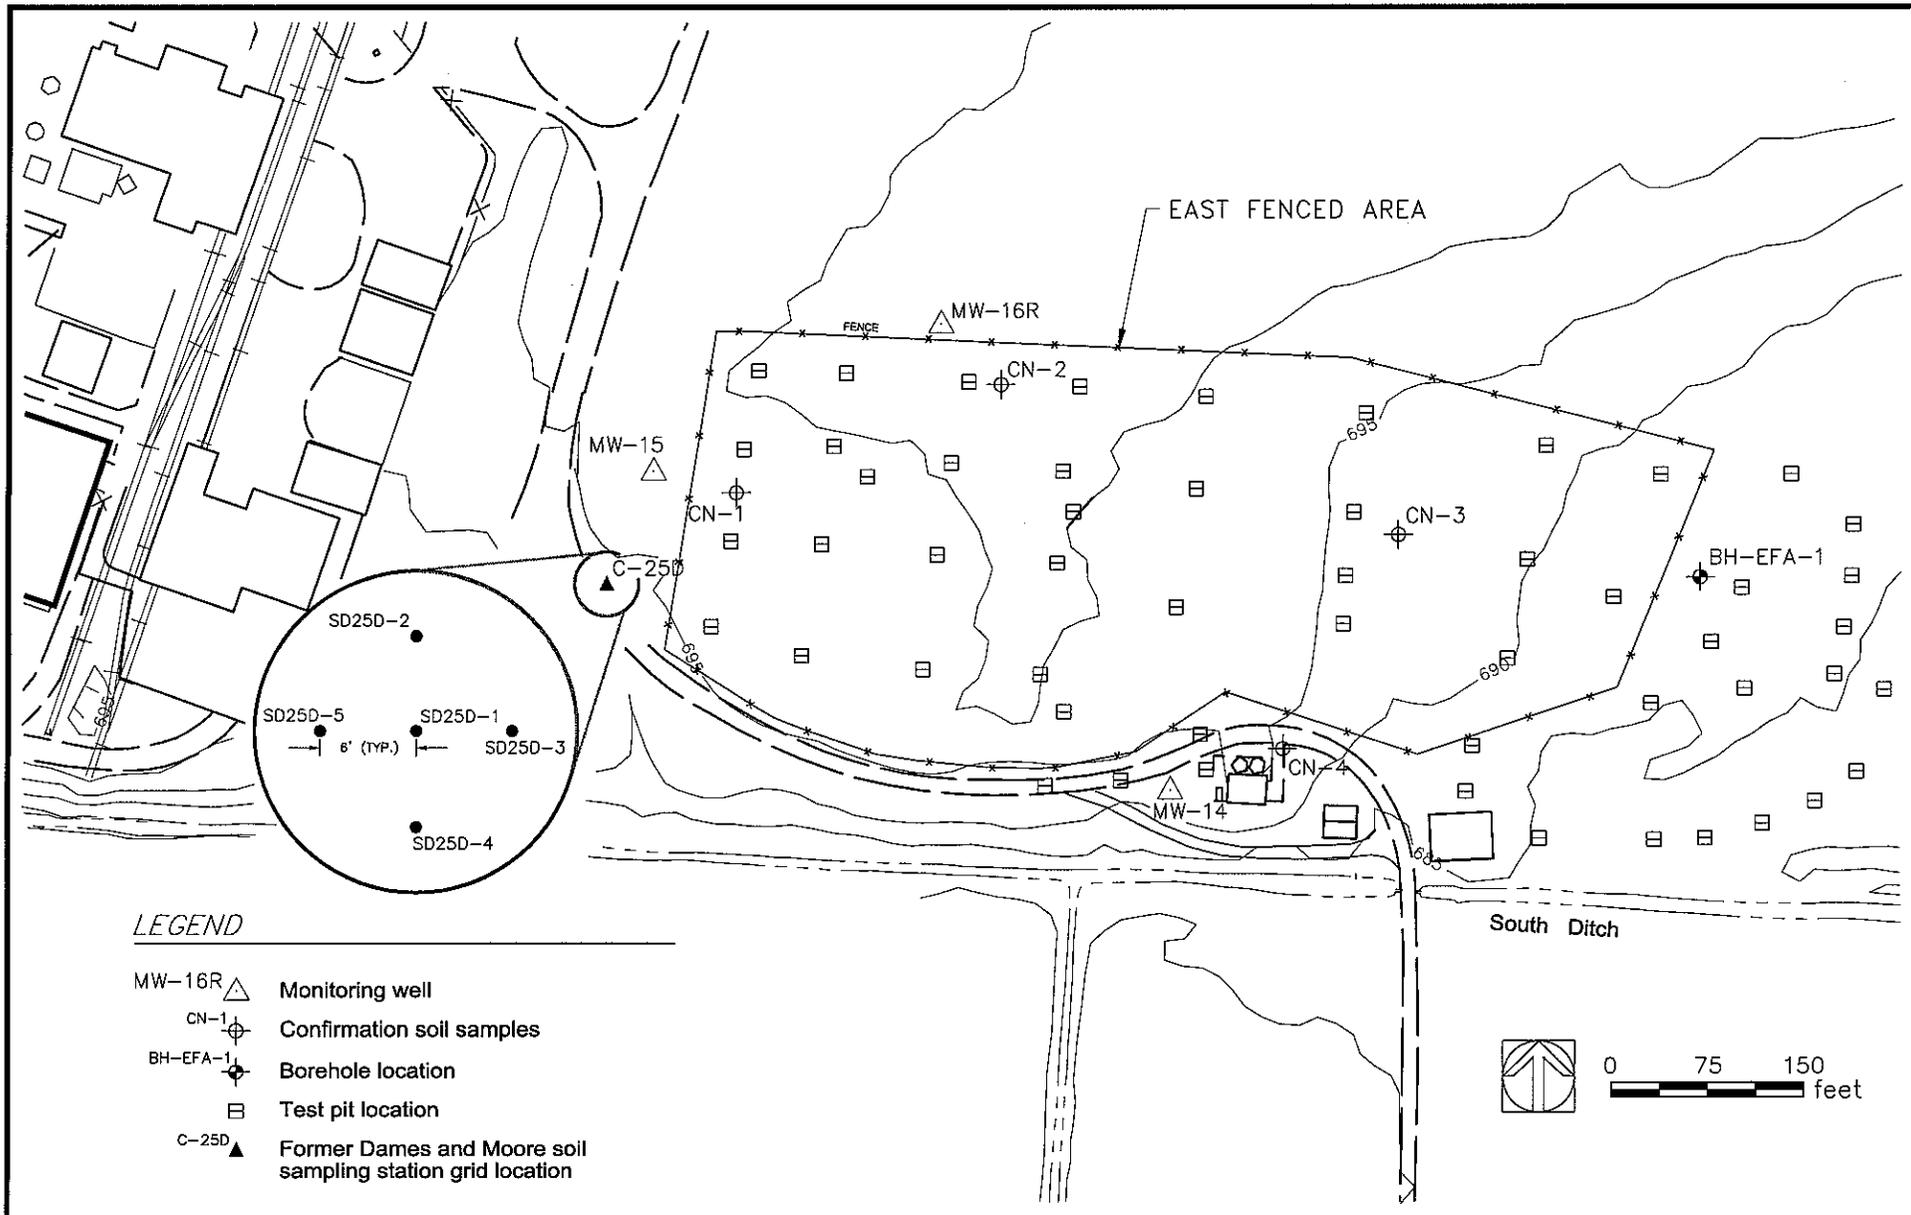
Figure 2-1. East Fenced Area features and remedial investigation components.

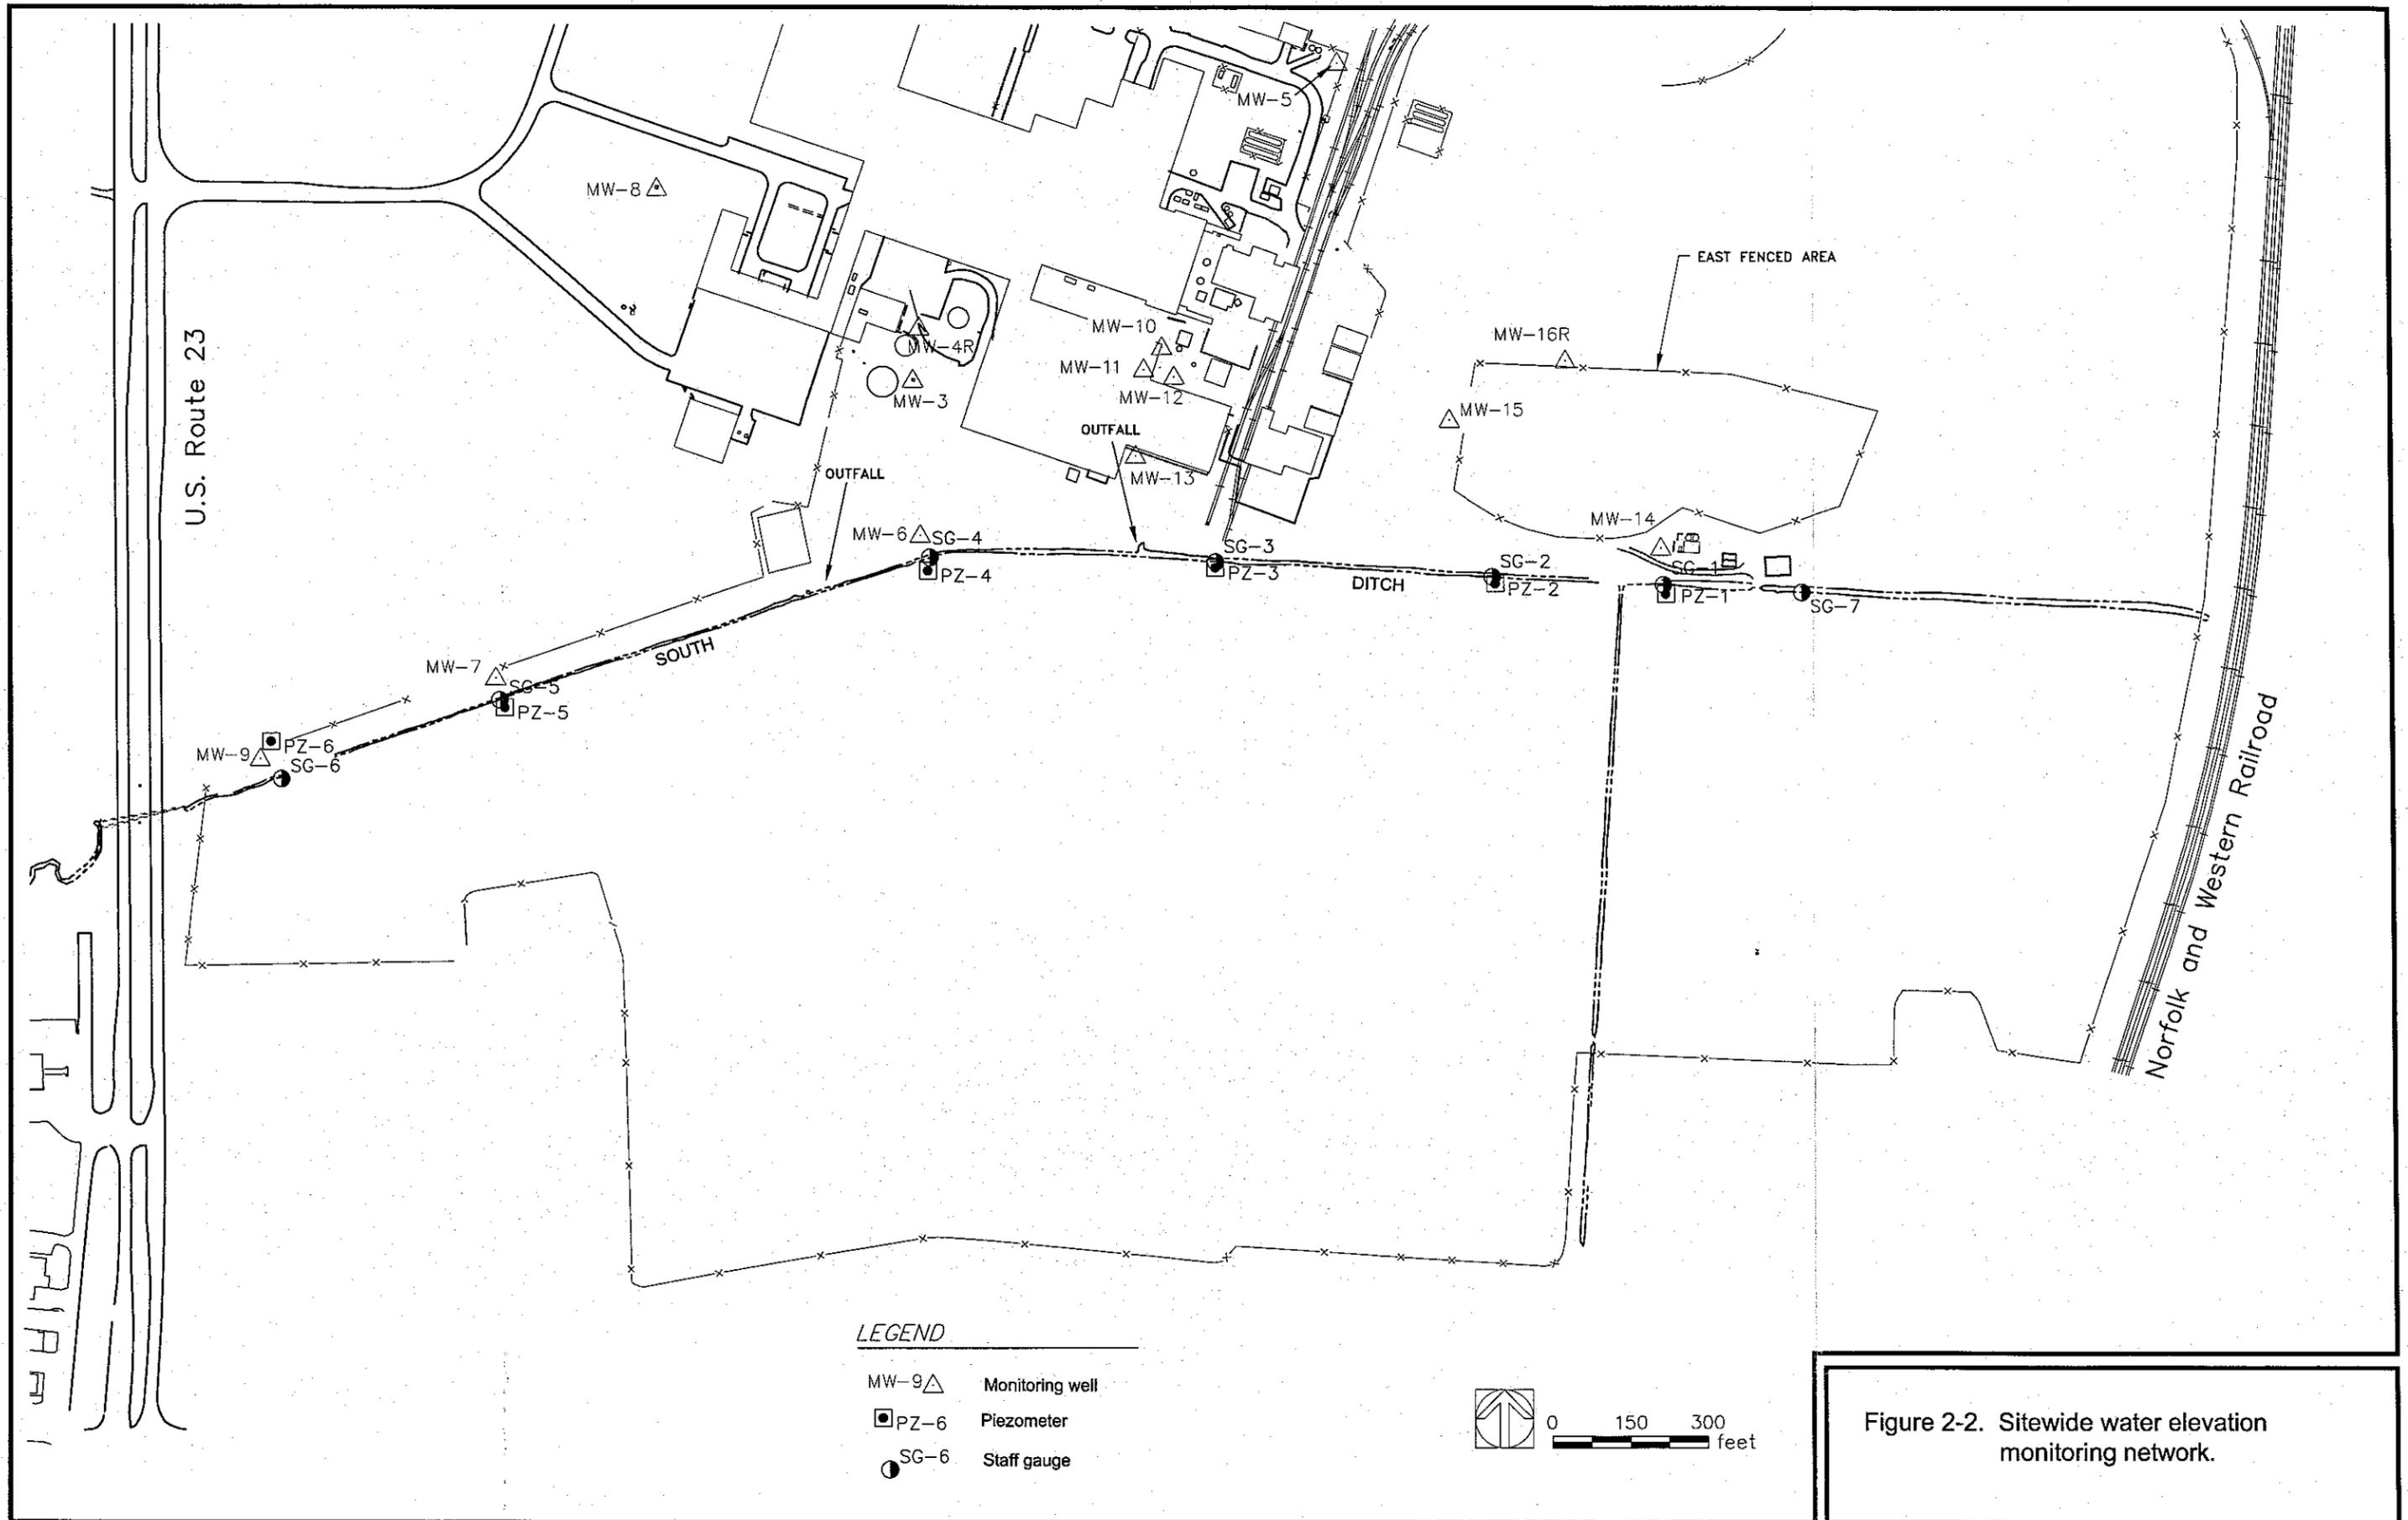
Figure 2-2. Sitewide water elevation monitoring network.

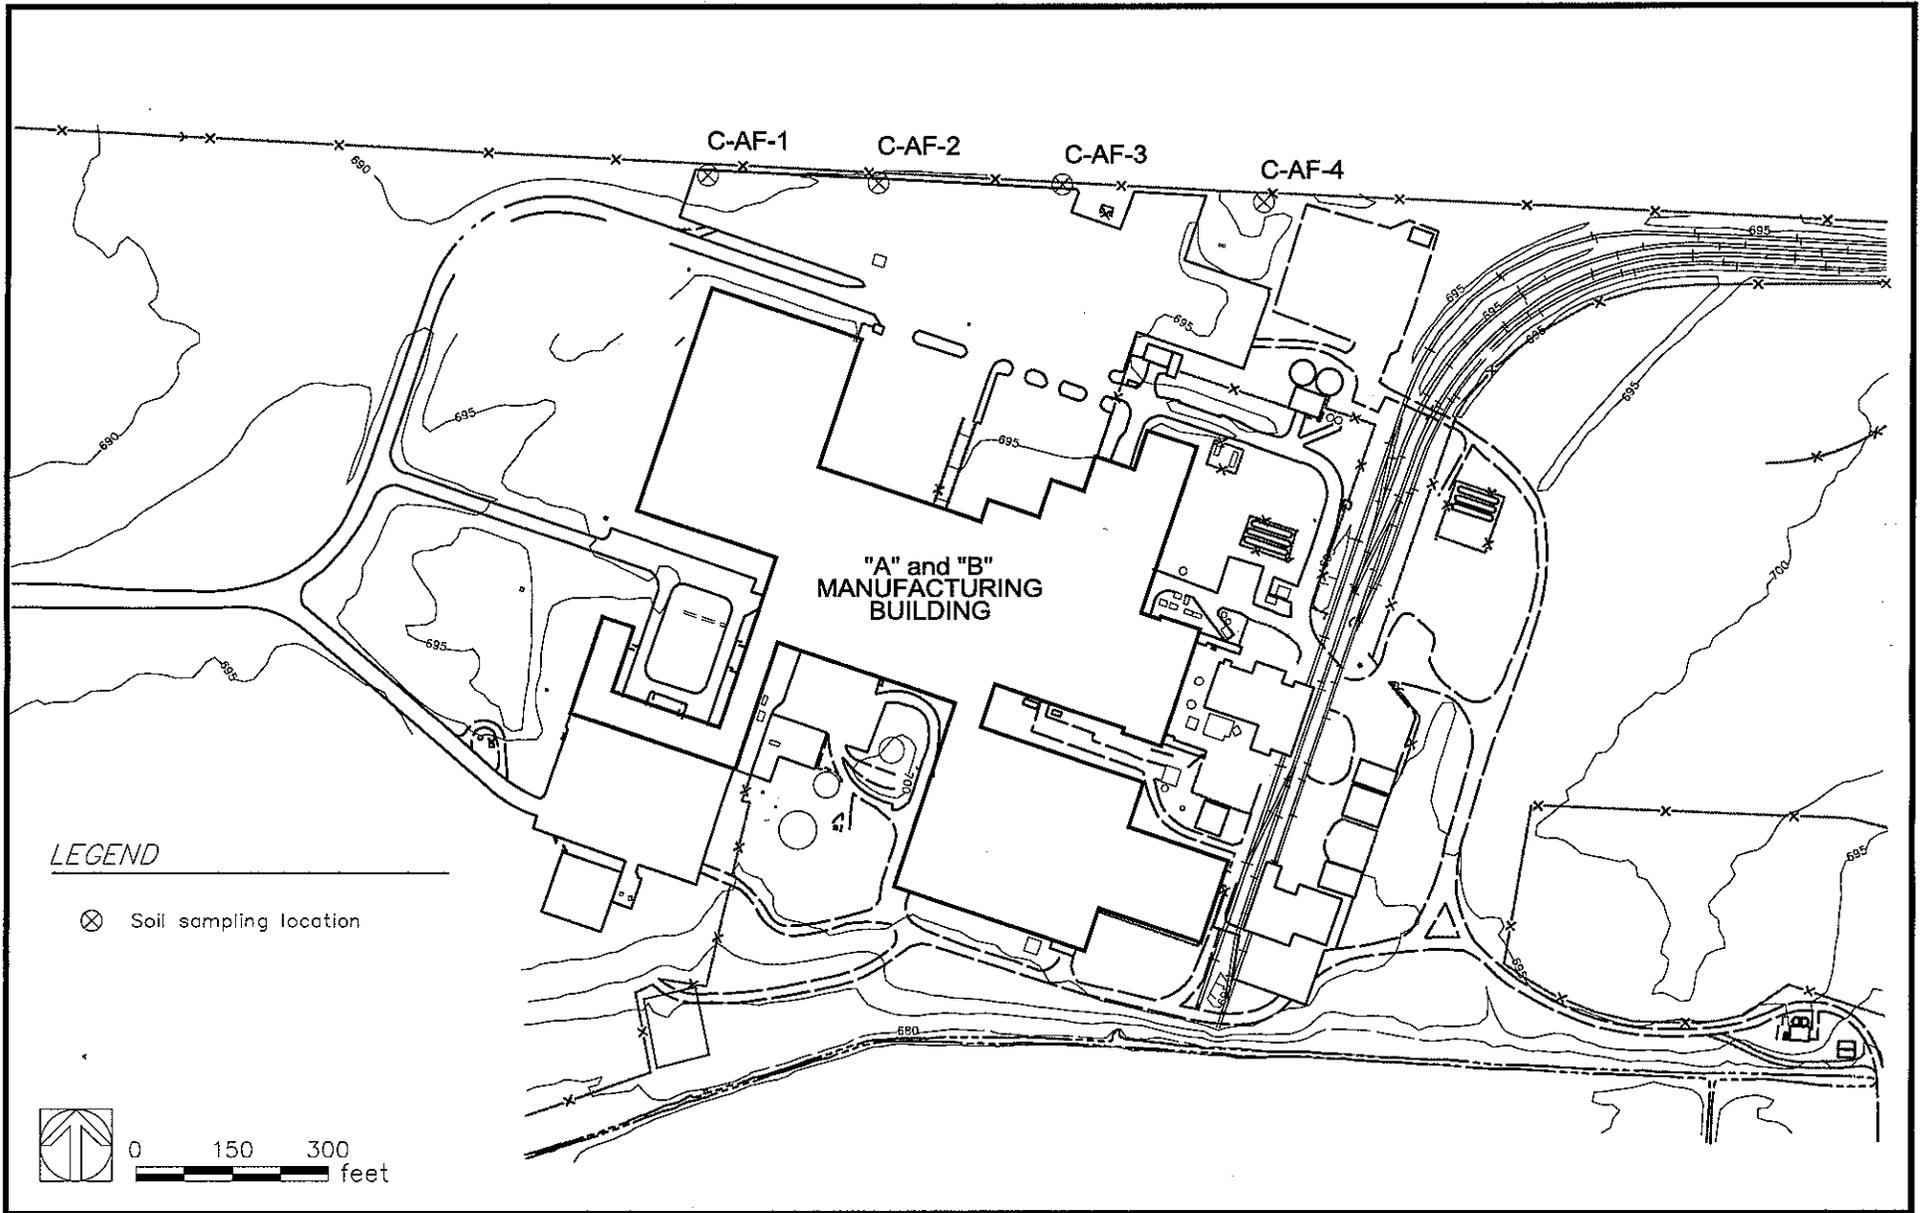
Figure 2-3. Adjacent Fields soil sampling locations.

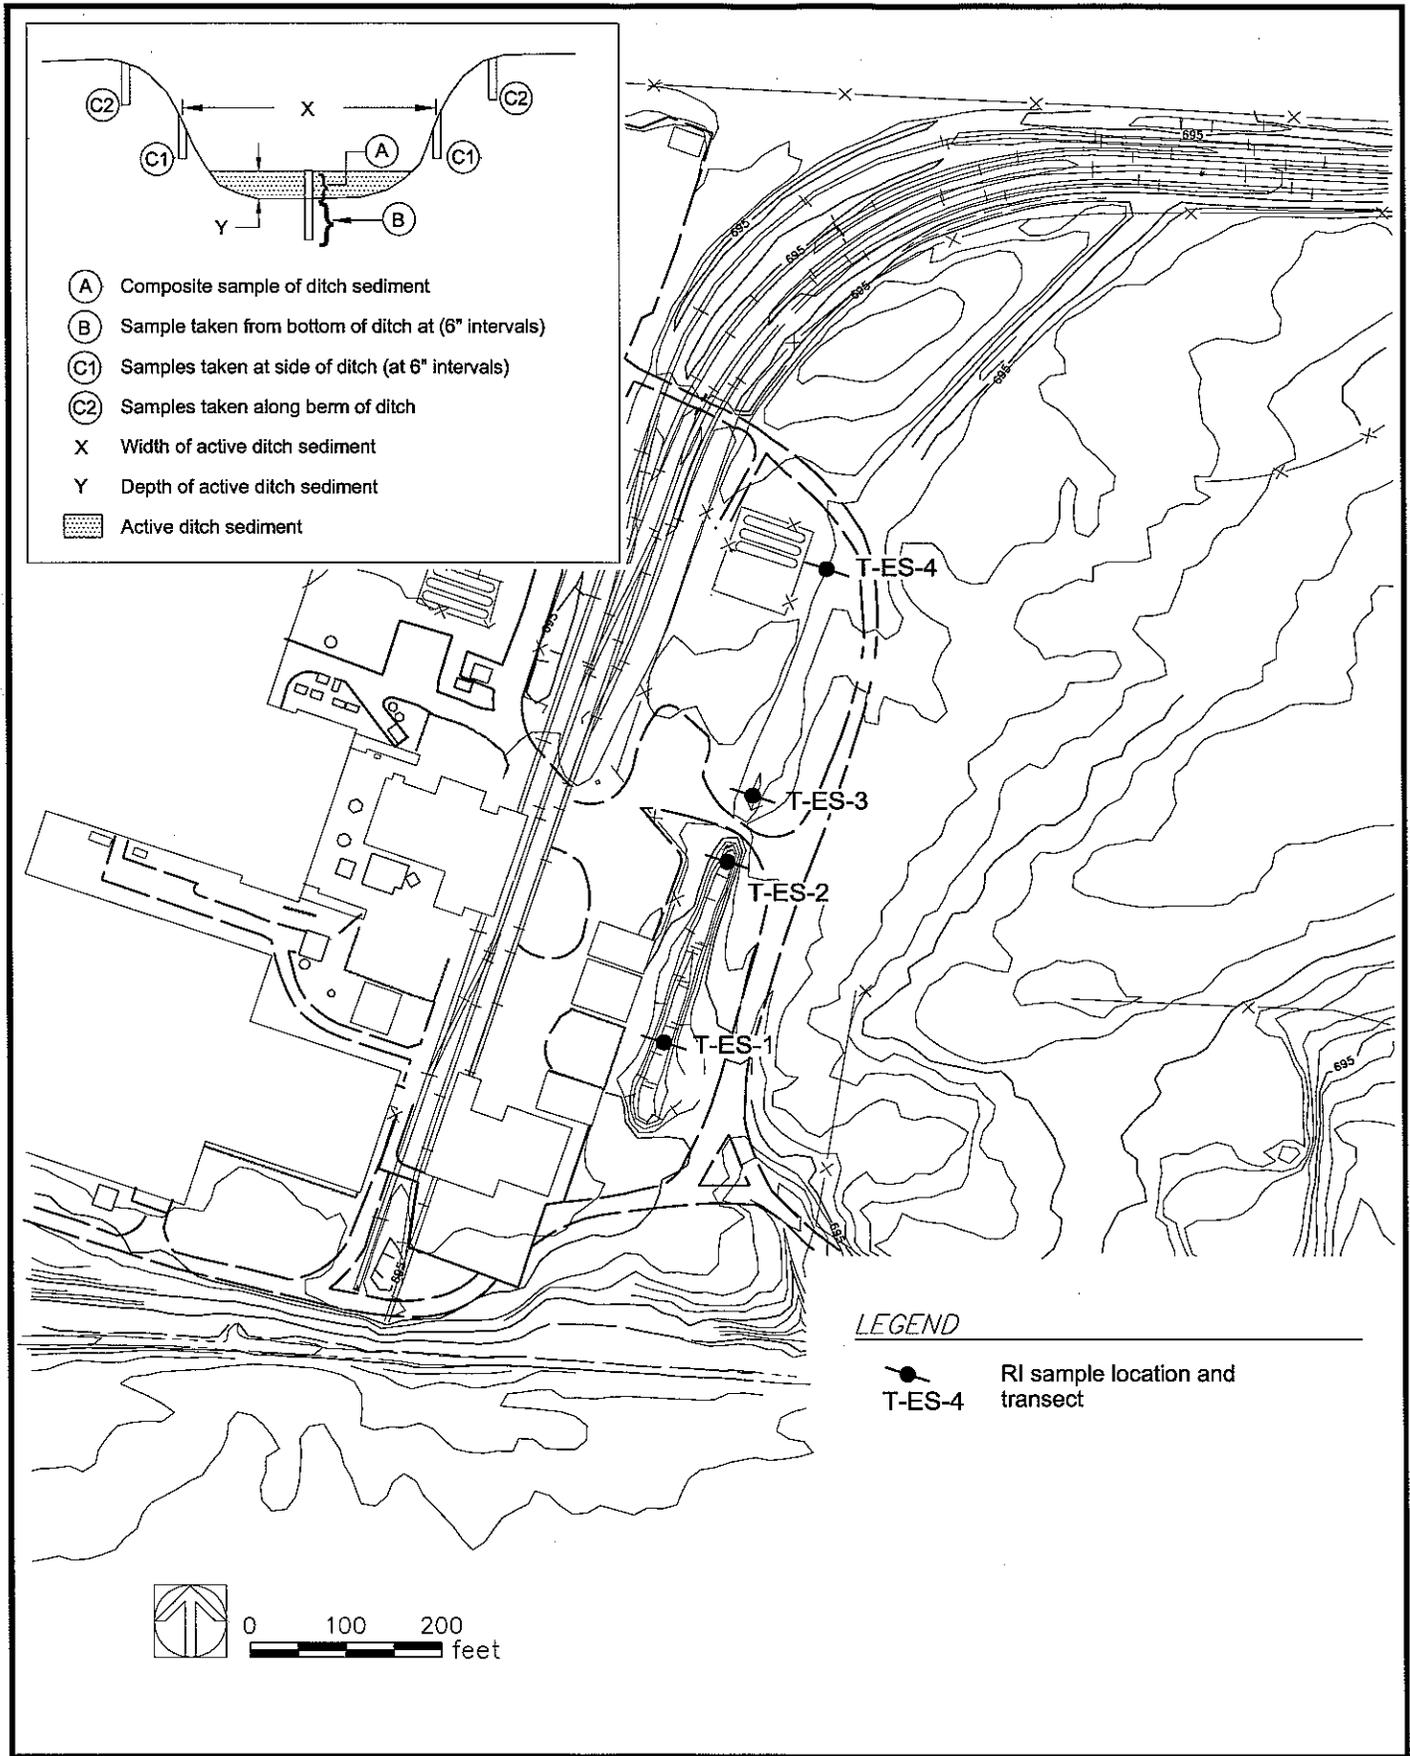
Figure 2-4. East Swale sampling locations.

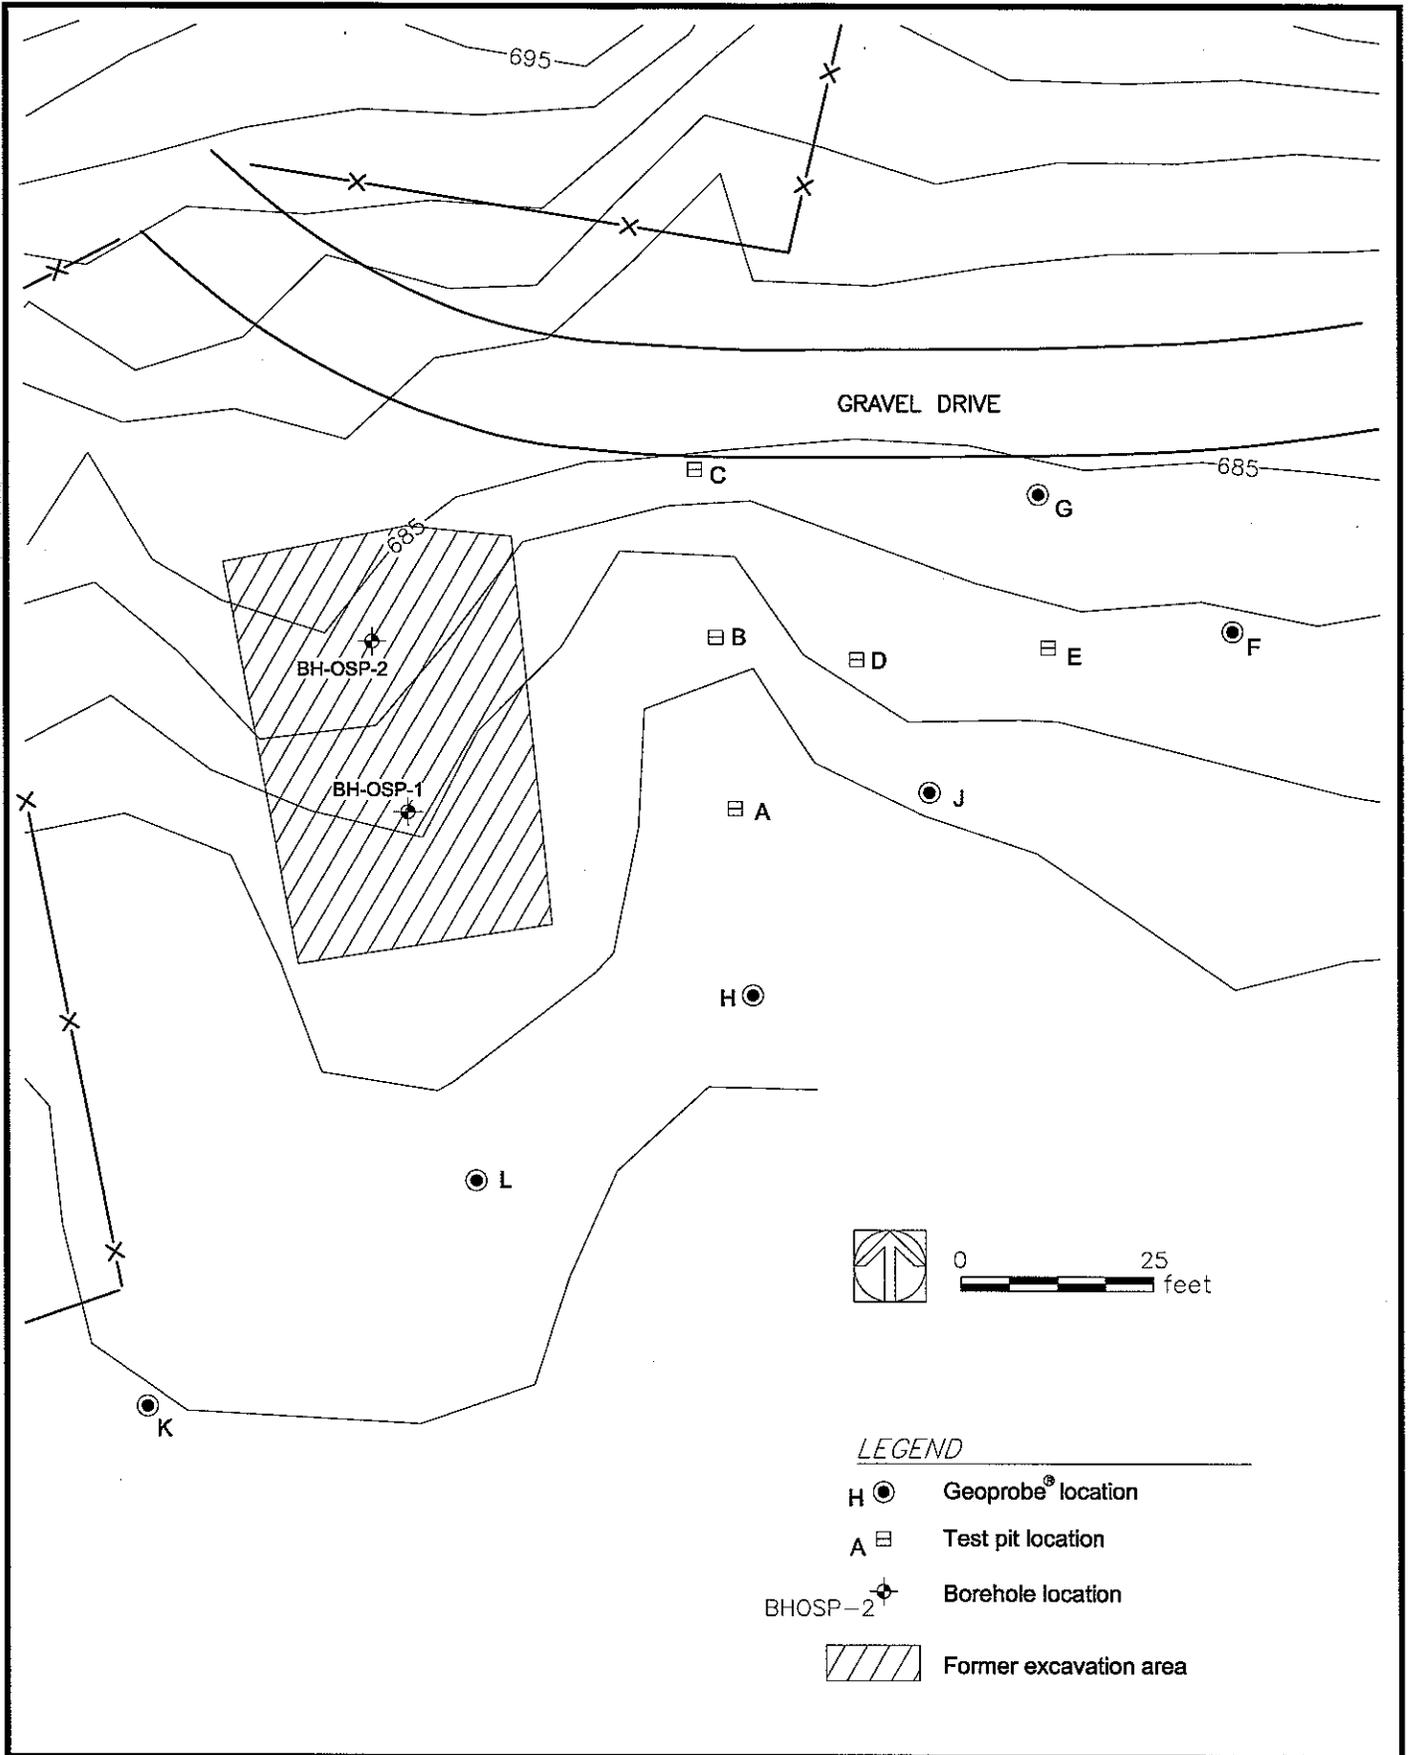
Figure 2-5. Borehole and Geoprobe® sampling locations in the vicinity of the former Oil Skimmer Pond.
