## **Figures**

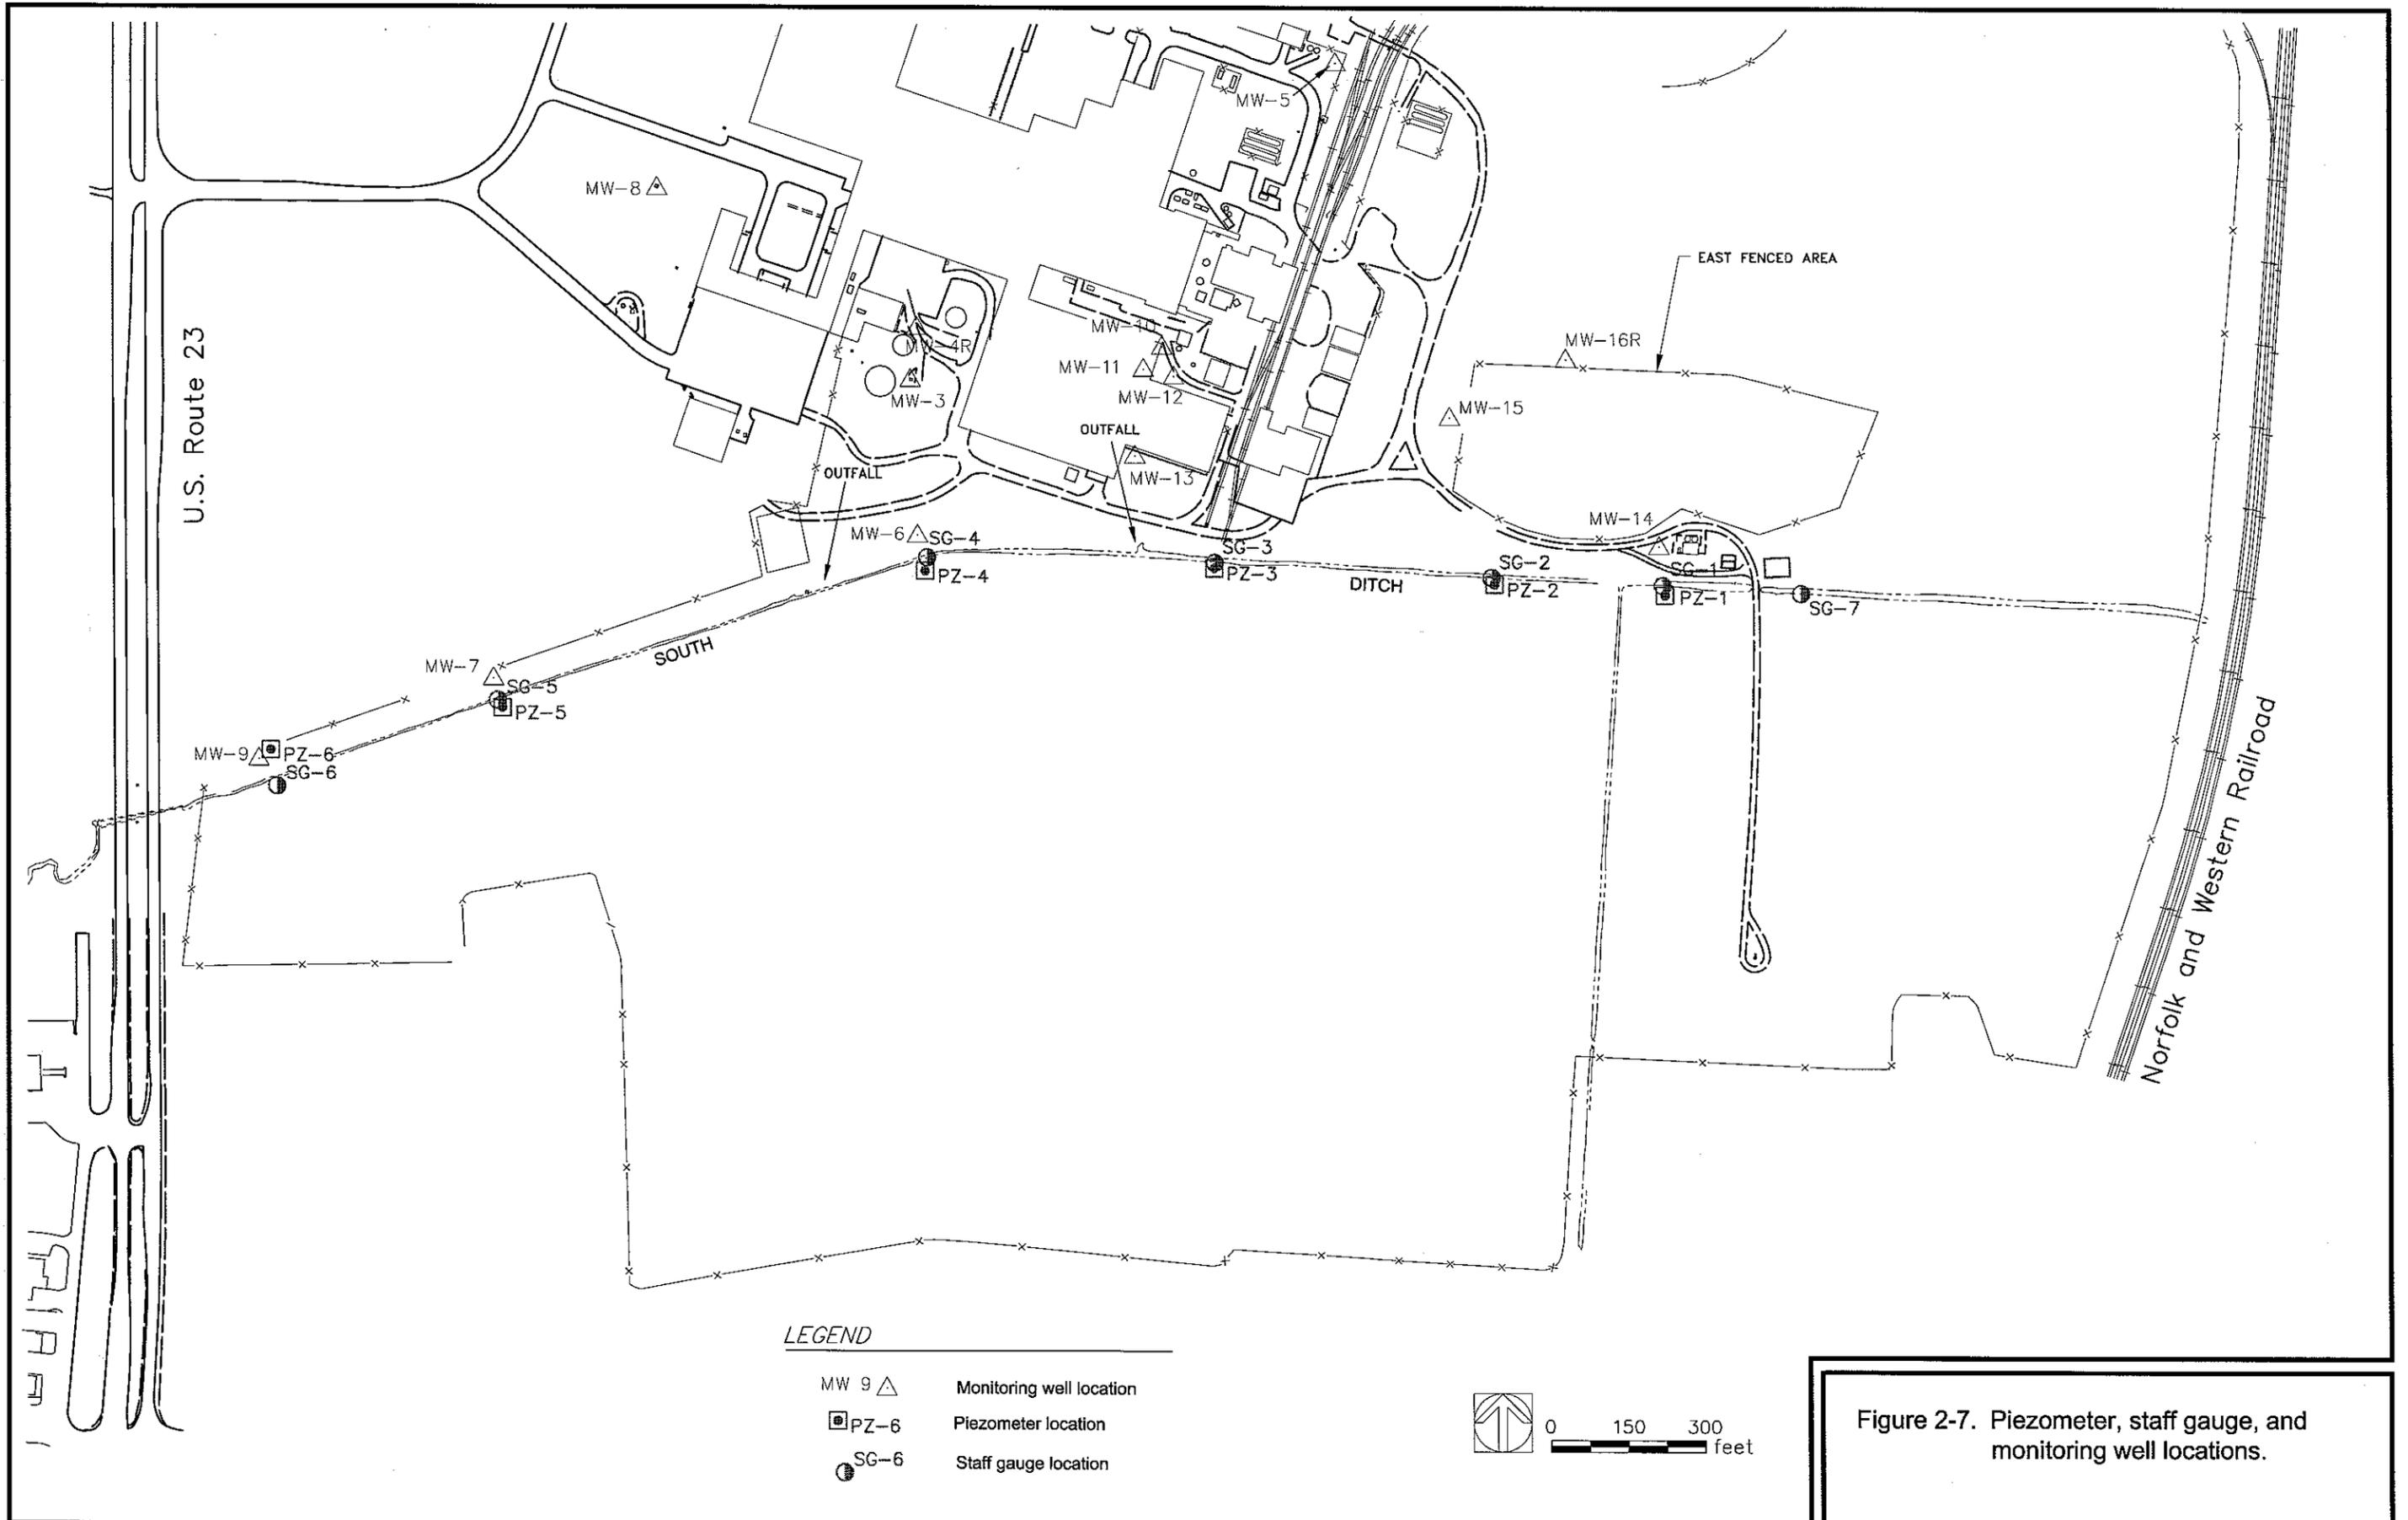
Figure 2-7. Piezometer, staff gauge, and monitoring well locations.

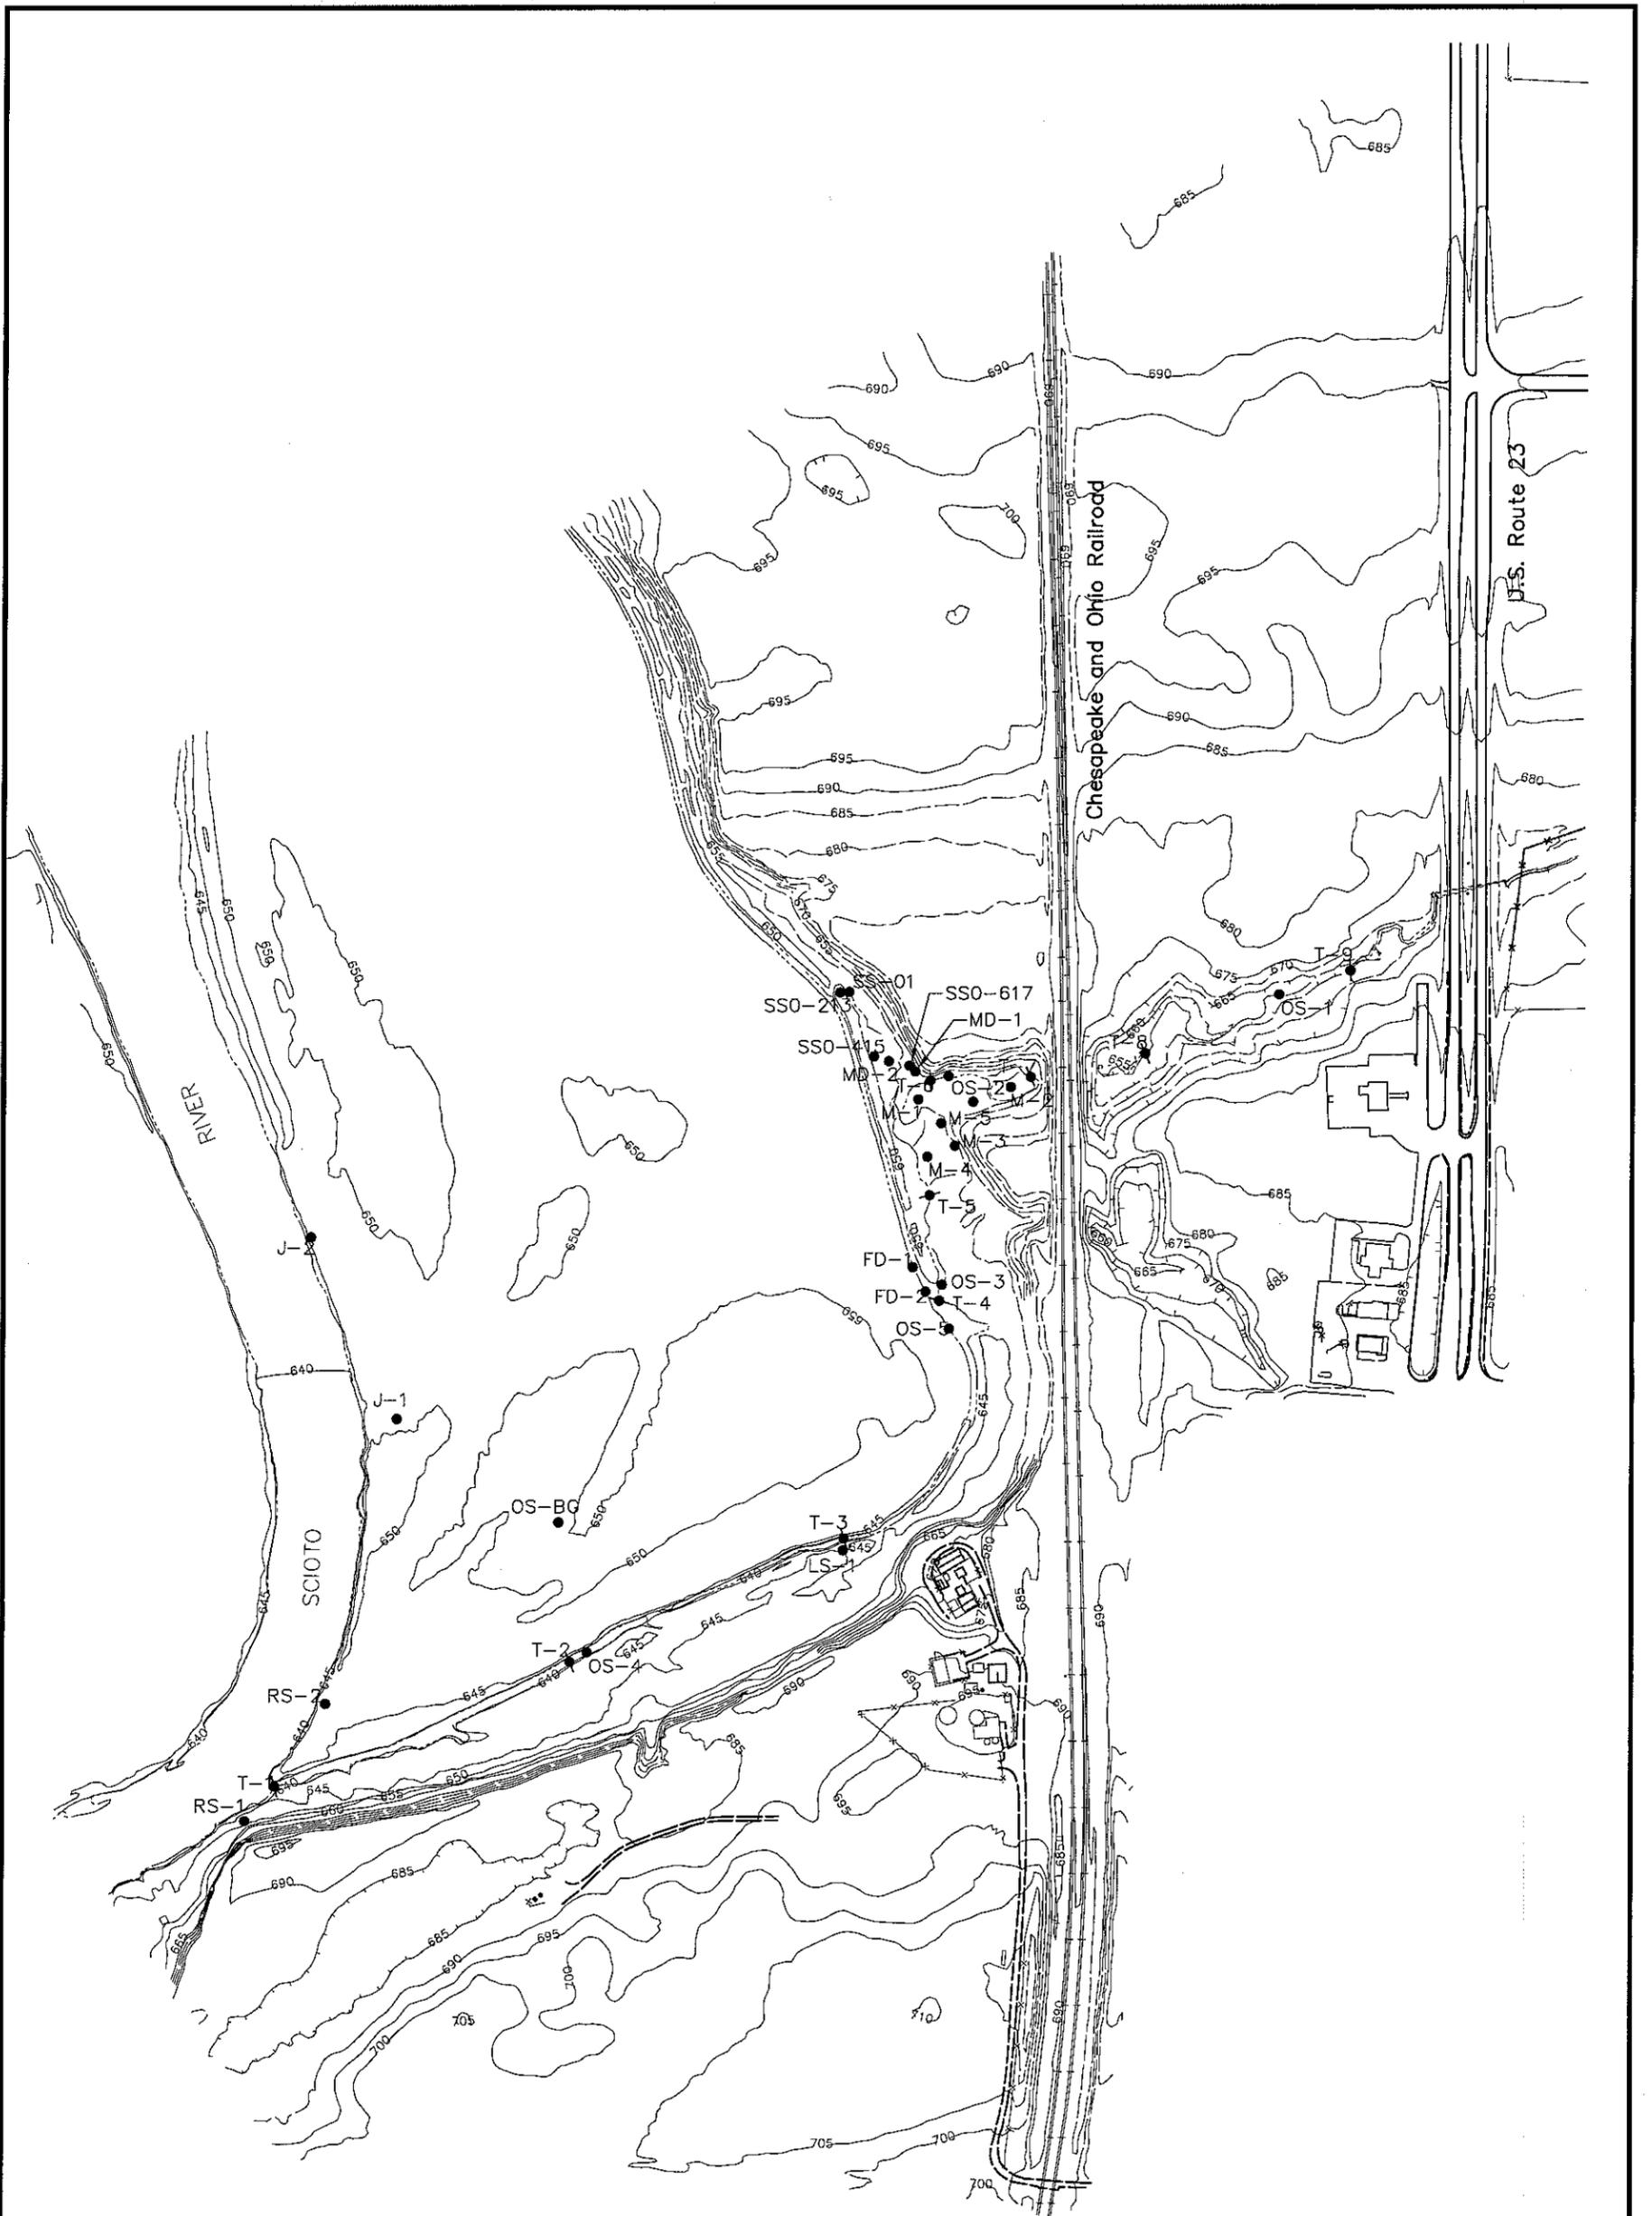
**Figure 2-8. Offsite Creek Area historical sampling stations.**

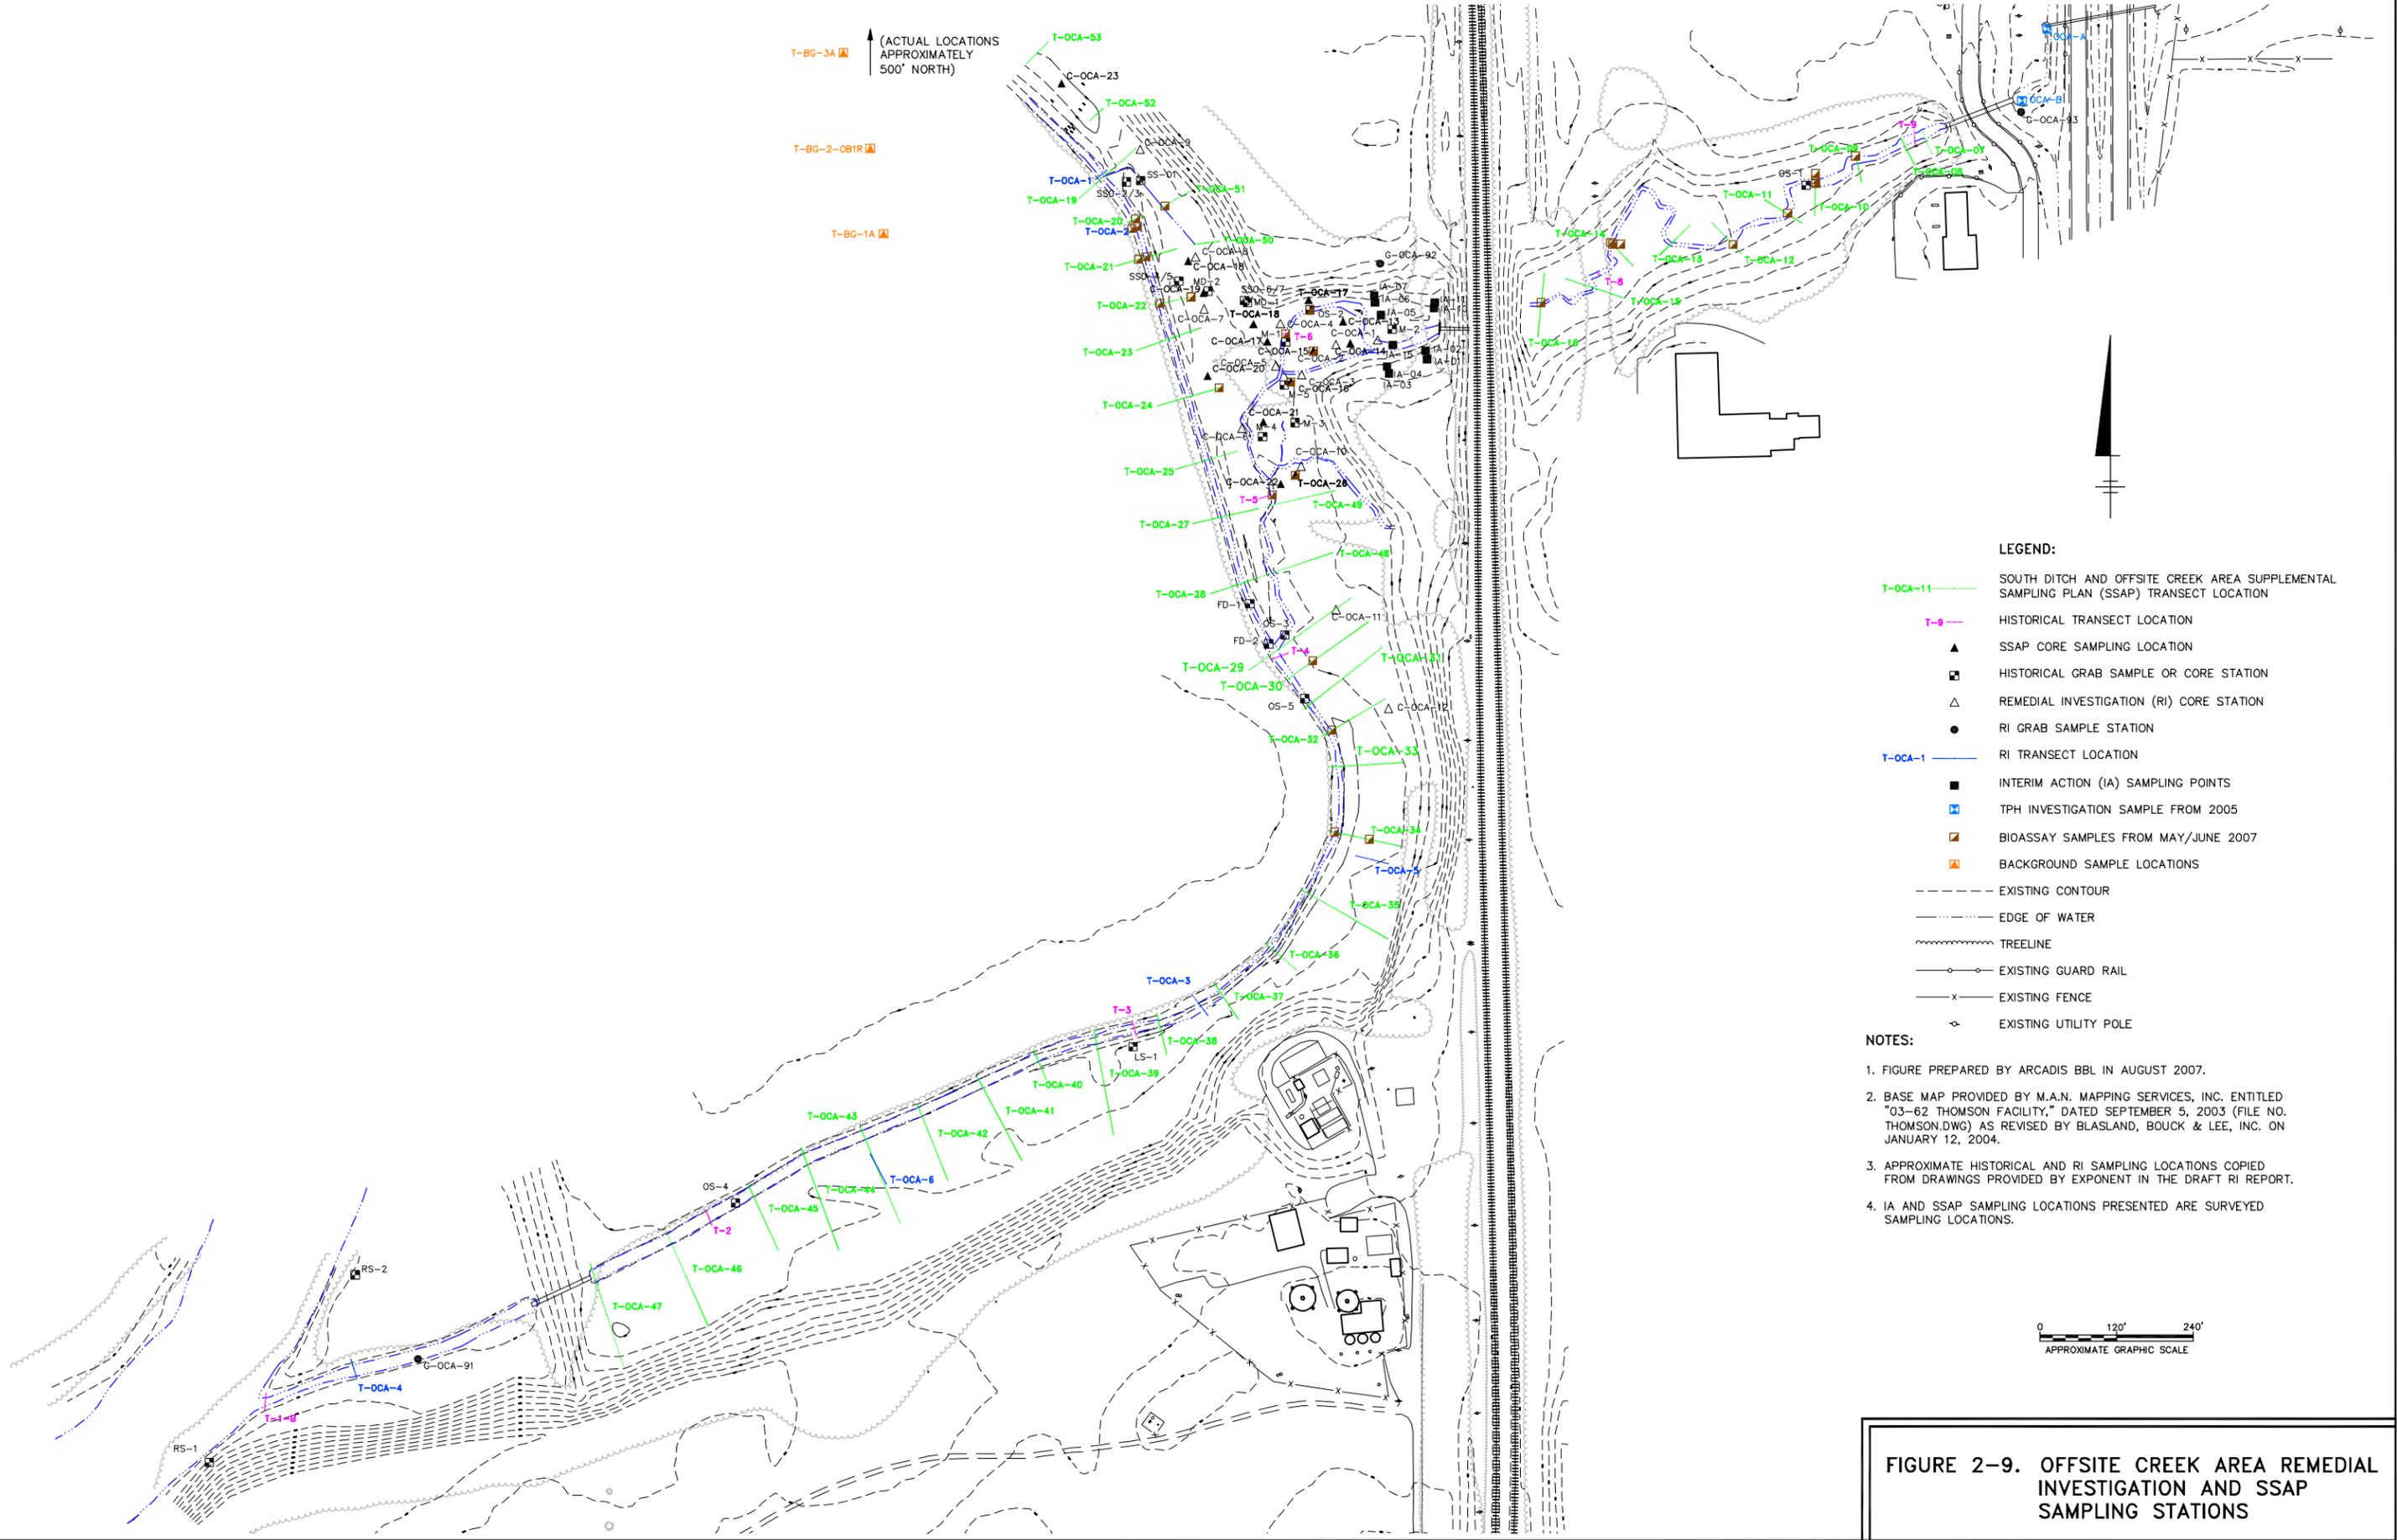
**FIGURE 2-9. OFFSITE CREEK AREA REMEDIAL INVESTIGATION AND SSAP SAMPLING STATIONS**

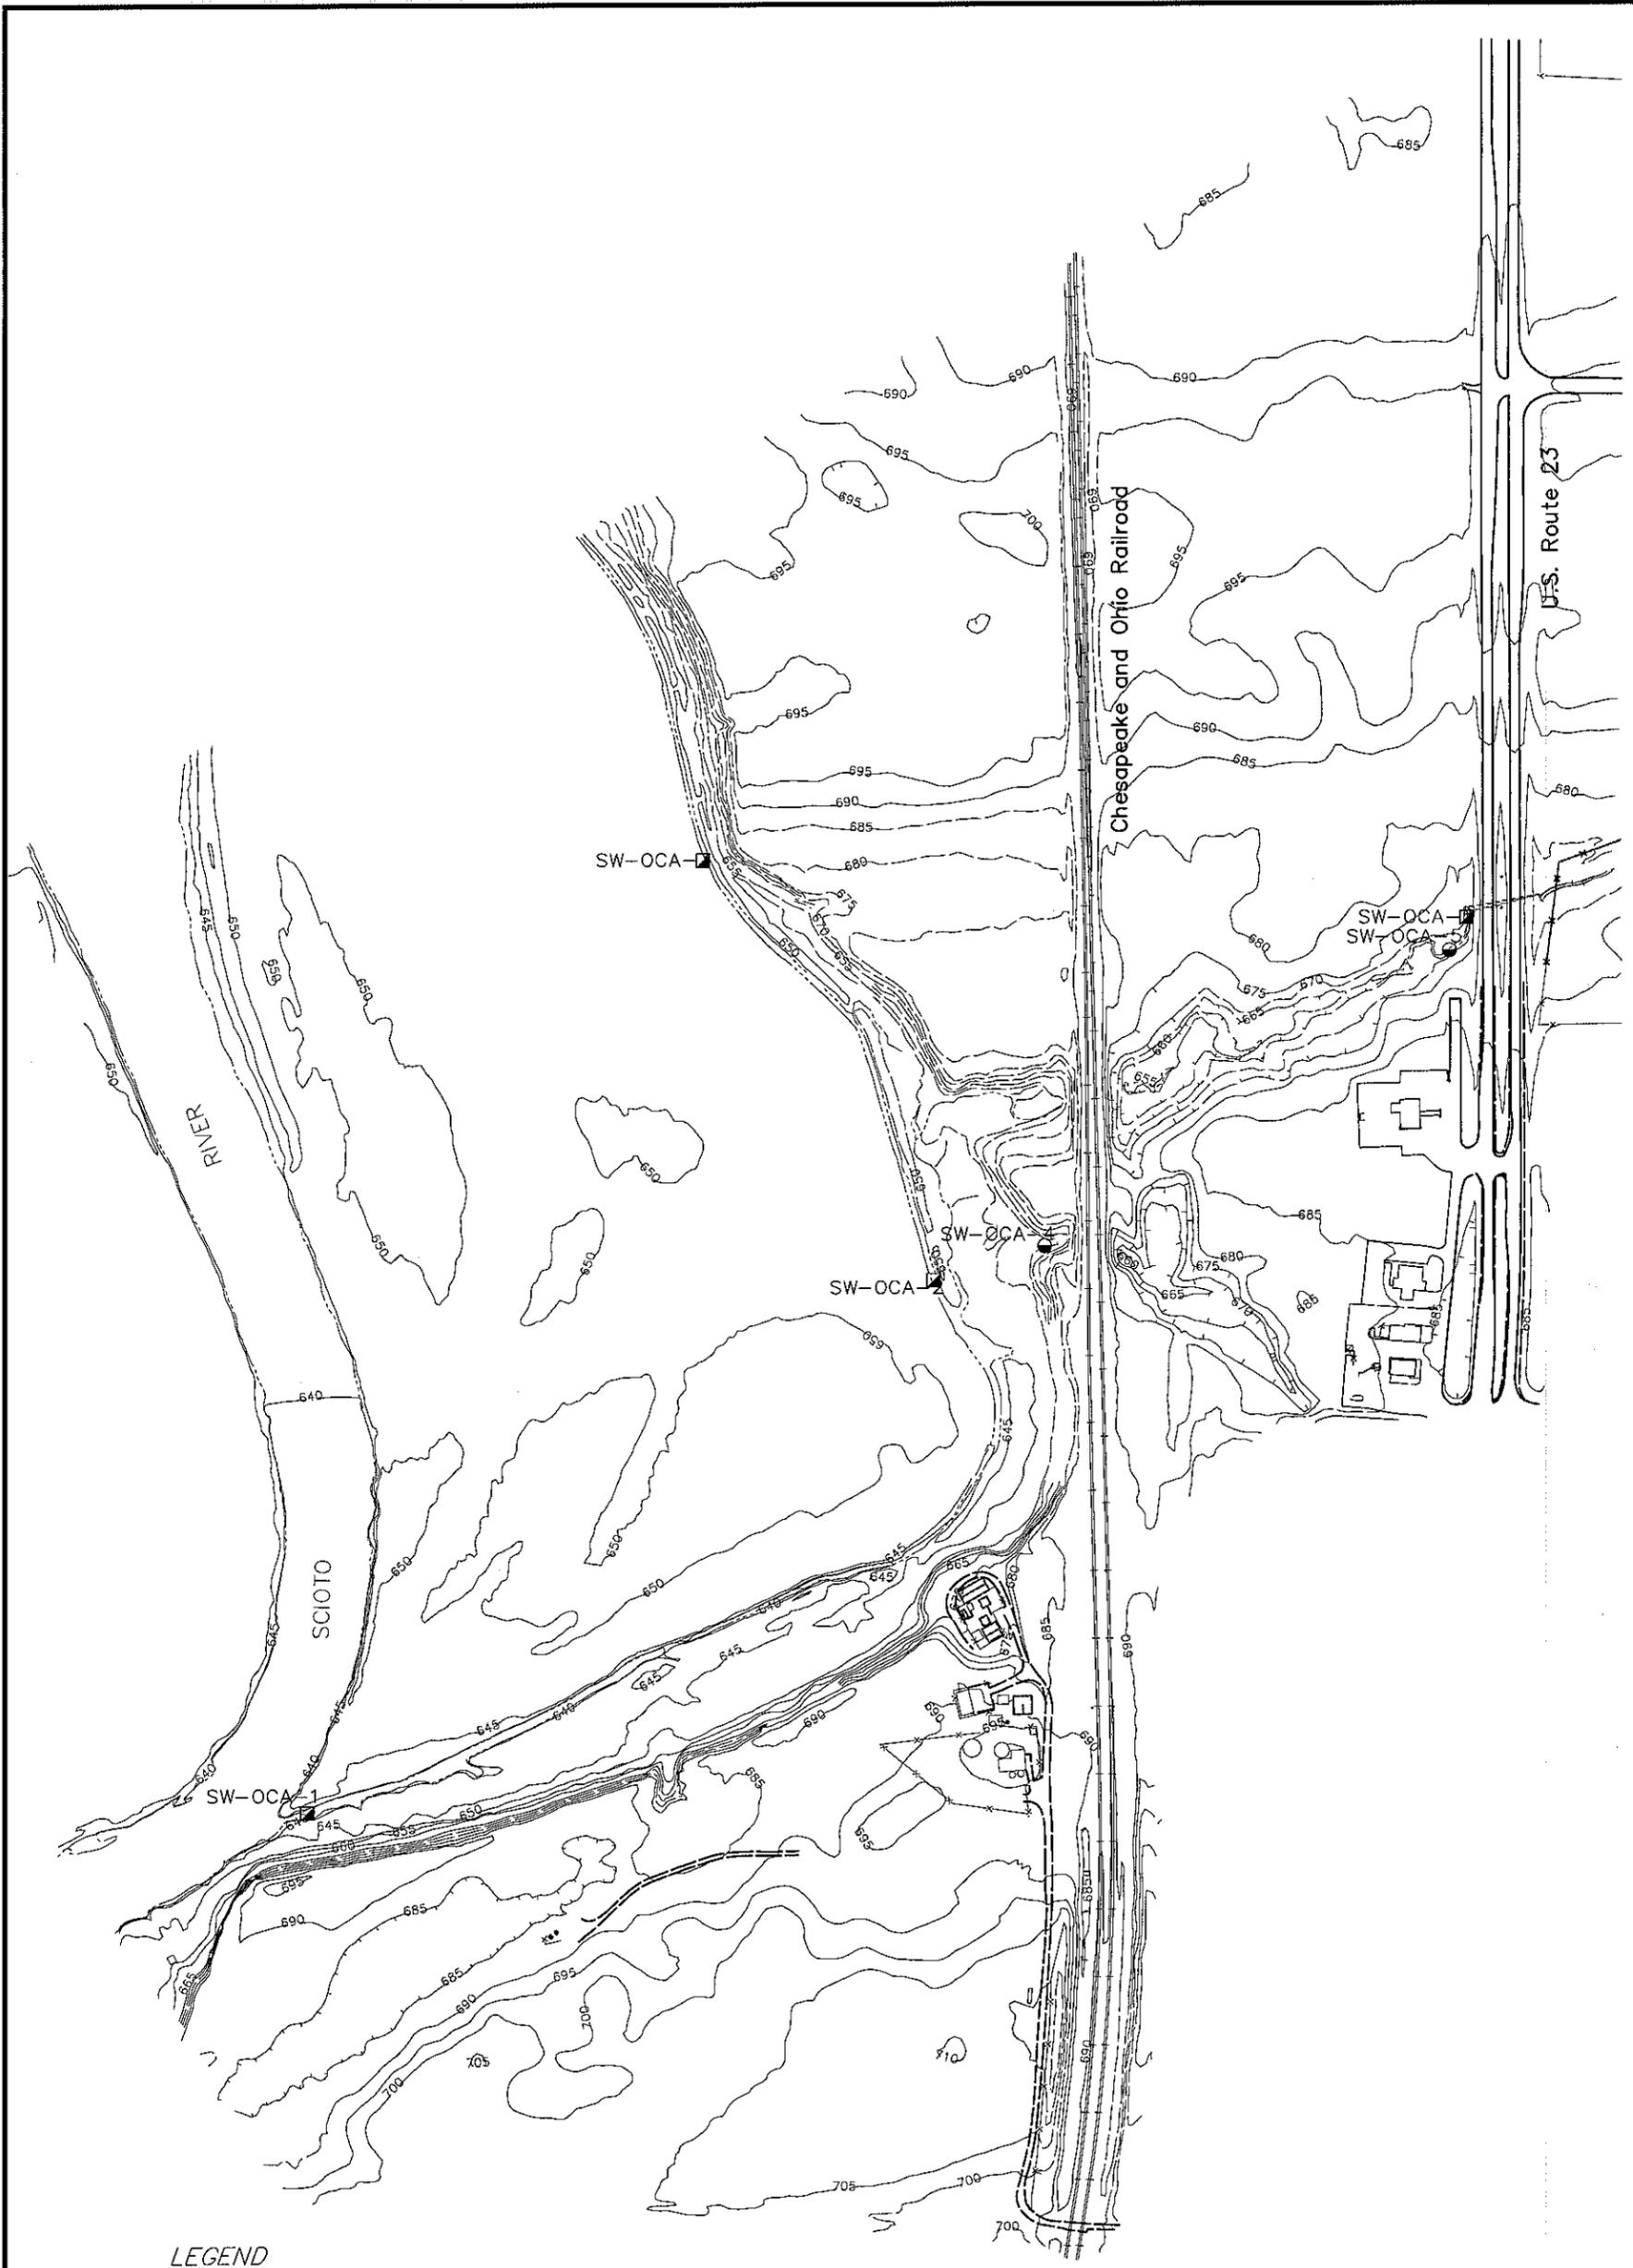
- Surface water sampling station  
 SW-OCA-1 (low water level)

- Surface water sampling station  
 SW-OCA-2 (high water level)

**Figure 2-10. Offsite Creek Area remedial investigation surface water sampling stations.**

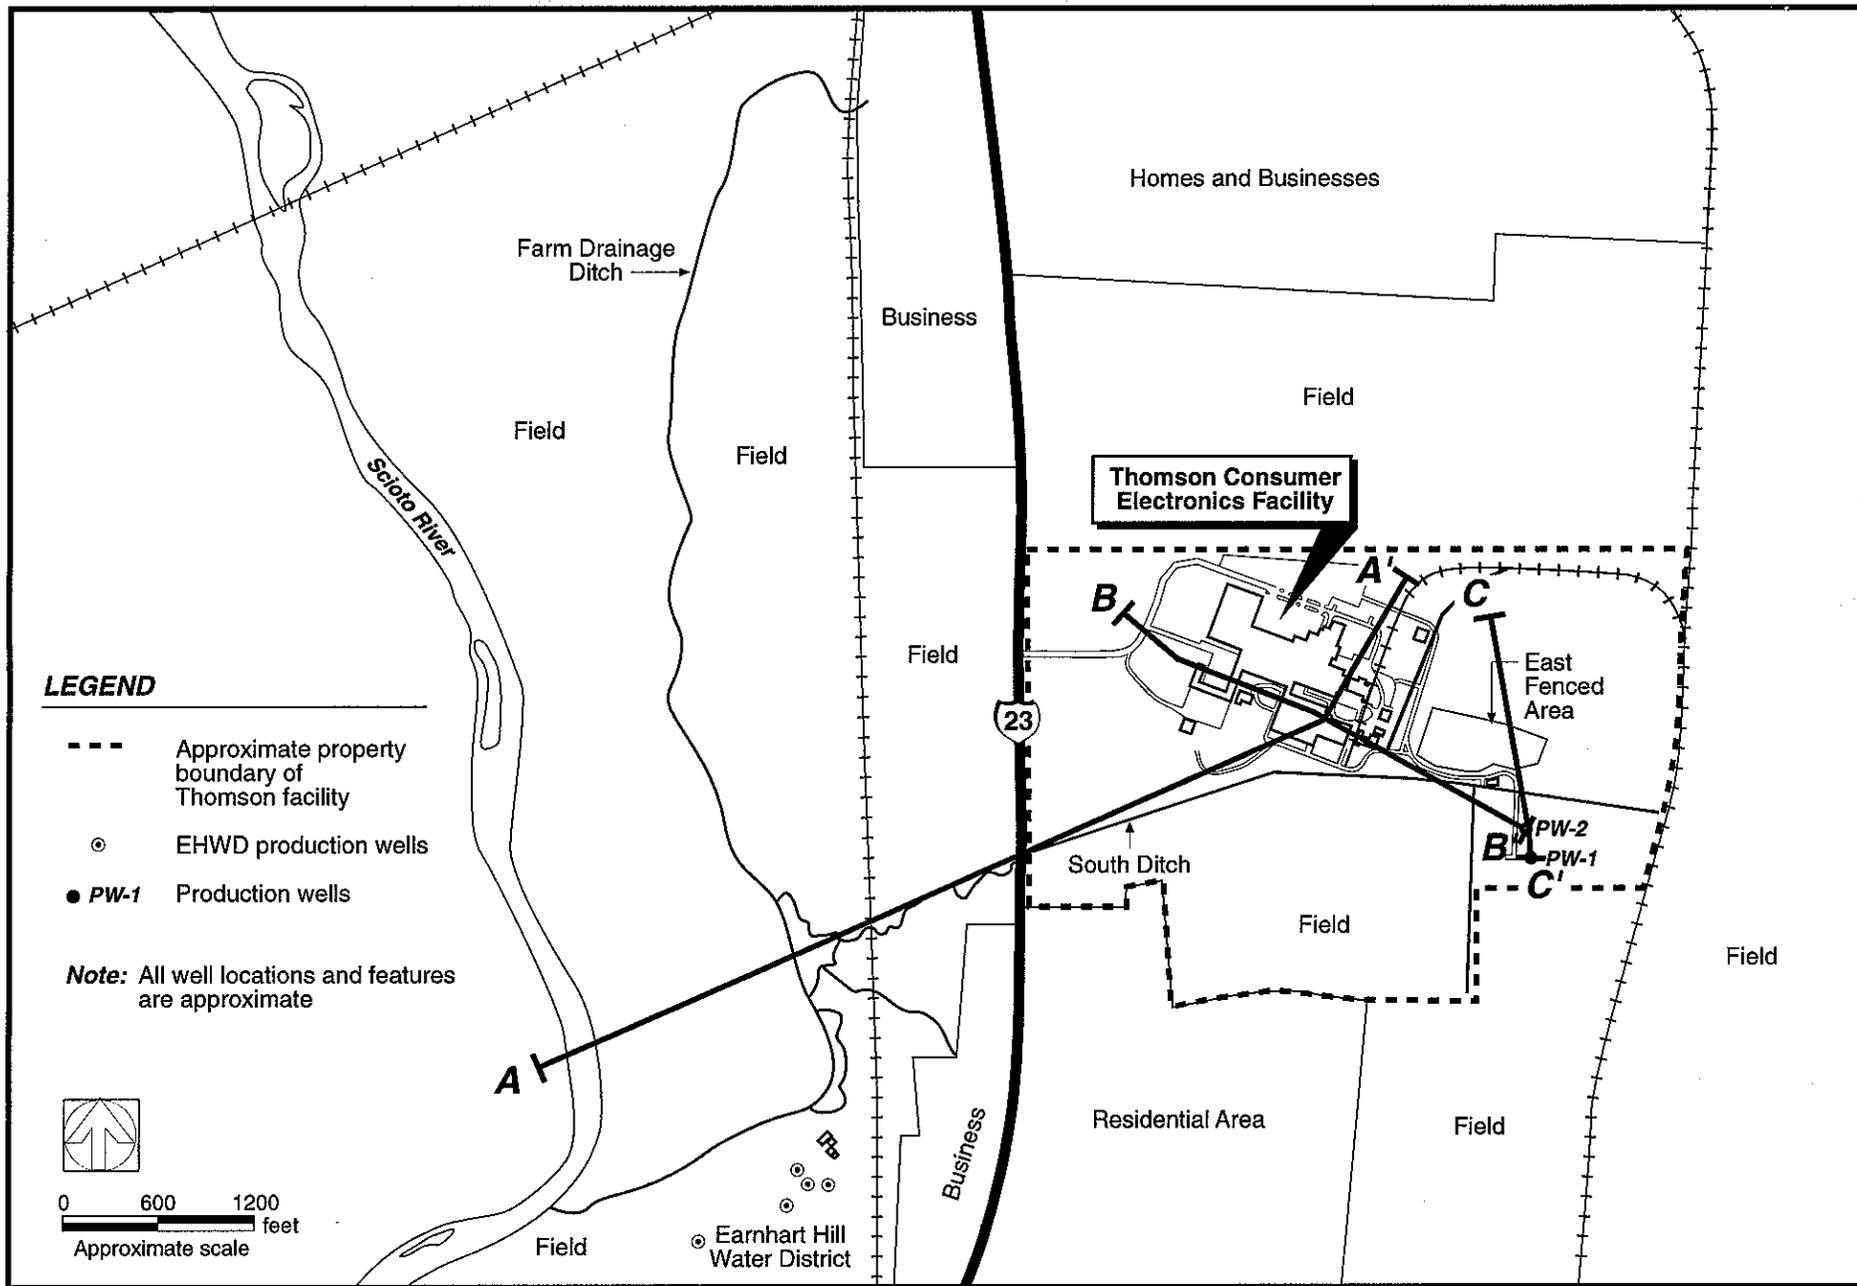
Figure 3-1. Regional cross-section locations.

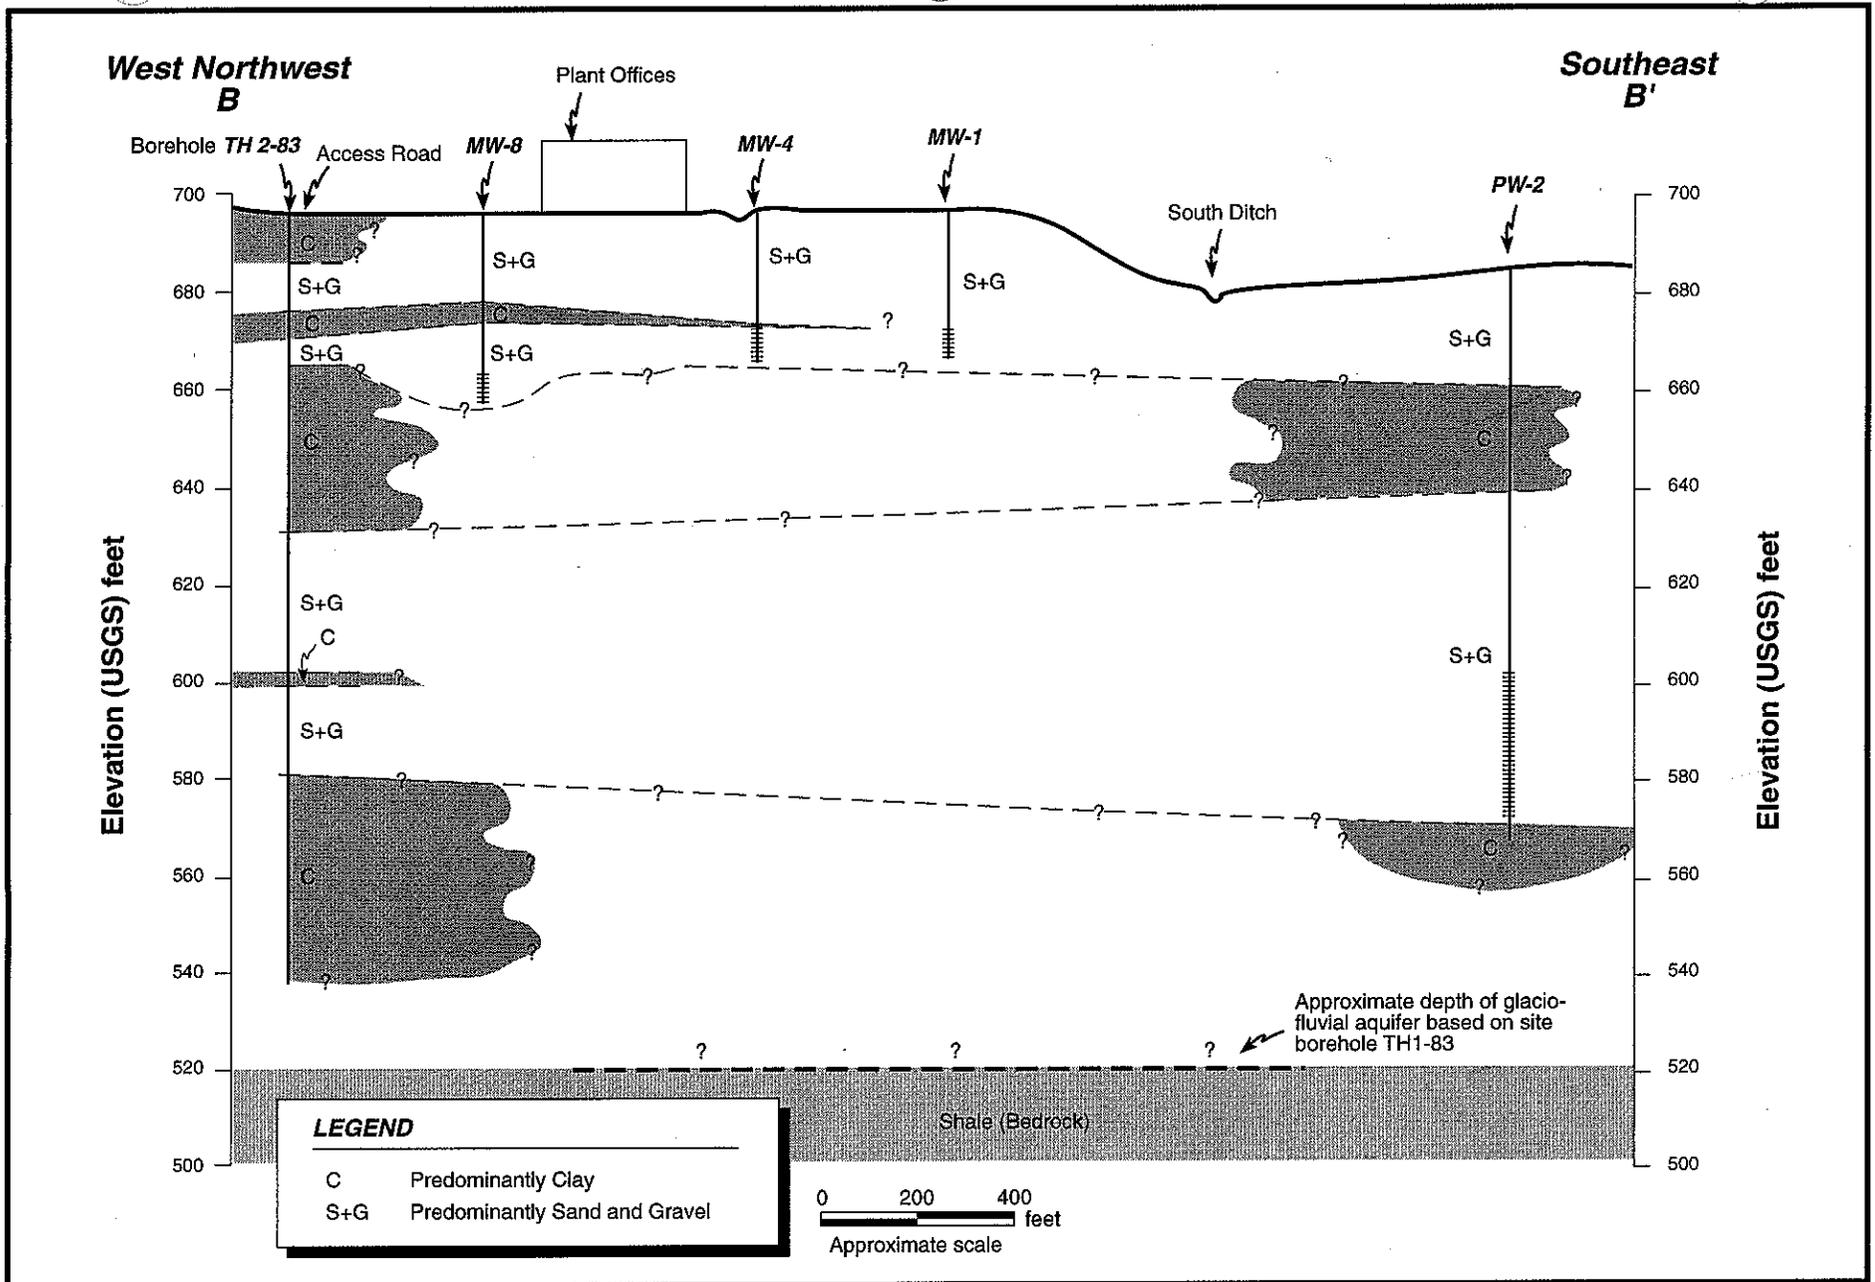
Figure 3-3. Site geology – west northwest/southeast cross section.

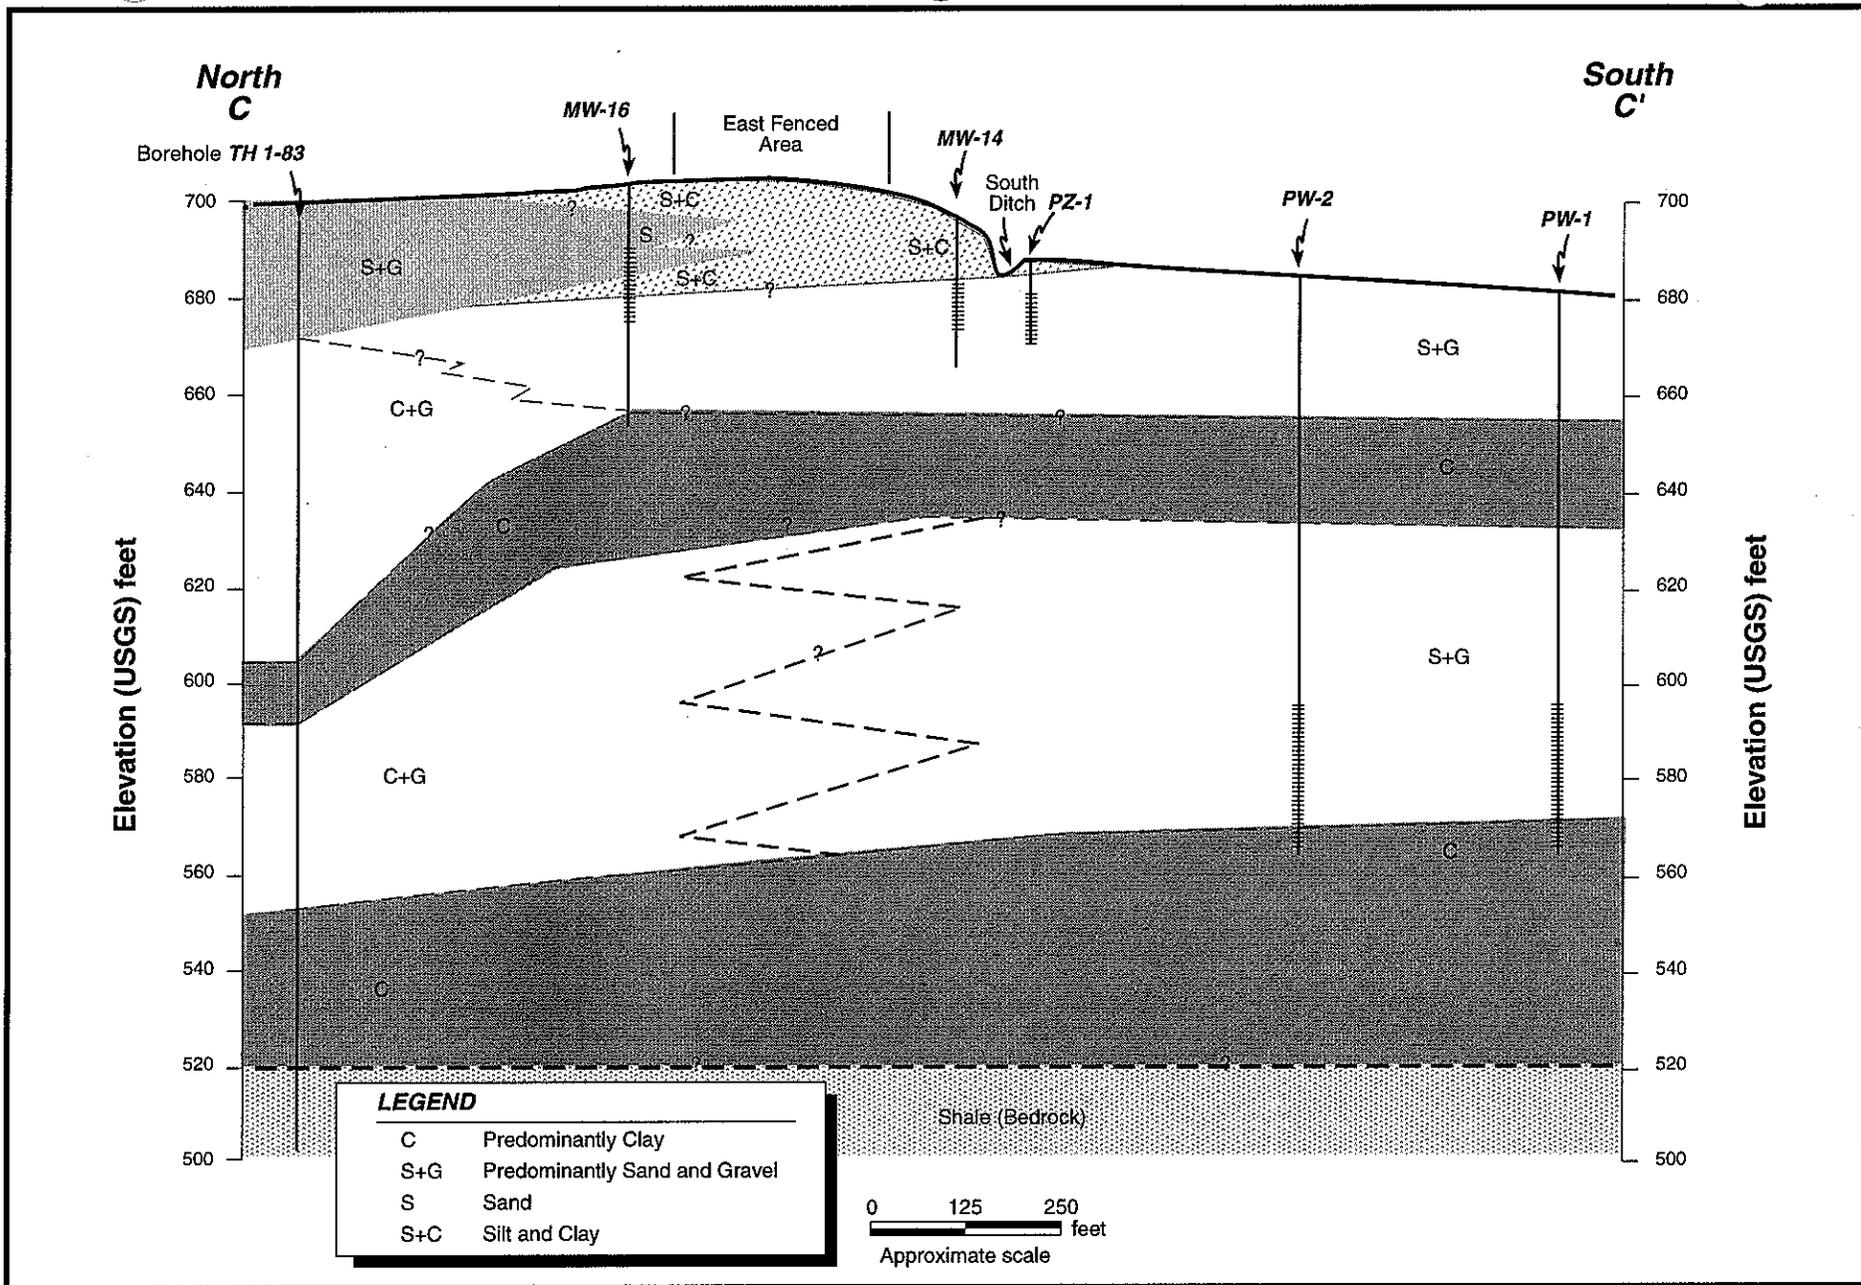
Figure 3-4. Site geology – north/south cross section.
