## **Figures**

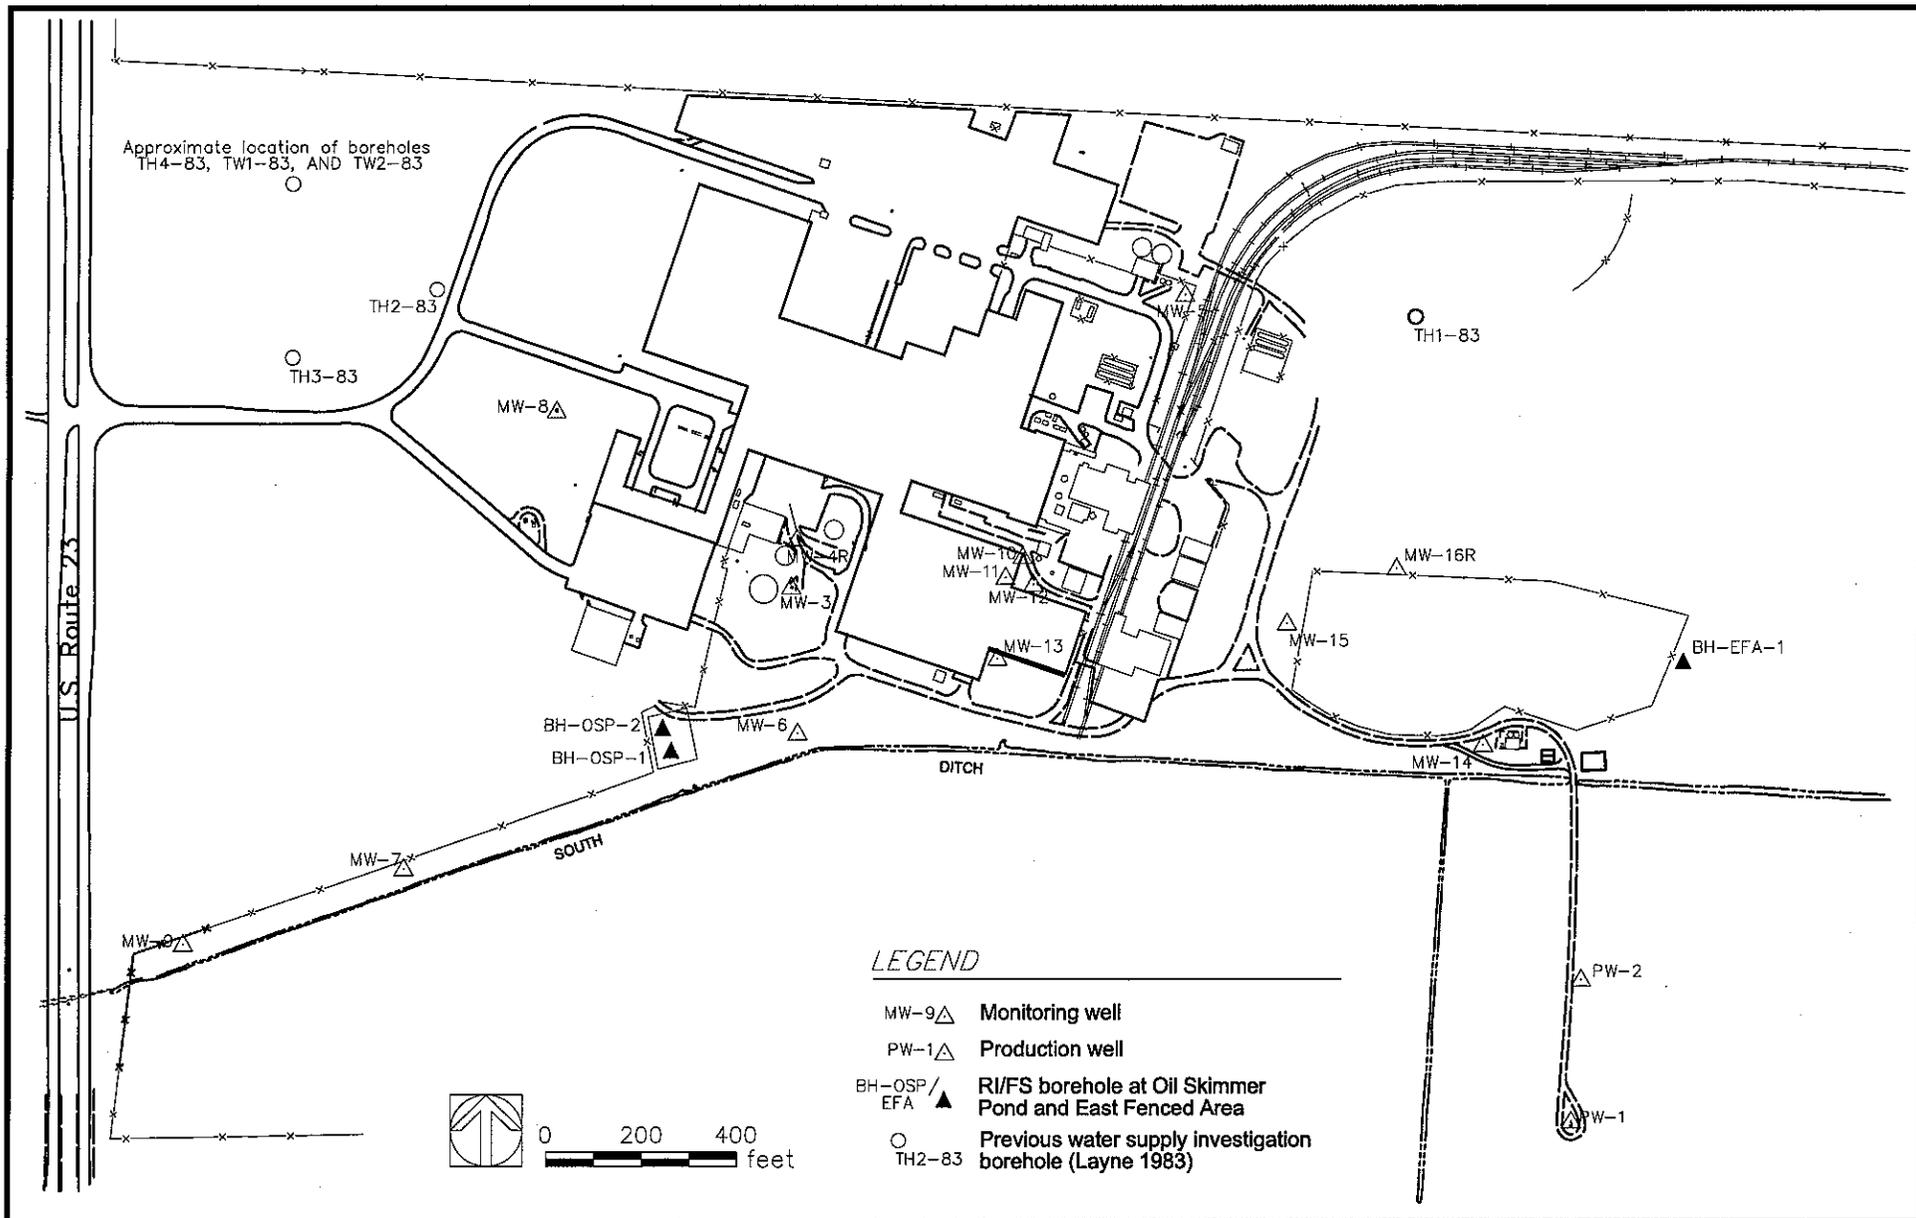
Figure 3-5. Existing and historical borehole and well locations.

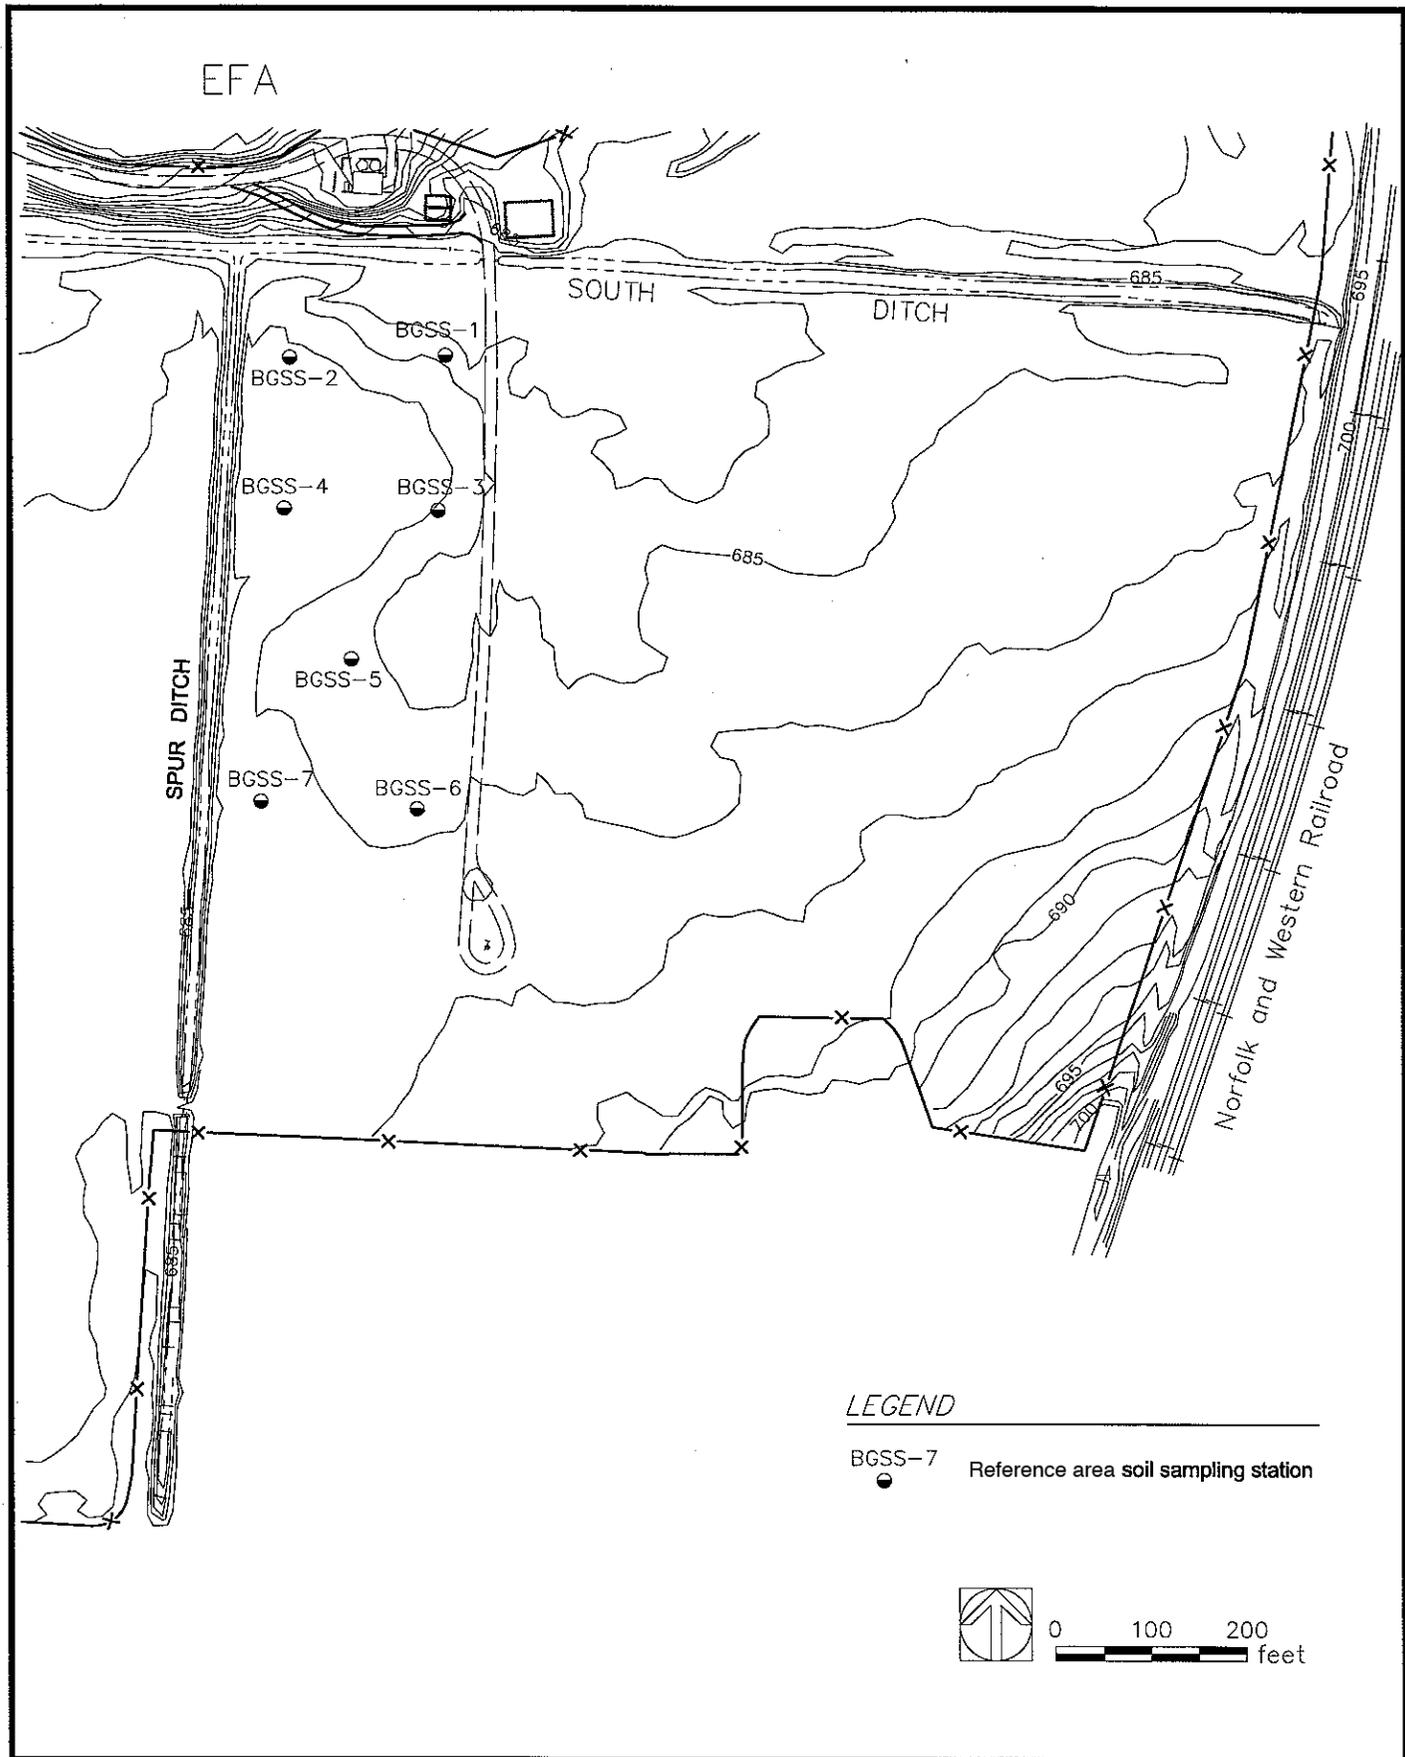
Figure 3-6. Reference area soil sampling locations.

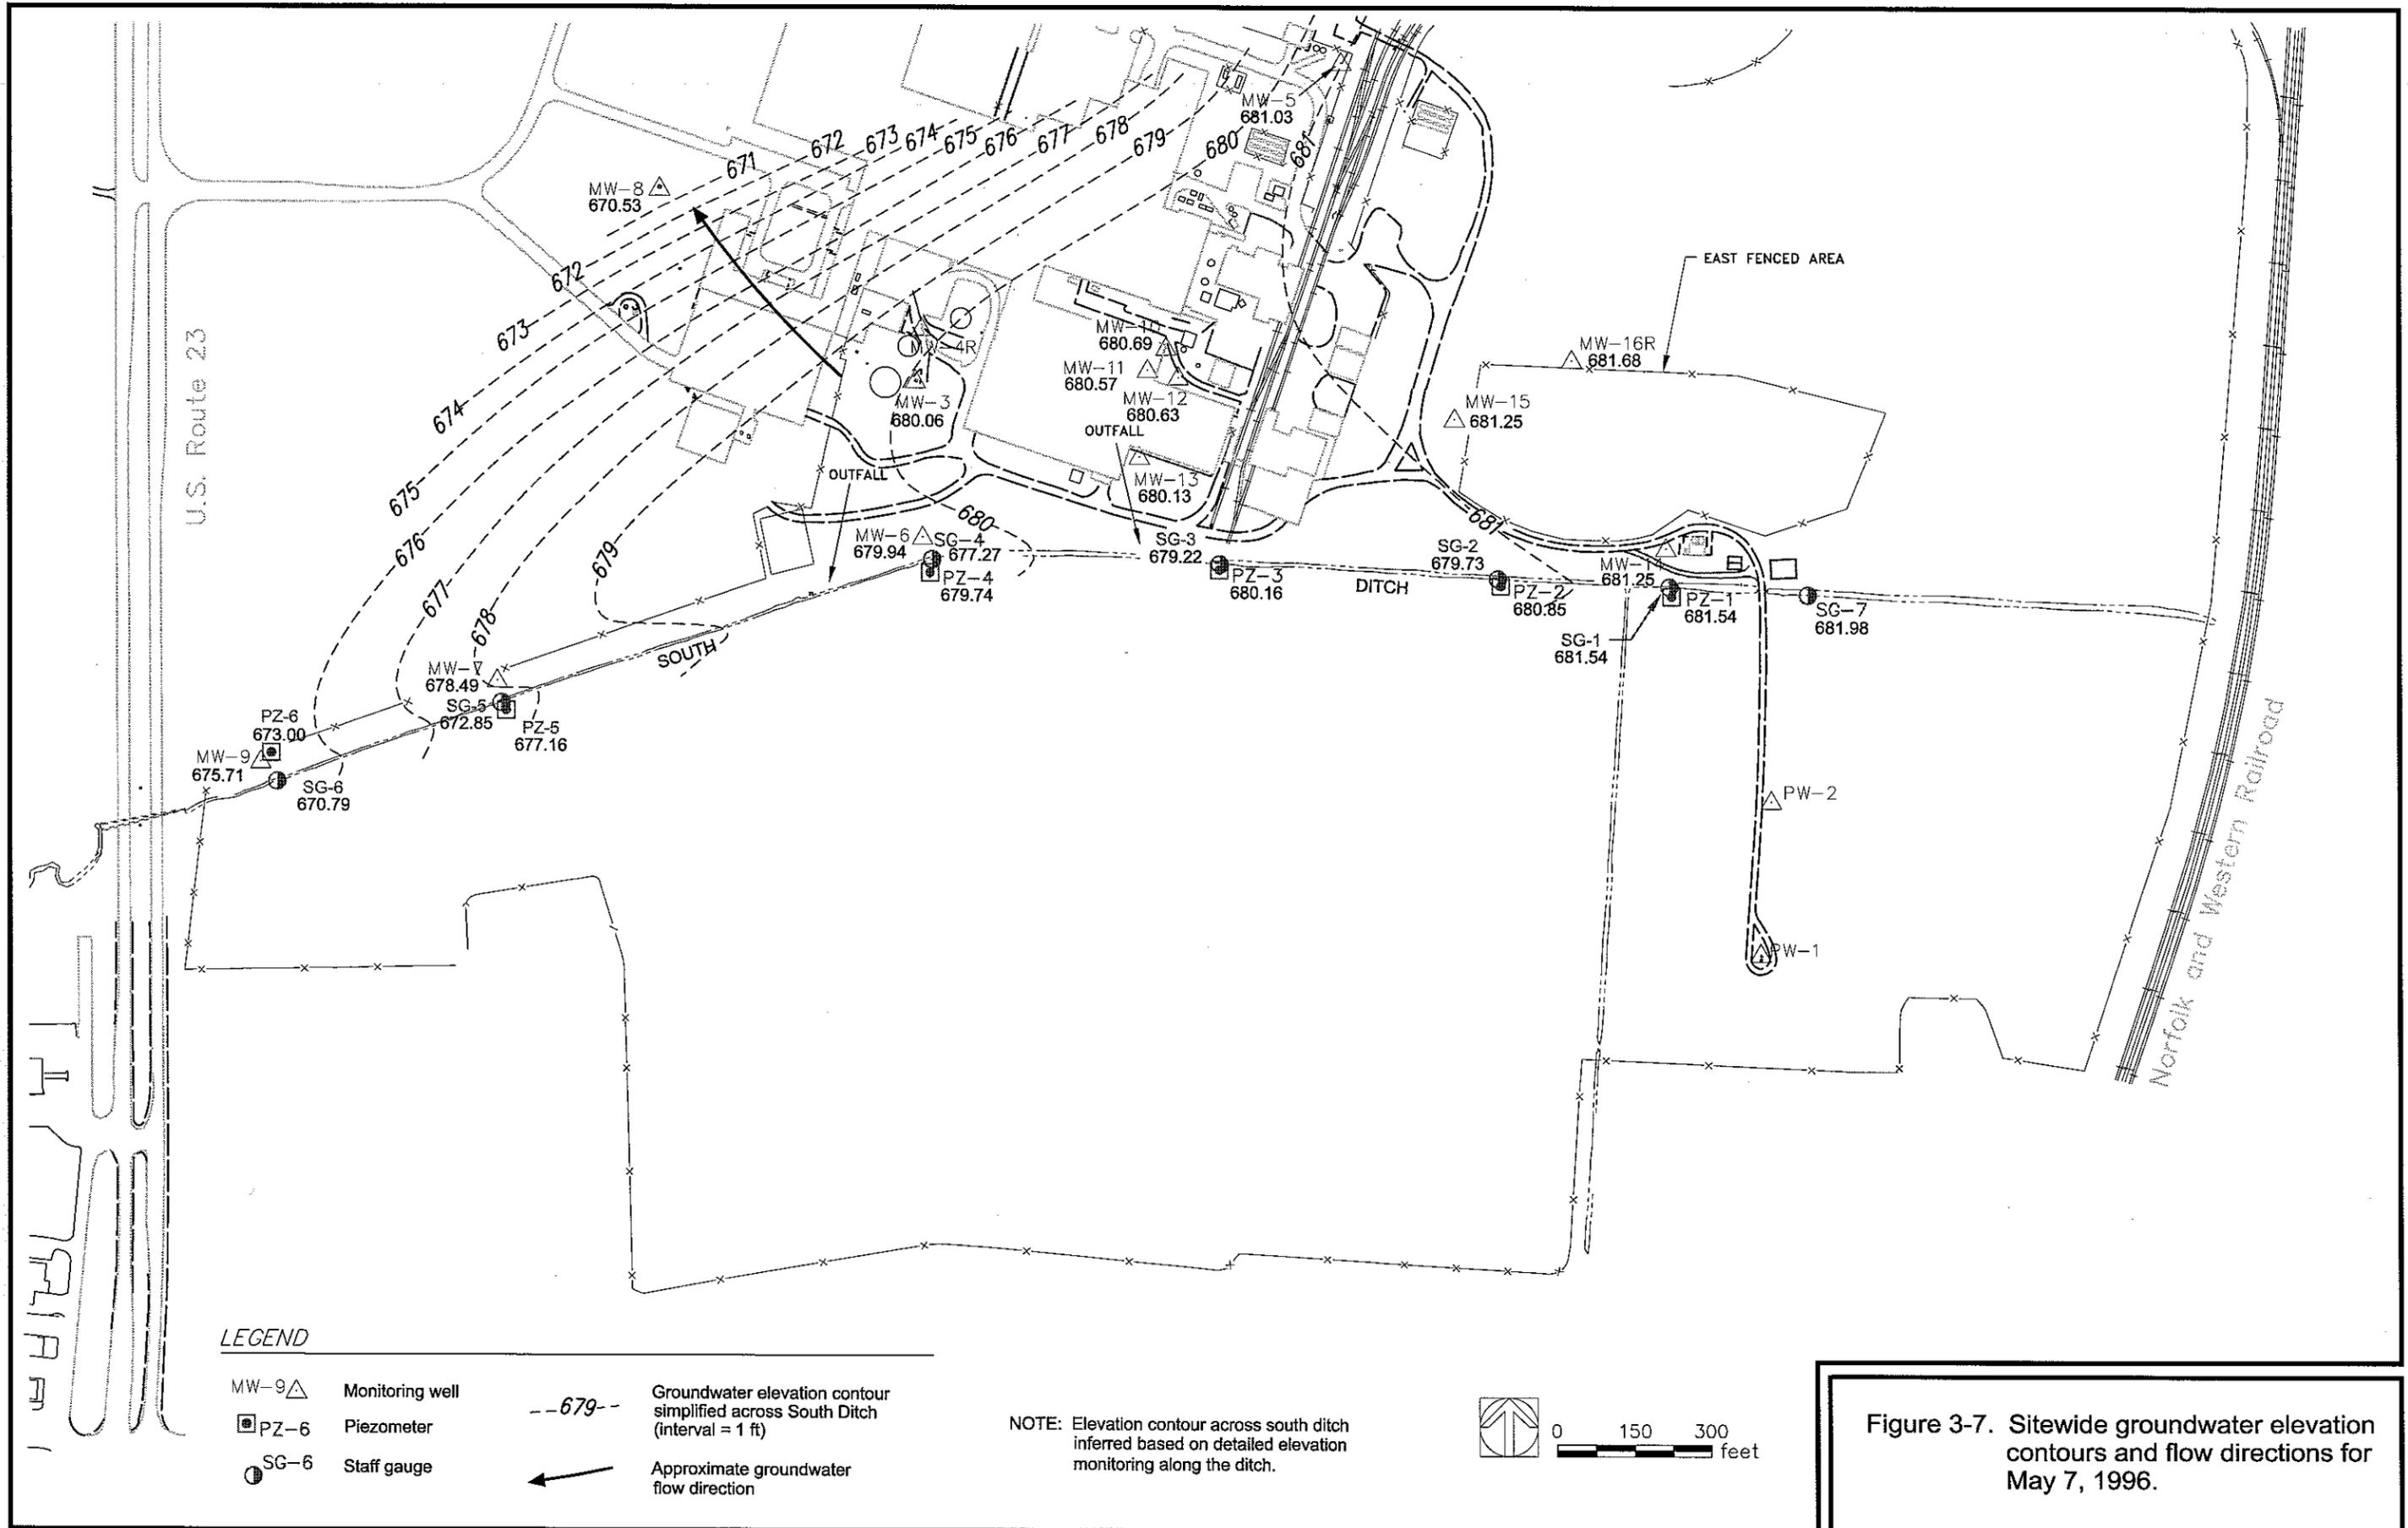
Figure 3-7. Sitewide groundwater elevation contours and flow directions for May 7, 1996.

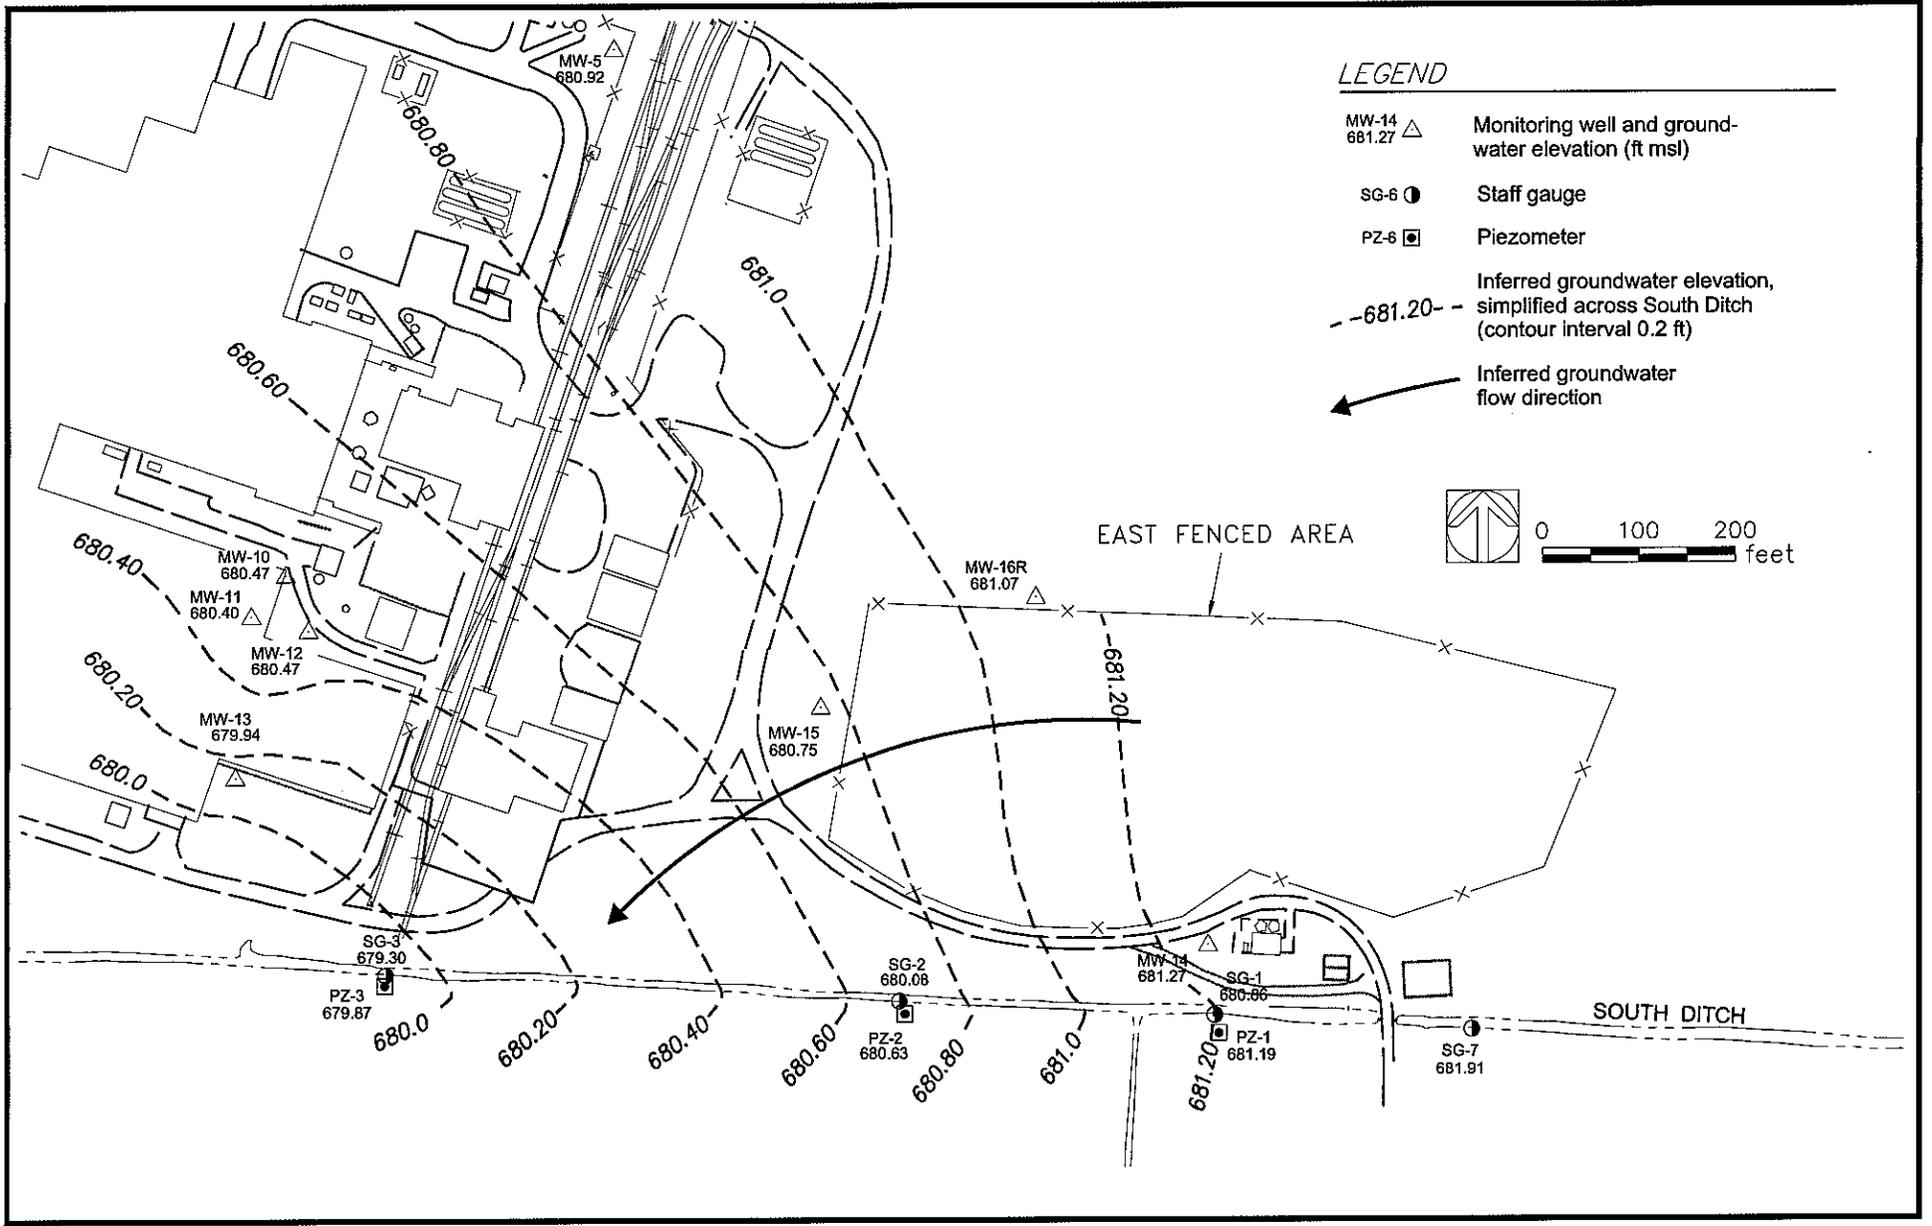
Figure 3-8. Groundwater elevation contours - first quarter (July 1996) groundwater sampling at East Fenced Area.

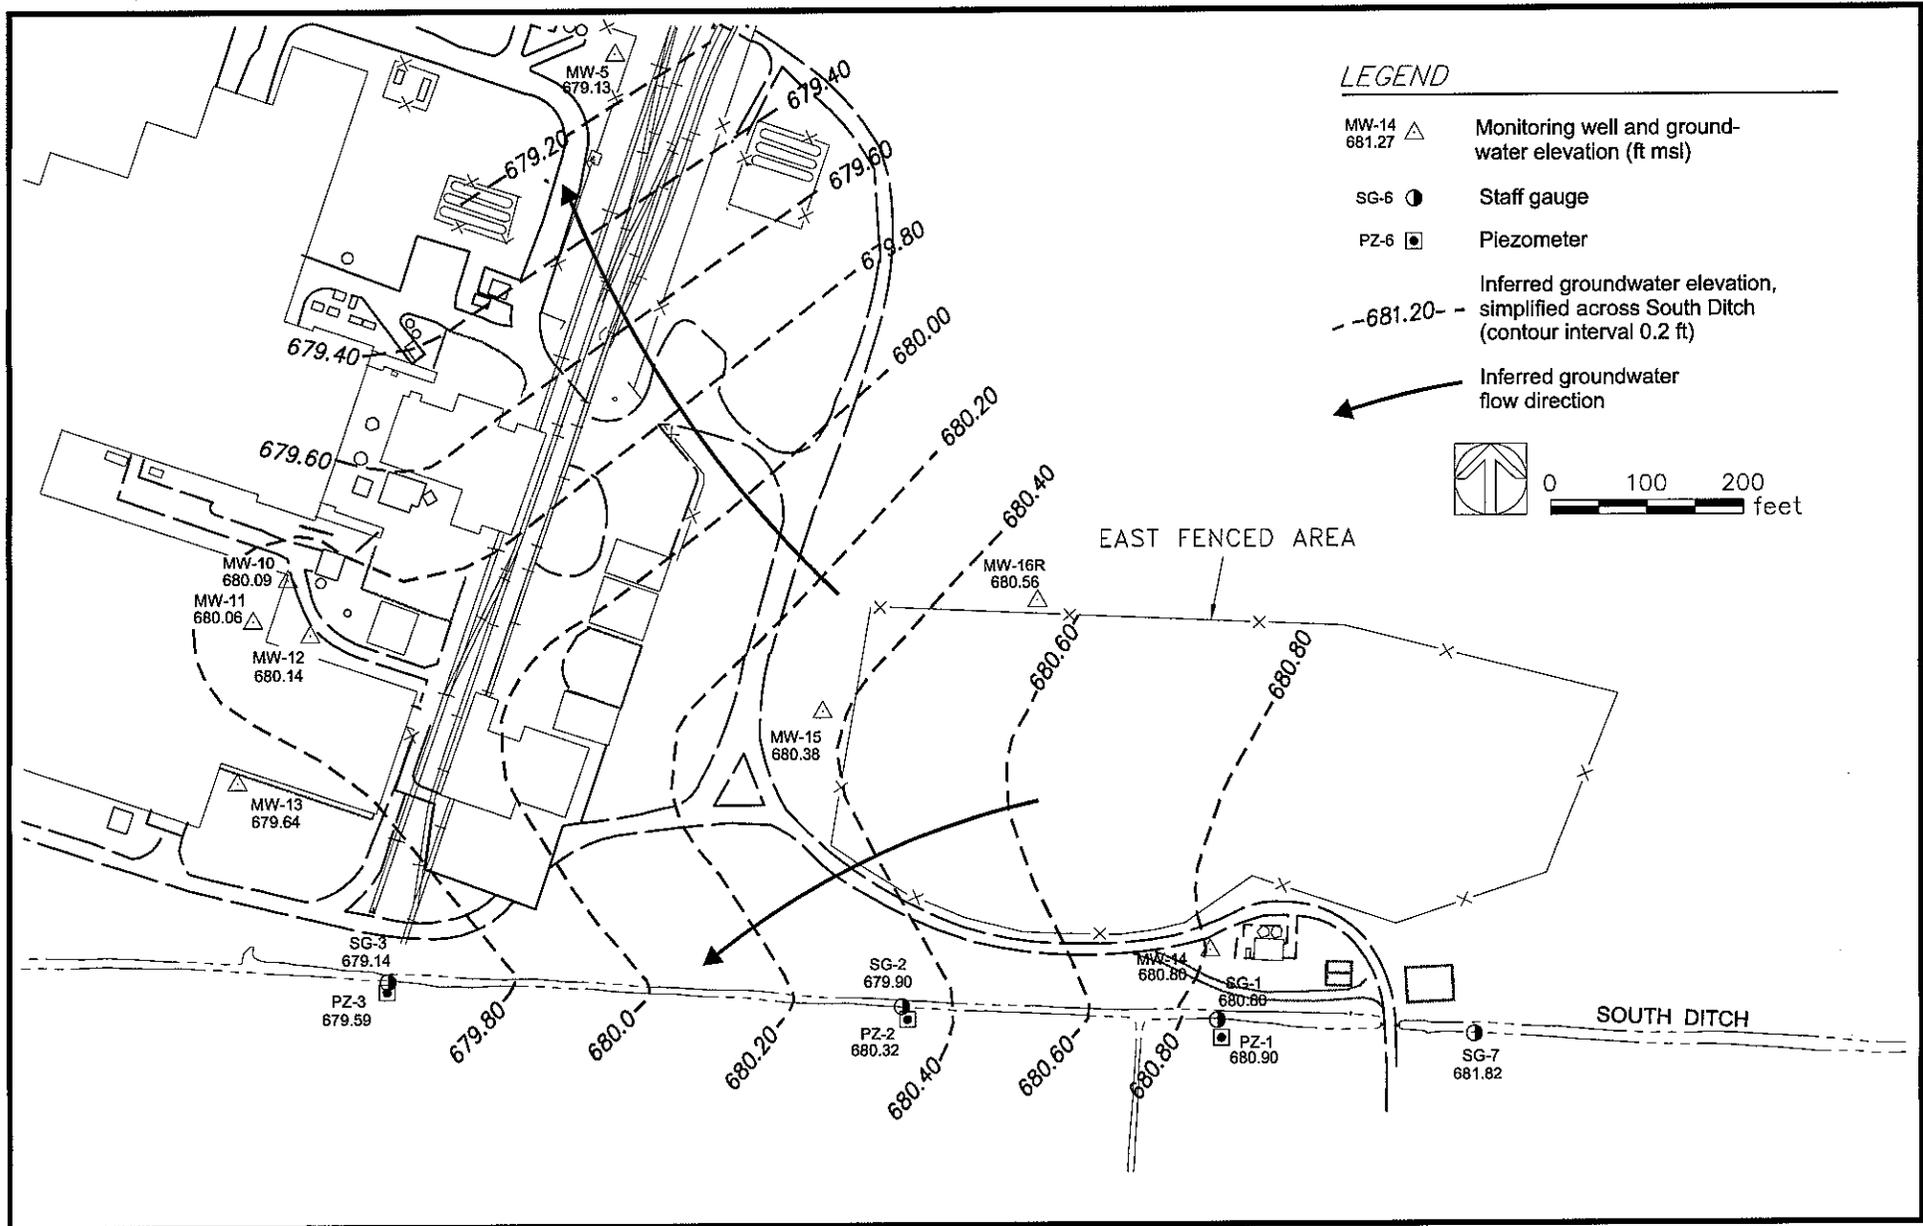
Figure 3-9. Groundwater elevation contours - second quarter (October 1996) groundwater sampling at East Fenced Area.

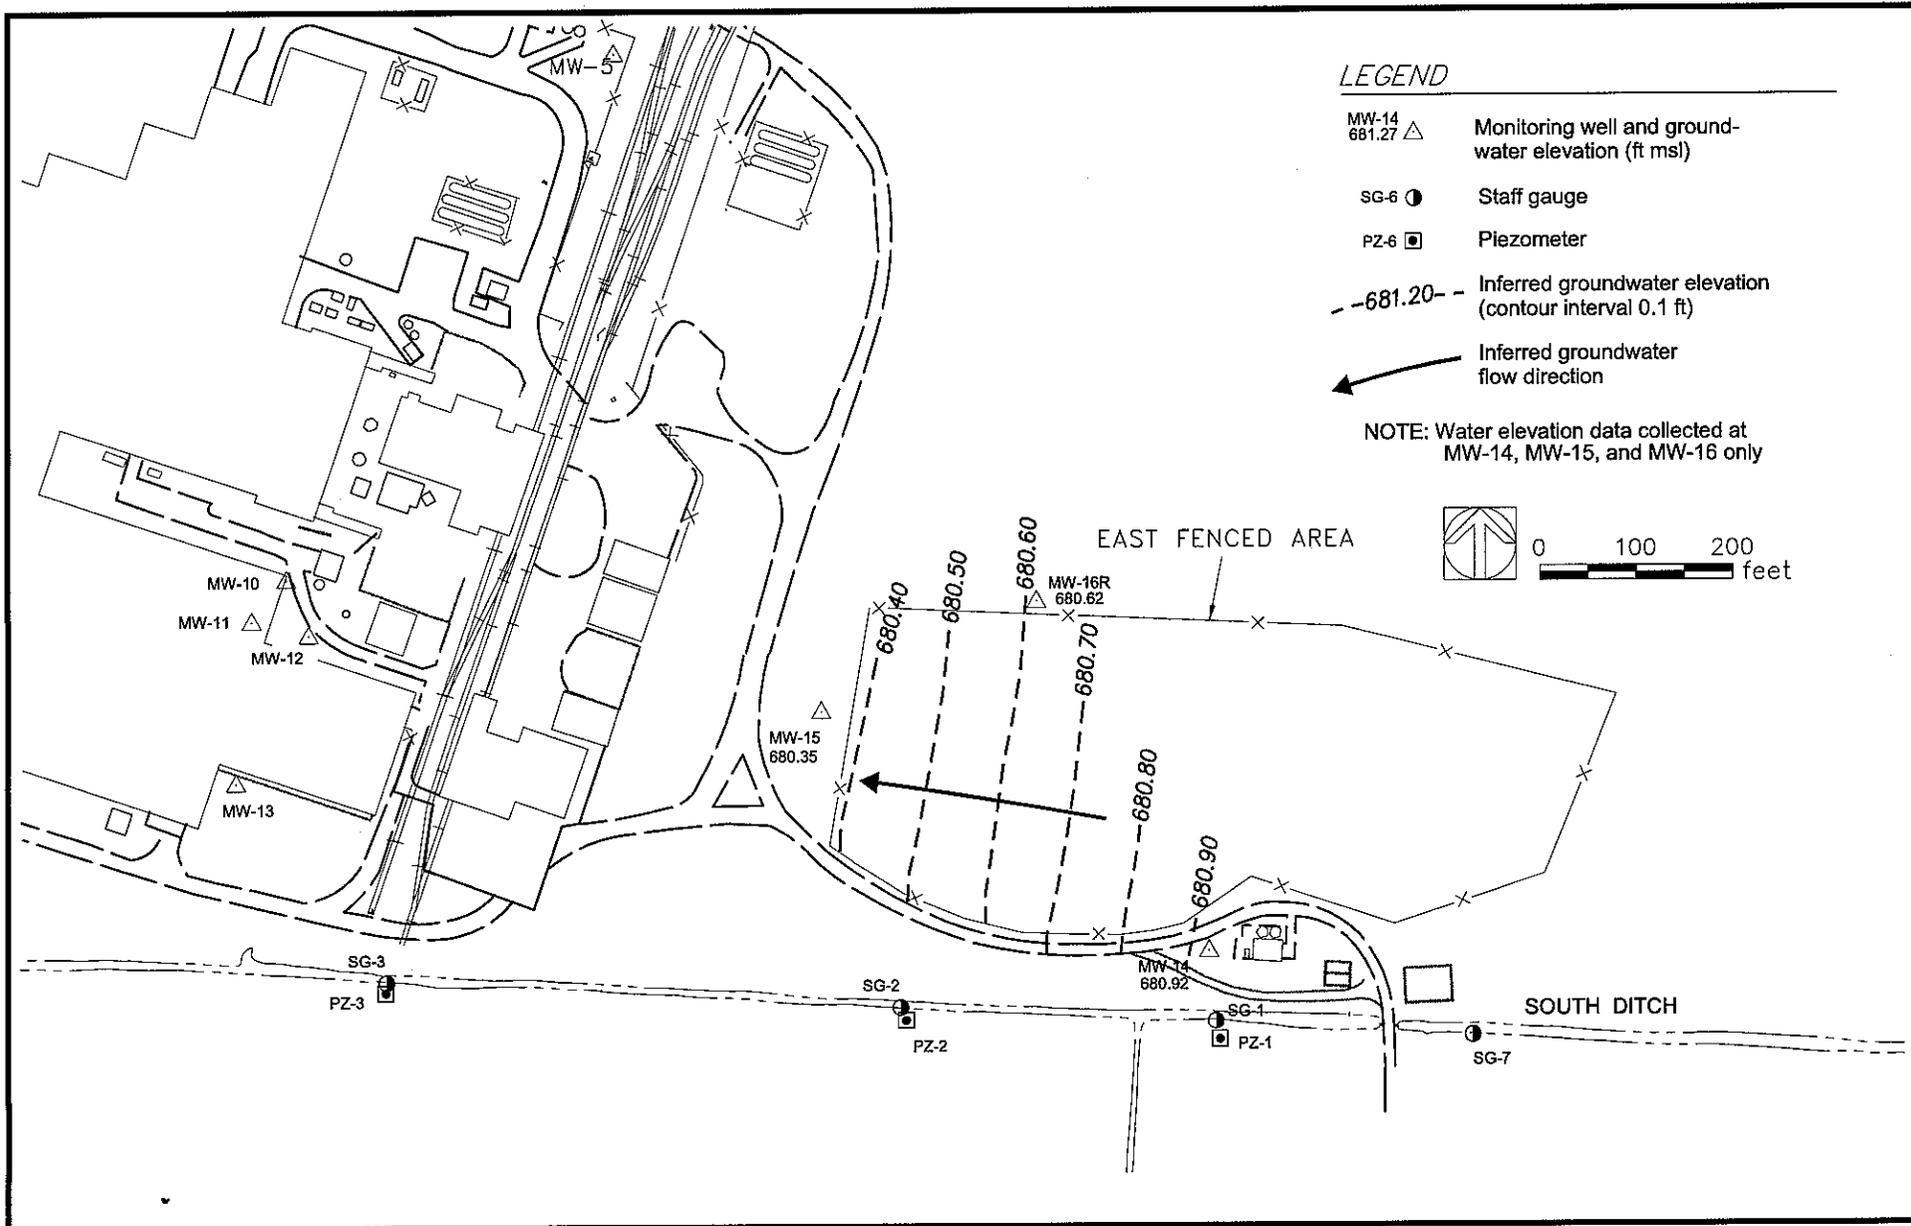
Figure 3-10. Groundwater elevation contours - third quarter (February 1997) groundwater sampling at East Fenced Area.

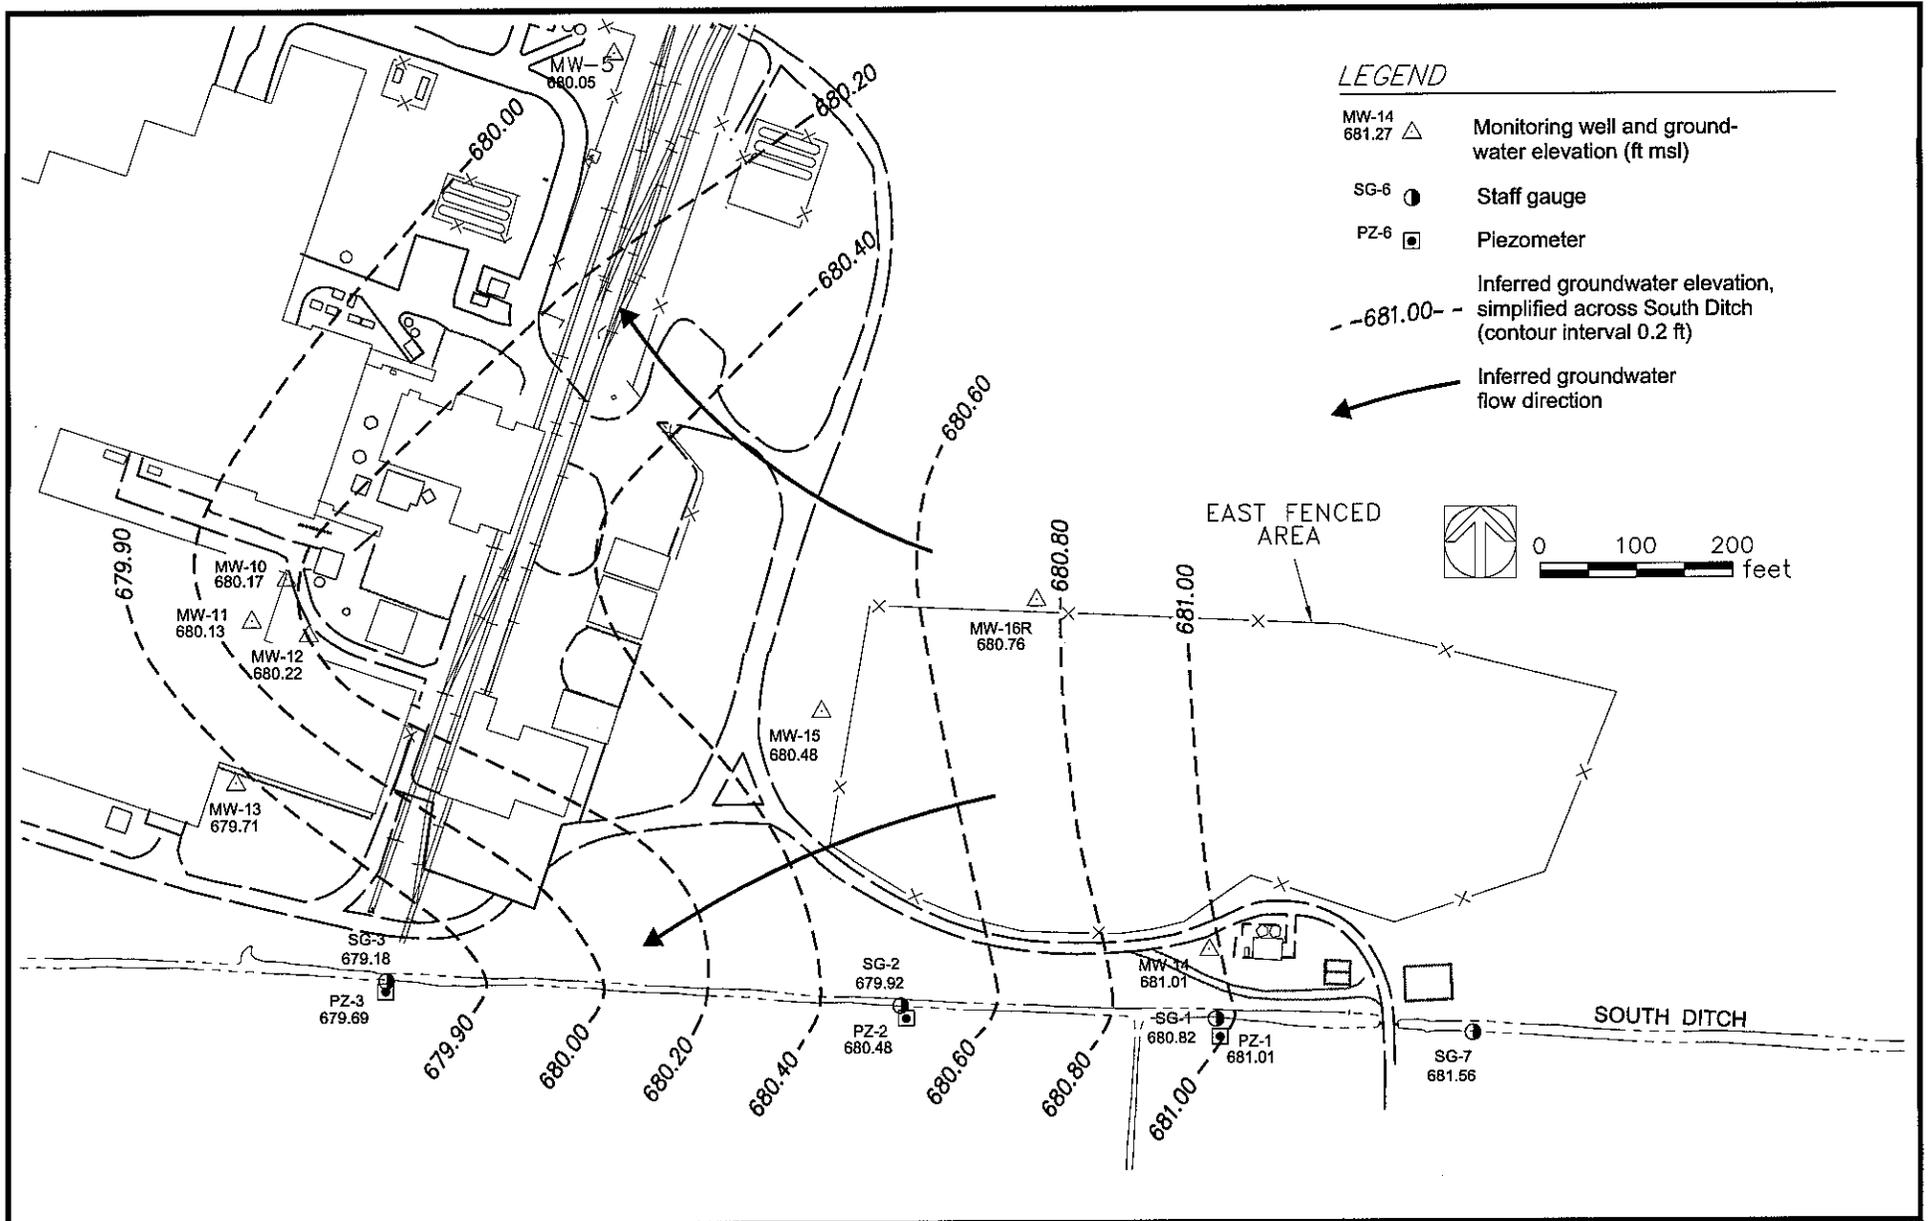
Figure 3-11. Groundwater elevation contours - fourth quarter (April 1997) groundwater sampling at East Fenced Area.

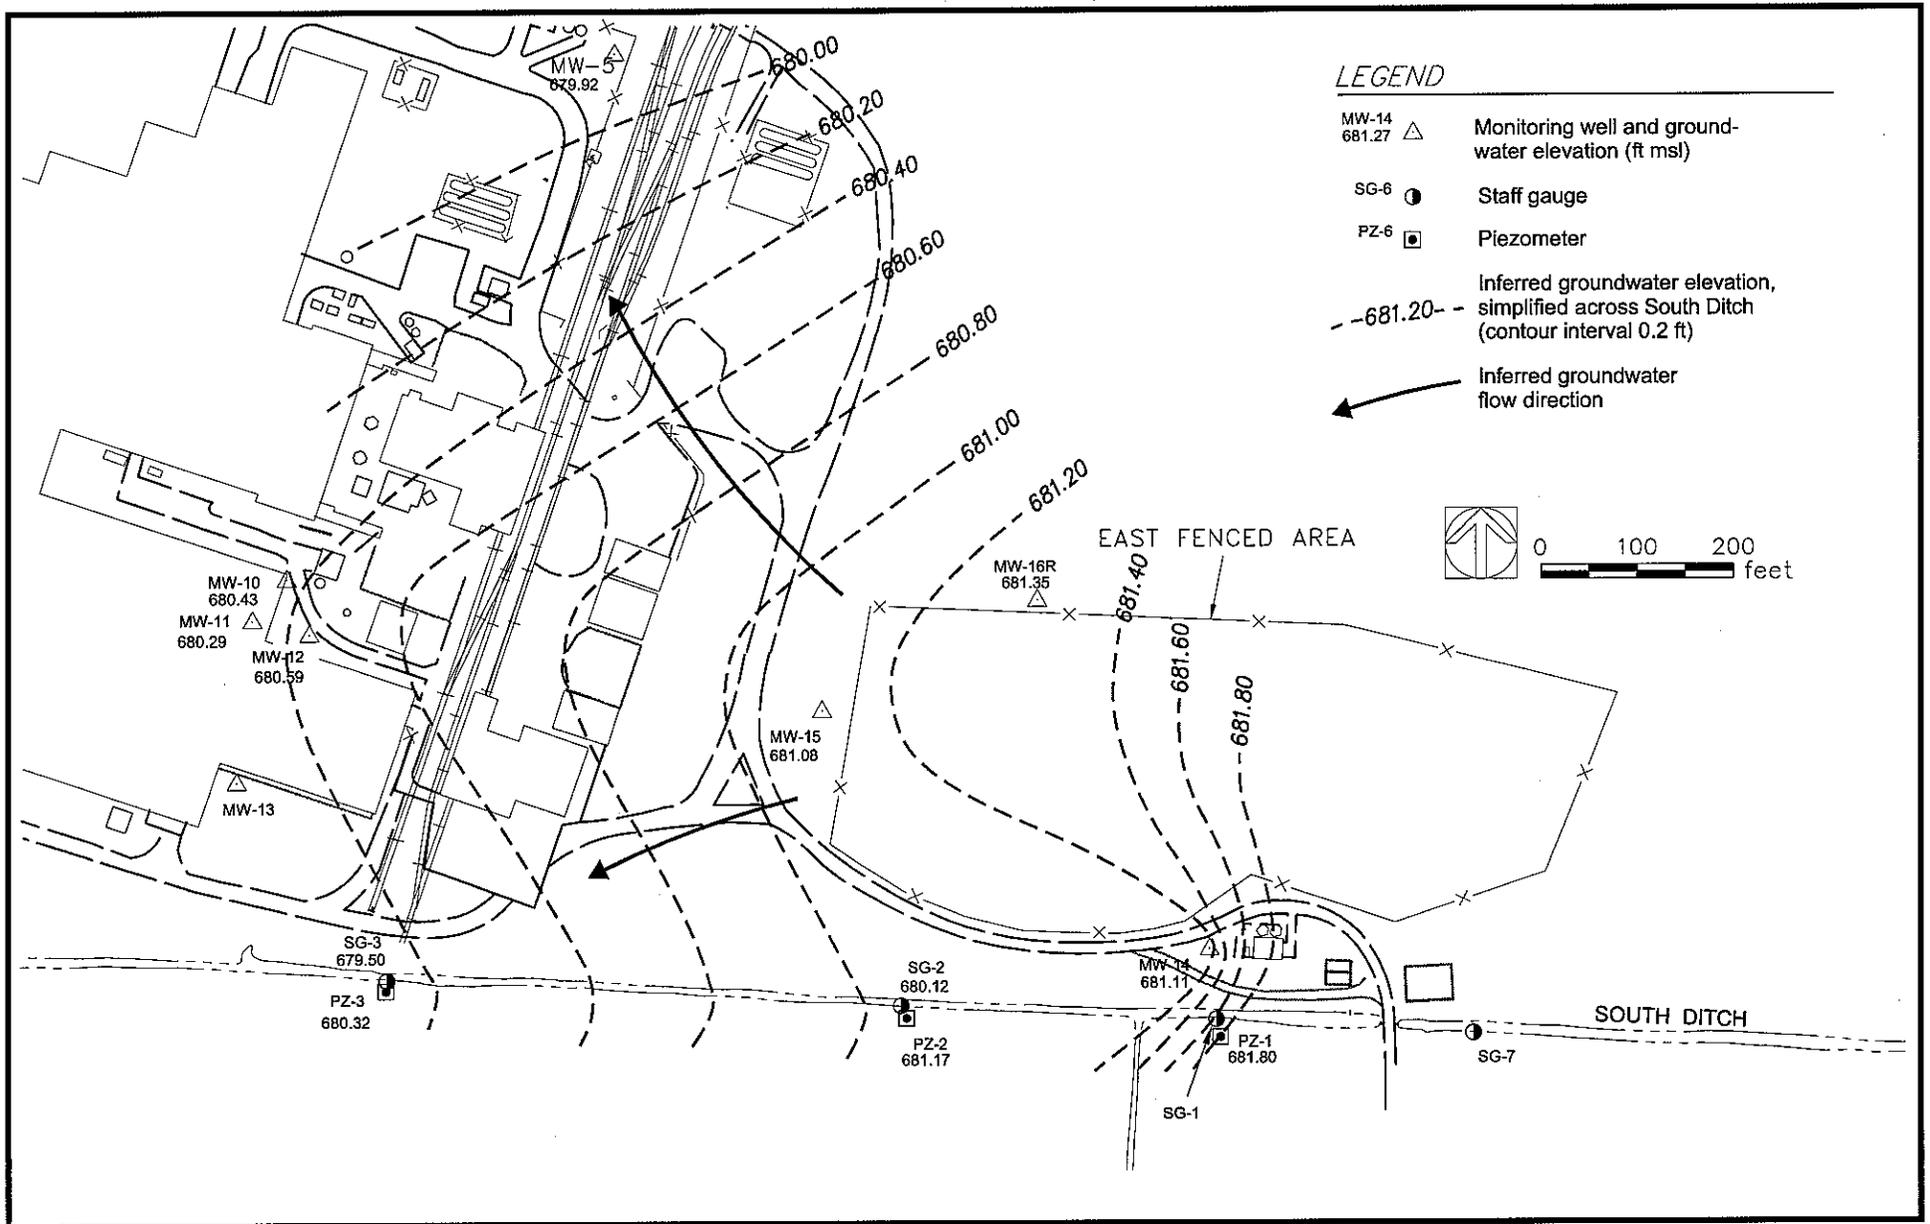
Figure 3-12. Groundwater elevation contours - fifth quarter (August 1997) groundwater sampling at East Fenced Area.

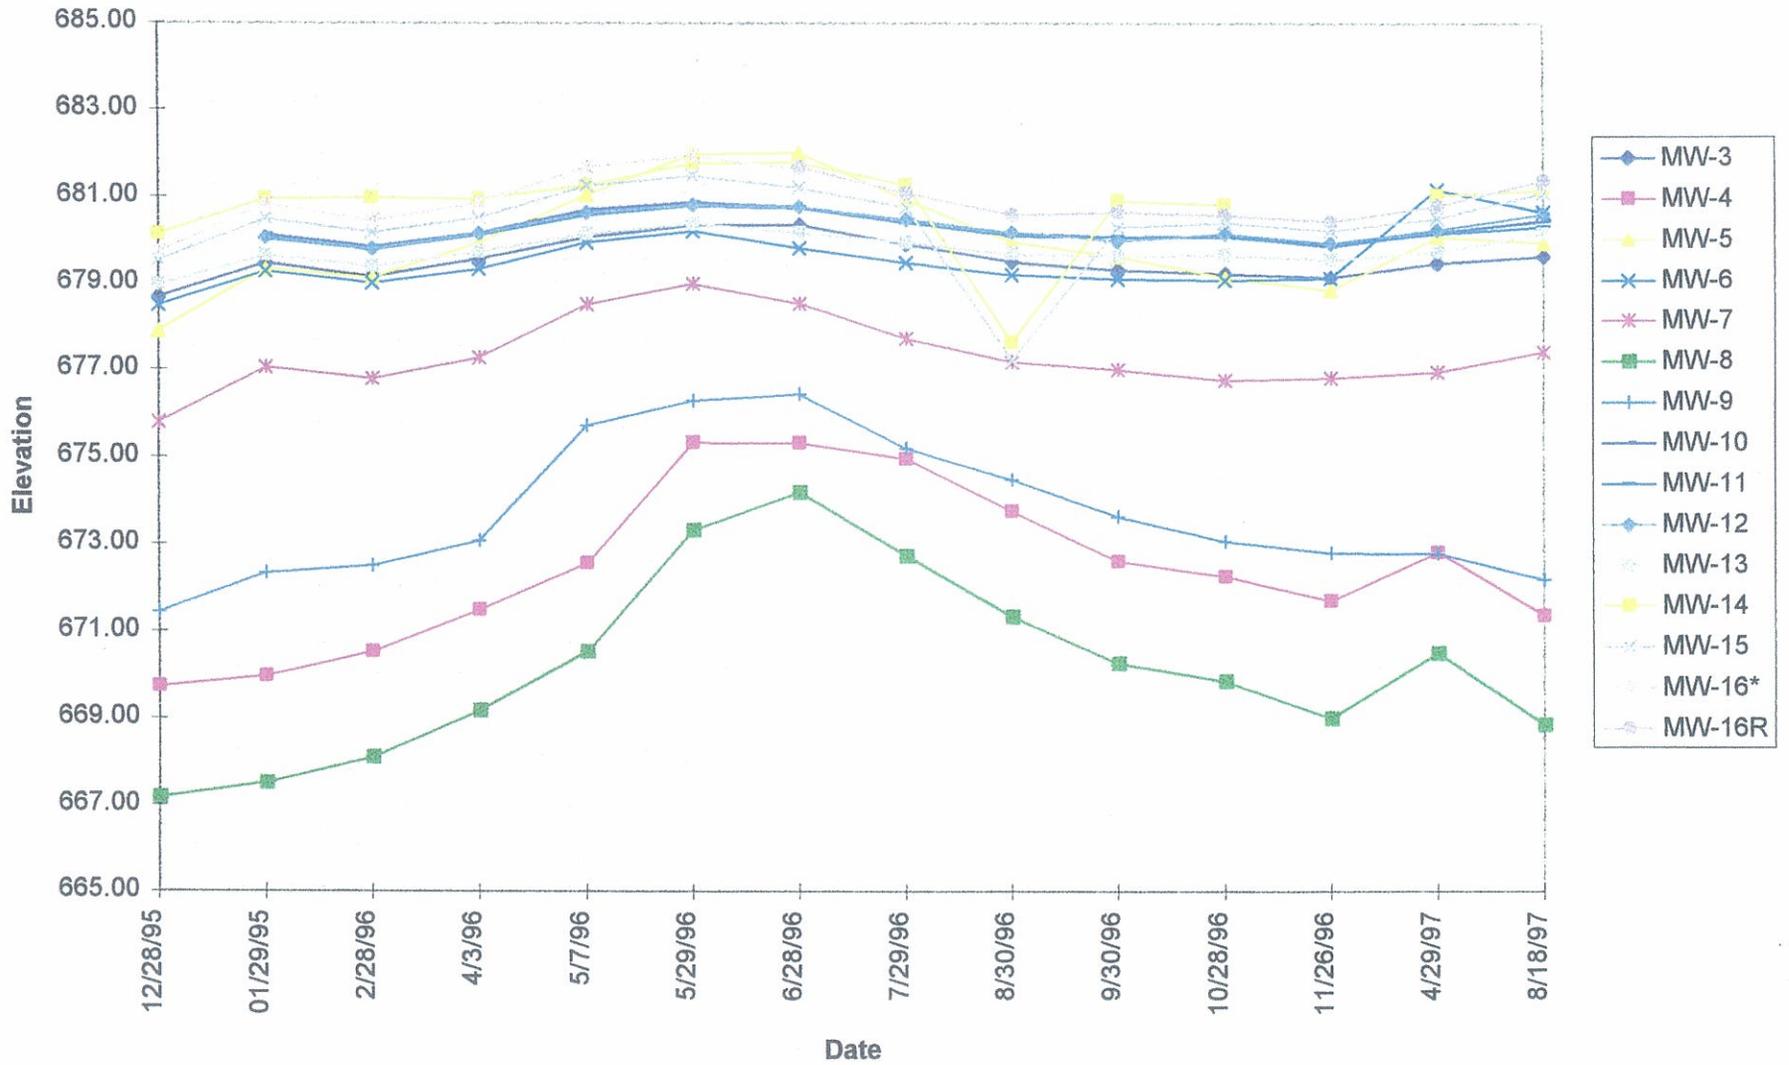
Figure 3-13. Groundwater elevations.
