## **Figures**

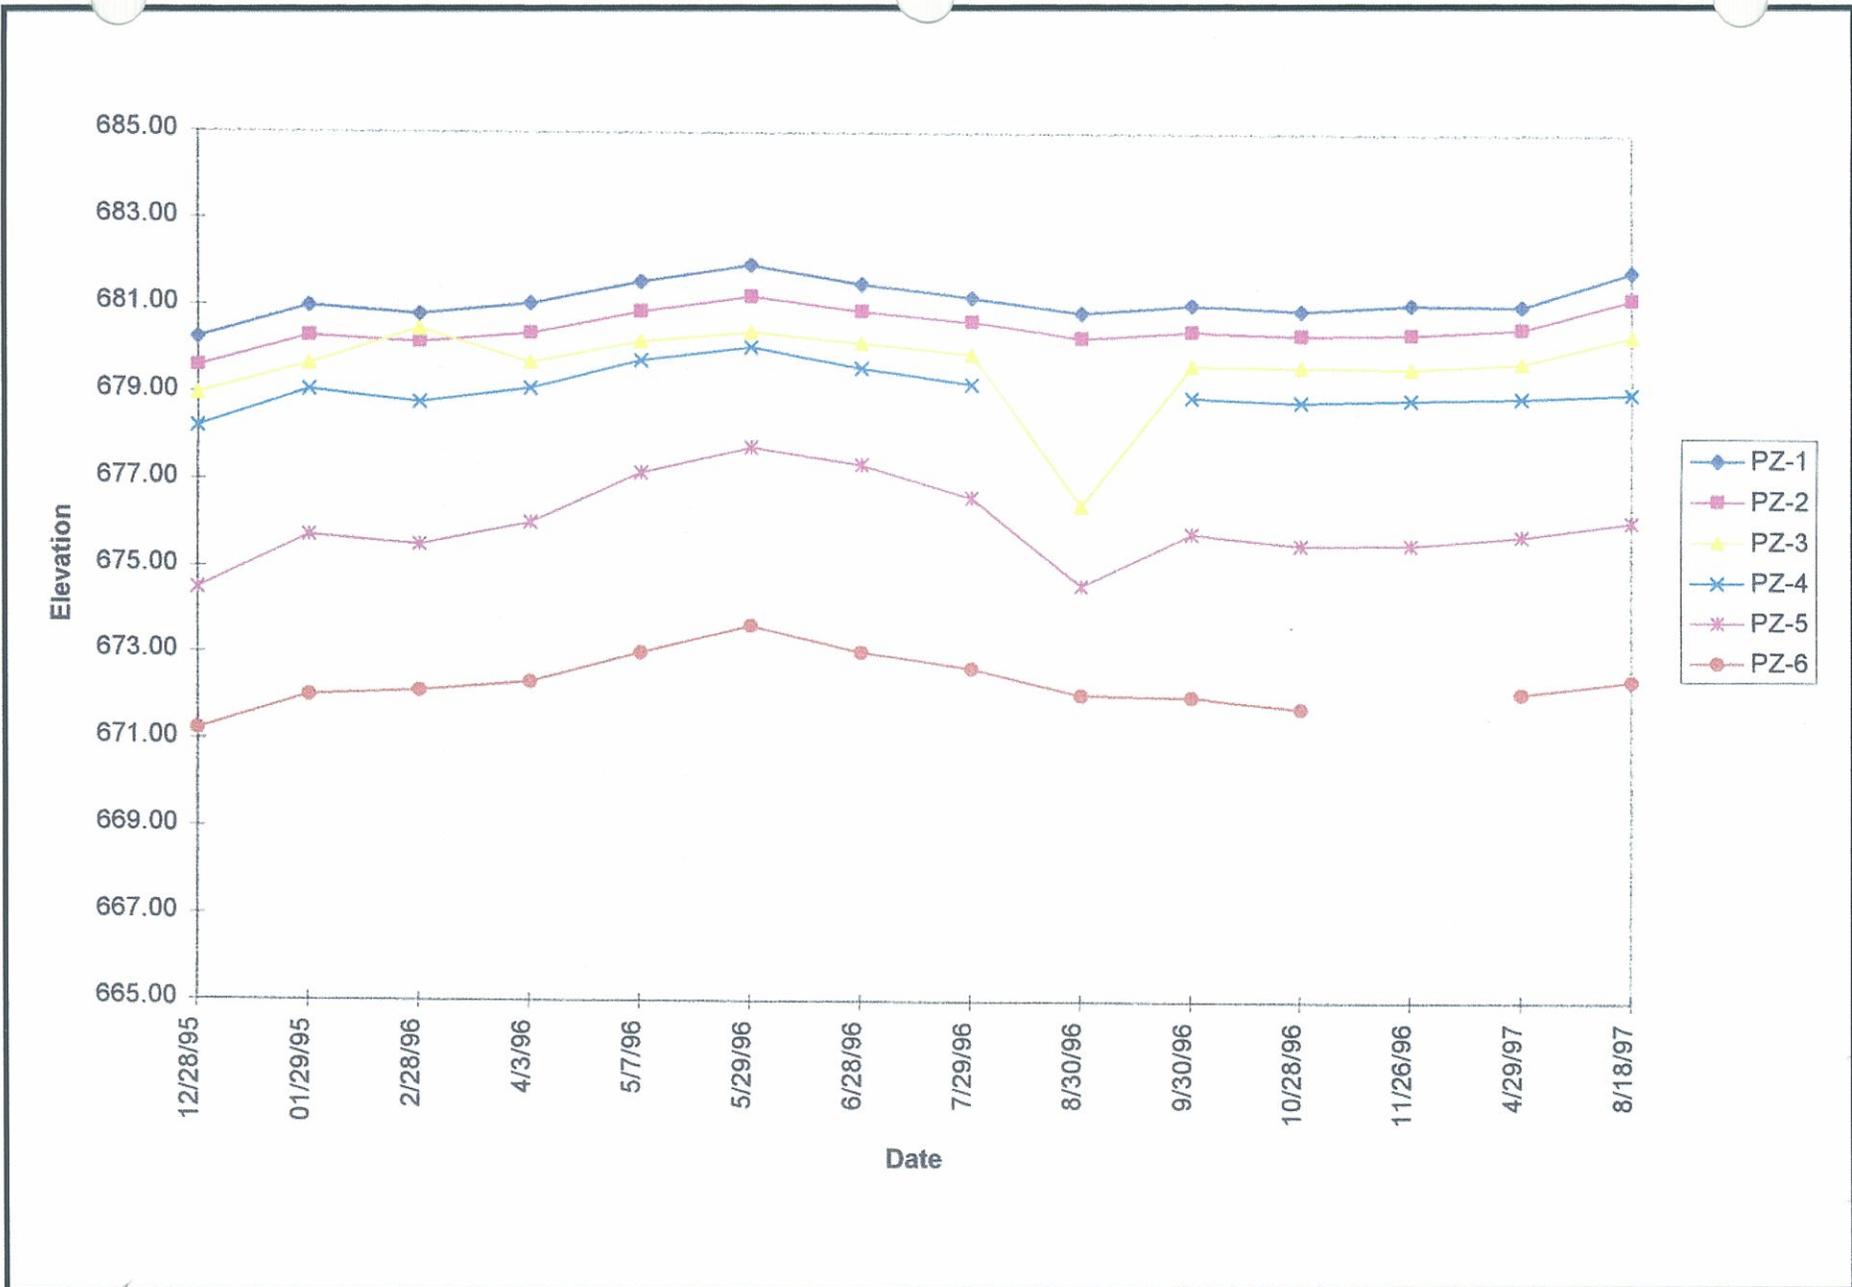
Figure 3-14. Piezometer elevations.

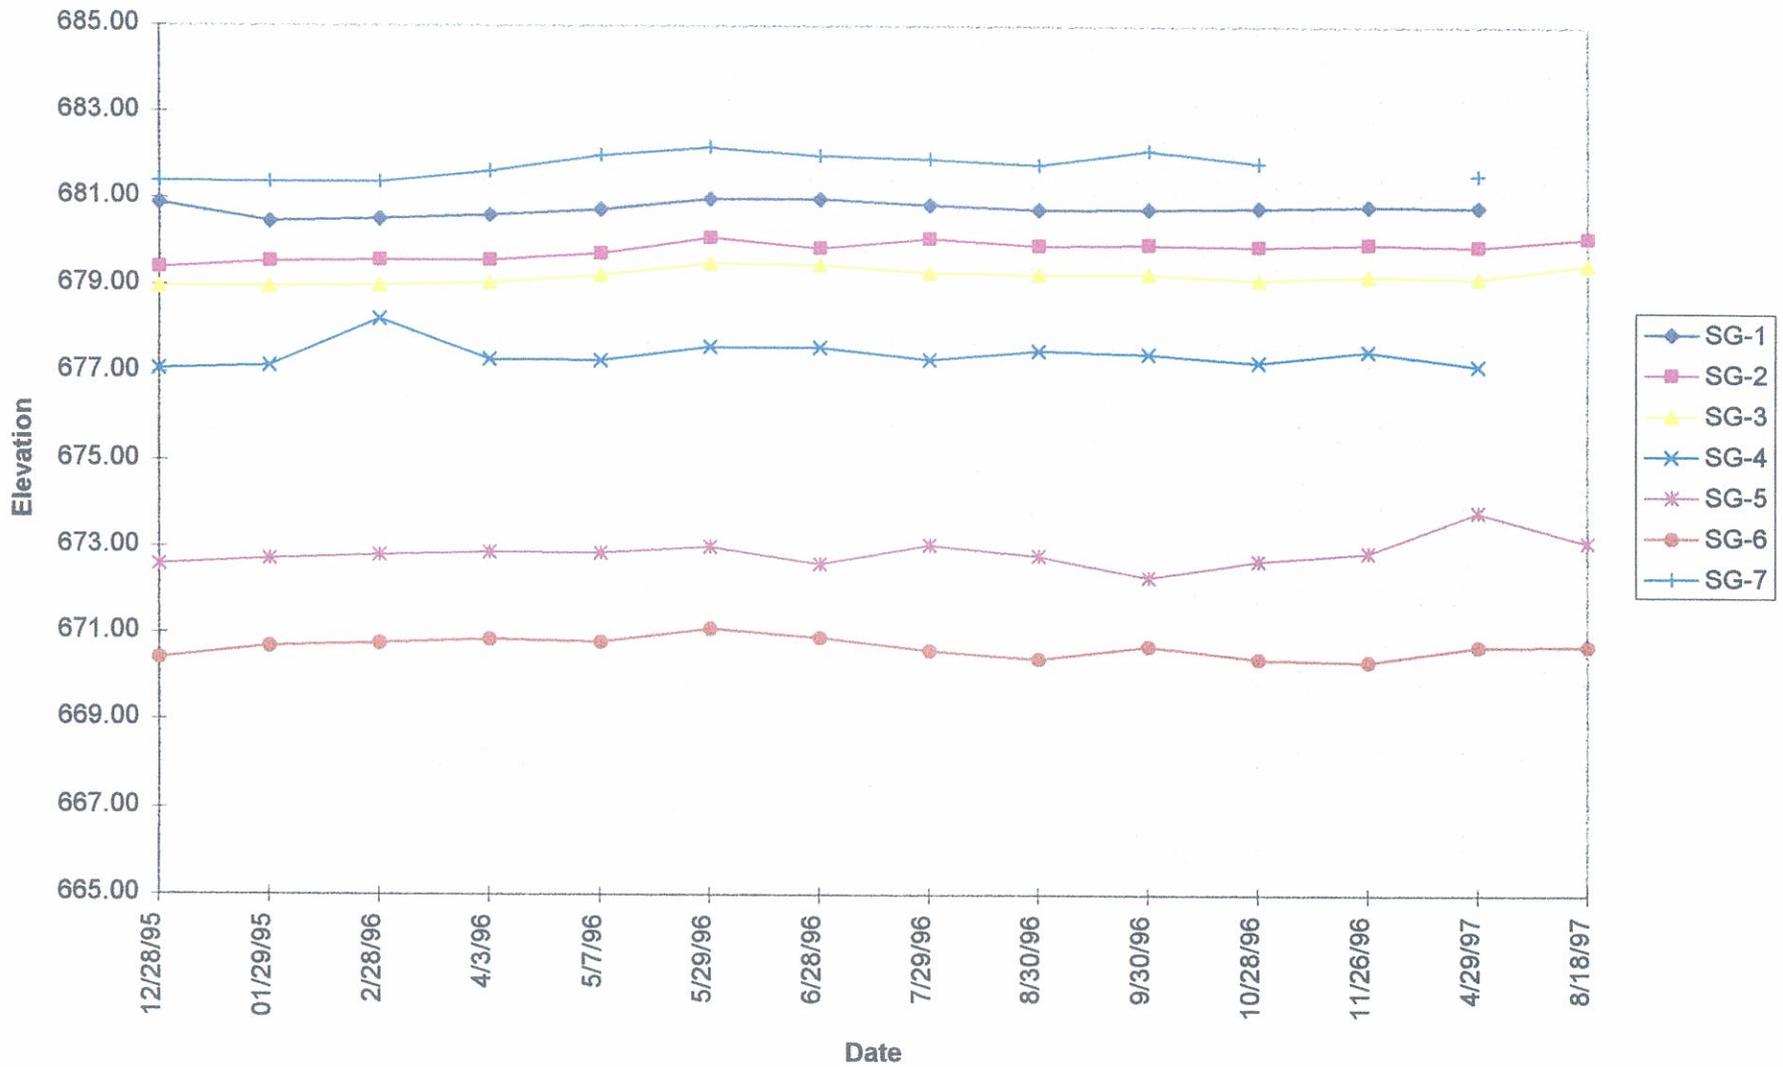
Figure 3-15. Staff gauge elevations.

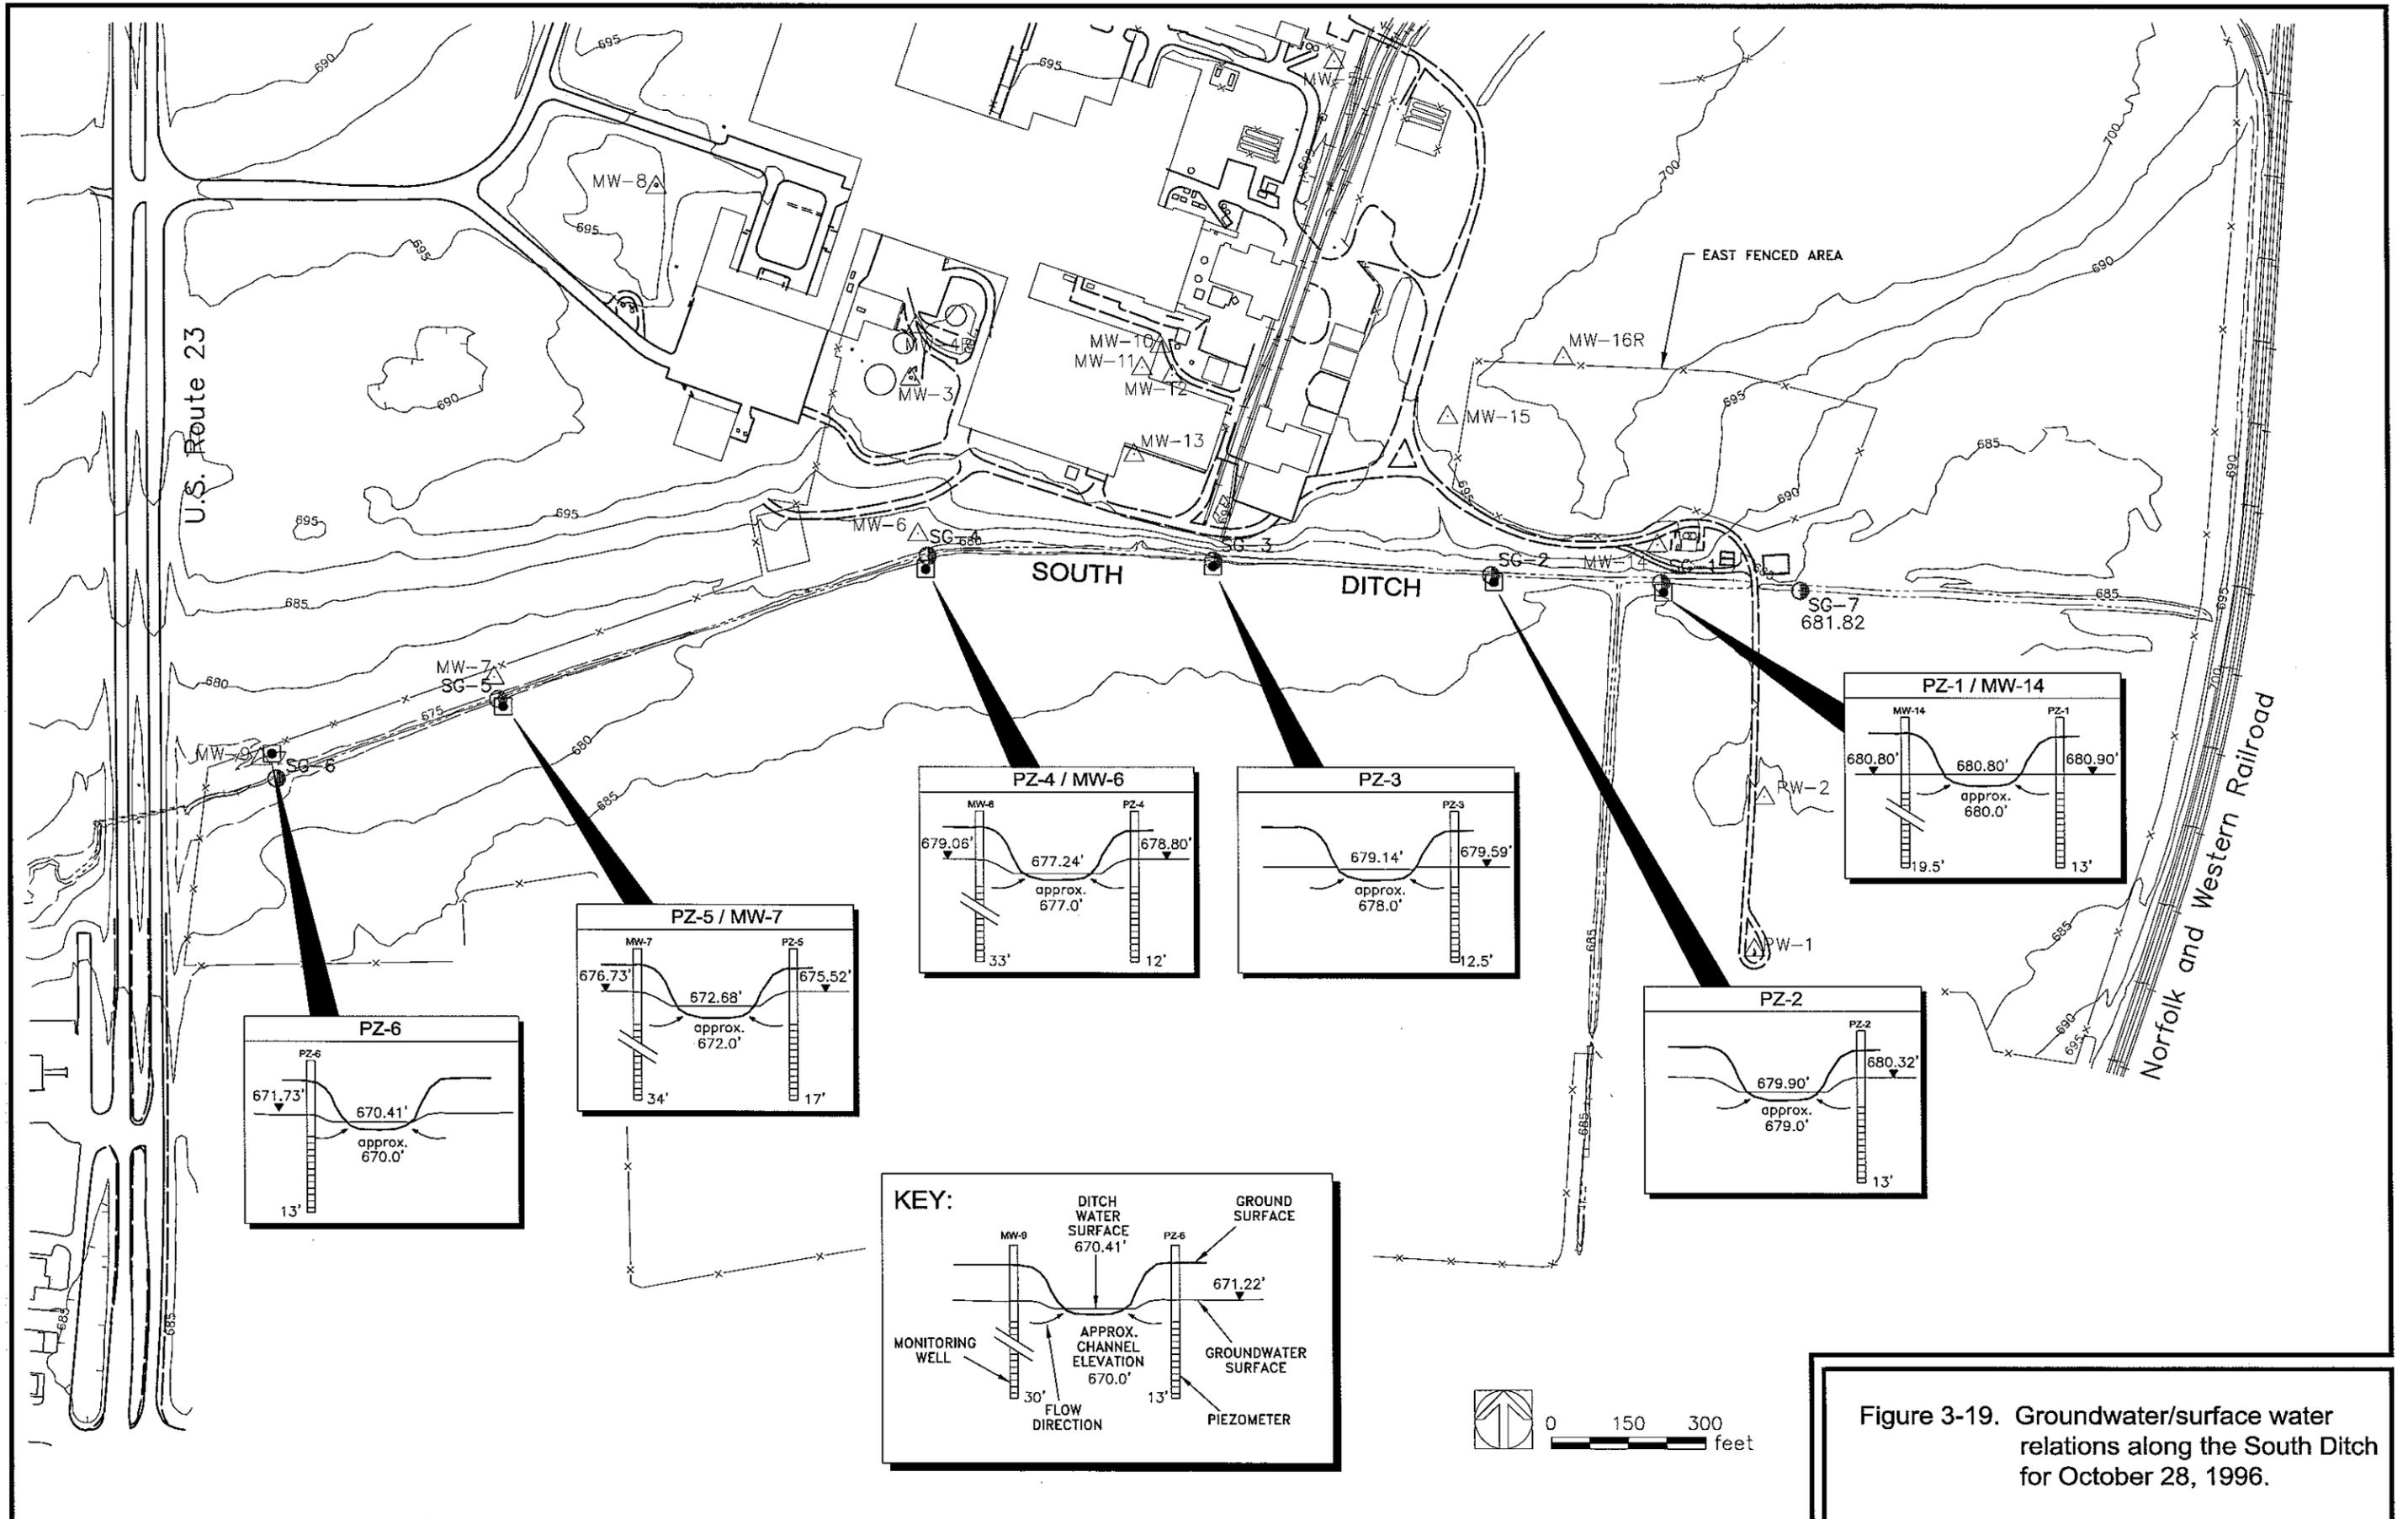
Figure 3-19. Groundwater/surface water relations along the South Ditch for October 28, 1996.

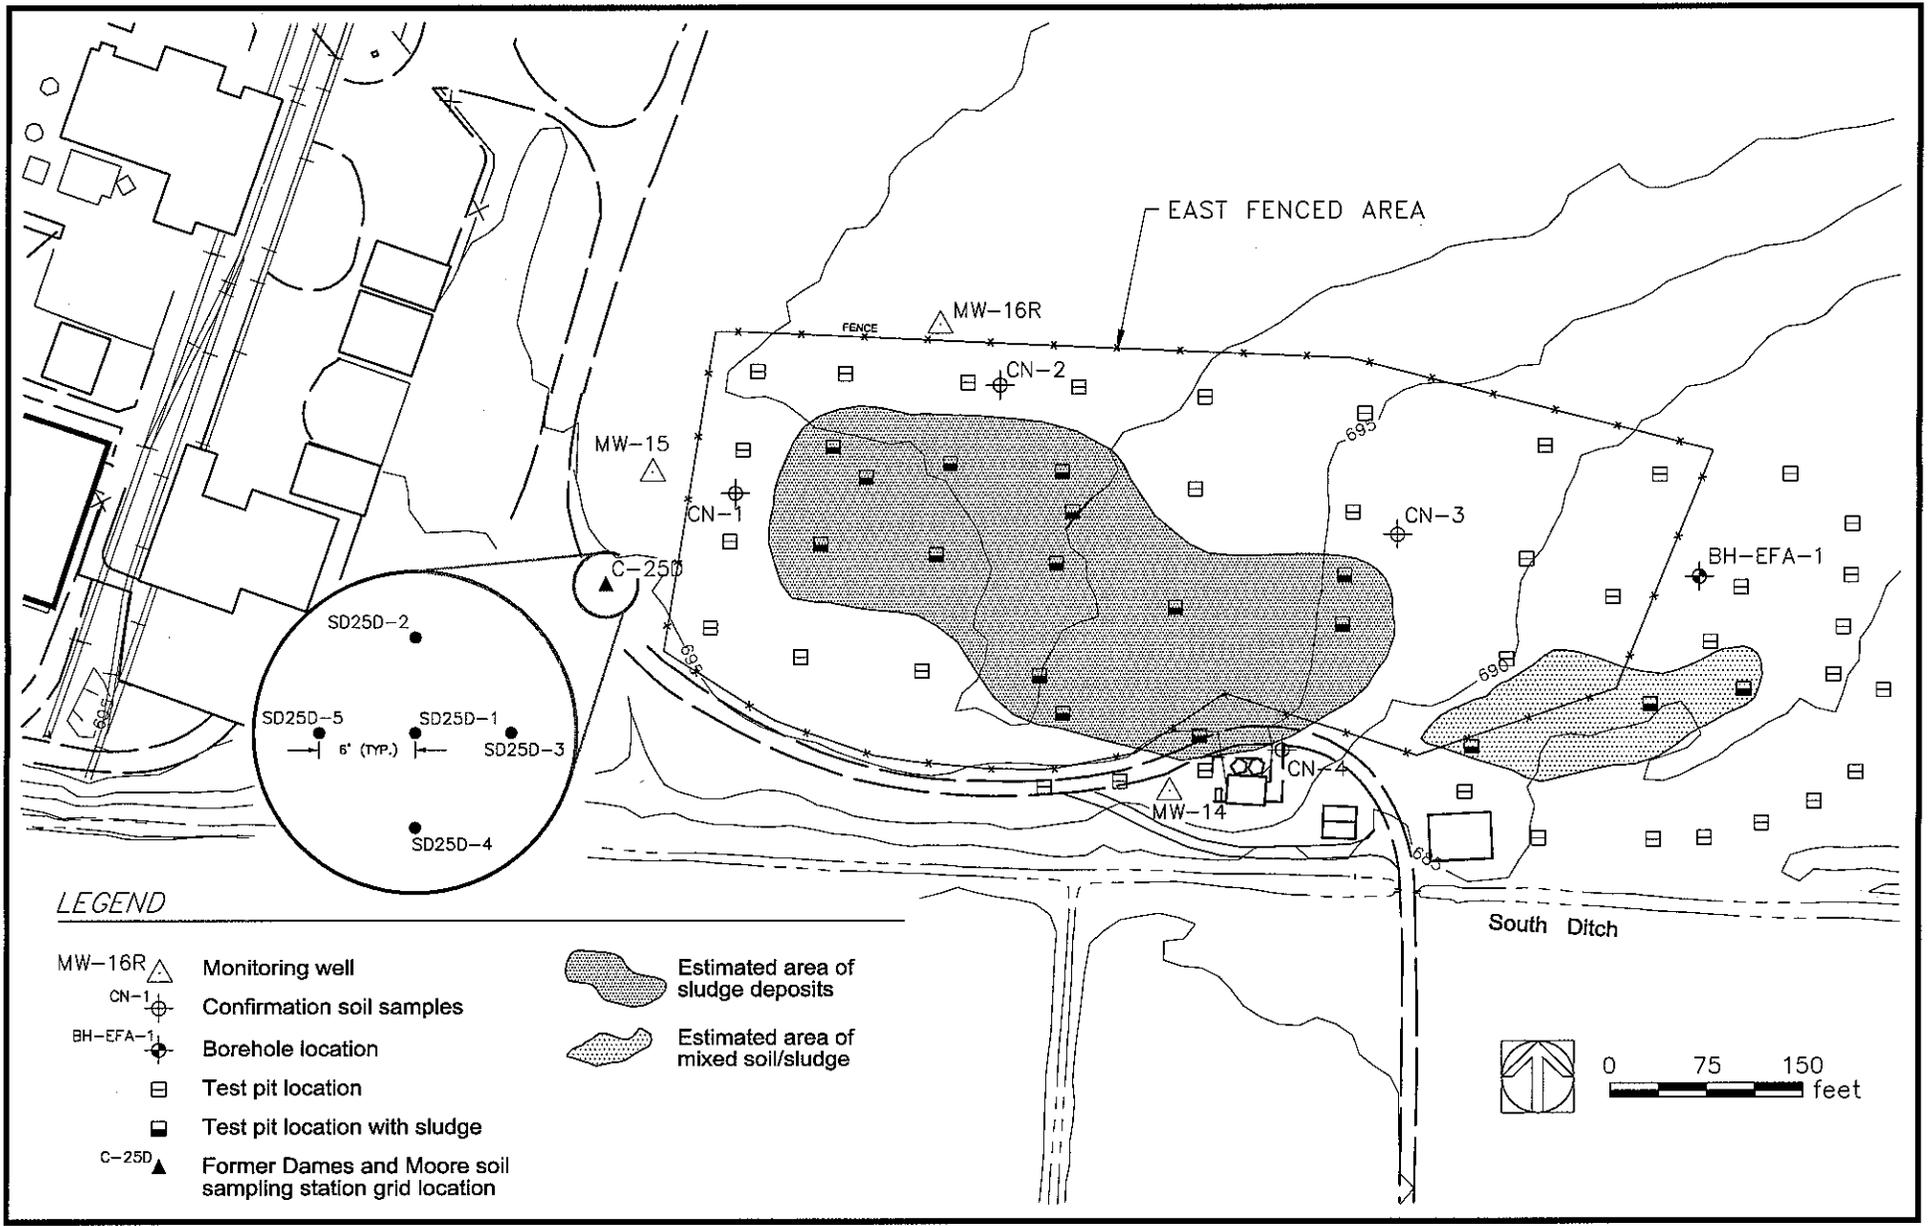
Figure 4-1. Extent of sludge at the East Fenced Area.

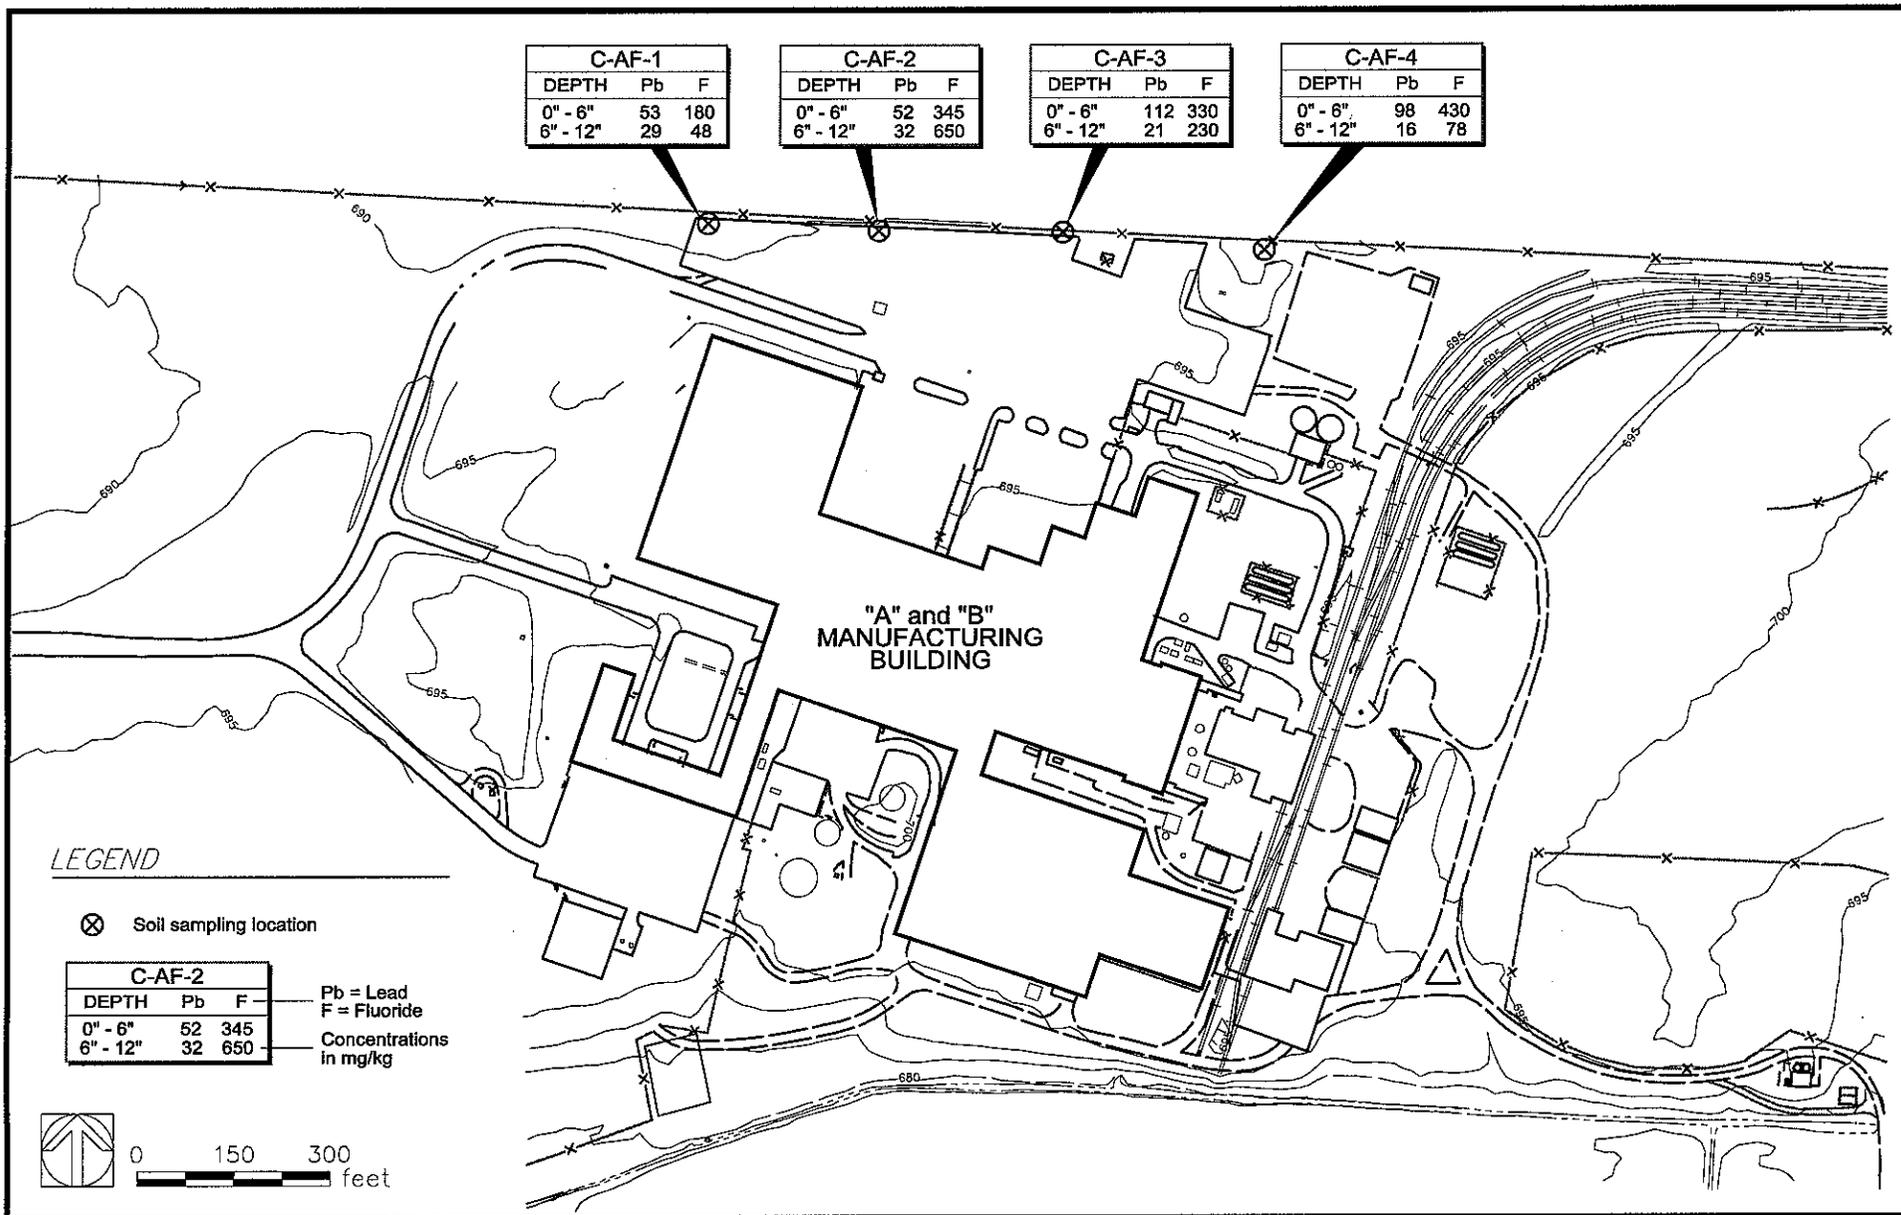
Figure 4-2. Adjacent Fields soil sampling locations and results.

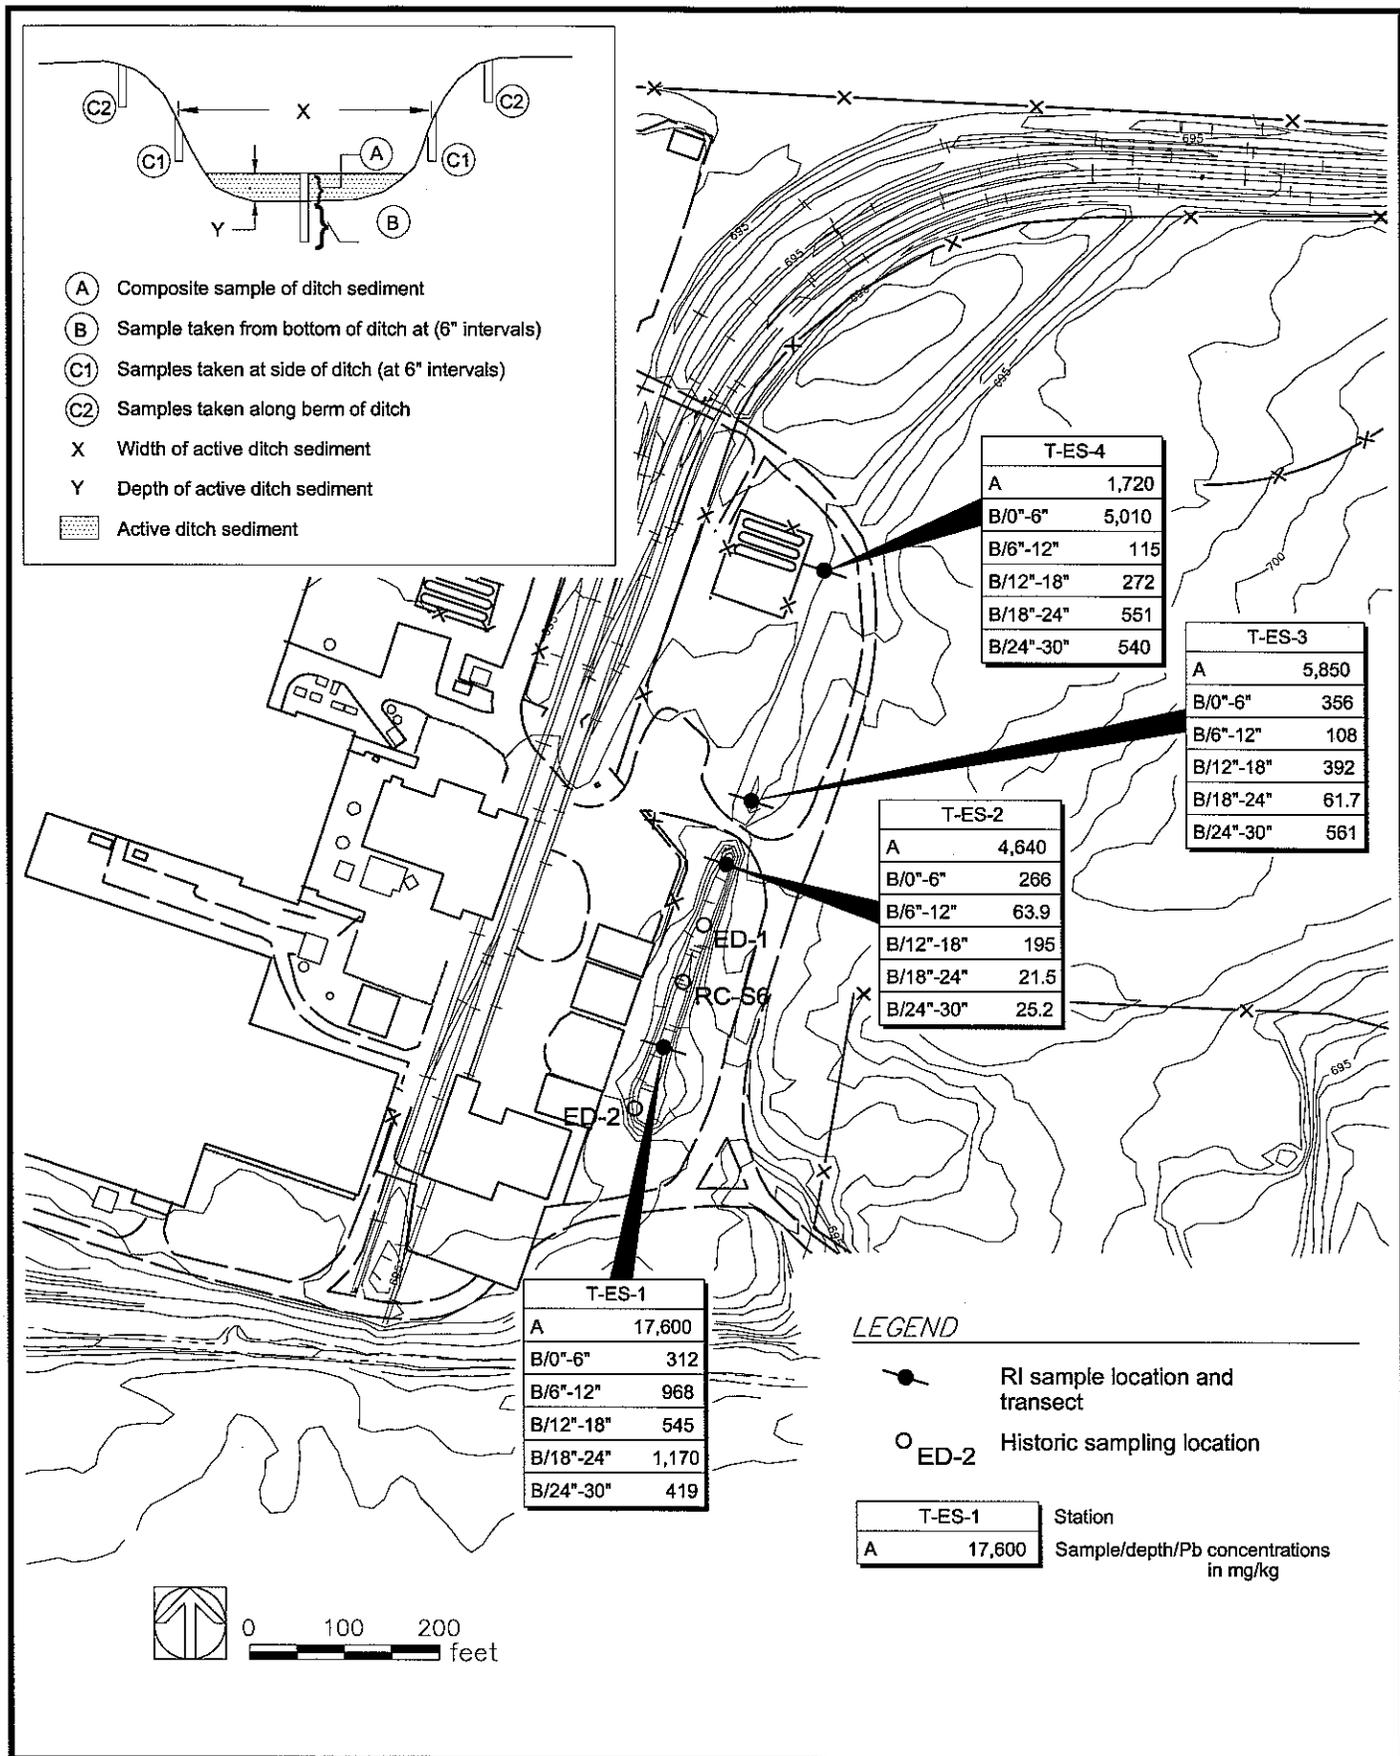
Figure 4-3. East Swale sampling locations and remedial investigation lead concentrations along central swale.

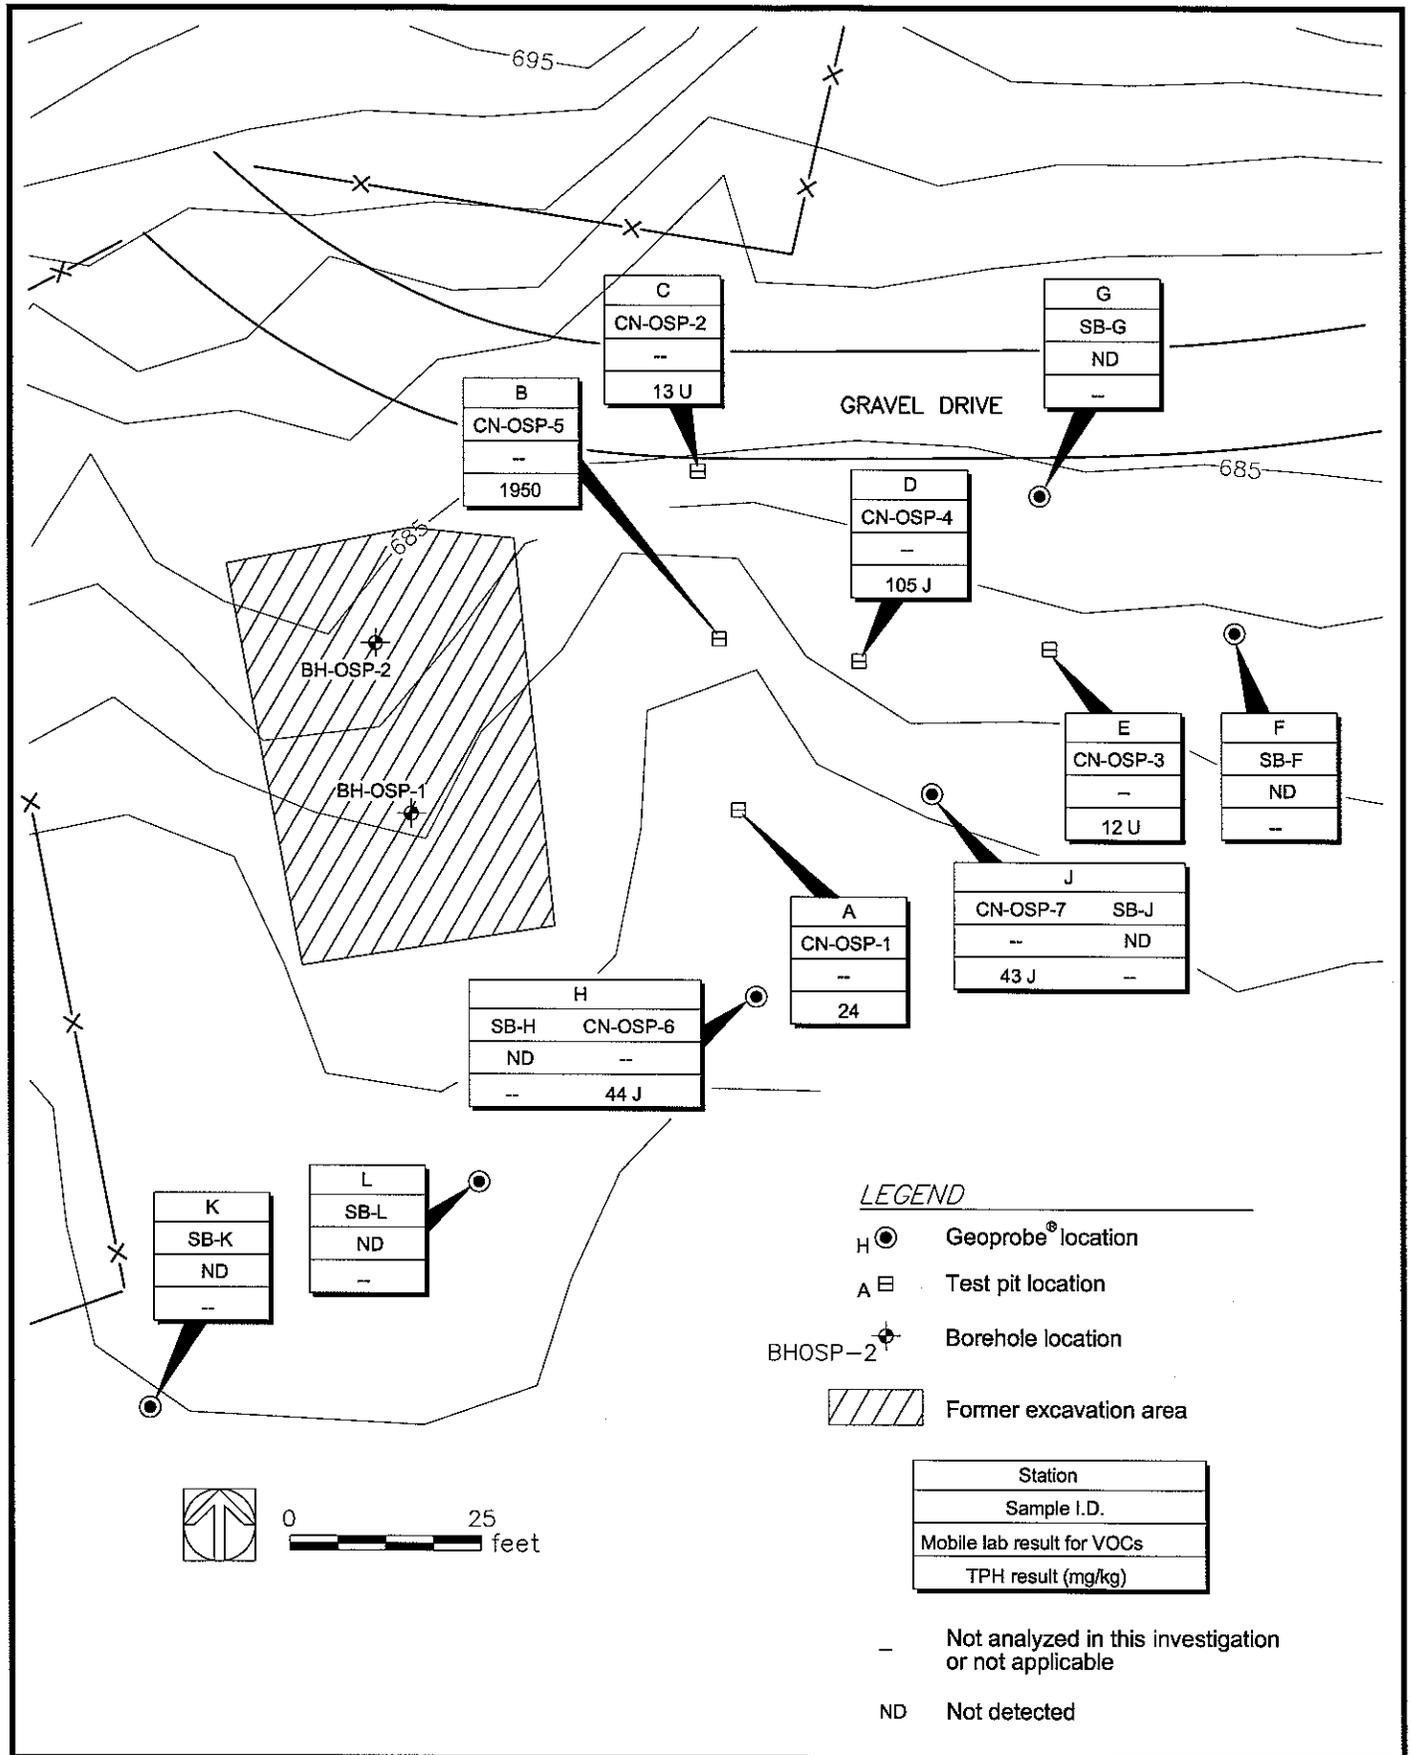
Figure 4-4. Borehole sampling locations and selected results for test pit/ Geoprobe sampling in the vicinity of the former Oil Skimmer Pond.

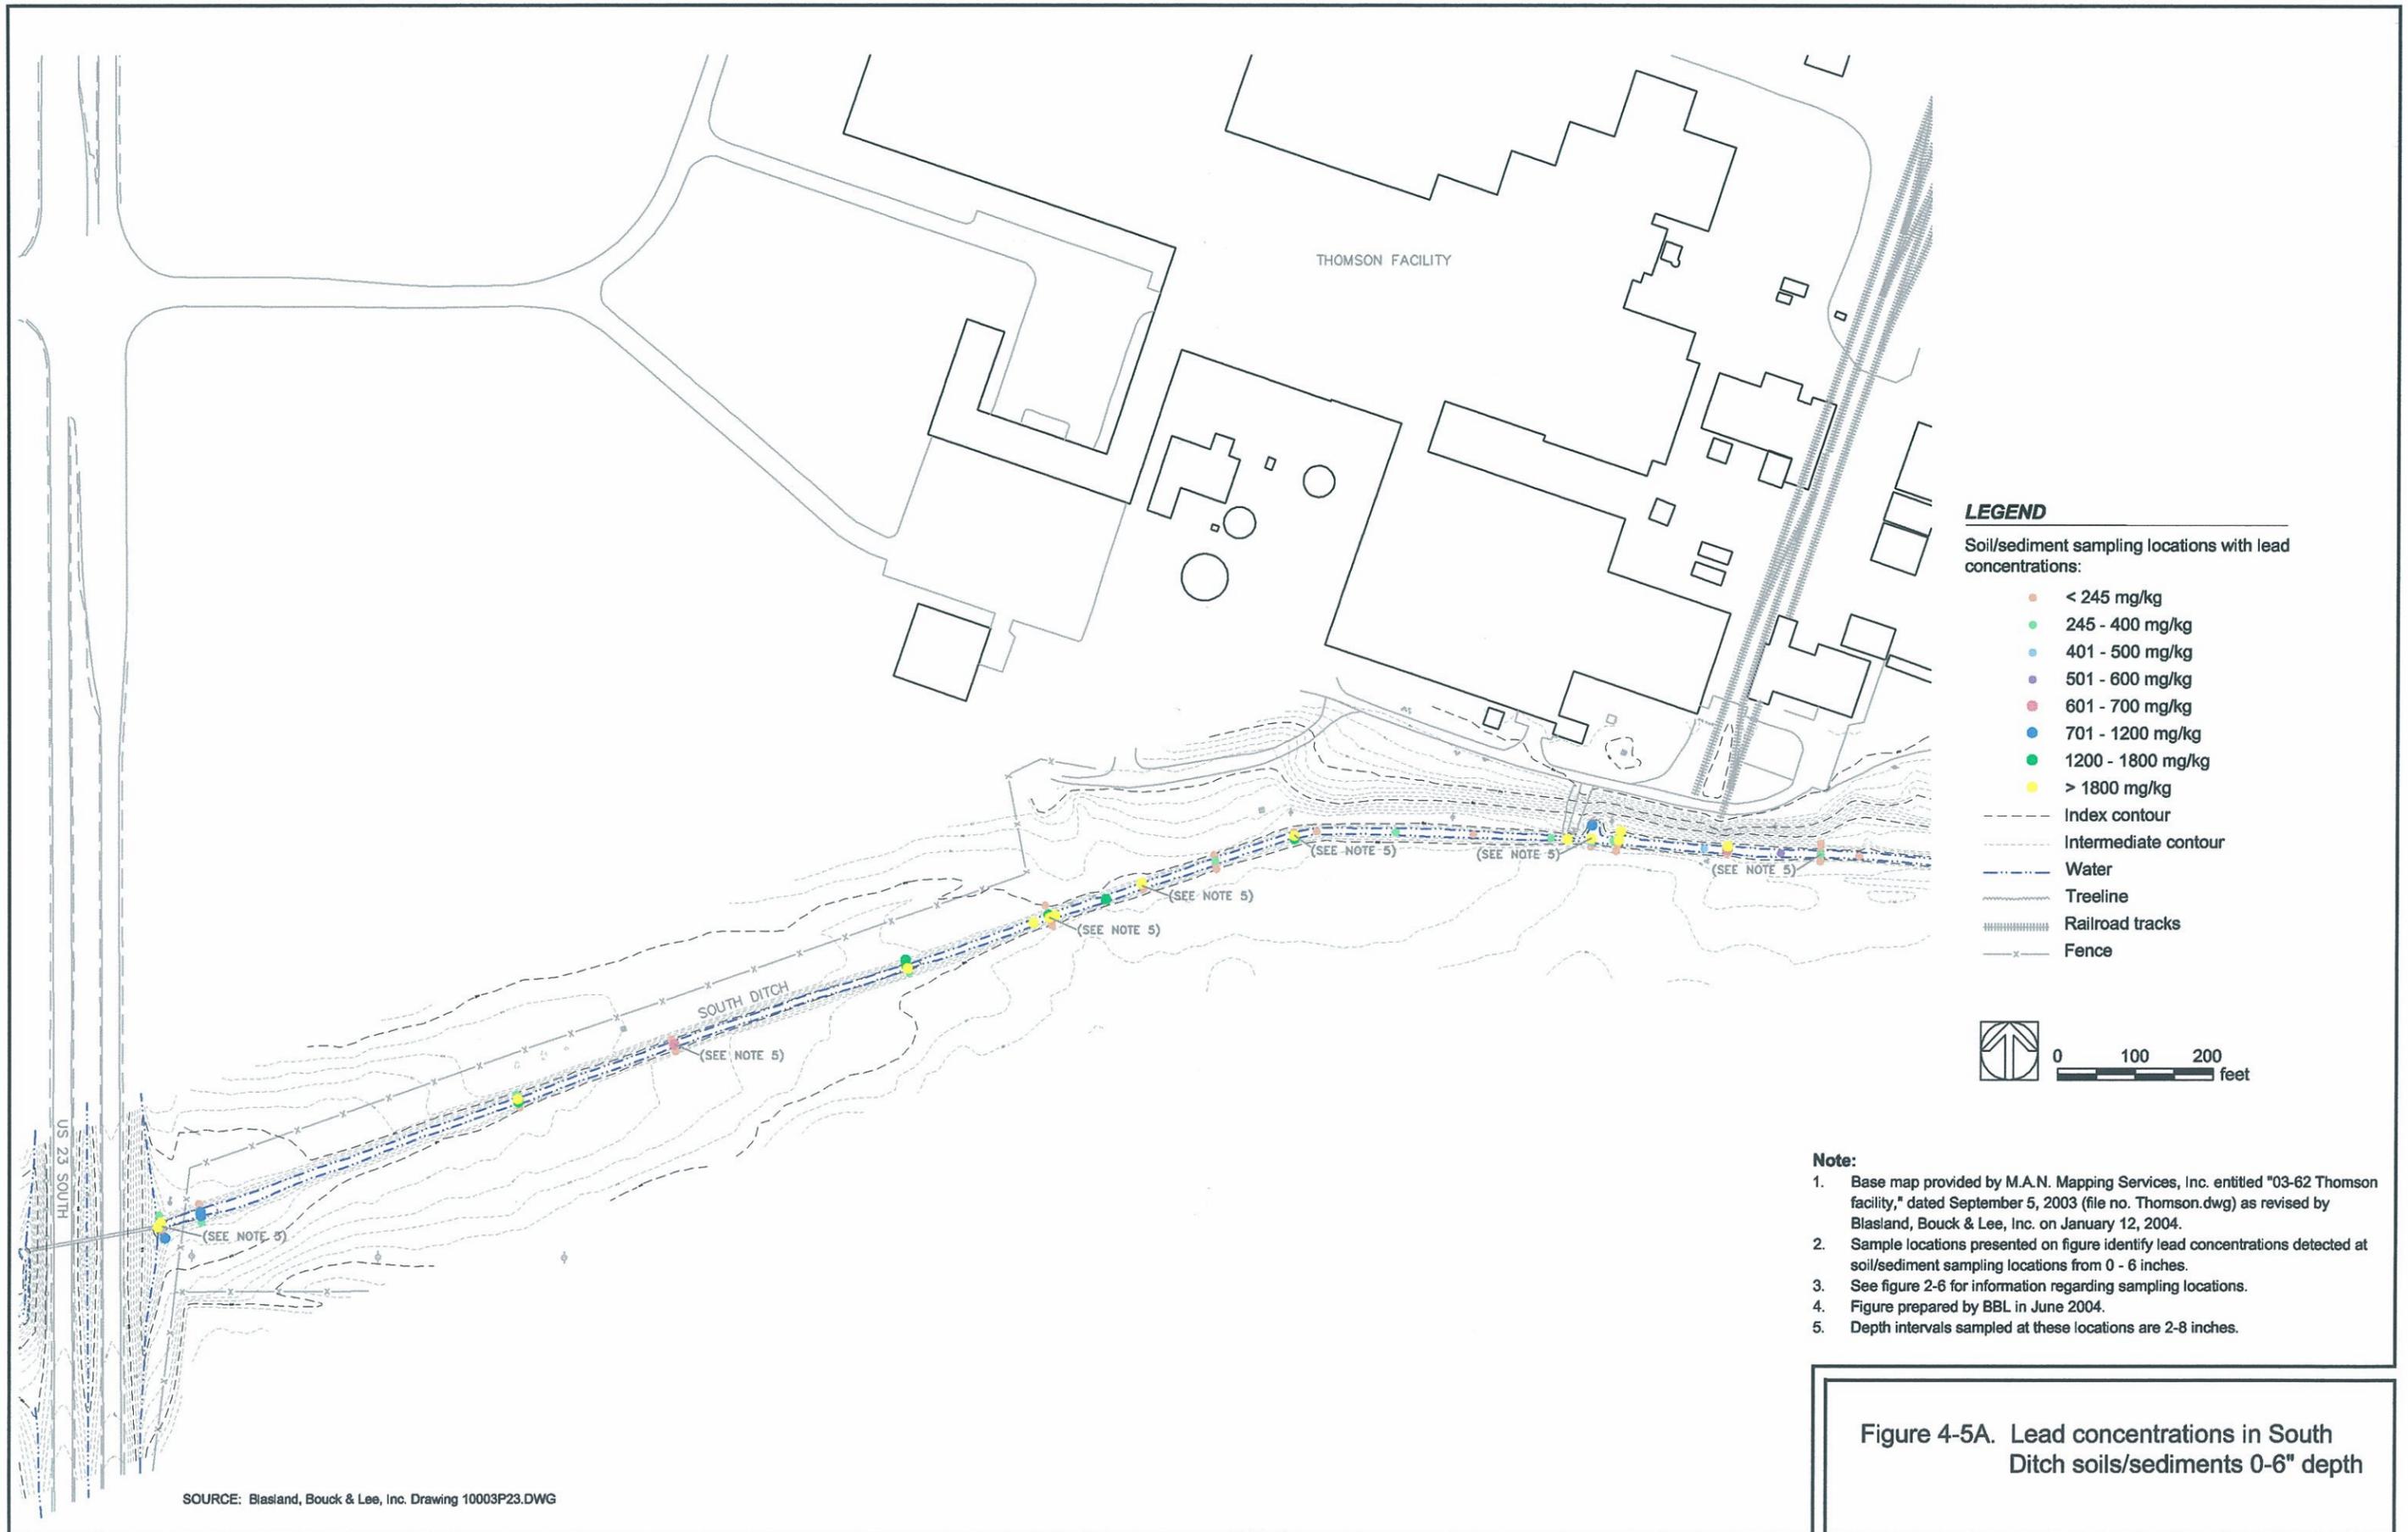
Figure 4-5A. Lead concentrations in South Ditch soils/sediments 0-6" depth
