## **Figures**

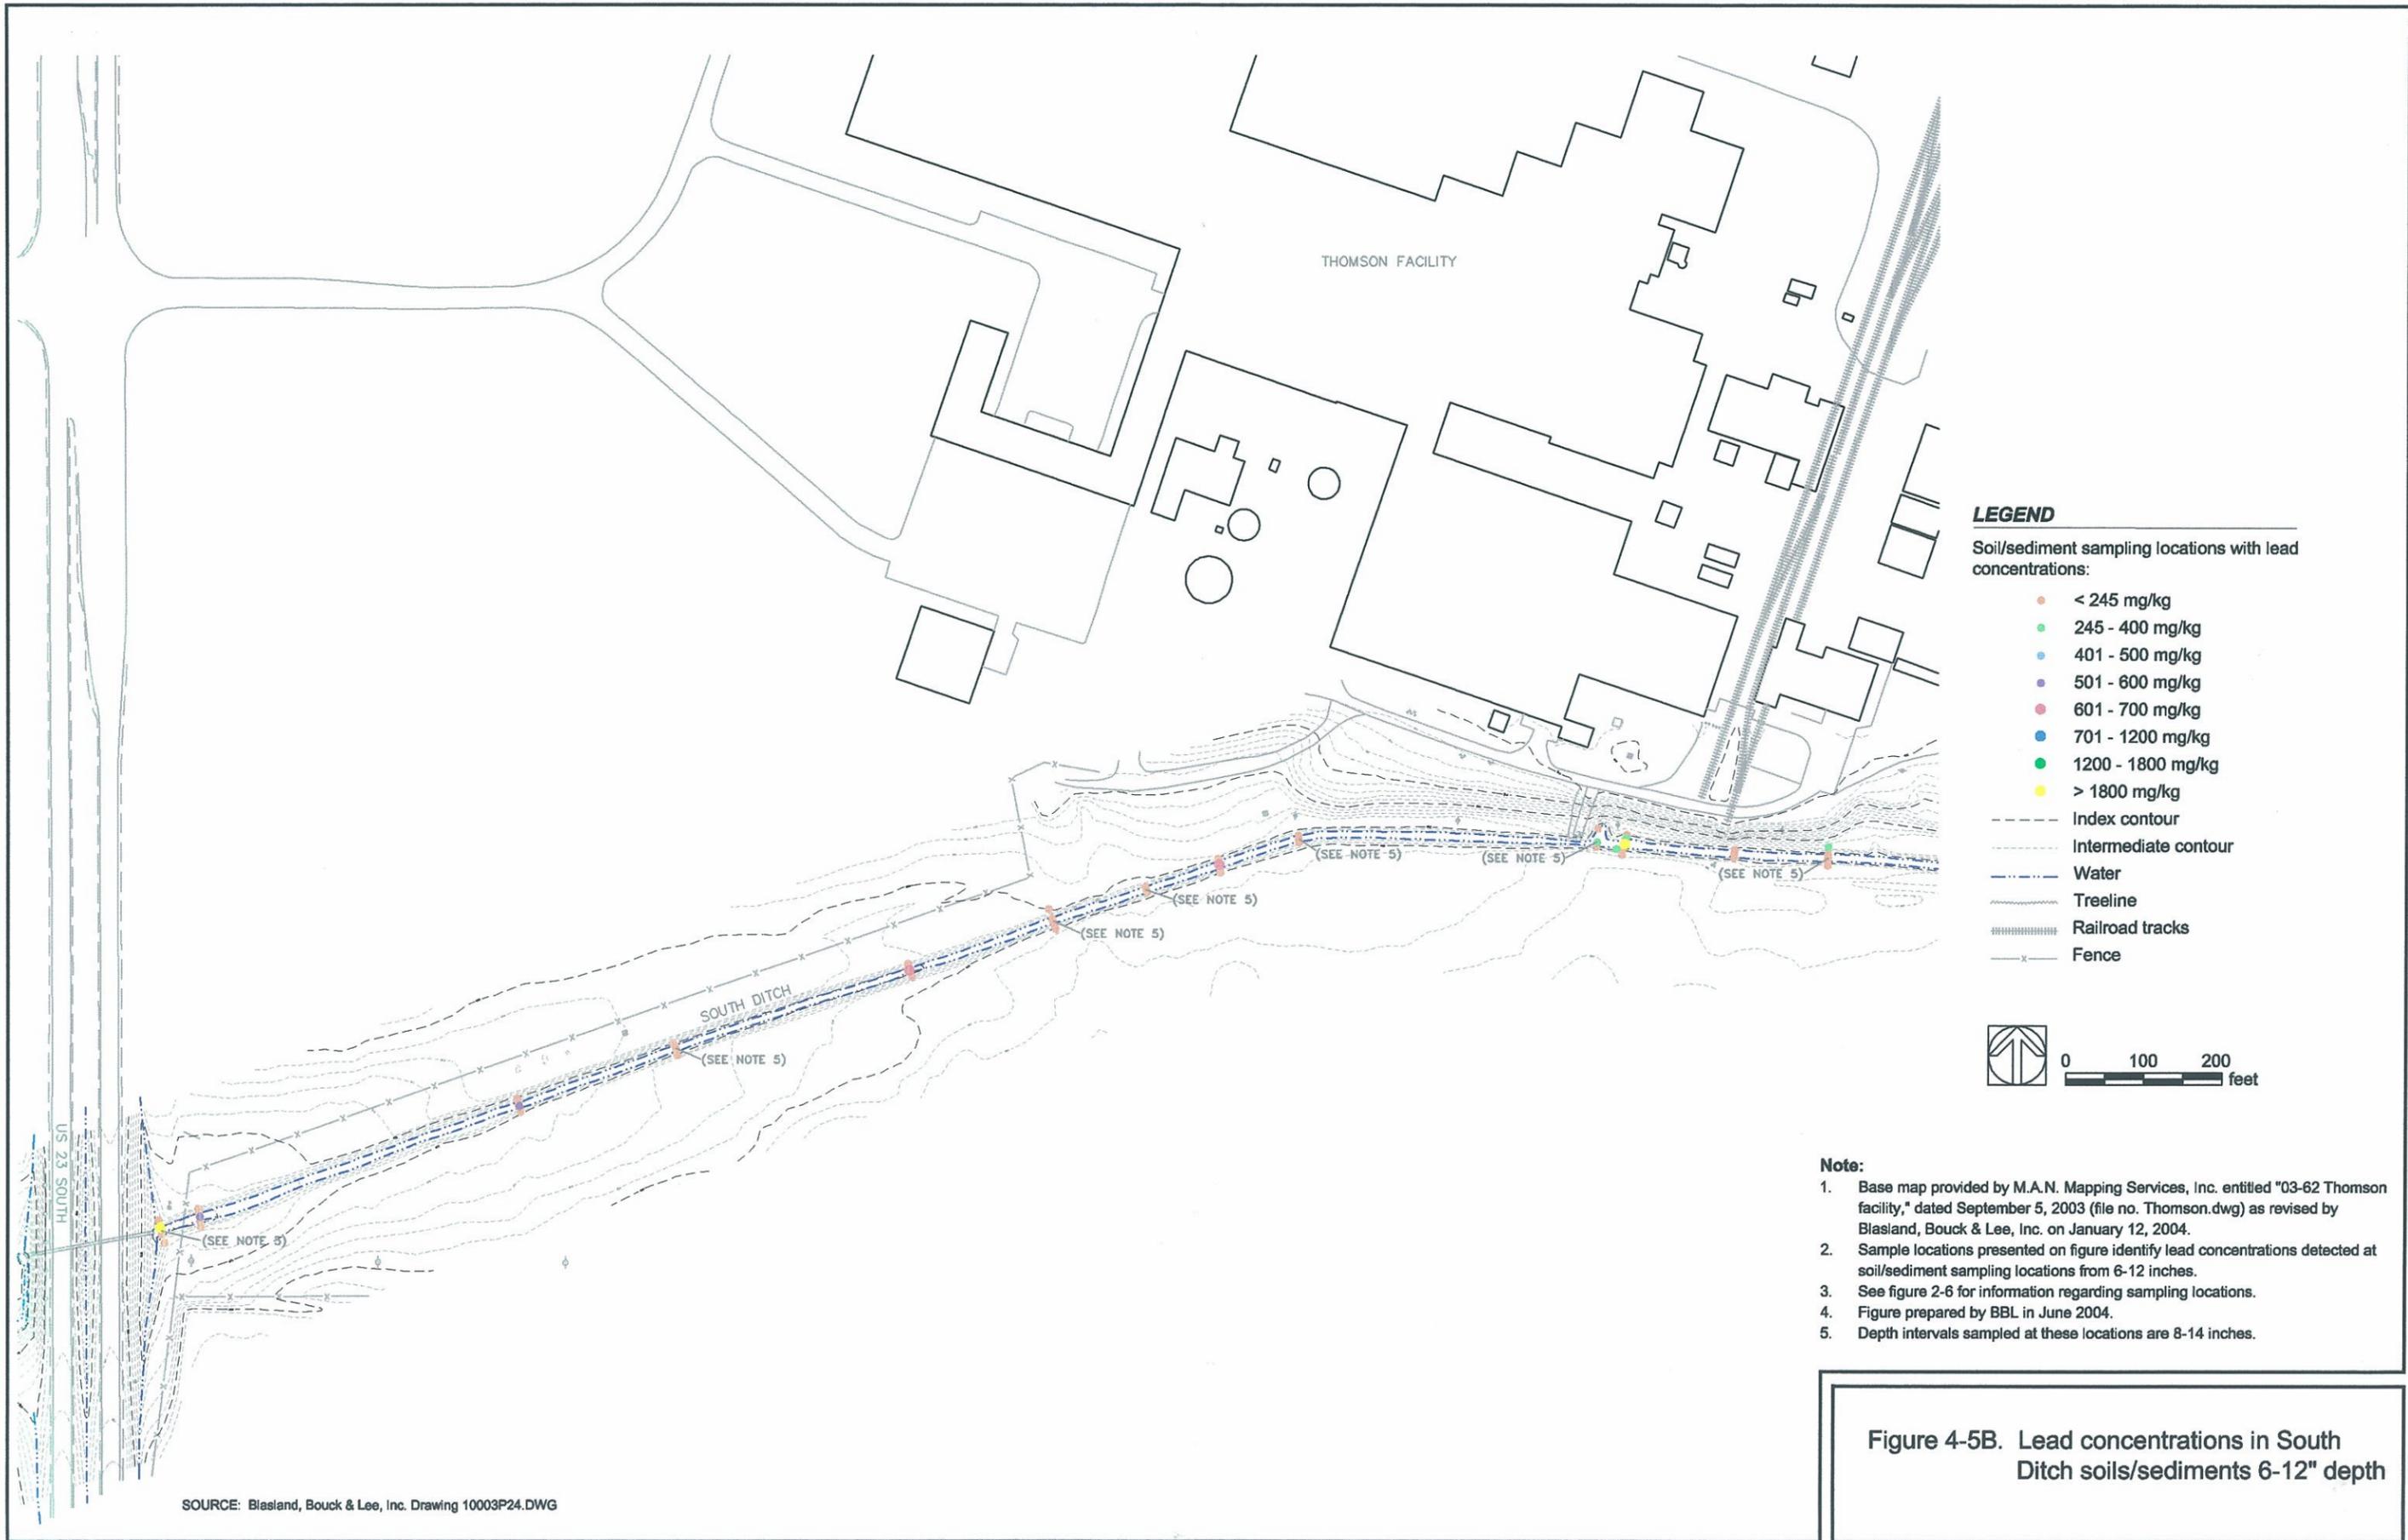
**Figure 4-5B. Lead concentrations in South Ditch soils/sediments 6-12" depth**

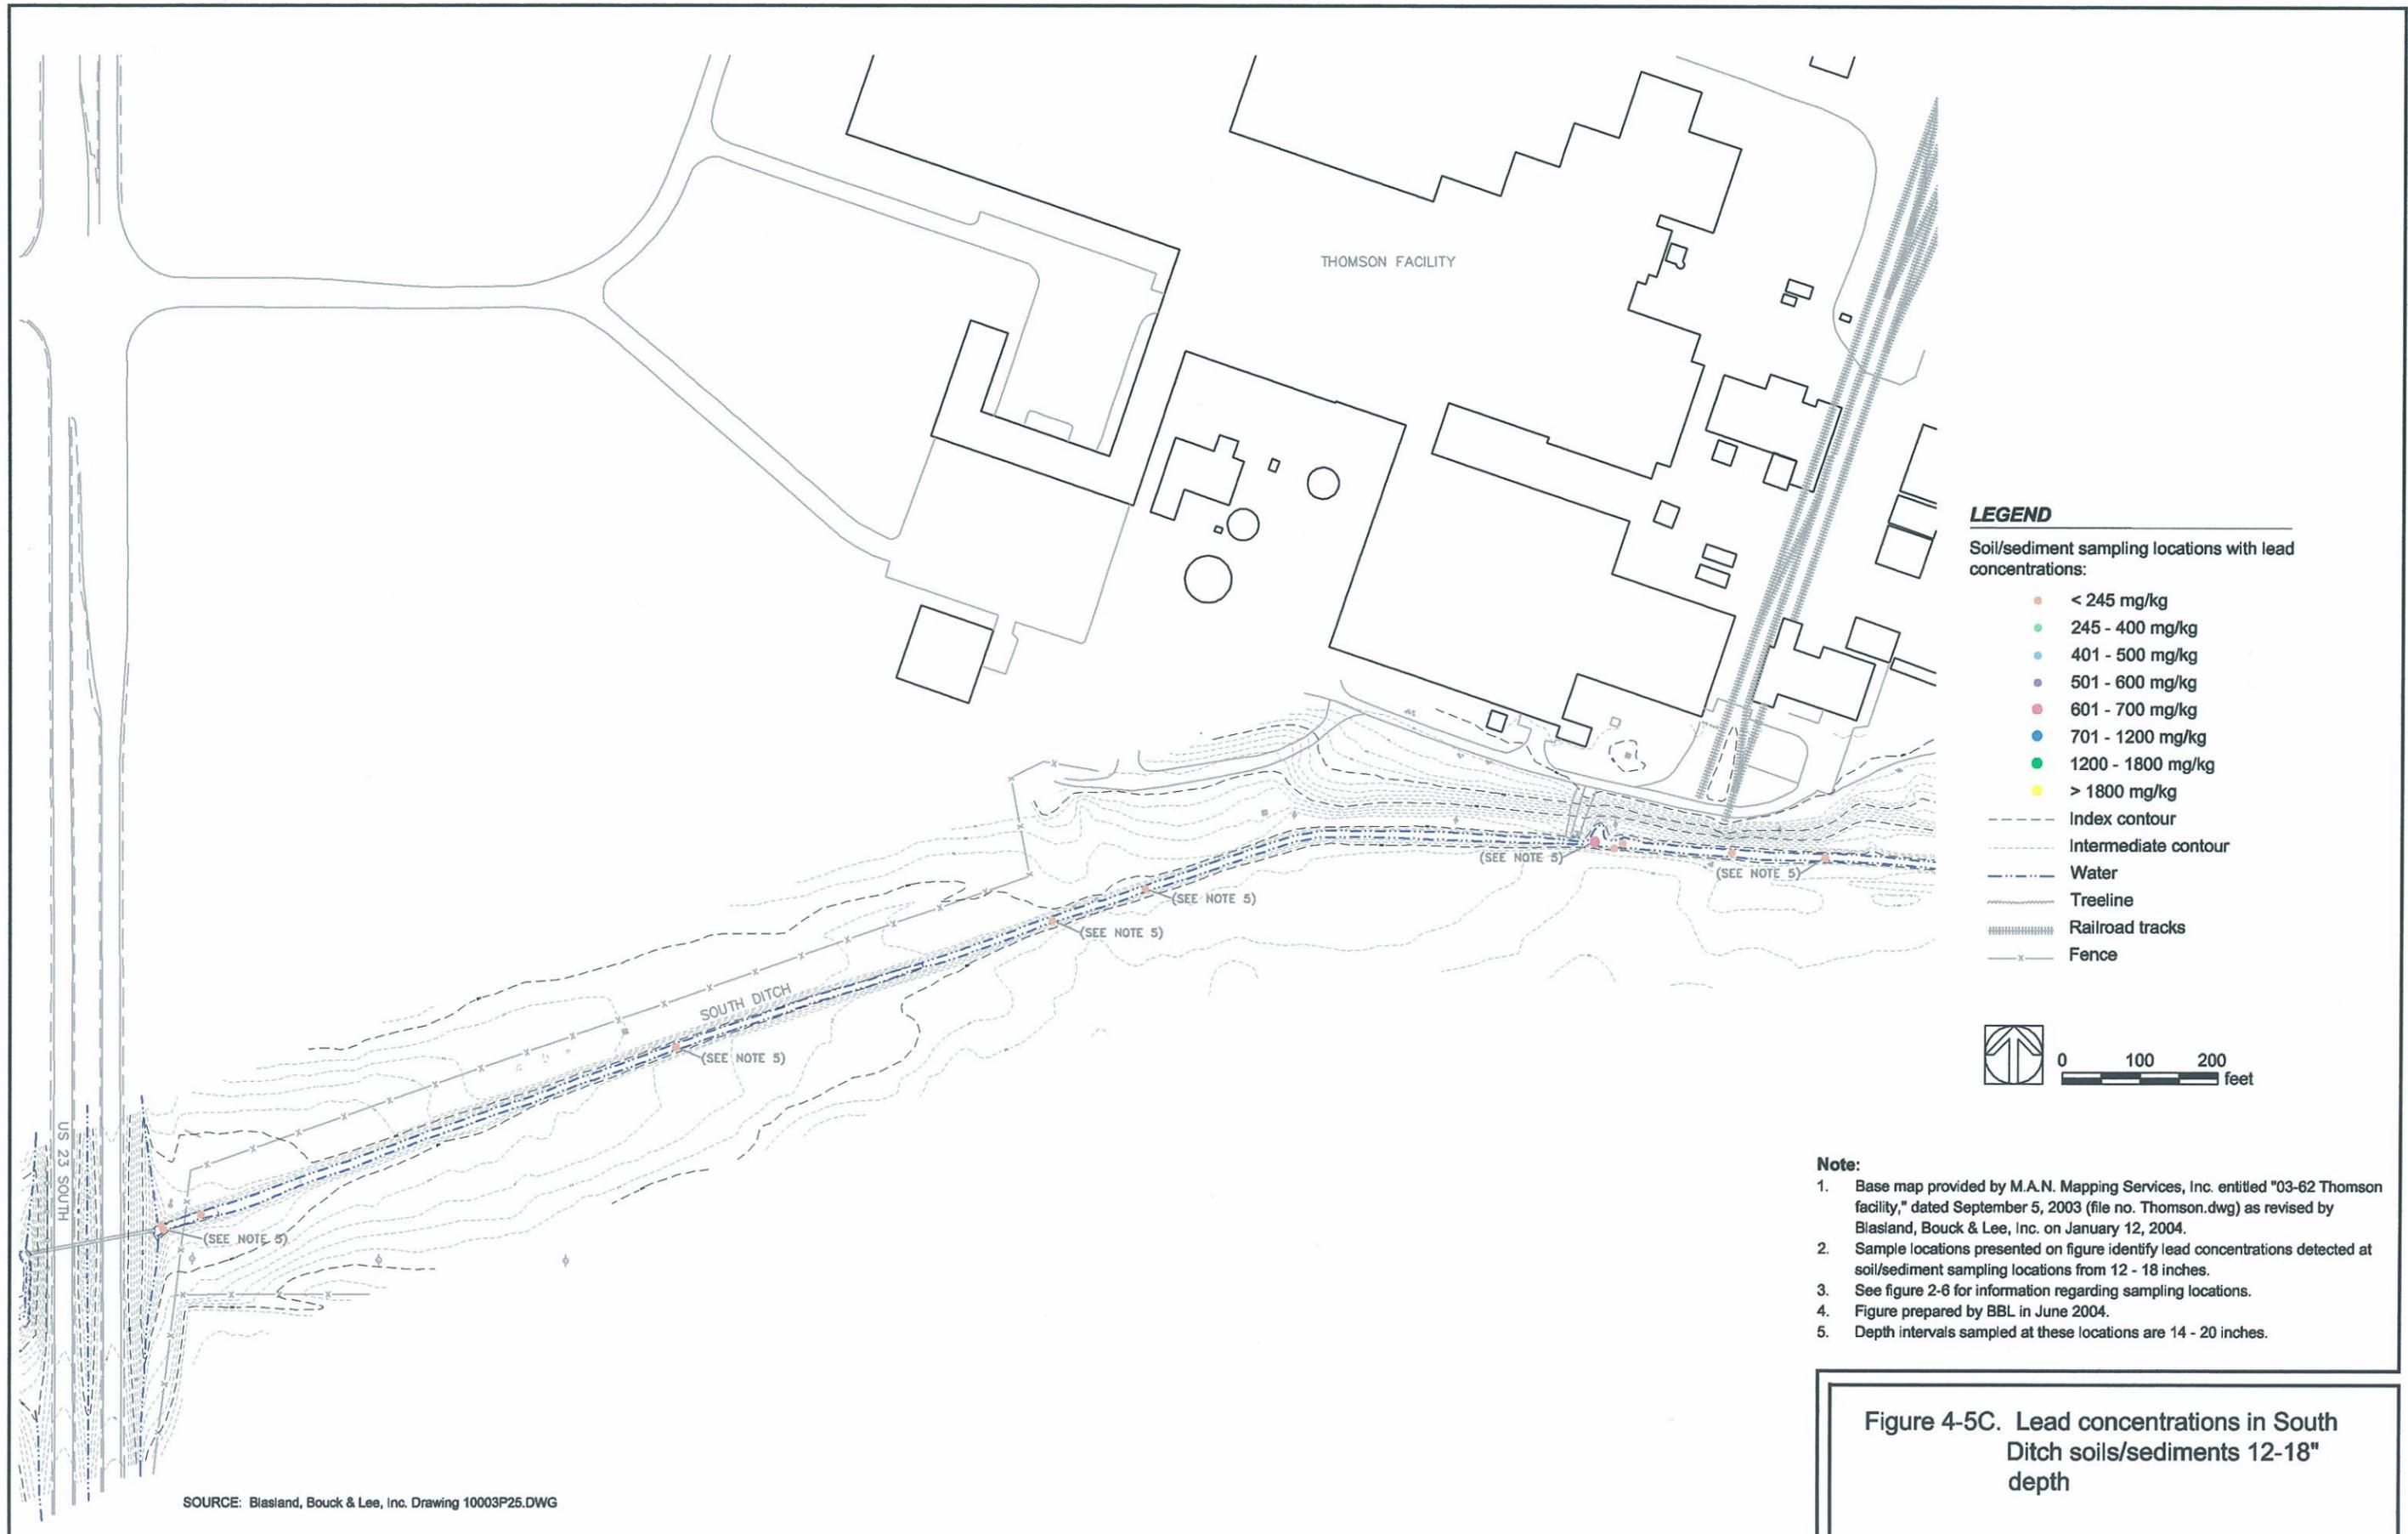
Figure 4-5C. Lead concentrations in South Ditch soils/sediments 12-18" depth

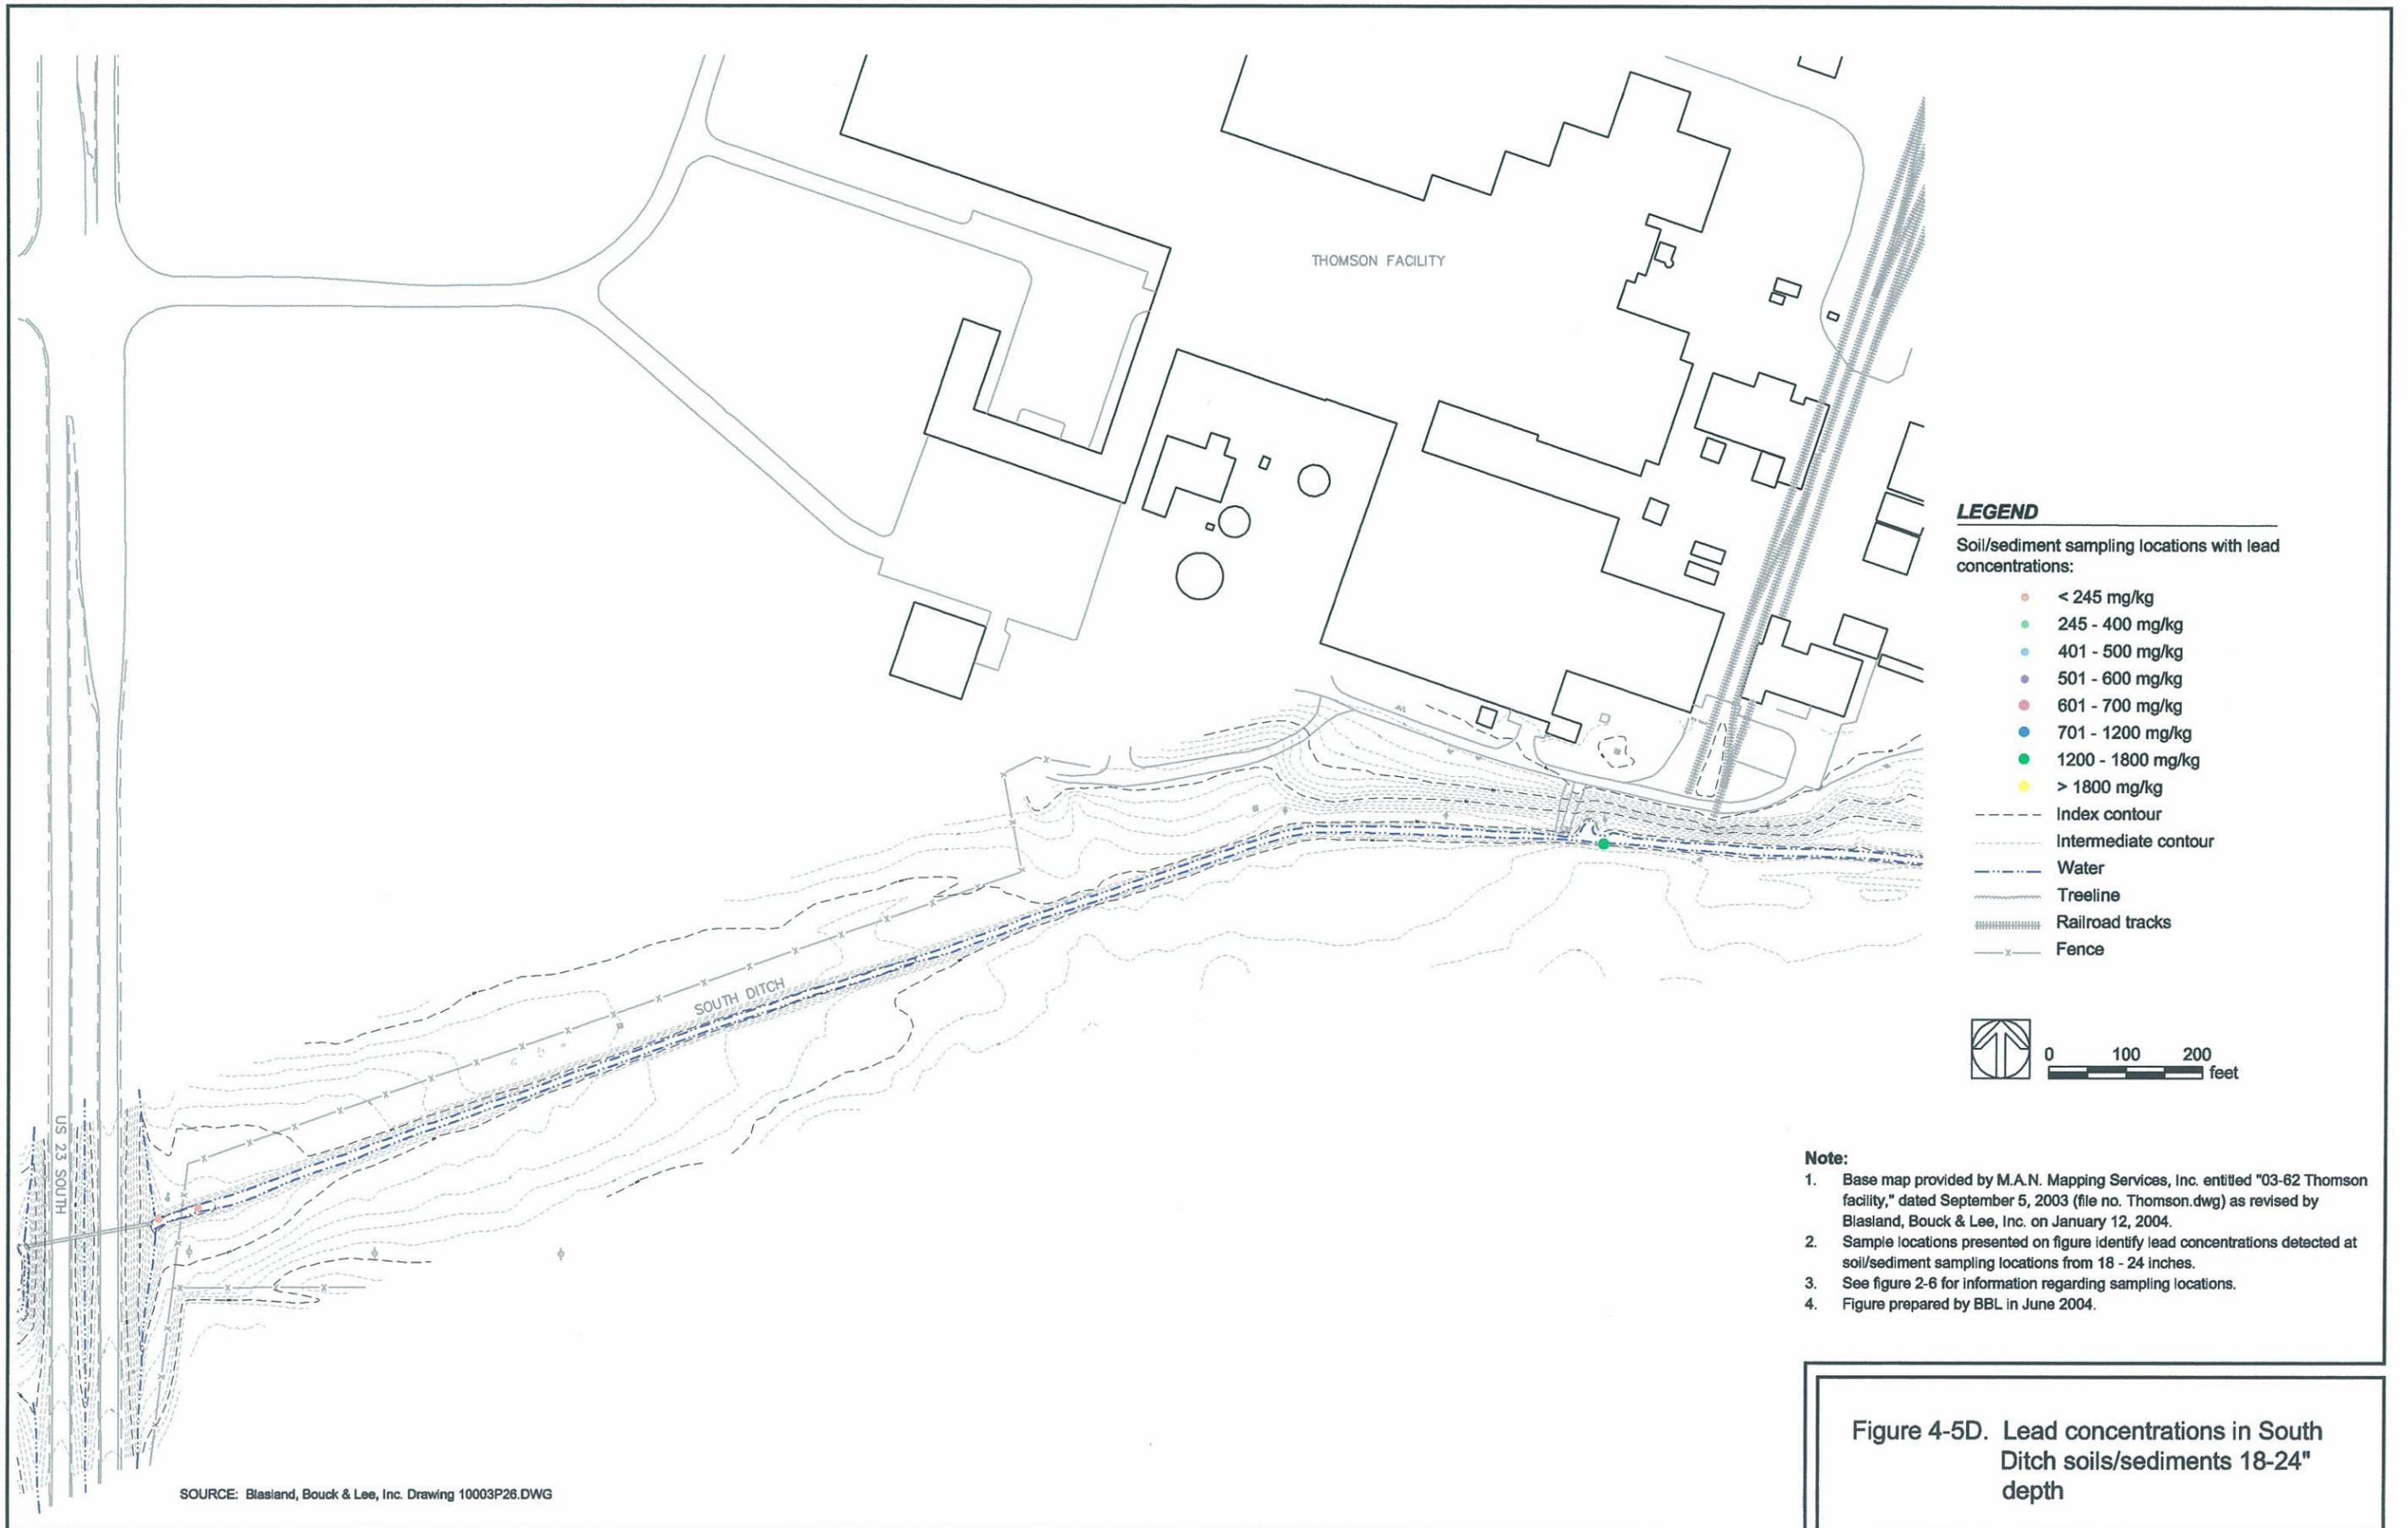
Figure 4-5D. Lead concentrations in South Ditch soils/sediments 18-24" depth

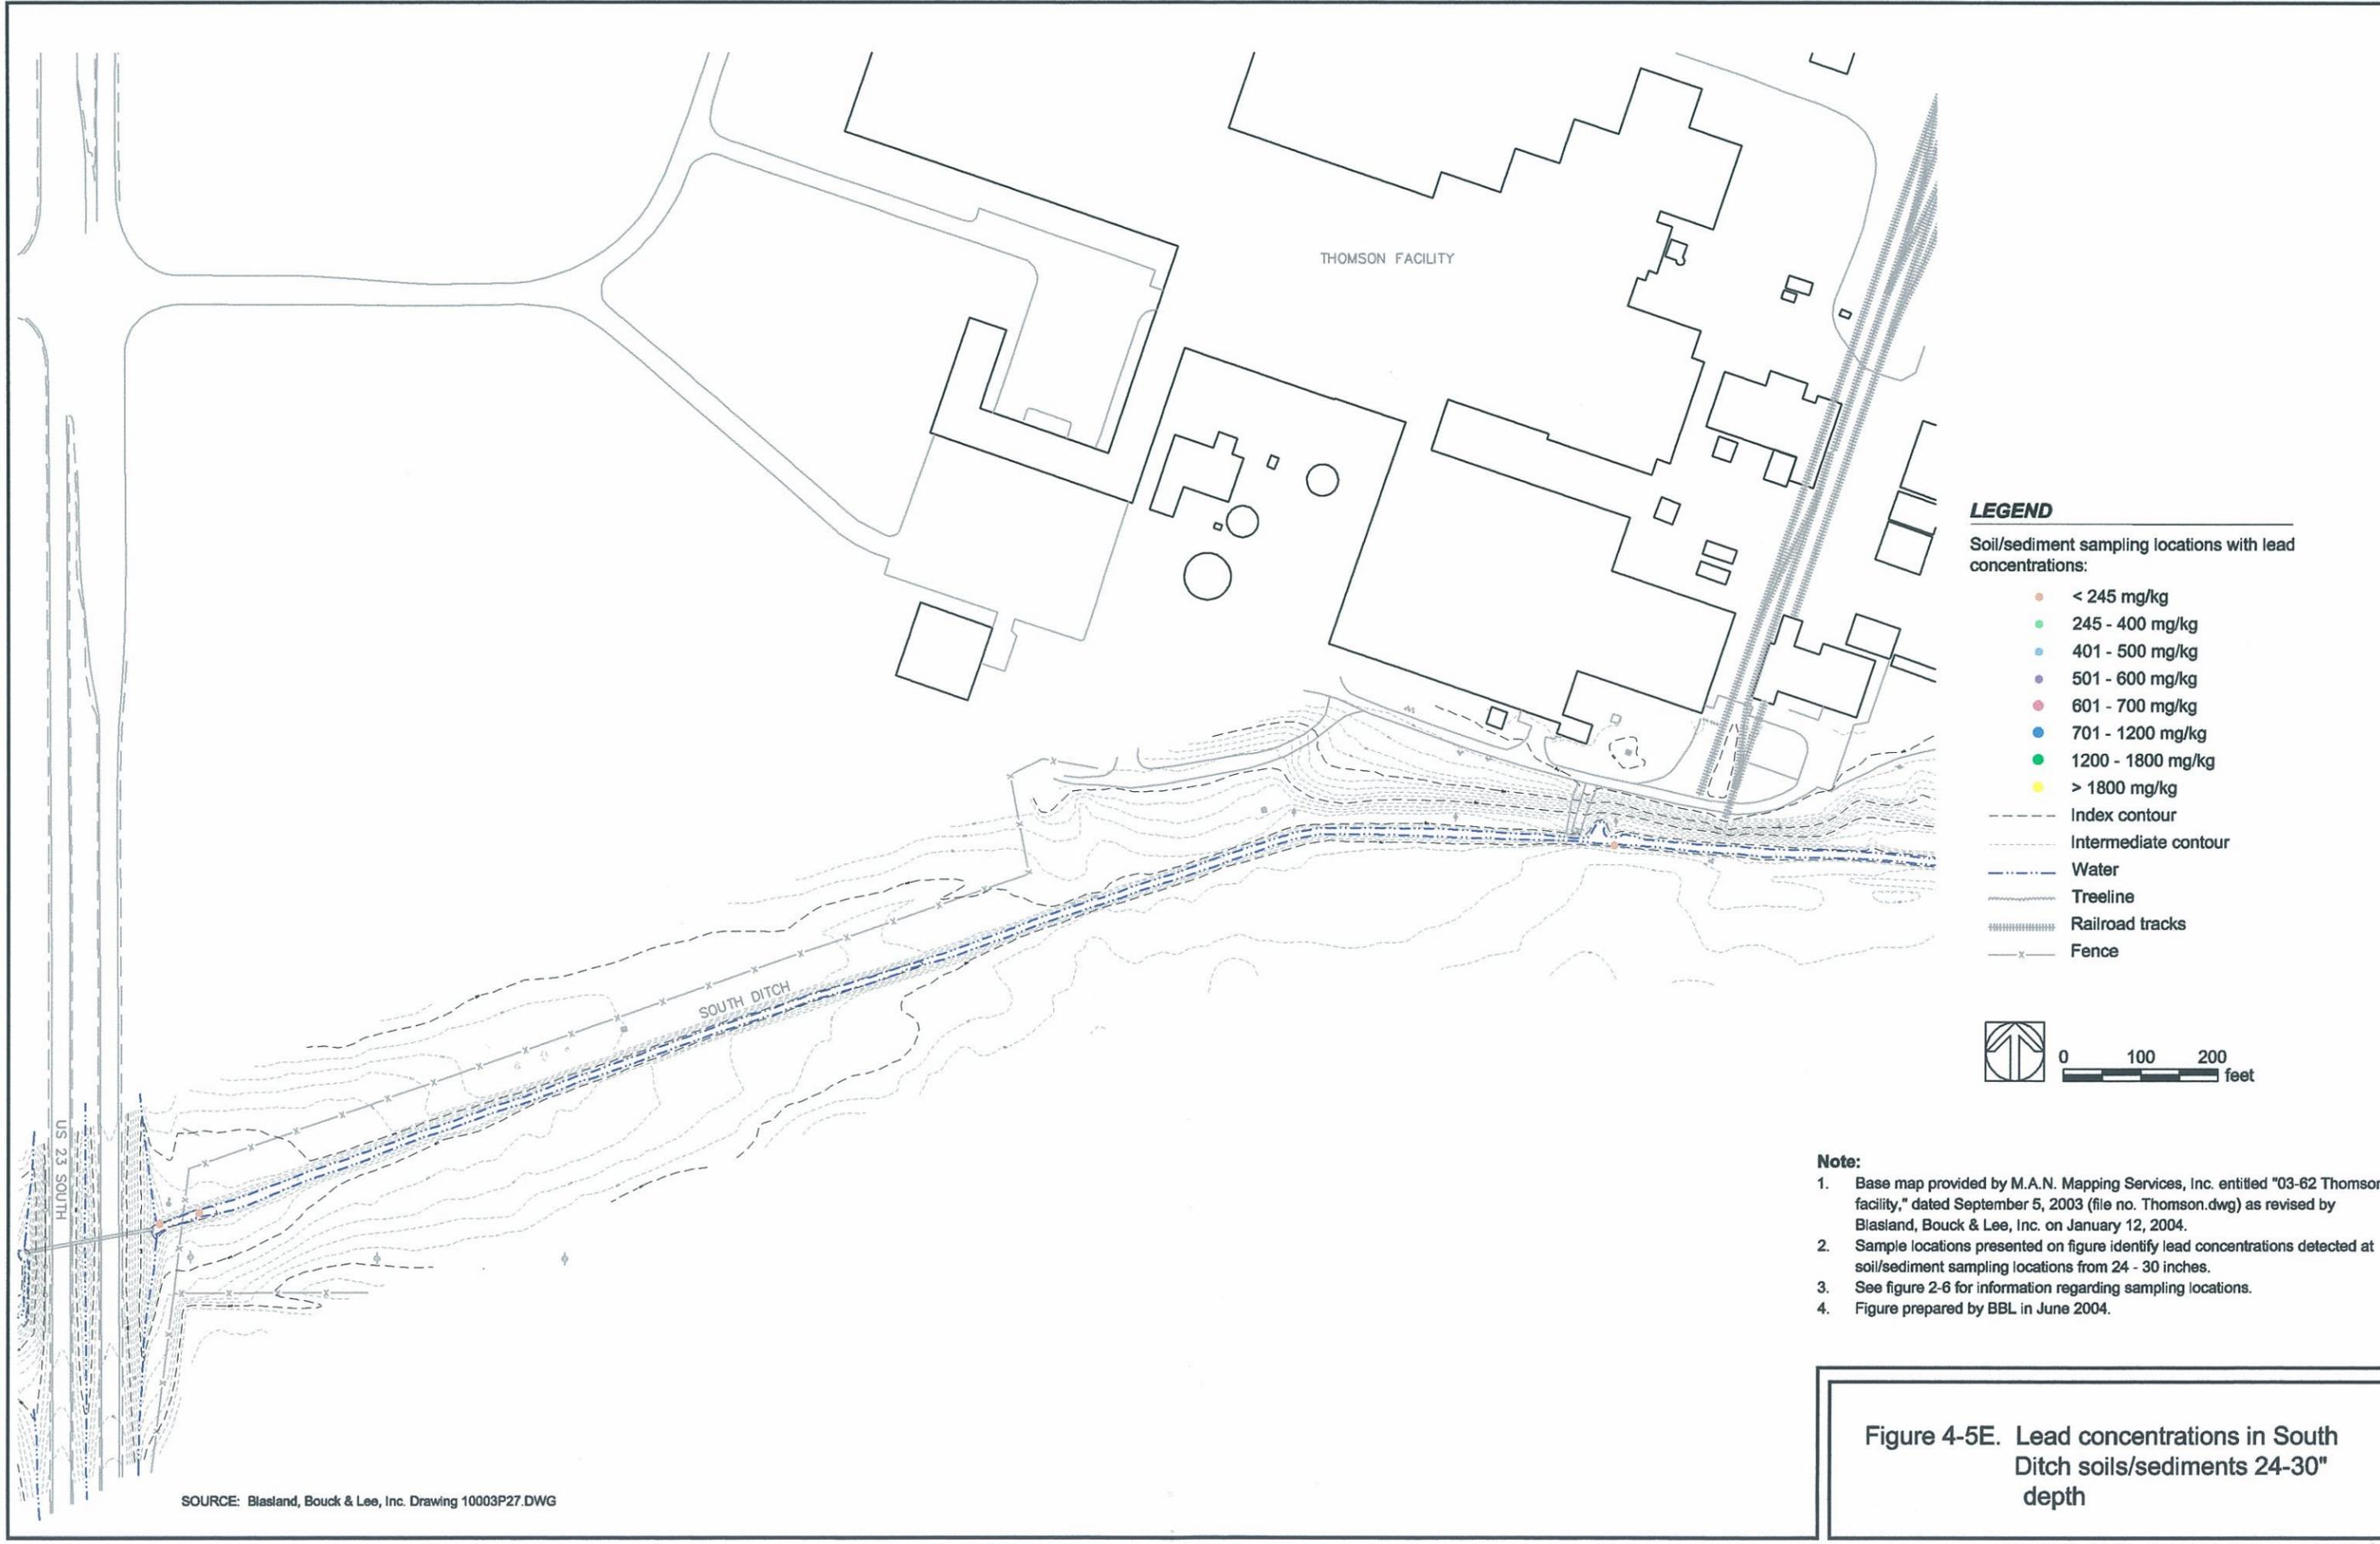
**Figure 4-5E. Lead concentrations in South Ditch soils/sediments 24-30" depth**

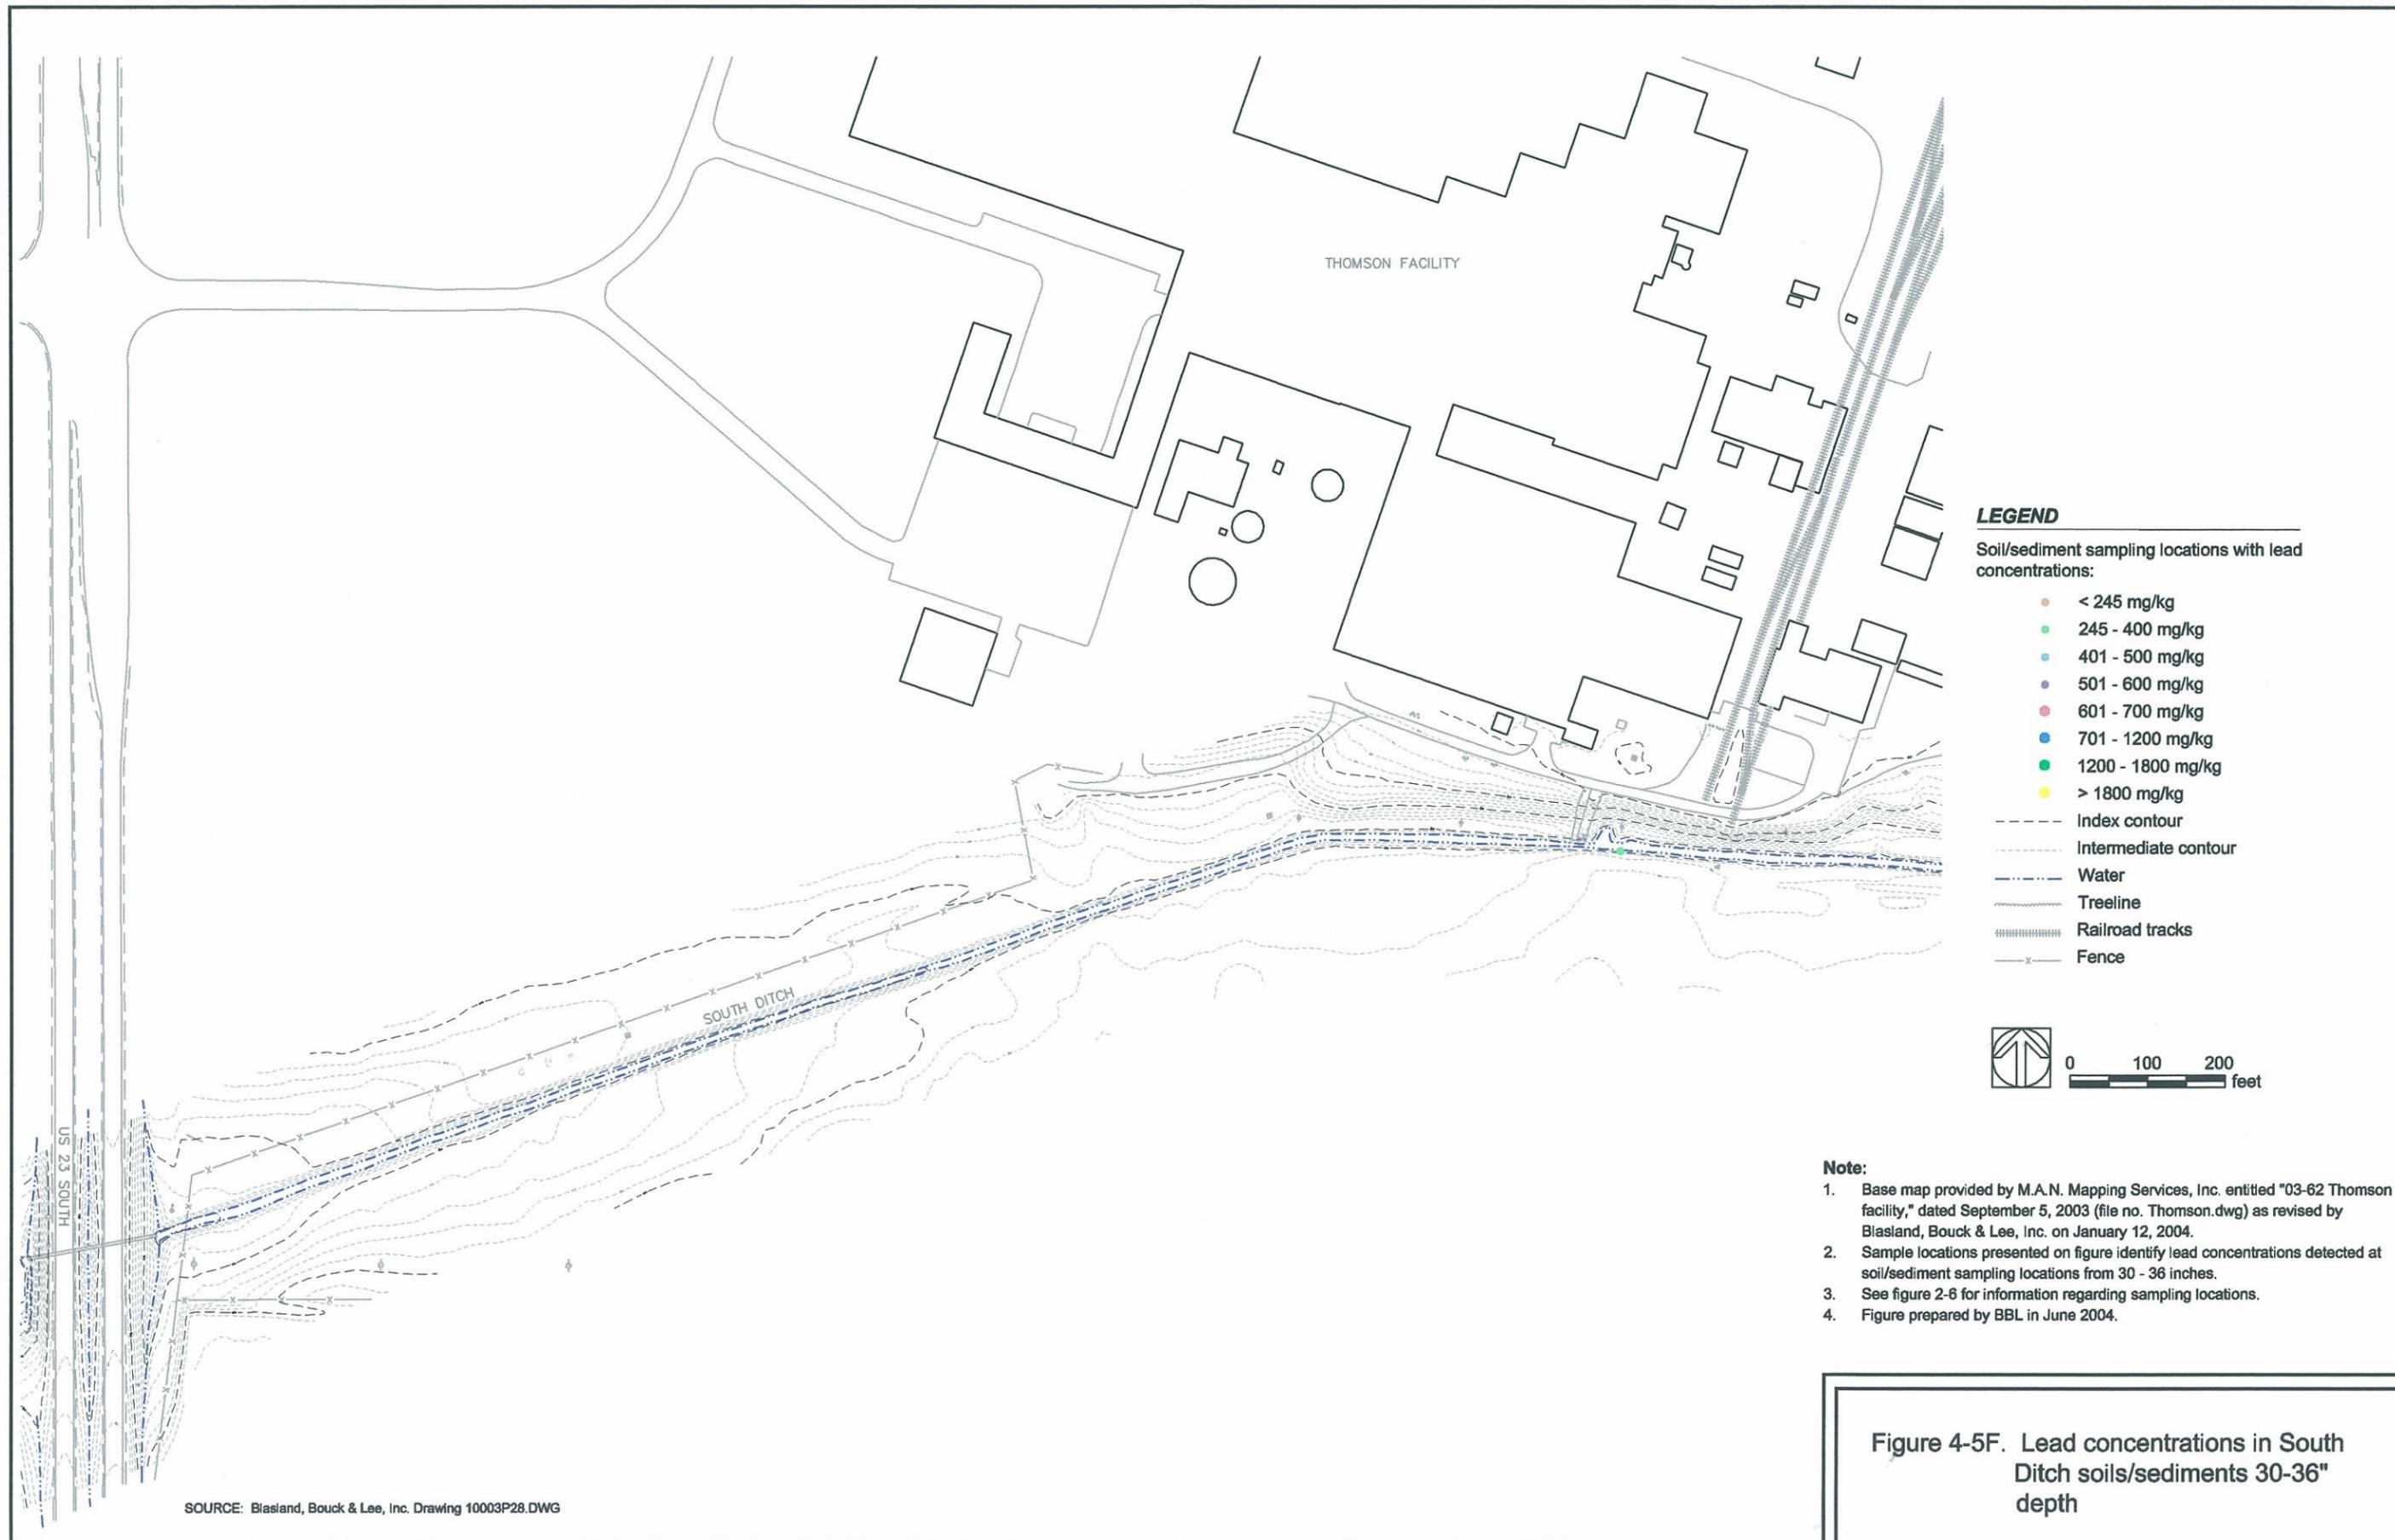
Figure 4-5F. Lead concentrations in South Ditch soils/sediments 30-36" depth

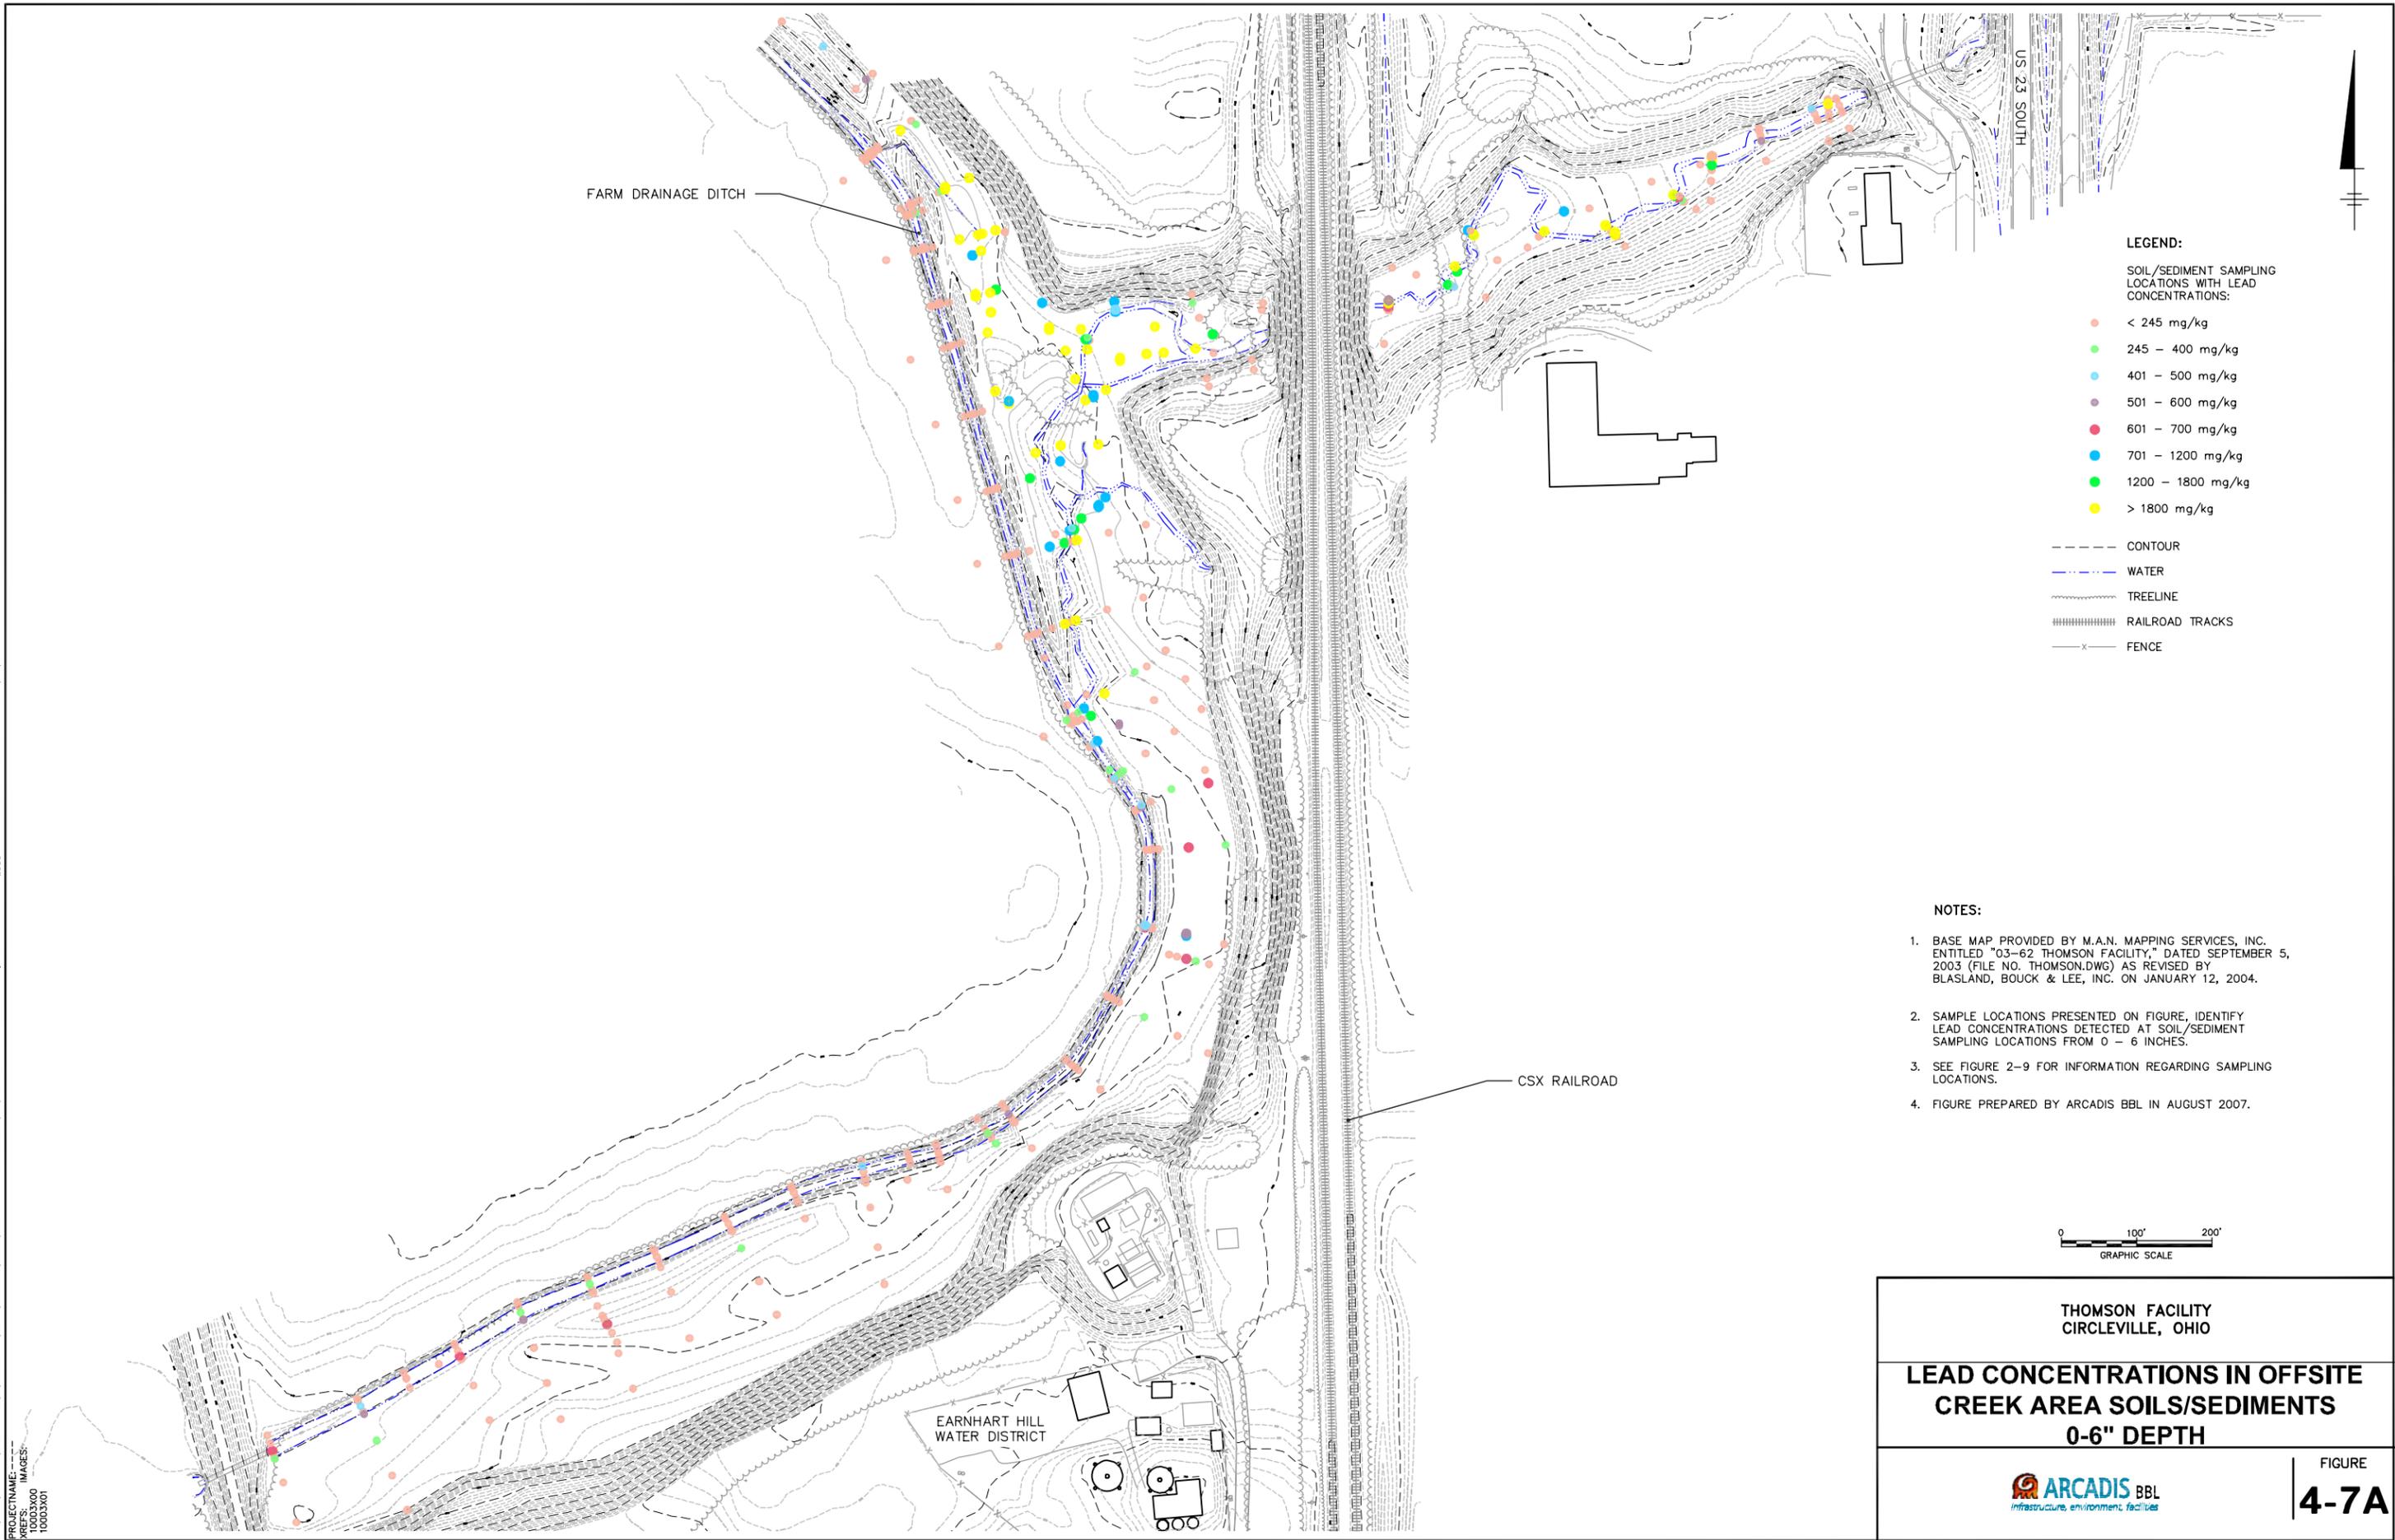
FIGURE  
**4-7A**

**LEAD CONCENTRATIONS IN OFFSITE  
 CREEK AREA SOILS/SEDIMENTS  
 0-6" DEPTH**
