## **Figures**

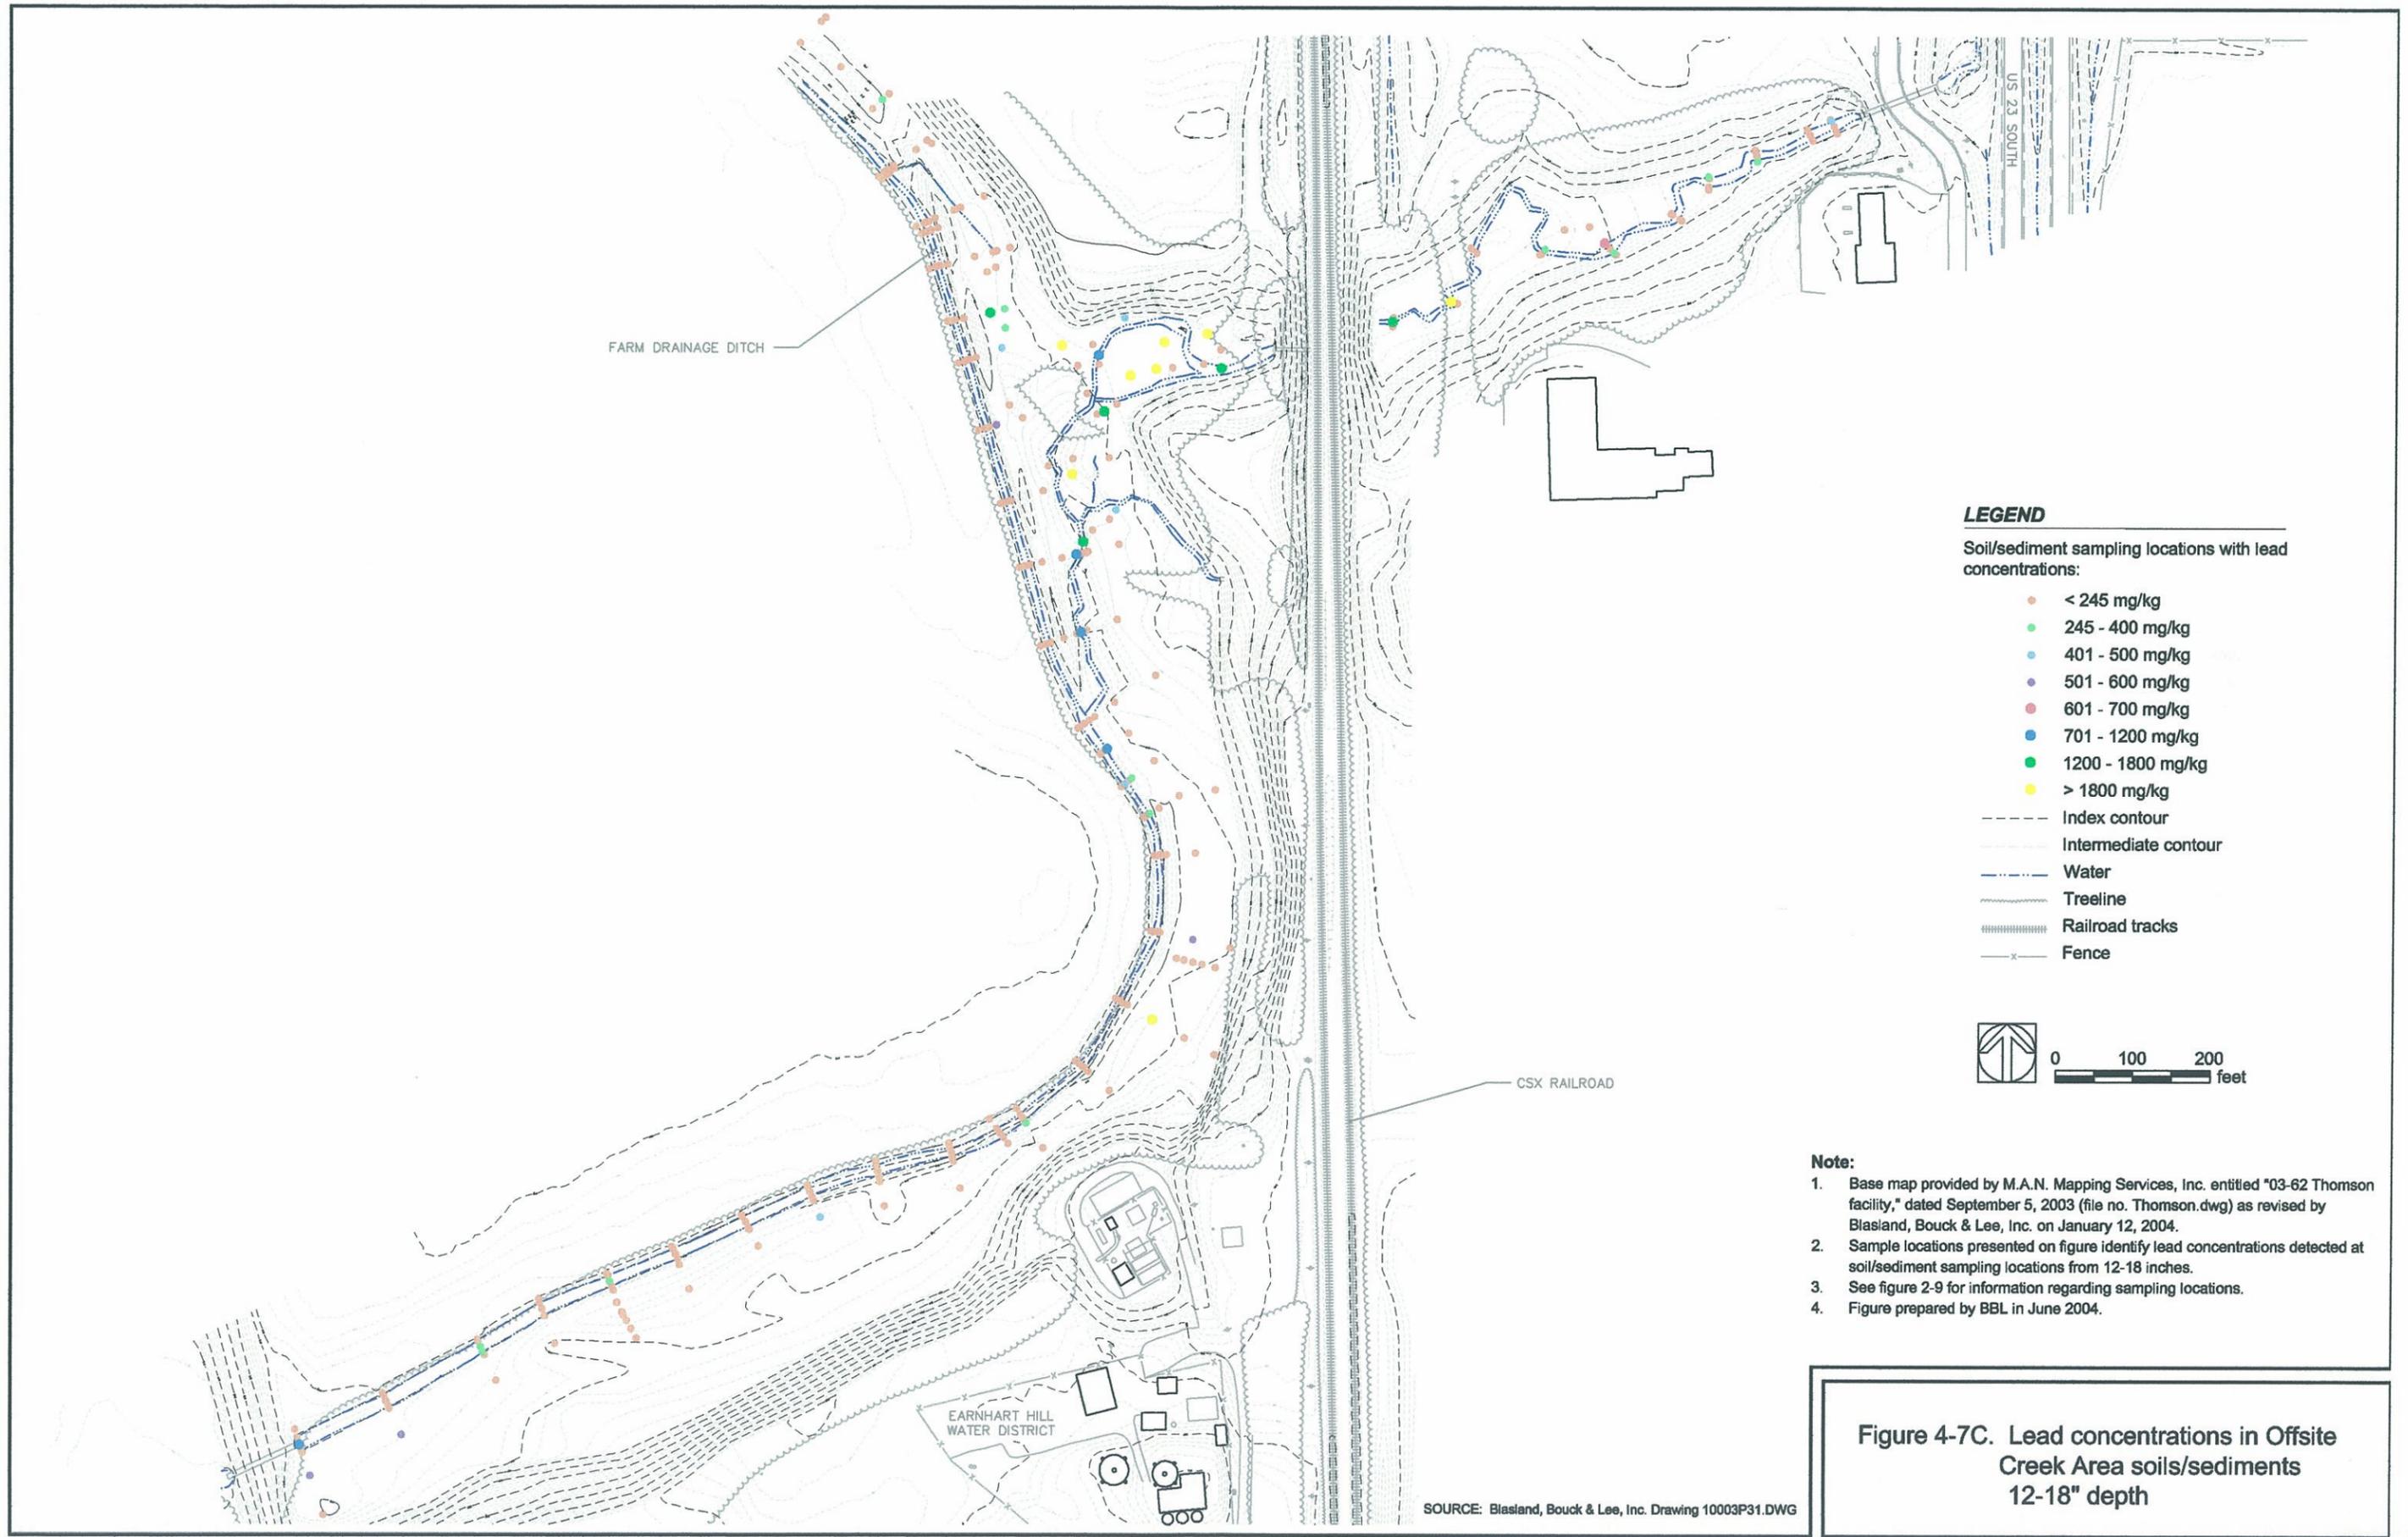
**Figure 4-7C. Lead concentrations in Offsite Creek Area soils/sediments 12-18" depth**

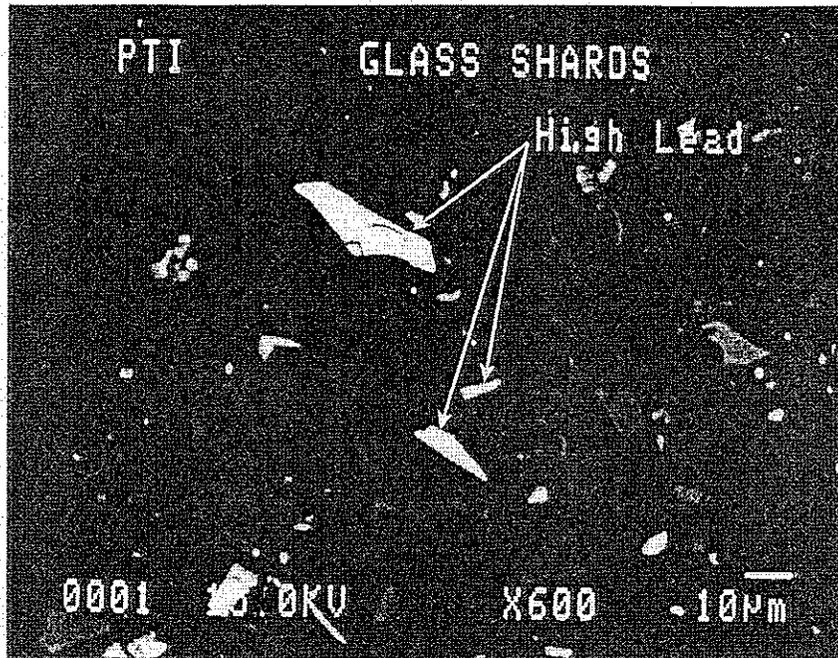
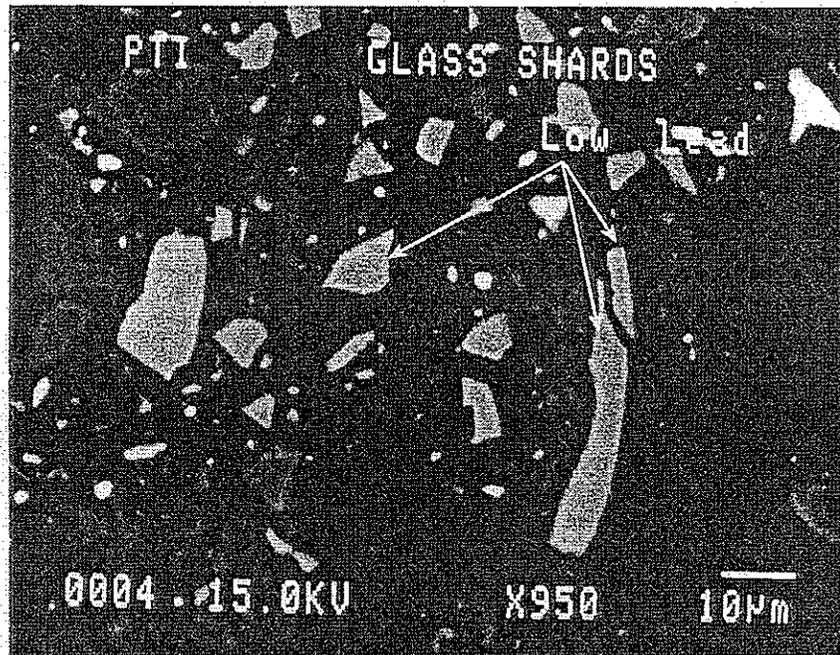
Figure 4-8. Photomicrograph showing (a) high-lead glass shards in sample C-OCA-2 6-12 and (b) low-lead glass shards in glass C-OCA-6-12

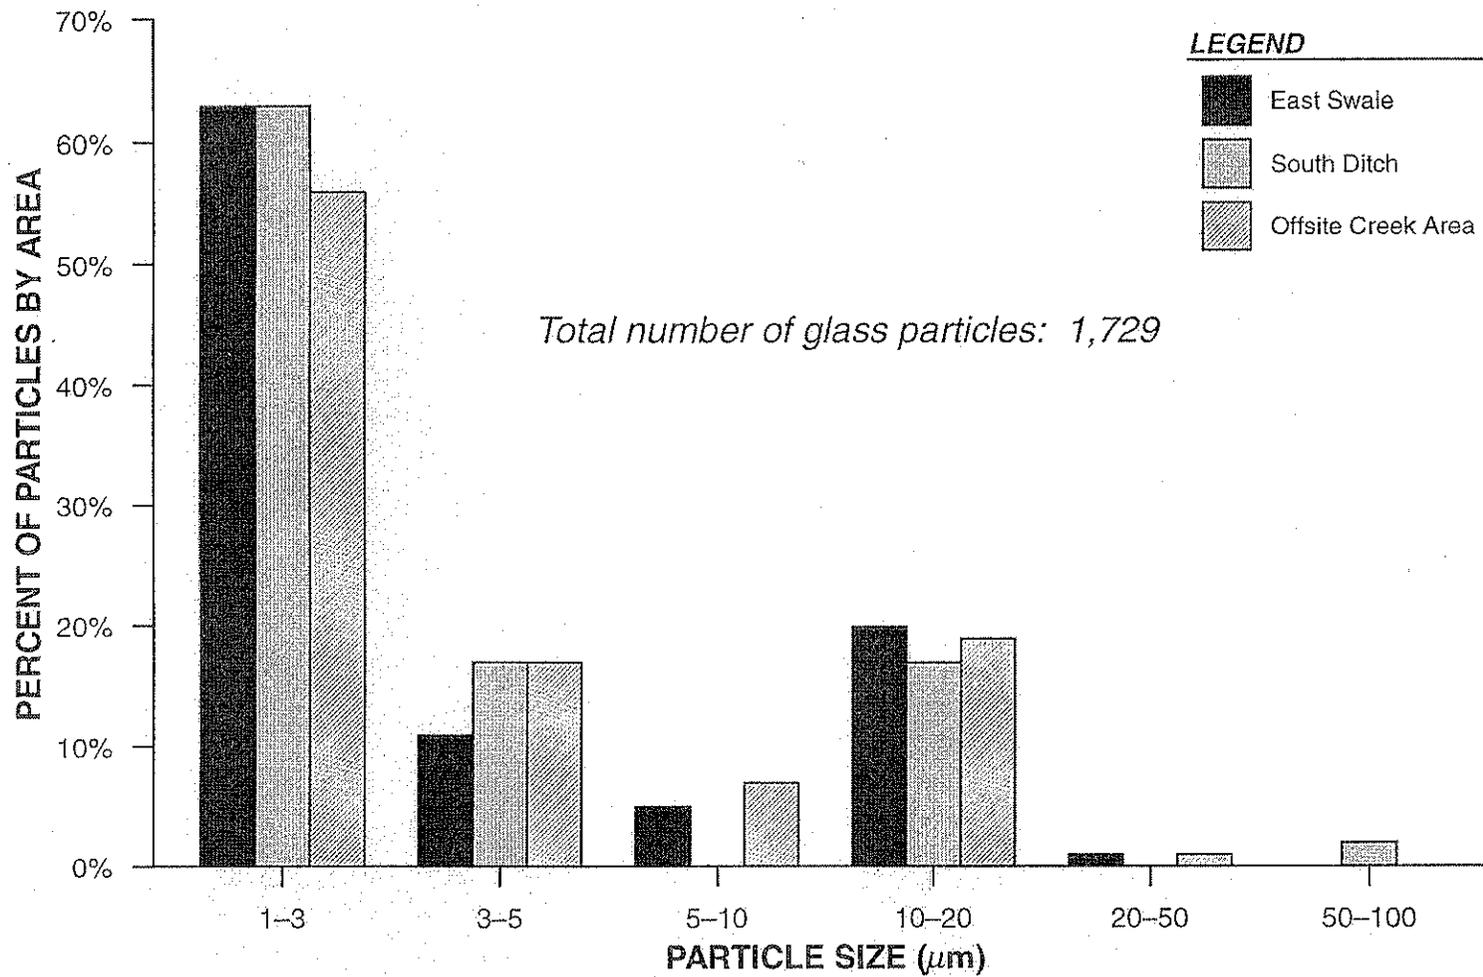
Figure 4-9. Size and distribution of both low- and high-lead glass particles.

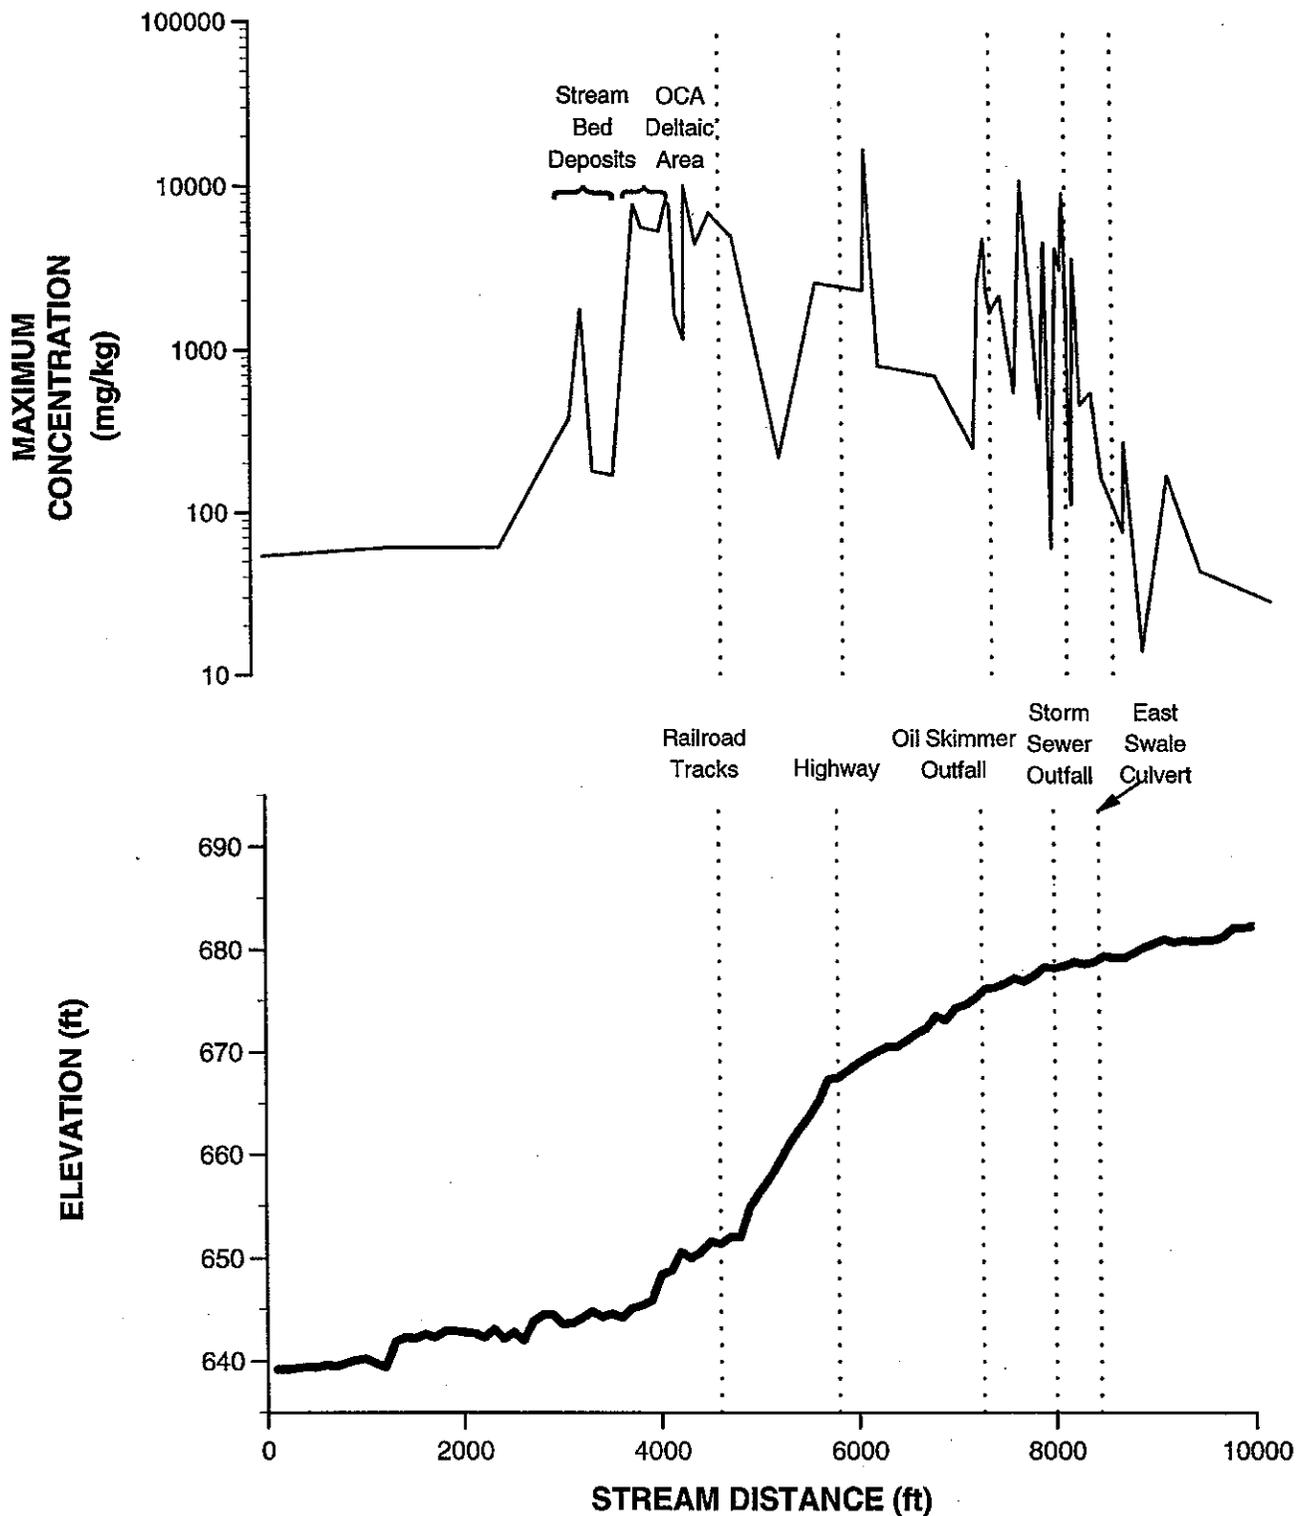
Note: Maximum concentration observed at each location including surface sediments, core and blank samples. Chart represents data collected prior to supplemental sampling in 2003.

Figure 5-1. A comparison between the maximum lead concentration observed in the South Ditch and OCA sediments and the stream elevation at the center of the channel.

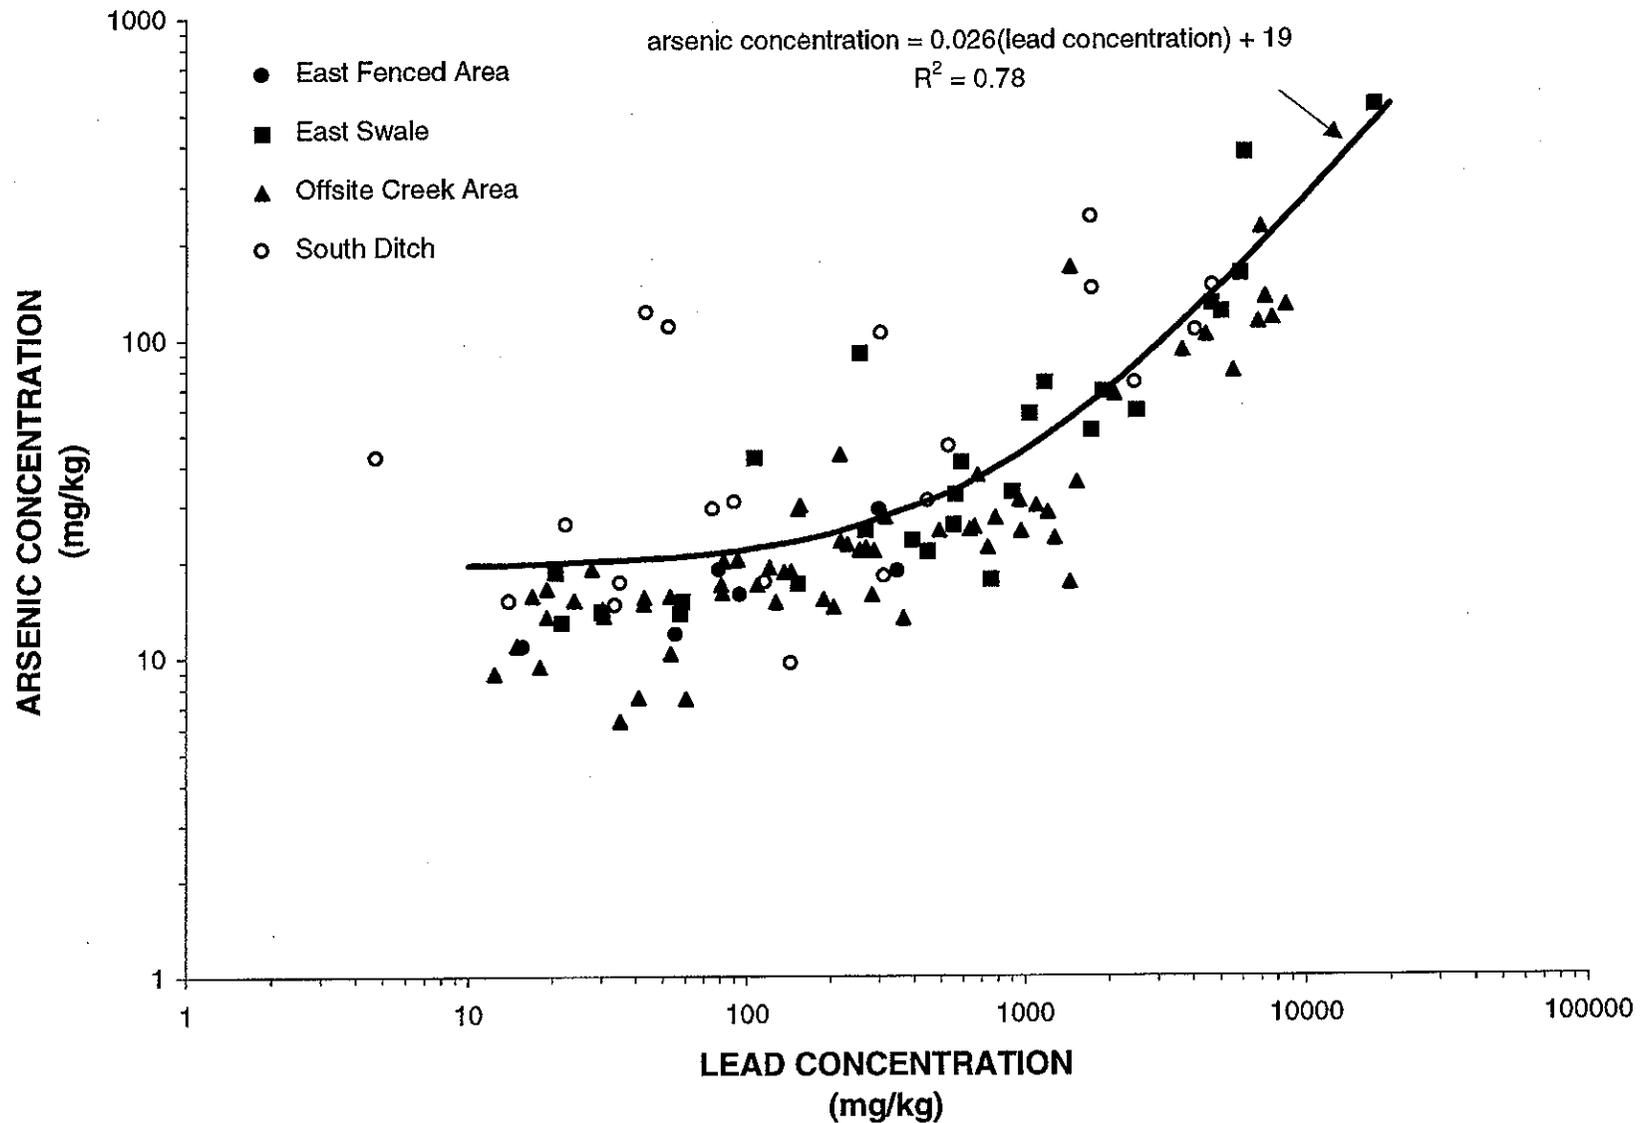
Figure 5-2. Comparison between lead and arsenic concentrations in EFA soils and ditch-system sediments.

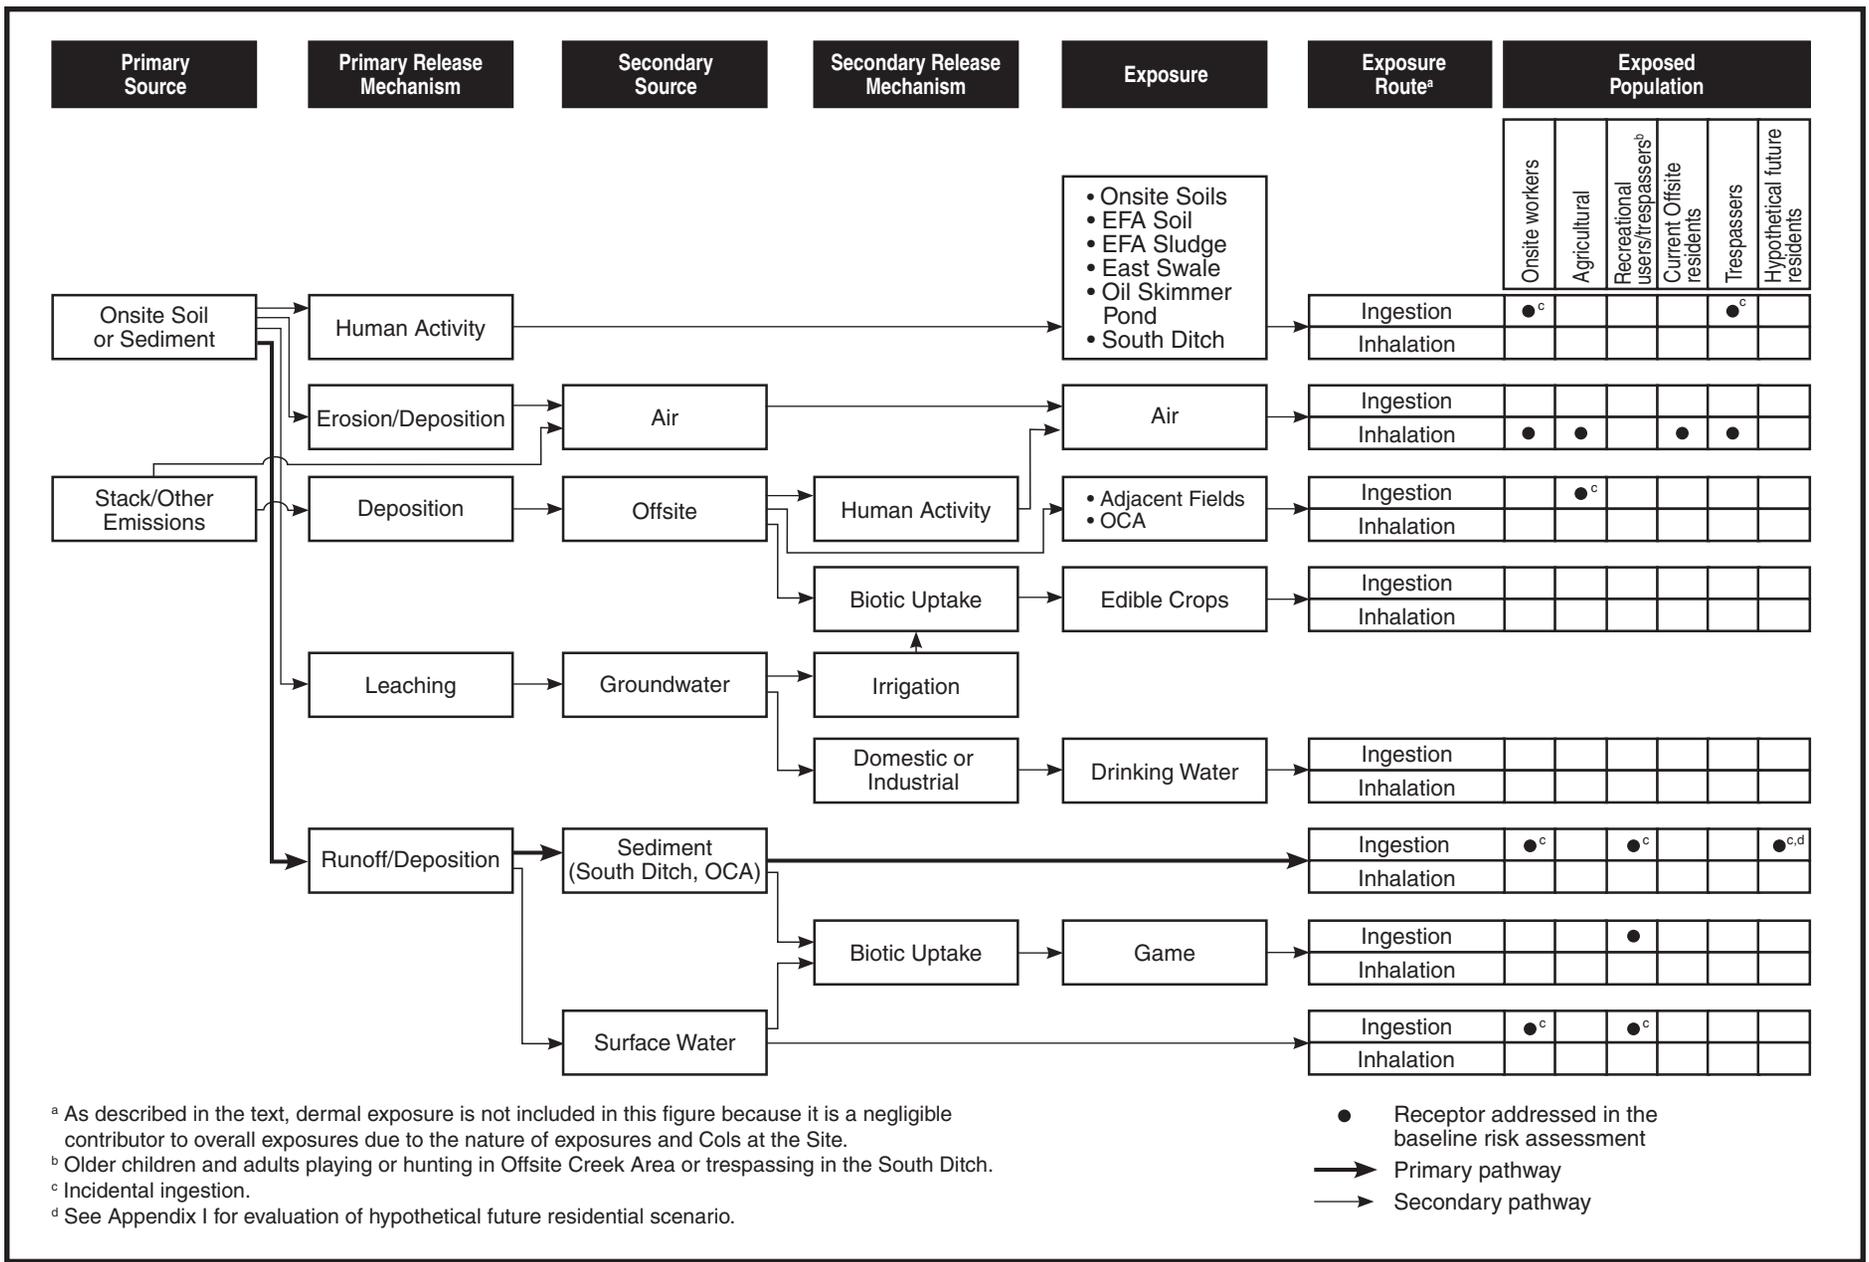
Figure 6-1. Conceptual site model for potential human exposure pathways considered in the HHRA
