Redevelopment as a Moving Target:

How Remedies Change
with Development Plans

3 Case Studies

Presentation by Atul Pandey, P.E.
VAP Certified Professional #224
PANDEY Environmental, LLC

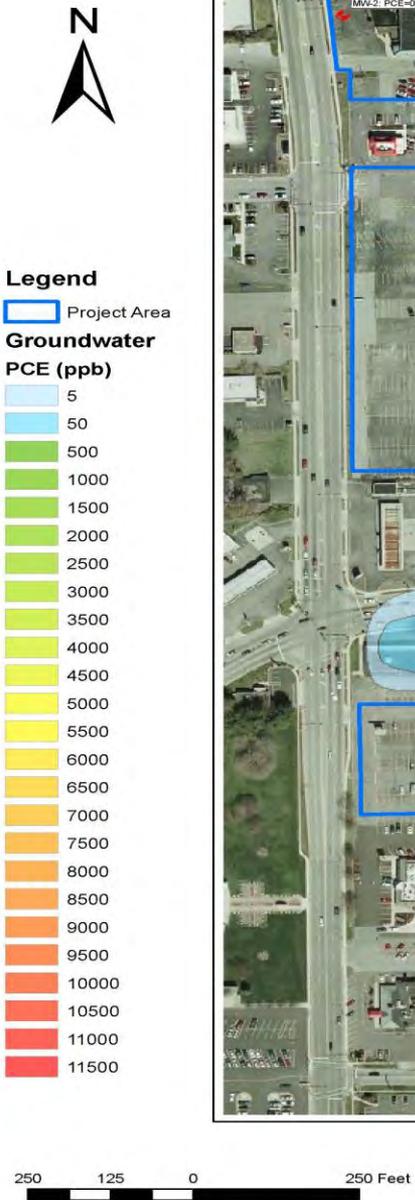
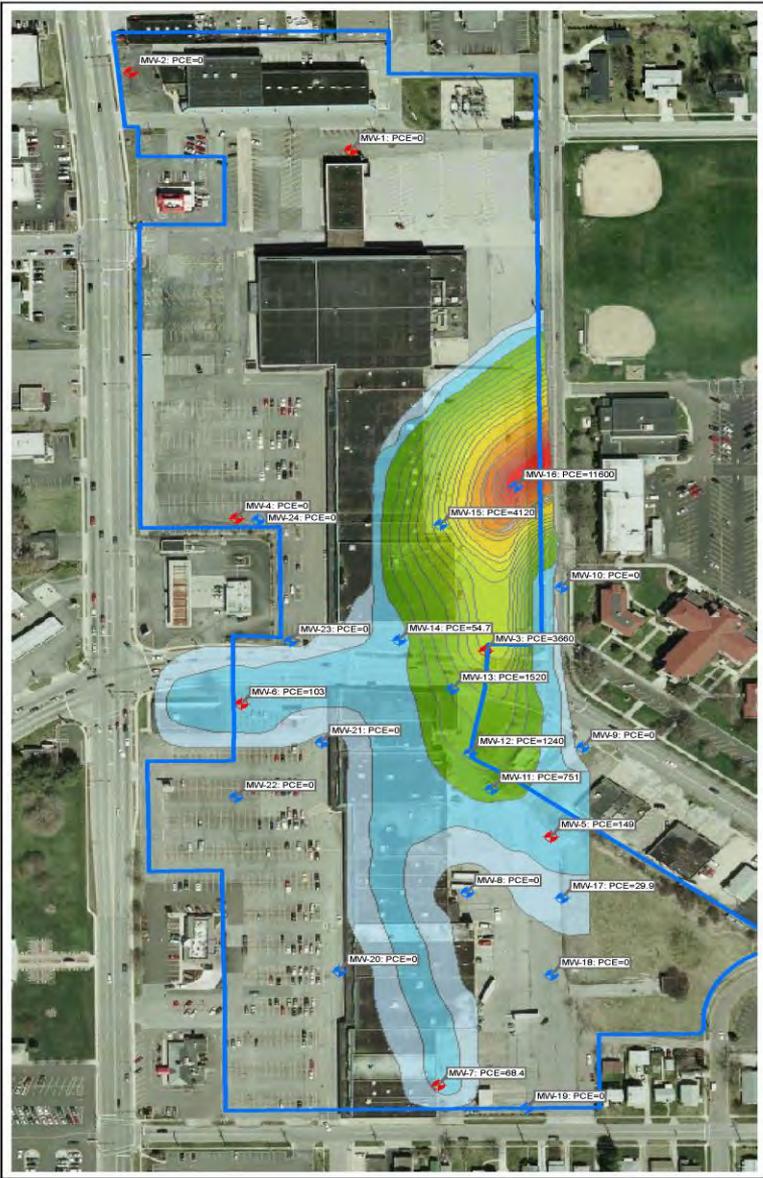
Figure 1
Tetrachloroethene (PCE)
Plume Map
December 2008
State Road Shopping Center
Cuyahoga Falls, Ohio

- Groundwater investigation revealed a contamination plume of Chlorinated Solvents such as Tetrachloroethene (PCE), Trichloroethene (TCE), Vinyl Chloride & others.
- Plume occupies a significant portion of site.
- Over the last 4 years, plume movement towards N/NE observed
- More degradation products found now than 4 years ago

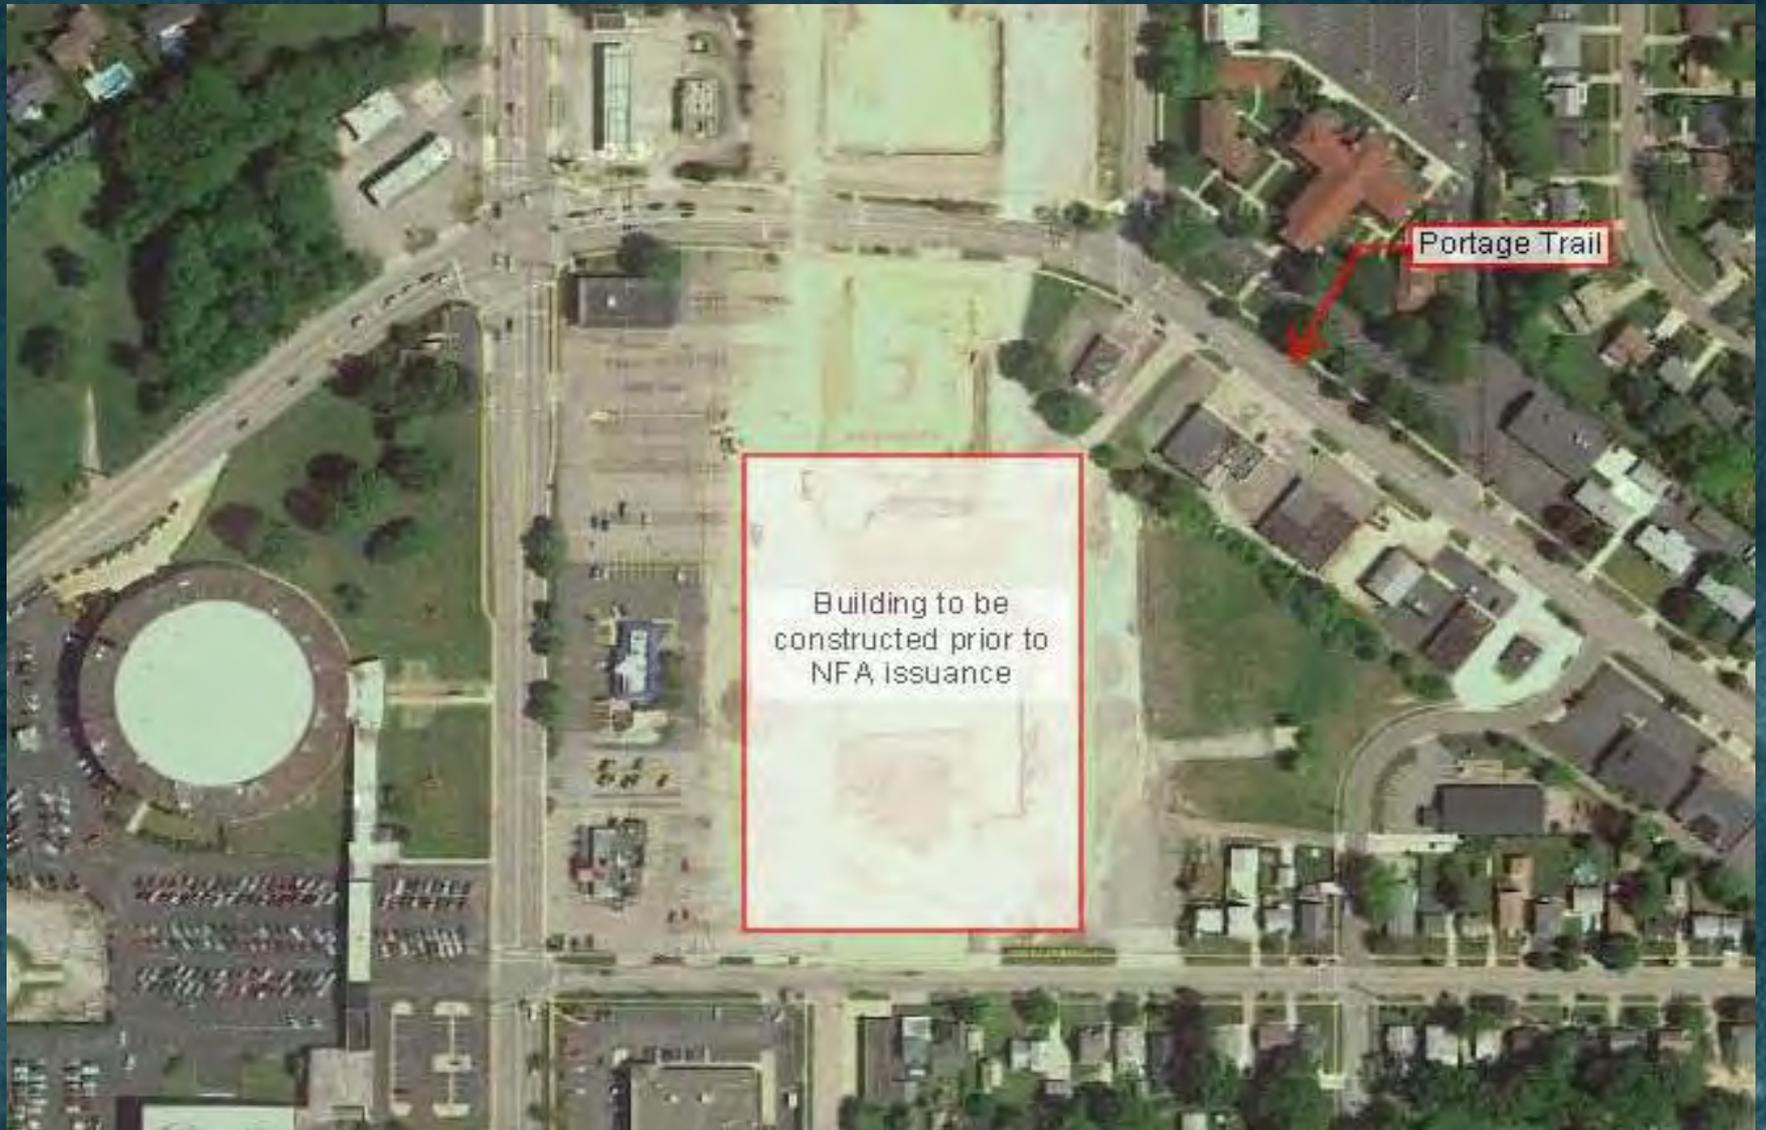
South of Portage Trail

- As Indoor Air risk thresholds are exceeded, the building will require a vapor barrier with an appropriate venting system to ensure building occupants are protected.

- The venting system and the vapor barrier system or components of these systems are subject to an Operation & Maintenance agreement to be maintained as engineering controls to show compliance with applicable standards.

- An Activity & Use Limitation (AUL) in the form of an Environmental Covenant (EC) needs to be recorded on the property as a whole to ensure that prior to occupancy of FUTURE building structures, they will either a) shown to comply with indoor air applicable standards, or b) a remedy would be instituted to comply with indoor air standards (similar to the building constructed pre NFA issuance)

- Groundwater response requirements for the appropriate groundwater classification apply as always to the whole property. This would also include a prohibition on future groundwater use which is part of the EC.

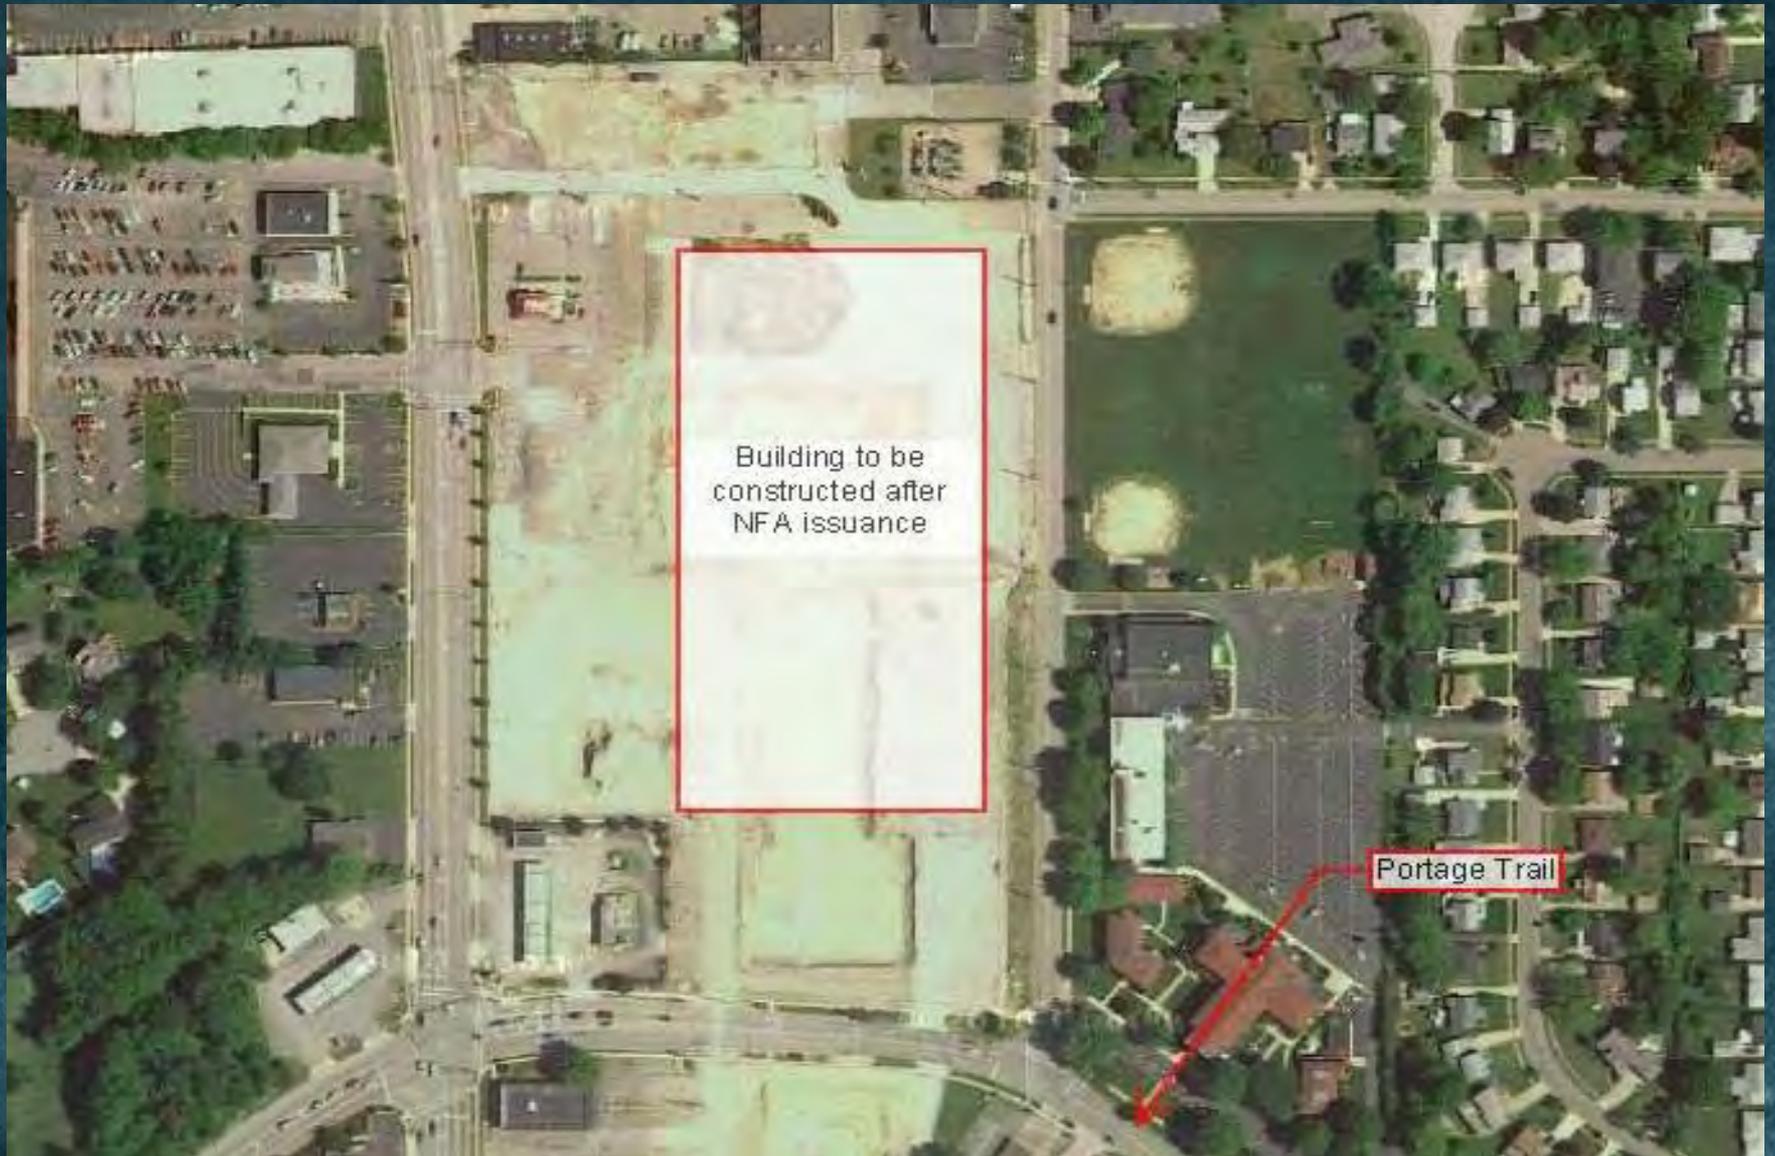
North of Portage Trail

- Per the AUL as presented in the EC, the building would either need a remedy such as a vapor barrier with a venting system or a demonstration would have to be made that such a remedy is not required.
- If needed and once constructed, the O&M plan would have to be modified to operate and maintain this remedy for the north building
- All other response requirements remain the same for this portion of the property as the whole property including groundwater response requirements.
- Any demonstration must be made under CP affidavit.

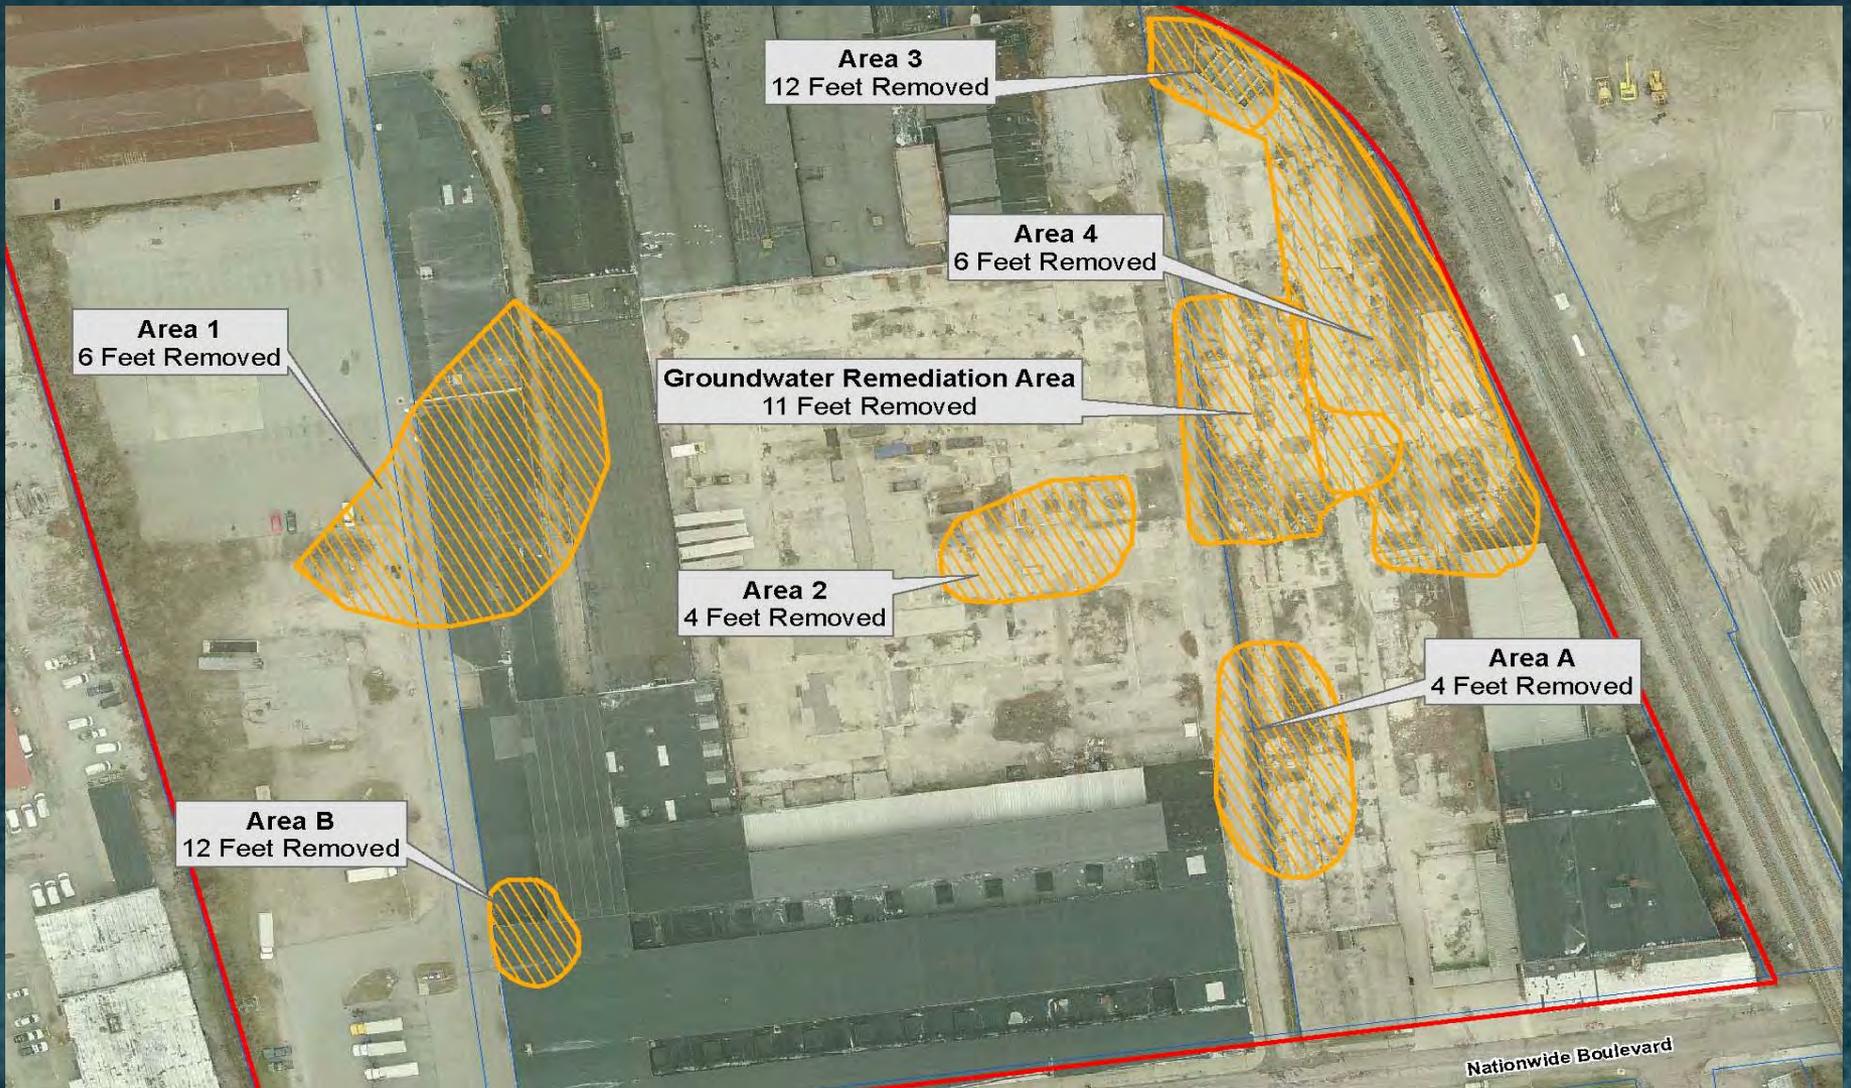
Areas of soil & groundwater contamination remediated

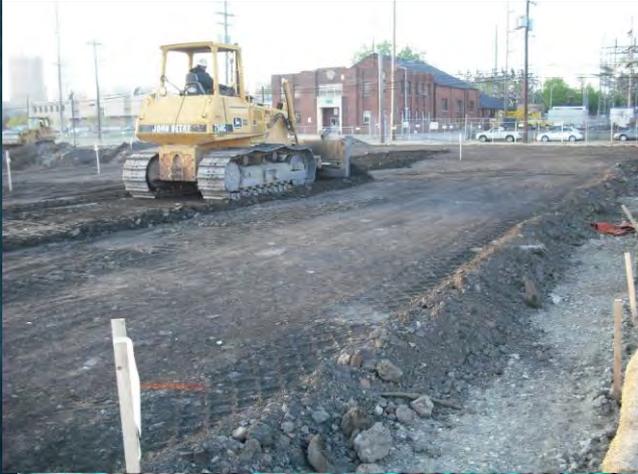
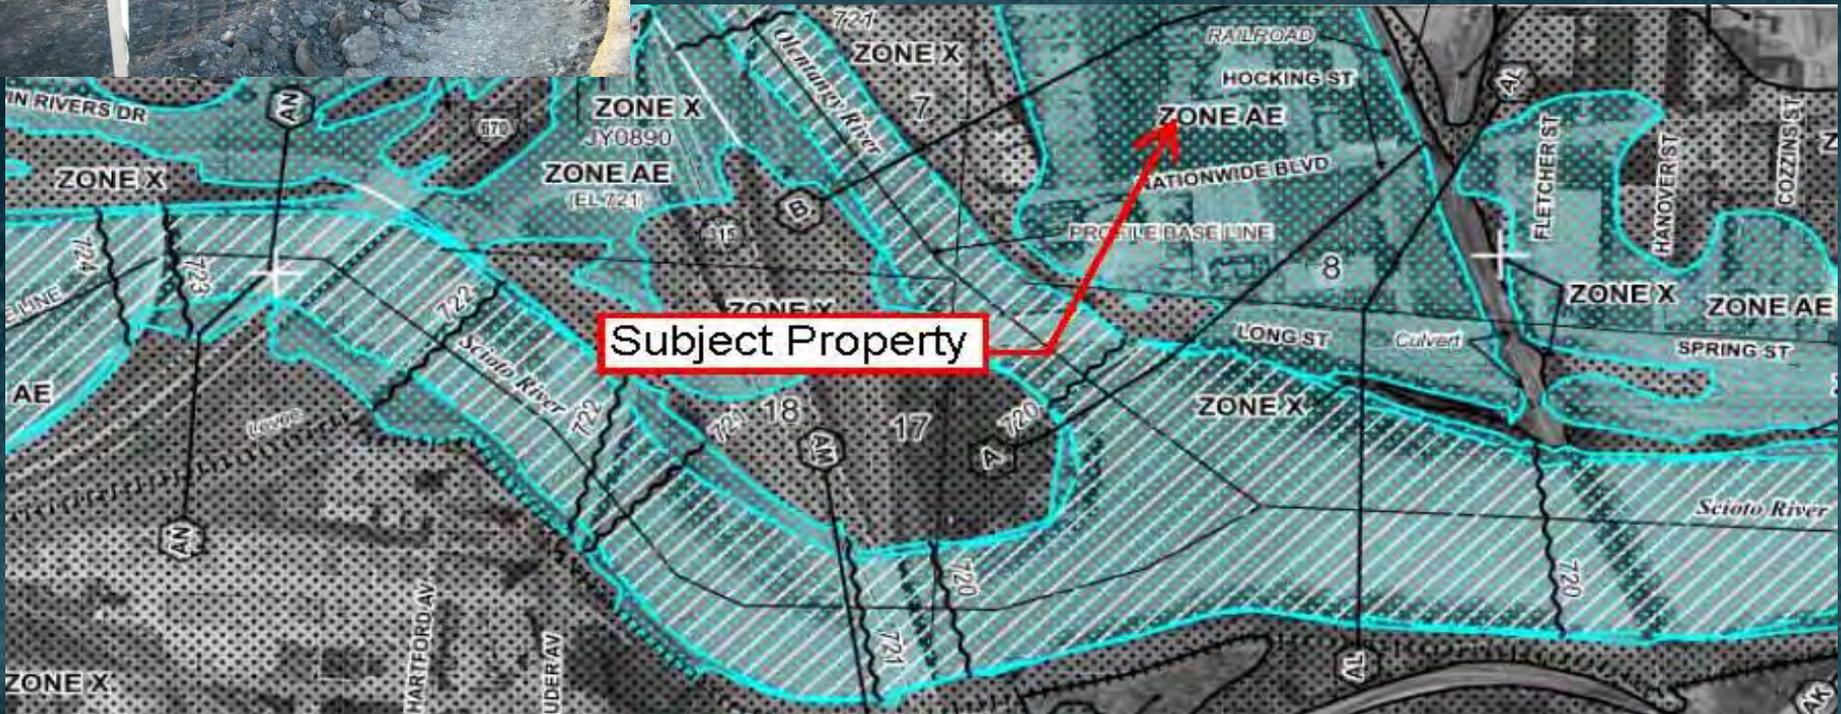
Meeting a Residential Standard:

-Cap site with minimum of 10' of fill material:

- Puts site above flood plain which is needed
- Achieves greater than 10' point of compliance for residential land use in some instances

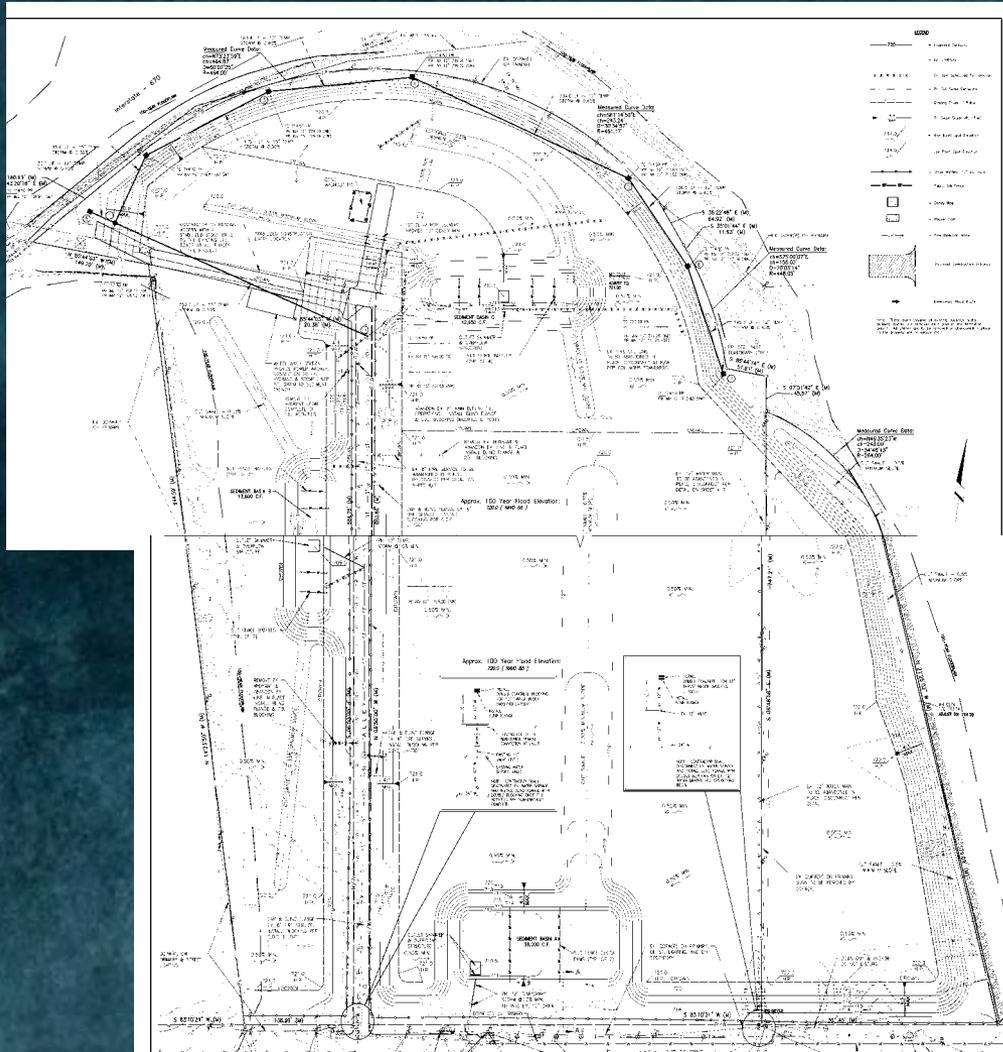
Meeting a Commercial / Industrial Standard:

- Cap site with 2' of fill materials:
 - Puts site still below the flood plain
 - Achieves 2' point of compliance for commercial / industrial land use.

- An EC must be recorded to document the requirement of continued commercial/industrial use of the subject property.

- All other pathways must be evaluated independent of the soils – direct contact issue. Total overall risk still needs to meet $1E-5$ and 1 thresholds

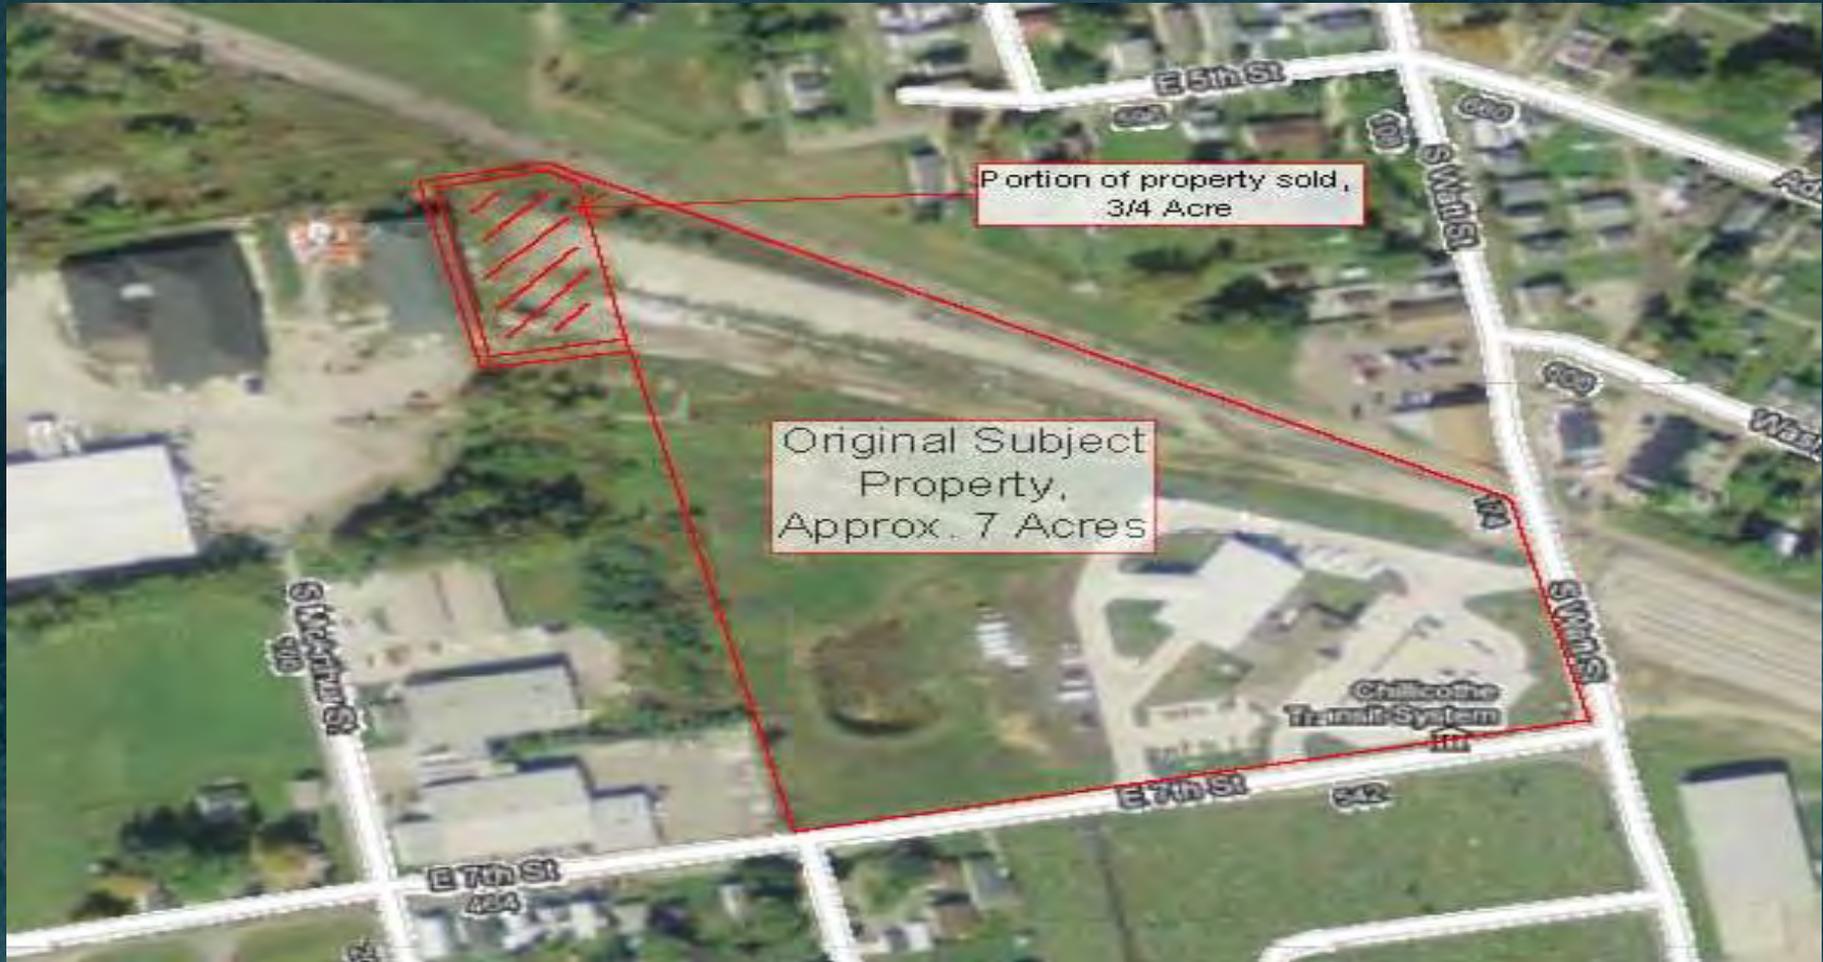
What happens when a portion of the property gets sold?

- Separate risk assessment completed on the $\frac{3}{4}$ acre parcel to show applicable risk assumptions for the CNS continue to be valid.
 - Because of heterogeneous nature of fill at the property, risk needed to be redone to show risk is met at the $\frac{3}{4}$ acre property by itself.
- New owners informed about conditions of the CNS
 - Commercial / Industrial land use restriction
 - CNS at risk if soils disturbed below 2'
 - Construction worker activities anticipated to be only 6' below existing grade
