Soil and Materials Engineers, Inc.

# REBUILDING A PARK ON AN UNCONTROLLED DUMP

**Mark J. Quimby**  
**Project Consultant**

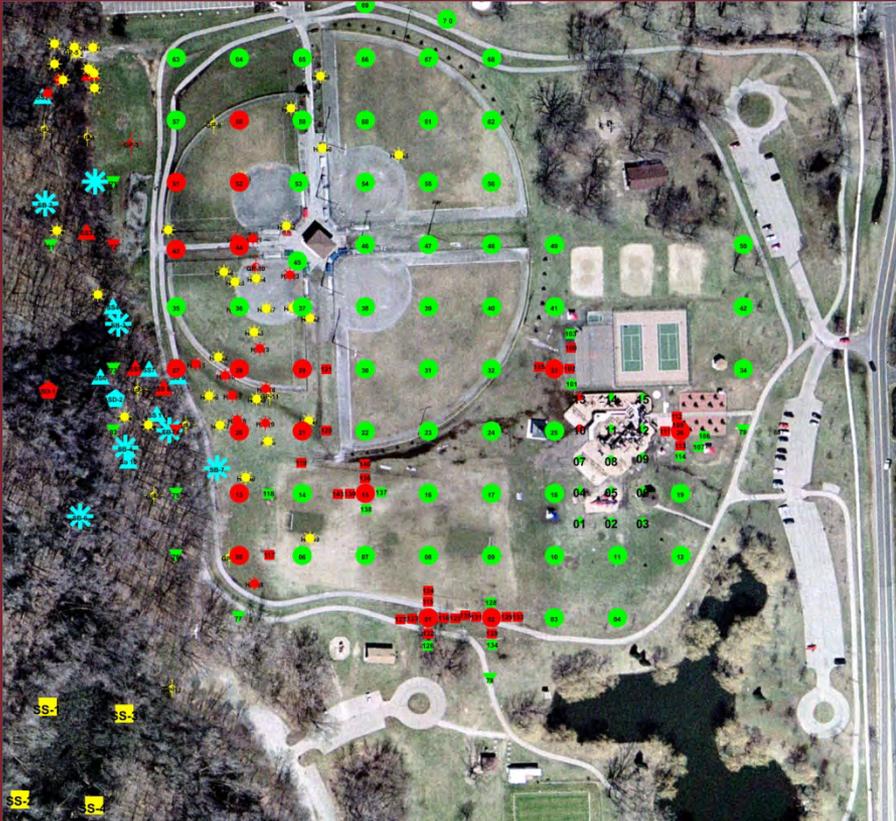
## PRE-2006 SAMPLING

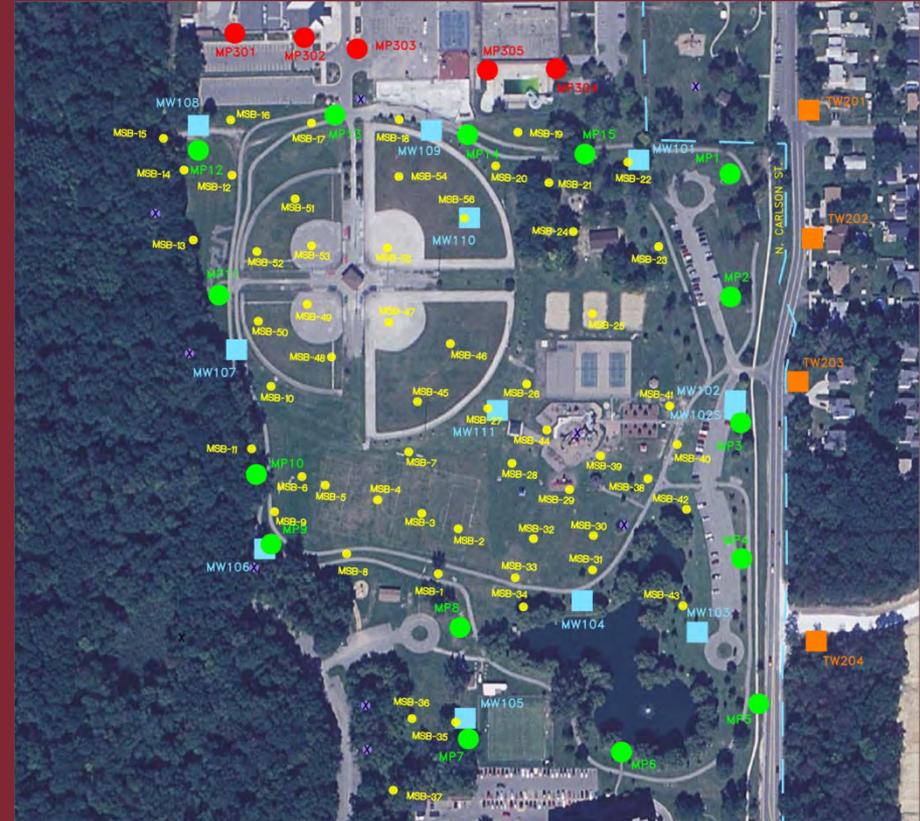
## POST-2006 SAMPLING

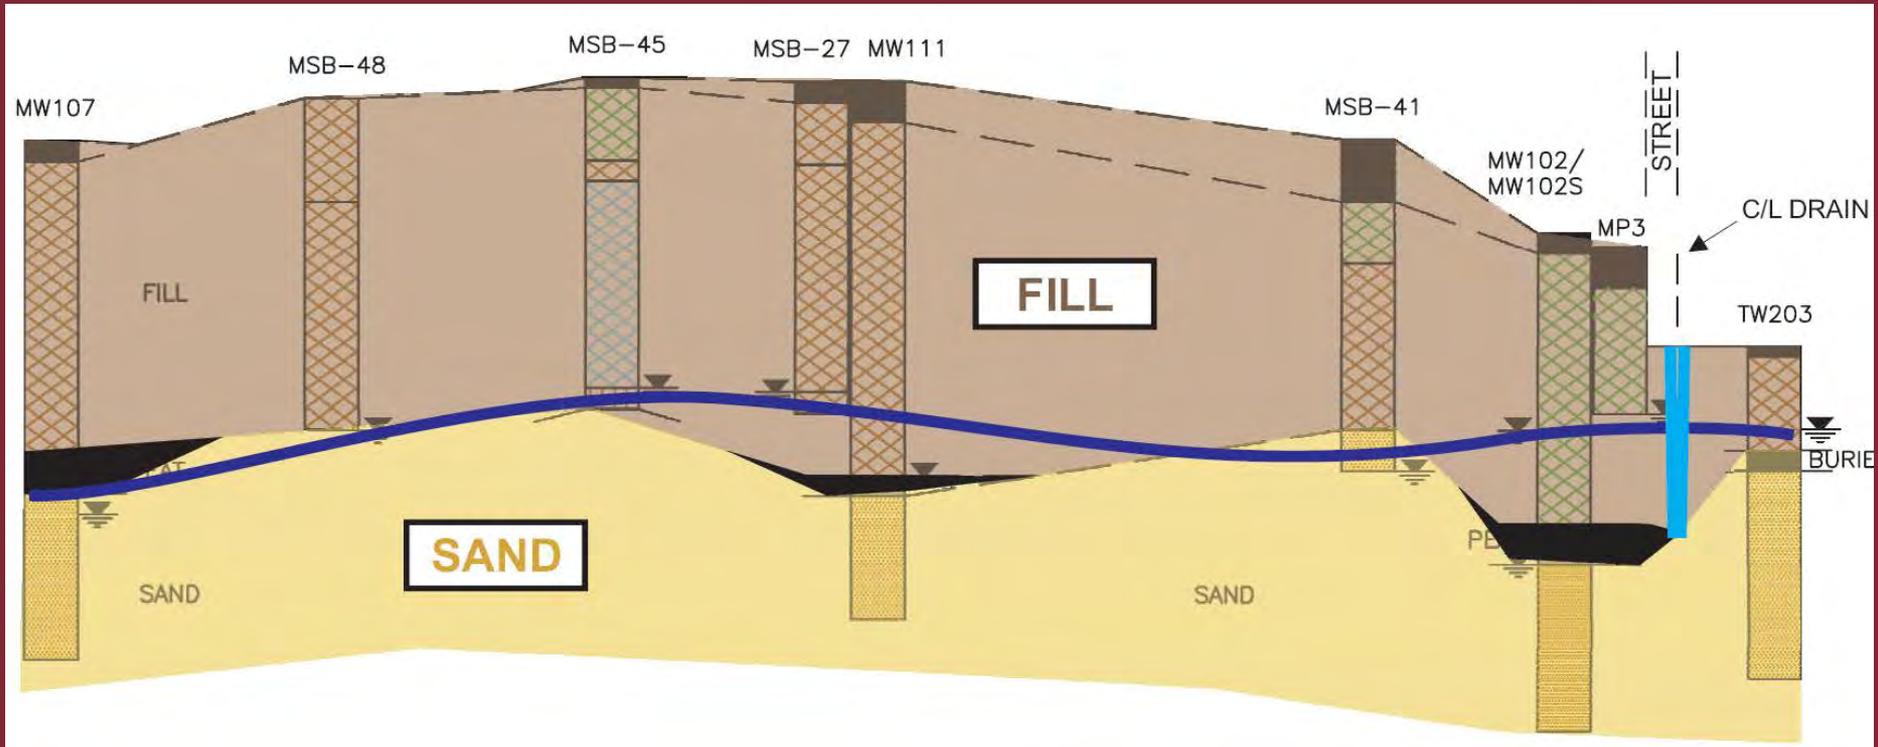
## CROSS SECTION

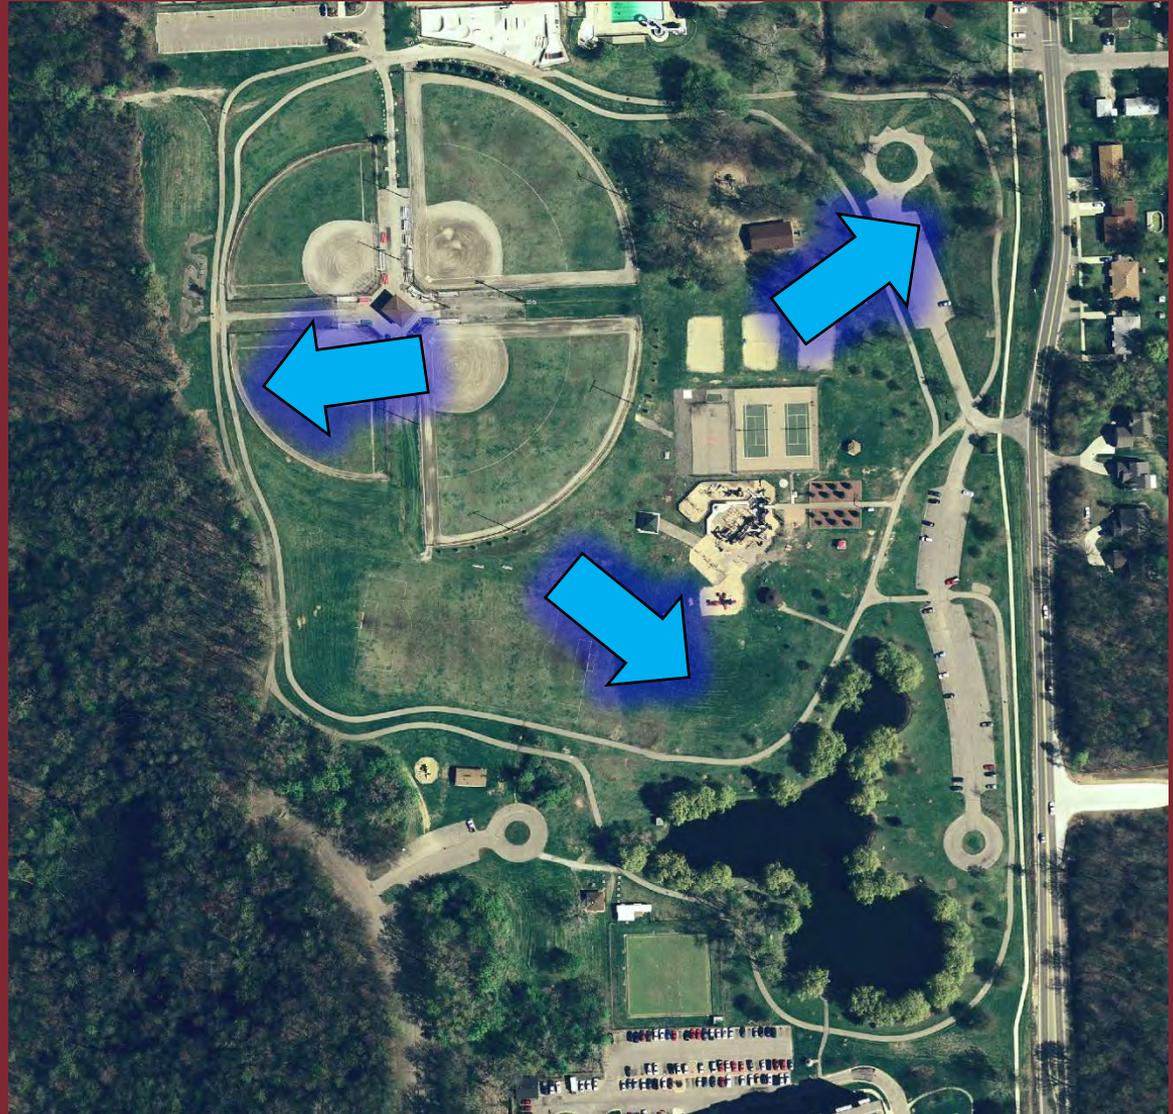
## ■ Surface Water Runoff

- Follows site topography
- West to adjacent wooded area
- South and southeast to pond
- East and northeast to local Drain

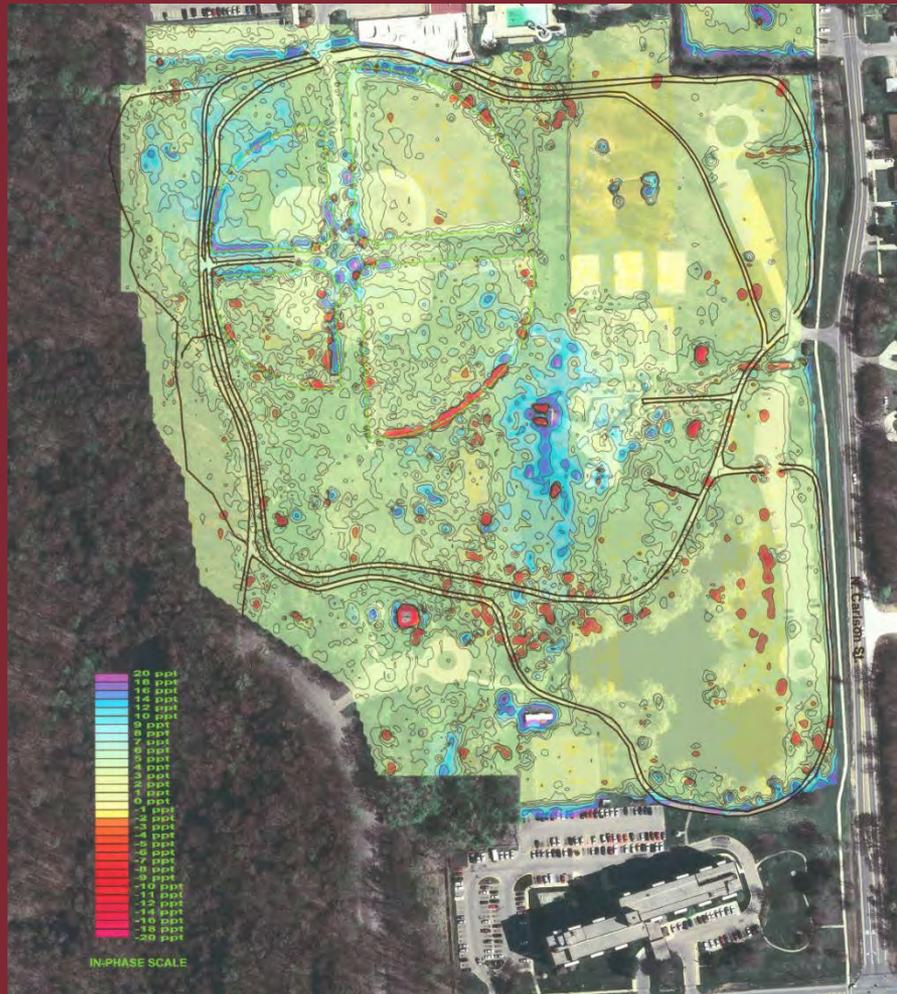
## METAL DETECTION

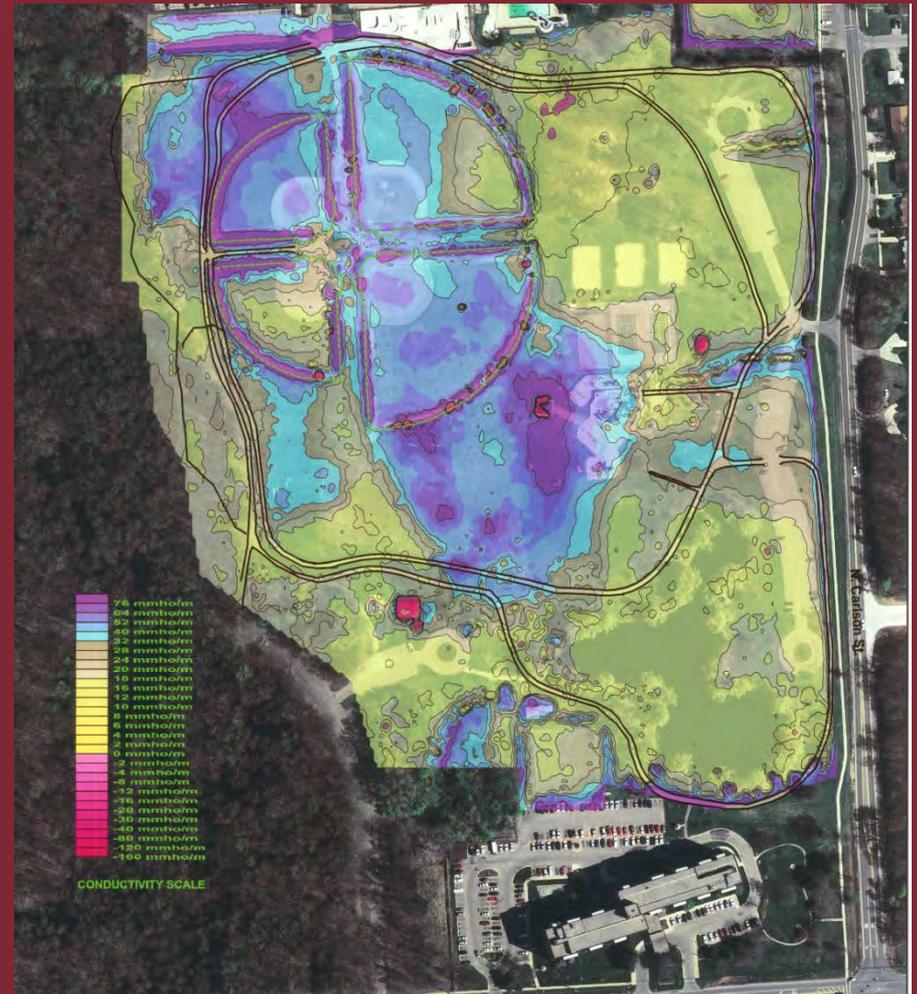
## CONDUCTIVITY

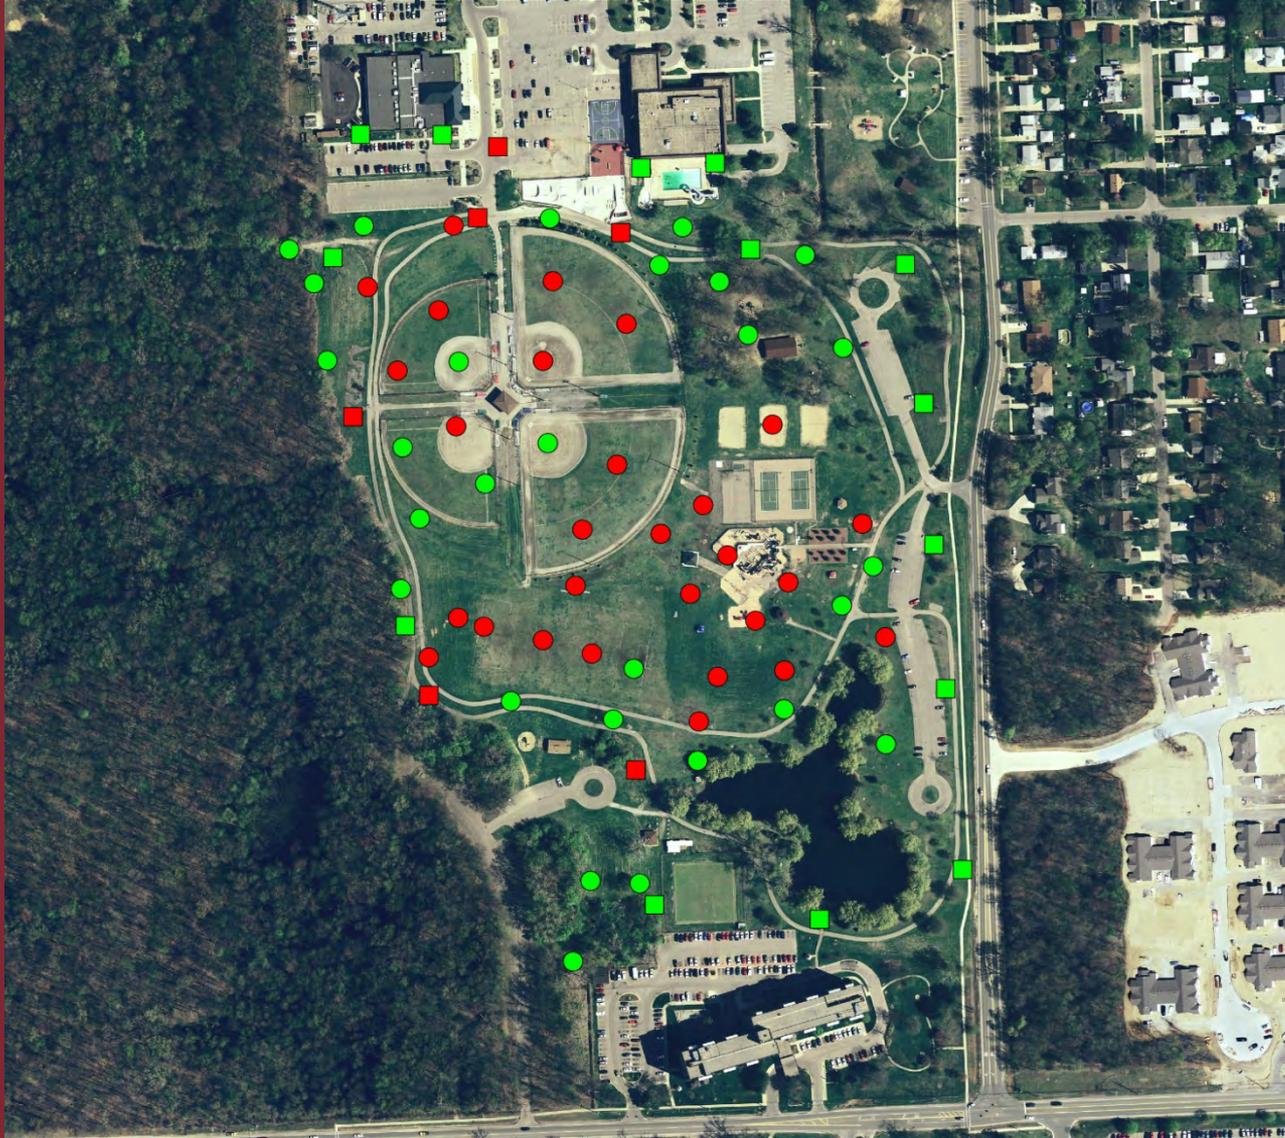
# METHANE

- Passive Ventilation Trench along Northwestern Site Boundary with monitoring
- Sub-slab vapor barrier and passive ventilation system installed under concession/comfort building and other future buildings with monitoring
- Monitor methane concentrations at:
  - » Eastern portion of northern Park boundary
  - » Eastern Park boundary
  - » Eastern portion of southern Park boundary
- O&M

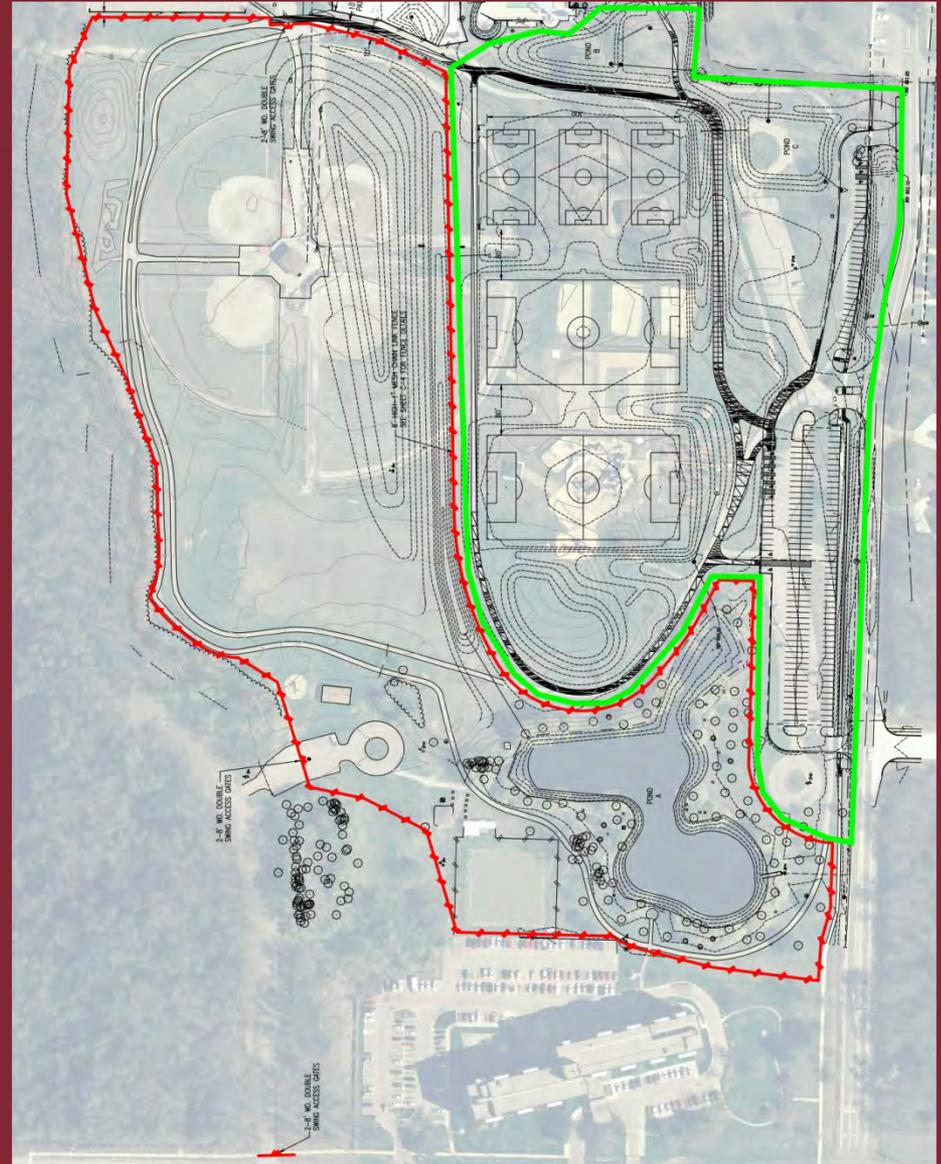
- **Divide Park into two areas**
  - Recreation Area on eastern portion of site to develop with:
    - » Park use
  - Restricted Access Area encompassing southern and western portions of site
    - » Remain undeveloped

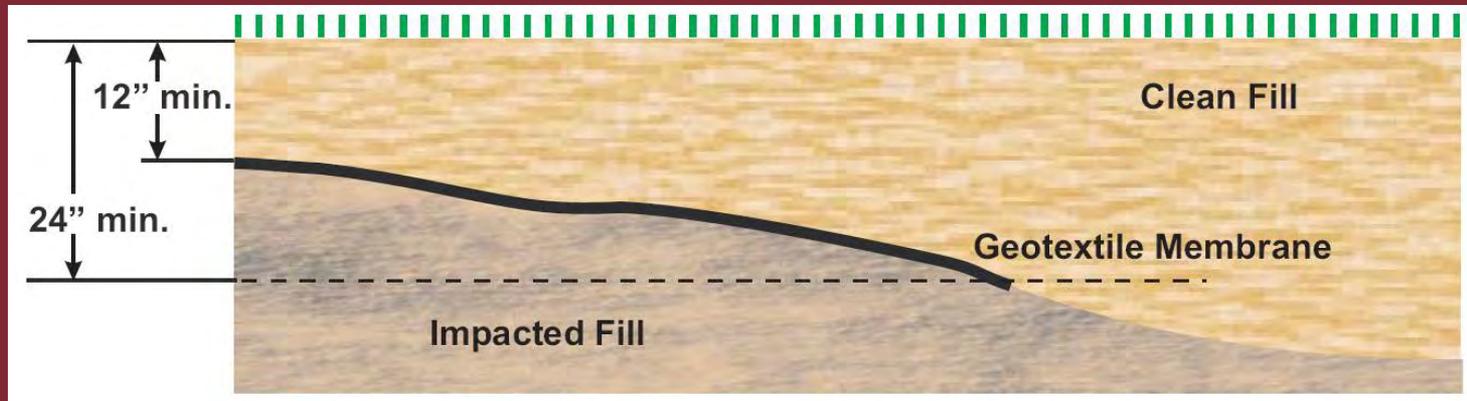
- **Recreation area remedy for direct contact**
  - Install engineered exposure barrier

- Rely on Impervious Surfaces (asphalt or concrete walkways and parking areas, concrete building foundations/floors)
- Implement O&M program to maintain exposure barriers or impervious surfaces

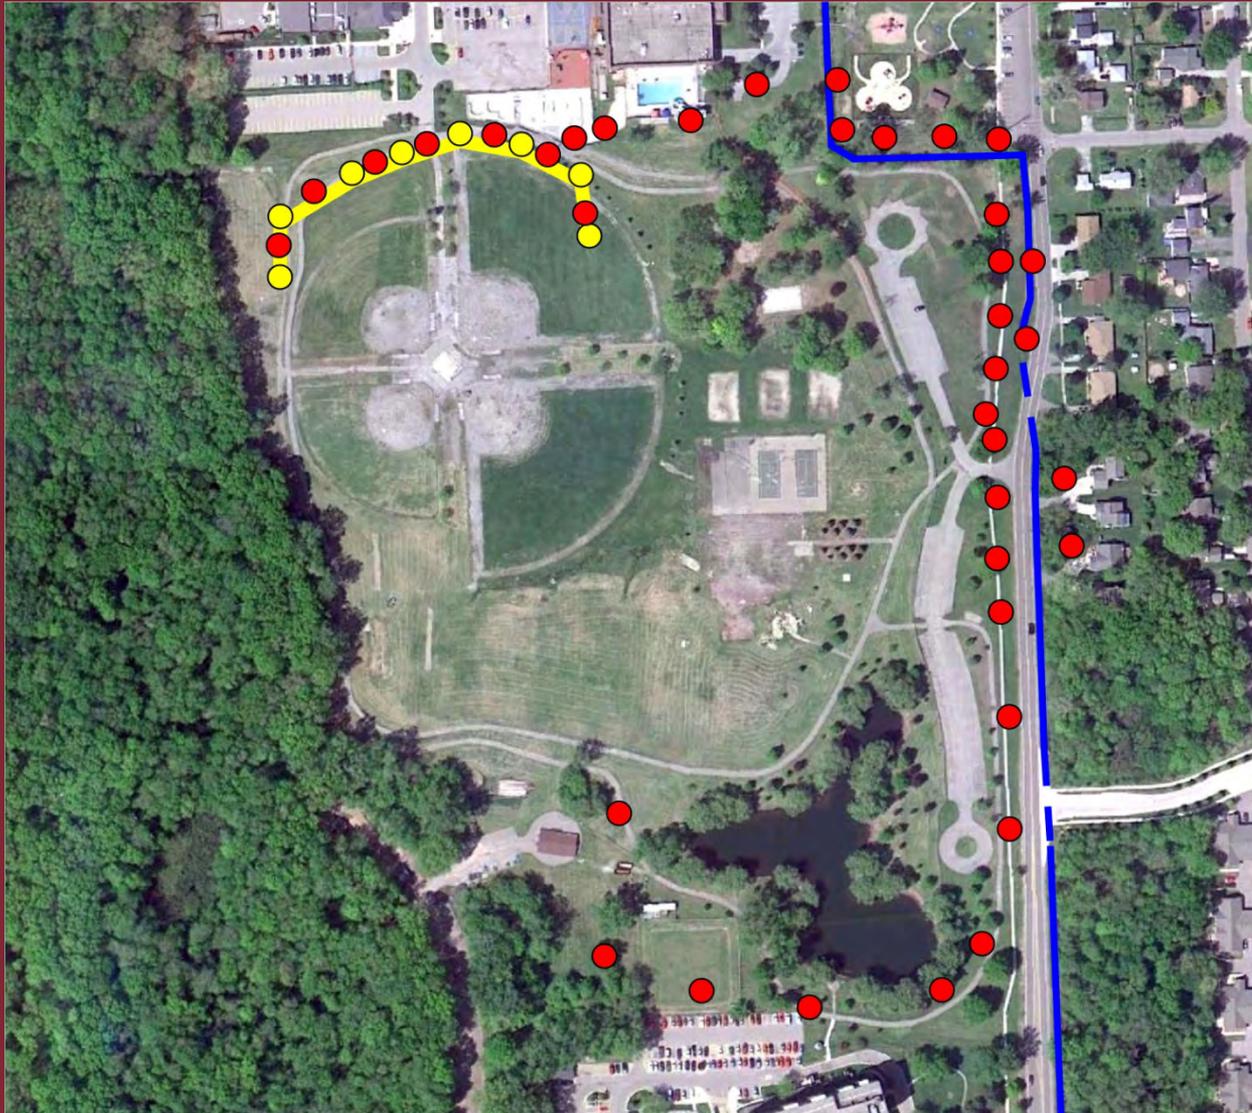
# METHANE MONITORING

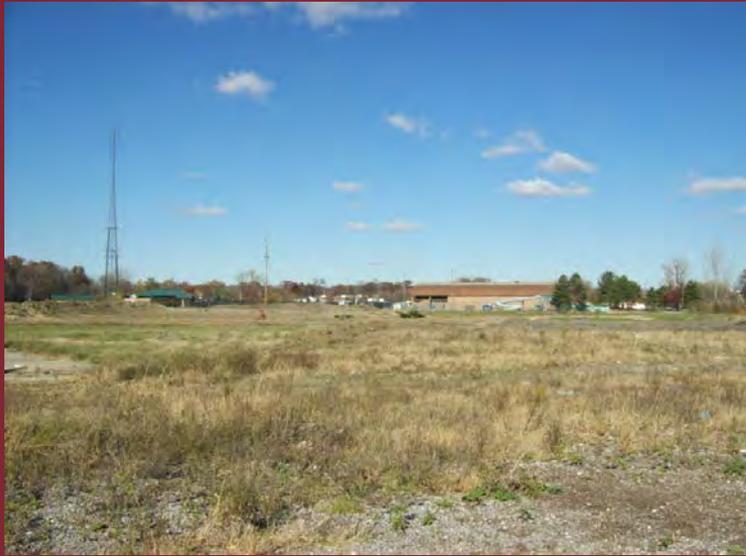
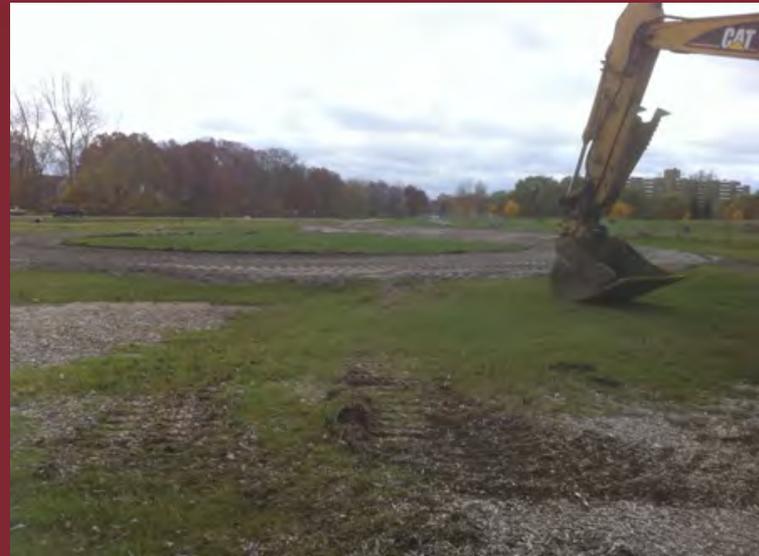
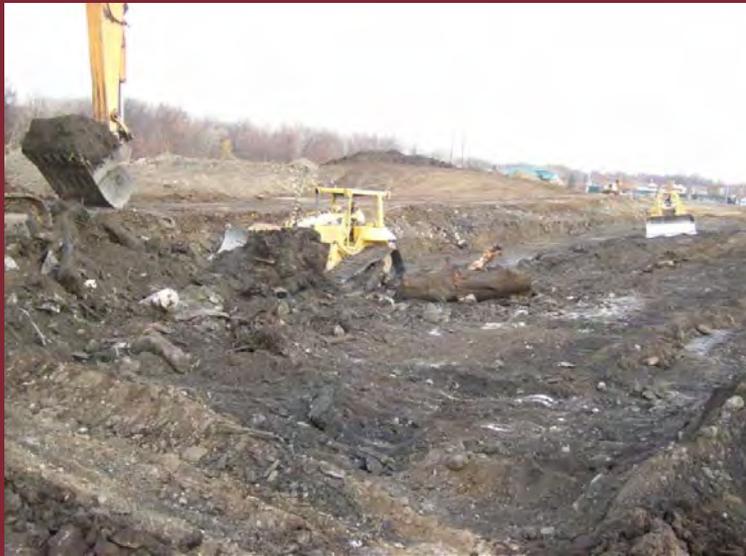
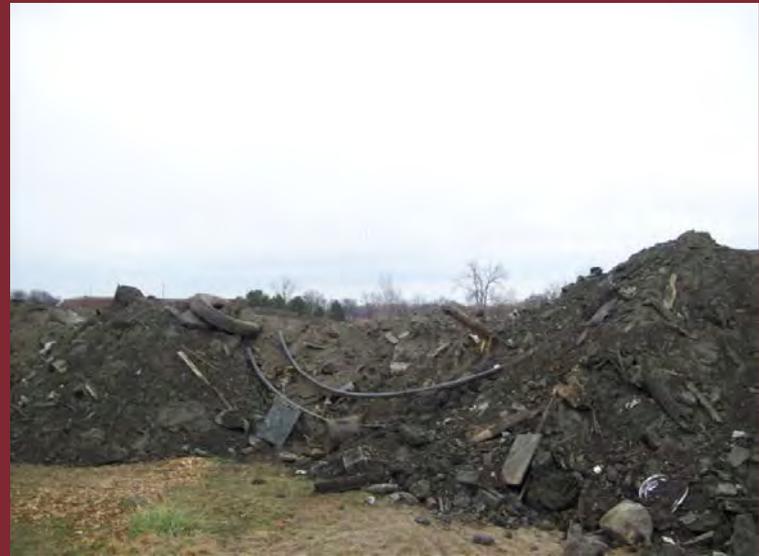
# GRADING

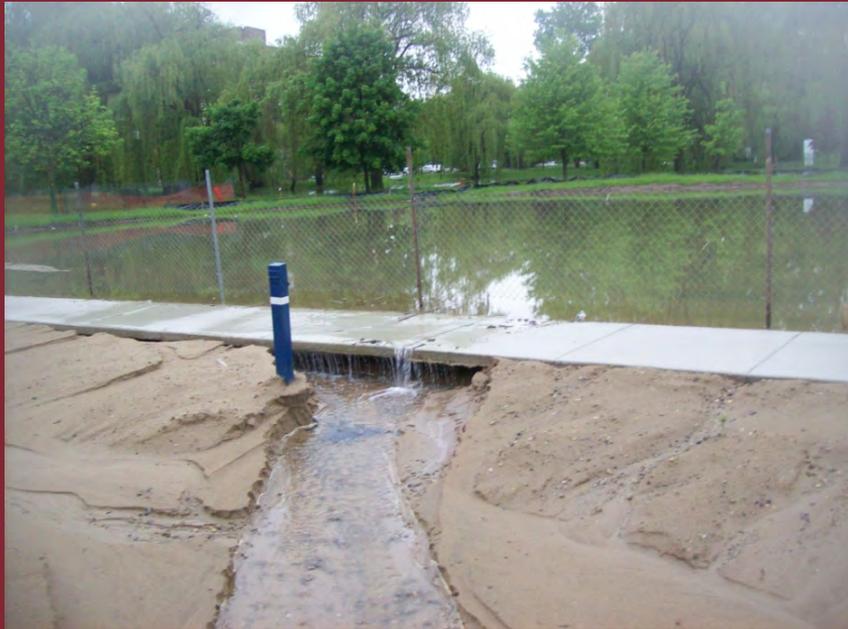
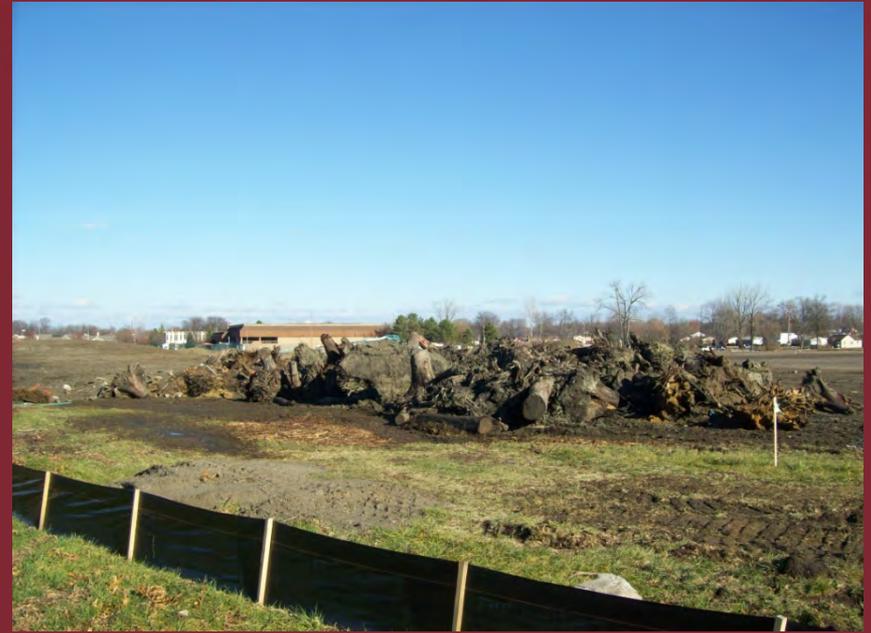
**BURIED STUMPS** →

← **SPRING RAINS**

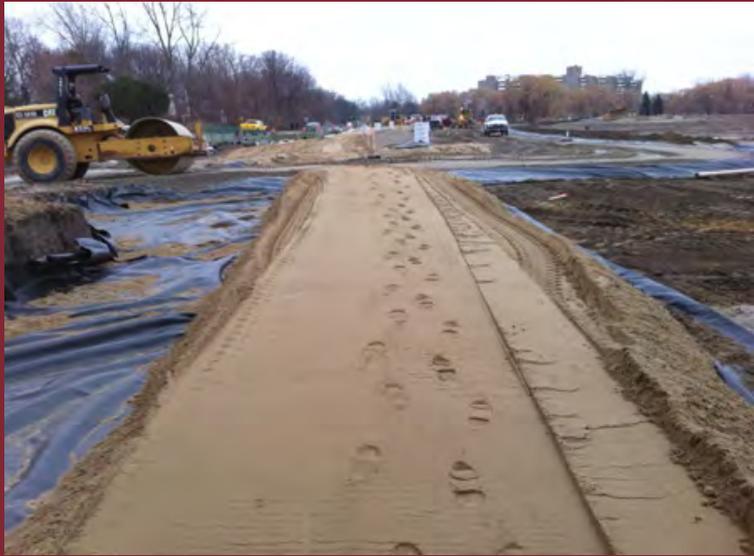
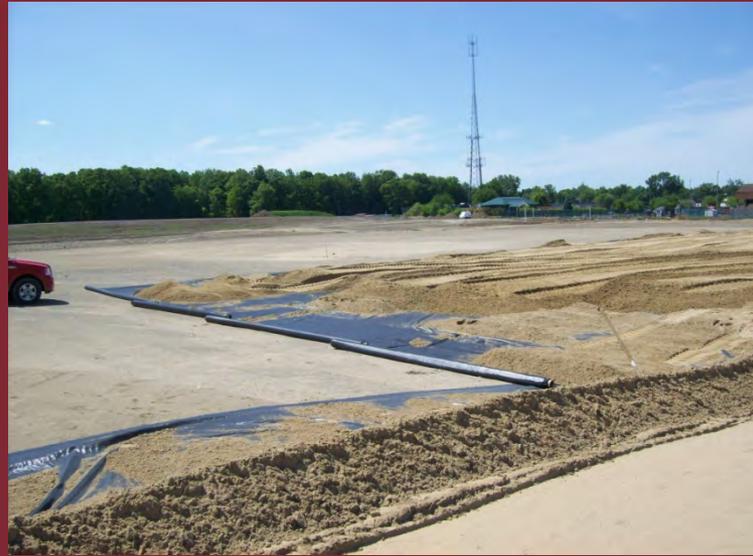
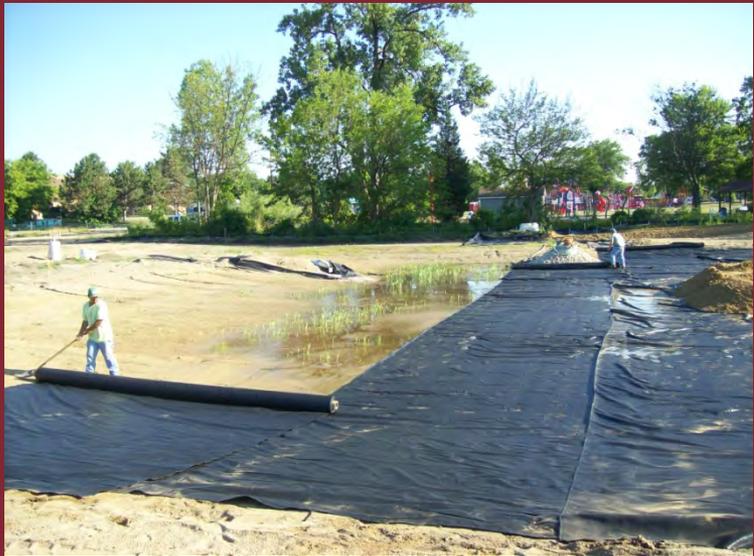
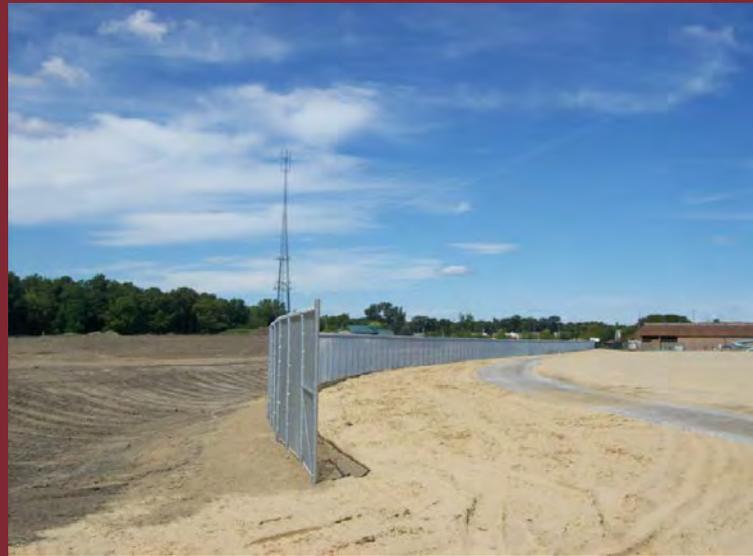
# GEOTEXTILE AND FILL PLACEMENT

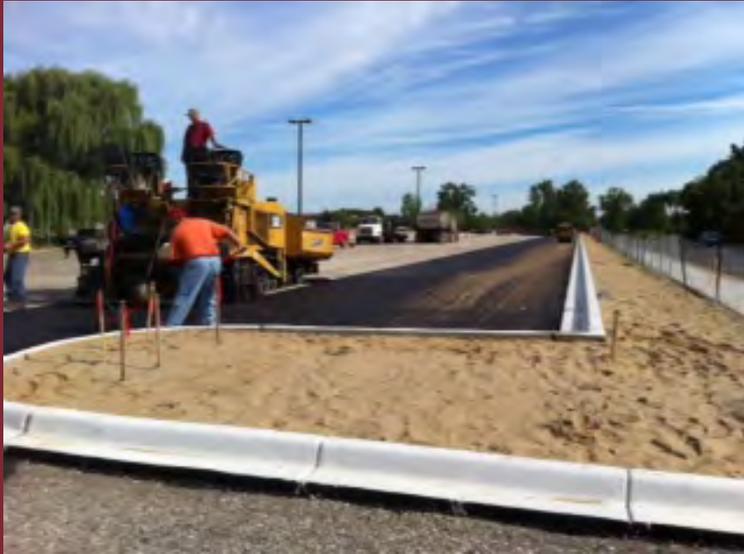
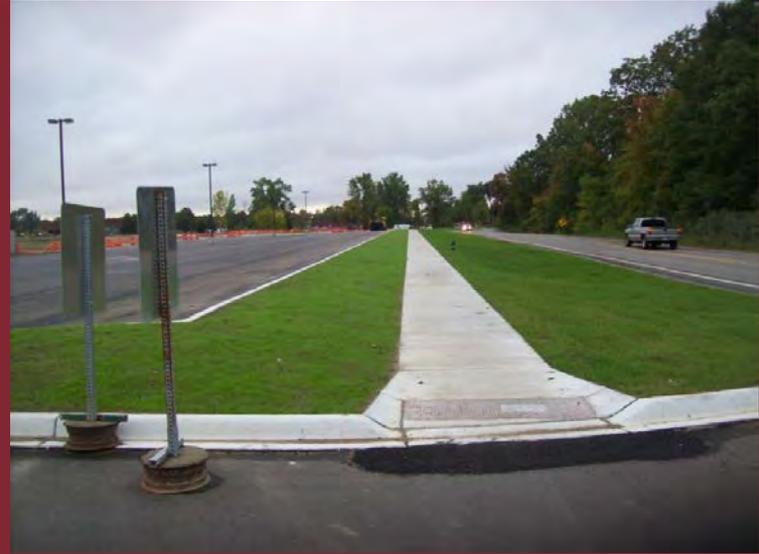
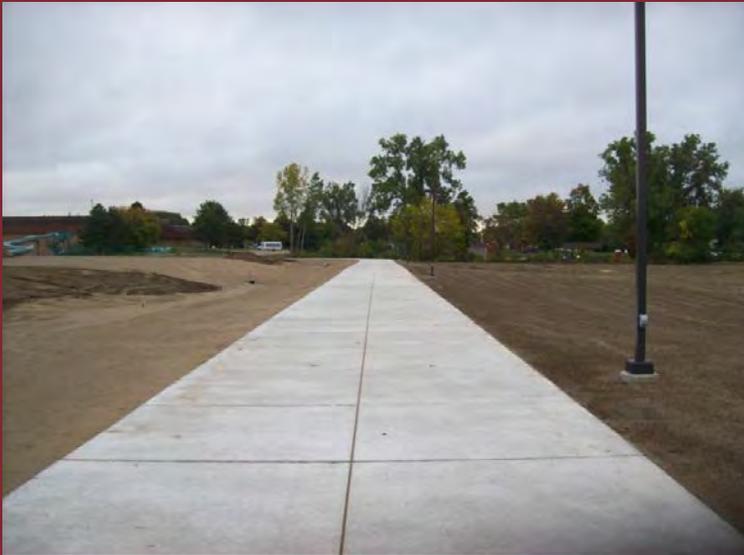
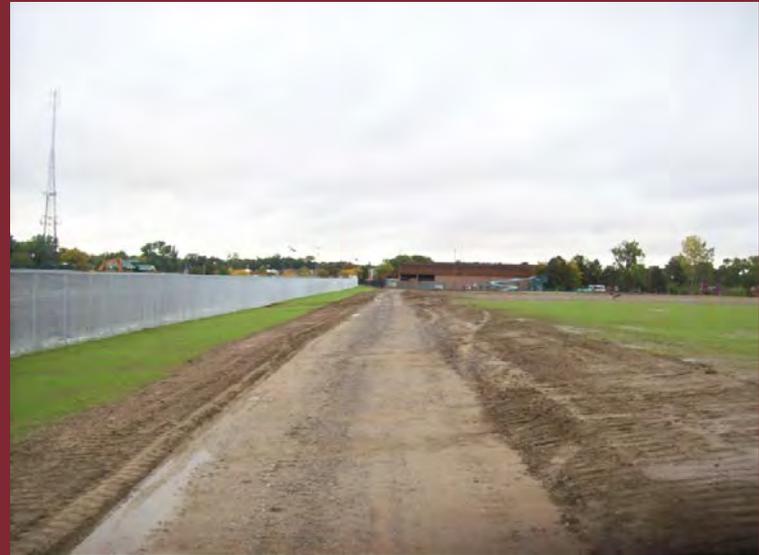
# PAVING

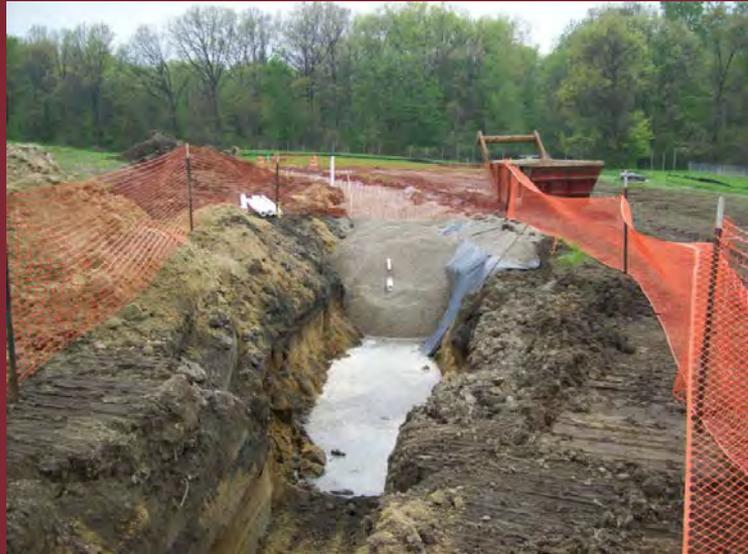
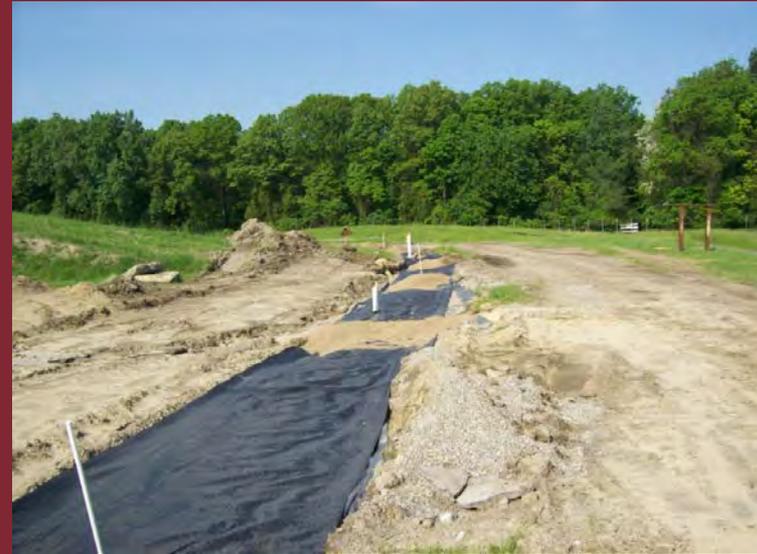
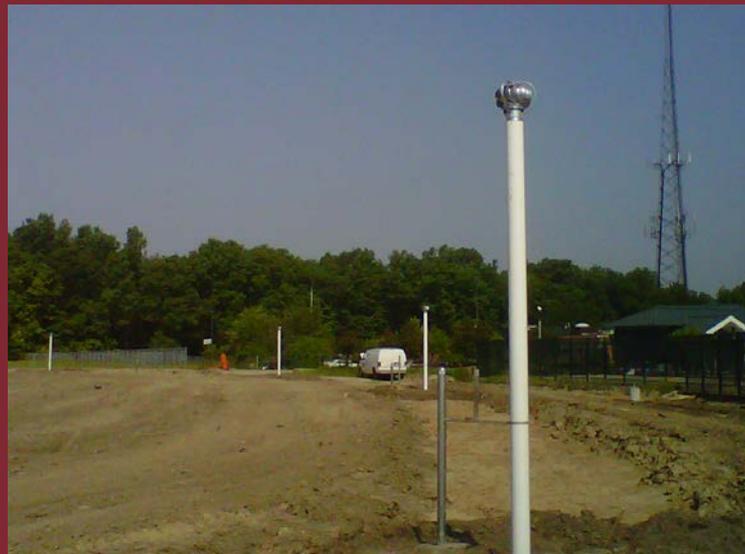
# PVT CONSTRUCTION
