Biological and Water Quality Study of the Paint Creek Watershed 2006

**Clinton, Fayette, Greene, Highland, Madison, and
Ross Counties**

OHIO EPA Technical Report EAS/2008-1-2

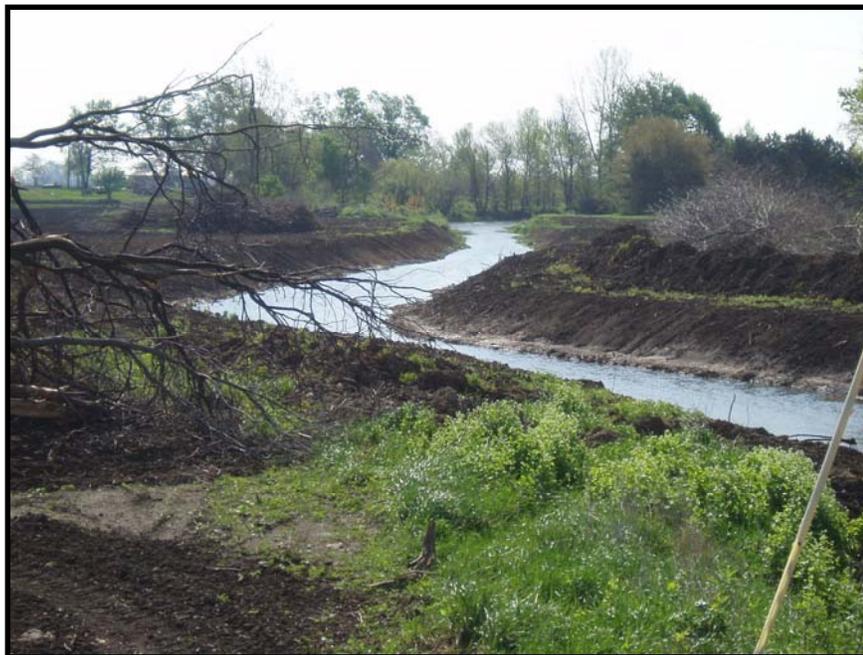
Figure 16. Channelization of the West Branch Rattlesnake Creek upstream from SR 729 observed in 2006. The West Branch Rattlesnake is petitioned for county drainage maintenance.

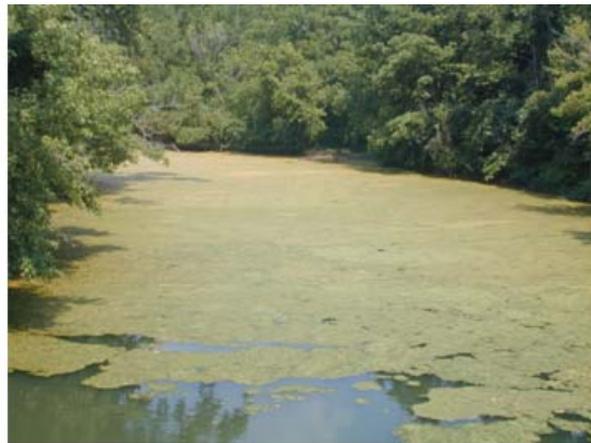
Figure 31. Algae bloom in Rocky Fork upstream Barrett Mill Road.

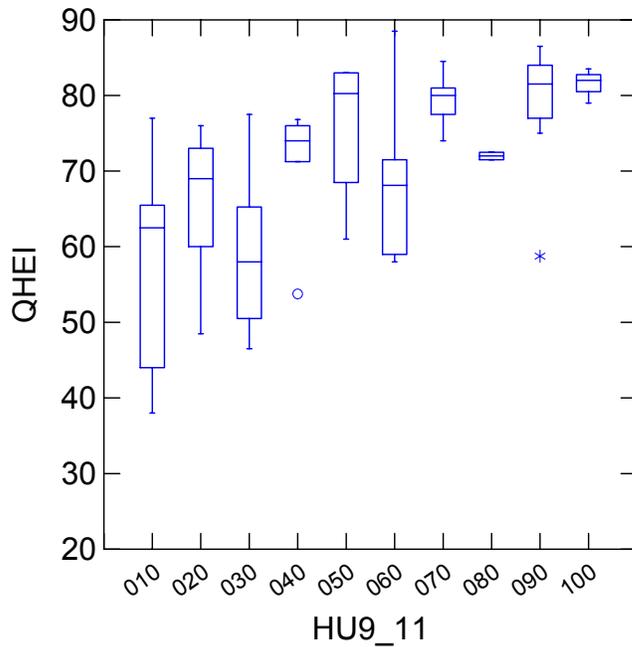
Figure 45. Distributions of QHEI scores by 11-digit hydrologic unit for wadeable streams sampled in the Paint Creek basin, 2006.

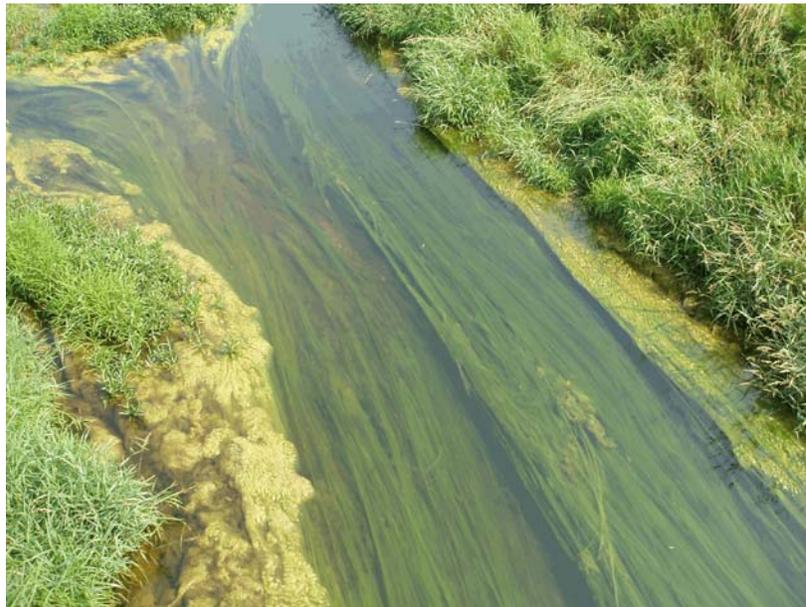
Figure 54. Top panel - line plot of IBI scores for Sugar Creek, 1997 and 2006, in relation to the Jeffersonville WWTP and the numeric biocriterion for wadeable WWH streams. Bottom panel - a nuisance bloom of filamentous algae in Sugar Creek.

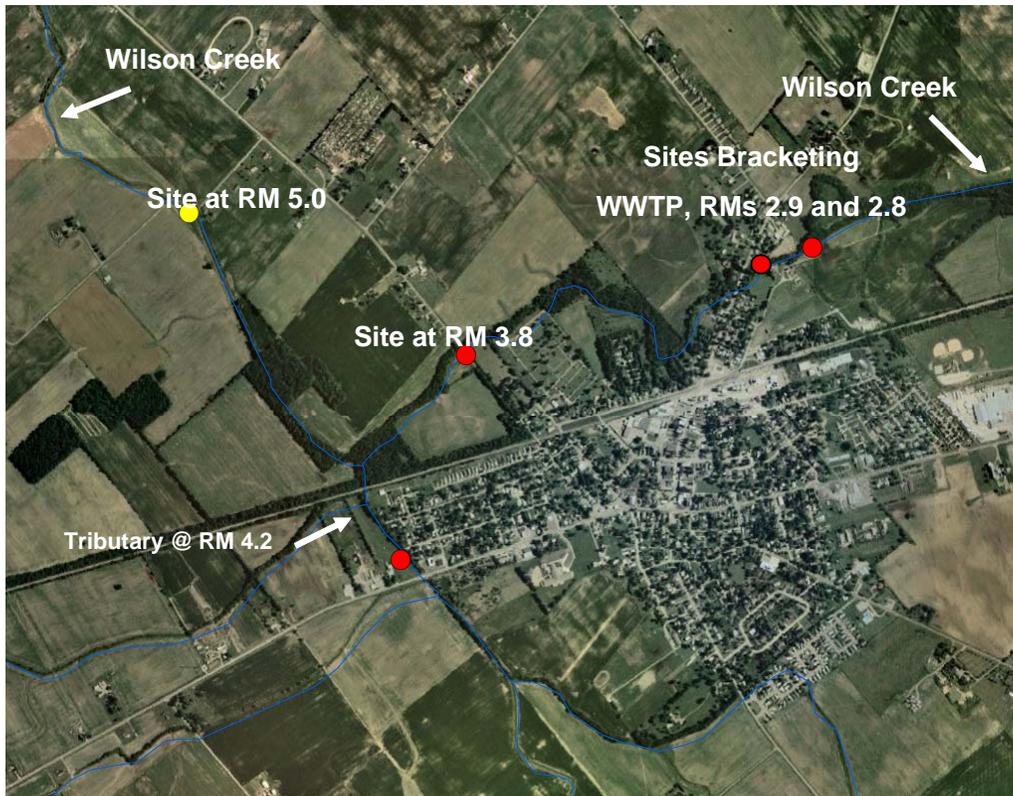
Figure 66. Aerial photo of the Wilson Creek drainage in the vicinity of Sabina. Sampling locations referenced in the text are noted and color-coded by attainment status (red - not meeting WWH; yellow partially meeting WWH).

Macroinvertebrate communities in Wilson Creek were sampled upstream from Sabina at RM 5.0, downstream from an unnamed tributary that receives stormwater from Sabina and enters Wilson Creek near RM 4.2, and bracketing the Sabina WWTP at RMs 2.9 and 2.8 (Figure 66). Upstream from Sabina (at RM 5.0), the macroinvertebrate community was limited by poor habitat, and rated at the lower end of the fair range. Downstream from the unnamed tributary, the macroinvertebrate community was also rated at the low-end of the fair range, and appeared limited by sediment and stormwater. Also, an organic odor was noted, and was especially pronounced in the unnamed tributary where macroinvertebrates similarly scored in the low-fair range. The sites bracketing the Sabina WWTP failed to meet WWH, as the macroinvertebrate communities were rated at the lower end of fair for the site downstream from the municipal WWTP, and poor immediately upstream from the WWTP. The sample collected upstream from the WWTP (RM 2.9) contained mostly flatworms, and was limited by poor habitat and stormwater from Sabina. Downstream from the WWTP the macroinvertebrate community was affected by organic enrichment, low D.O.s, and elevated ammonia concentrations from the effluent.
