U.S. Army Corps of Engineers - Buffalo District

**Black River Area of Concern/Remedial Action
Plan (AOC/RAP)
French Creek Watershed Survey
Lorain County, Ohio**

**SUBJECT: U.S. Army Corps of Engineers, Buffalo District - Survey of French Creek
Final Report - July 2004**

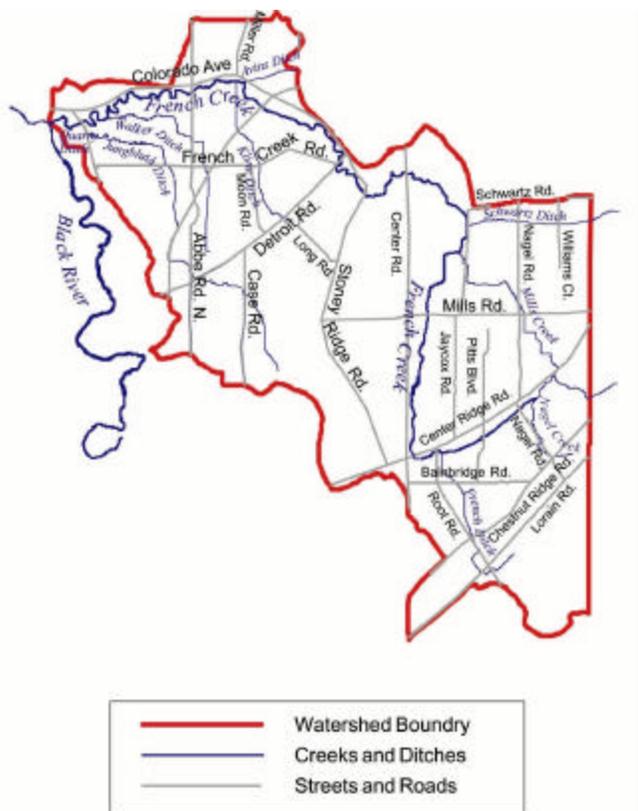
Figure 1: French Creek Watershed.

The stream segments investigated during this survey included portions of the following (reference Figure 1):

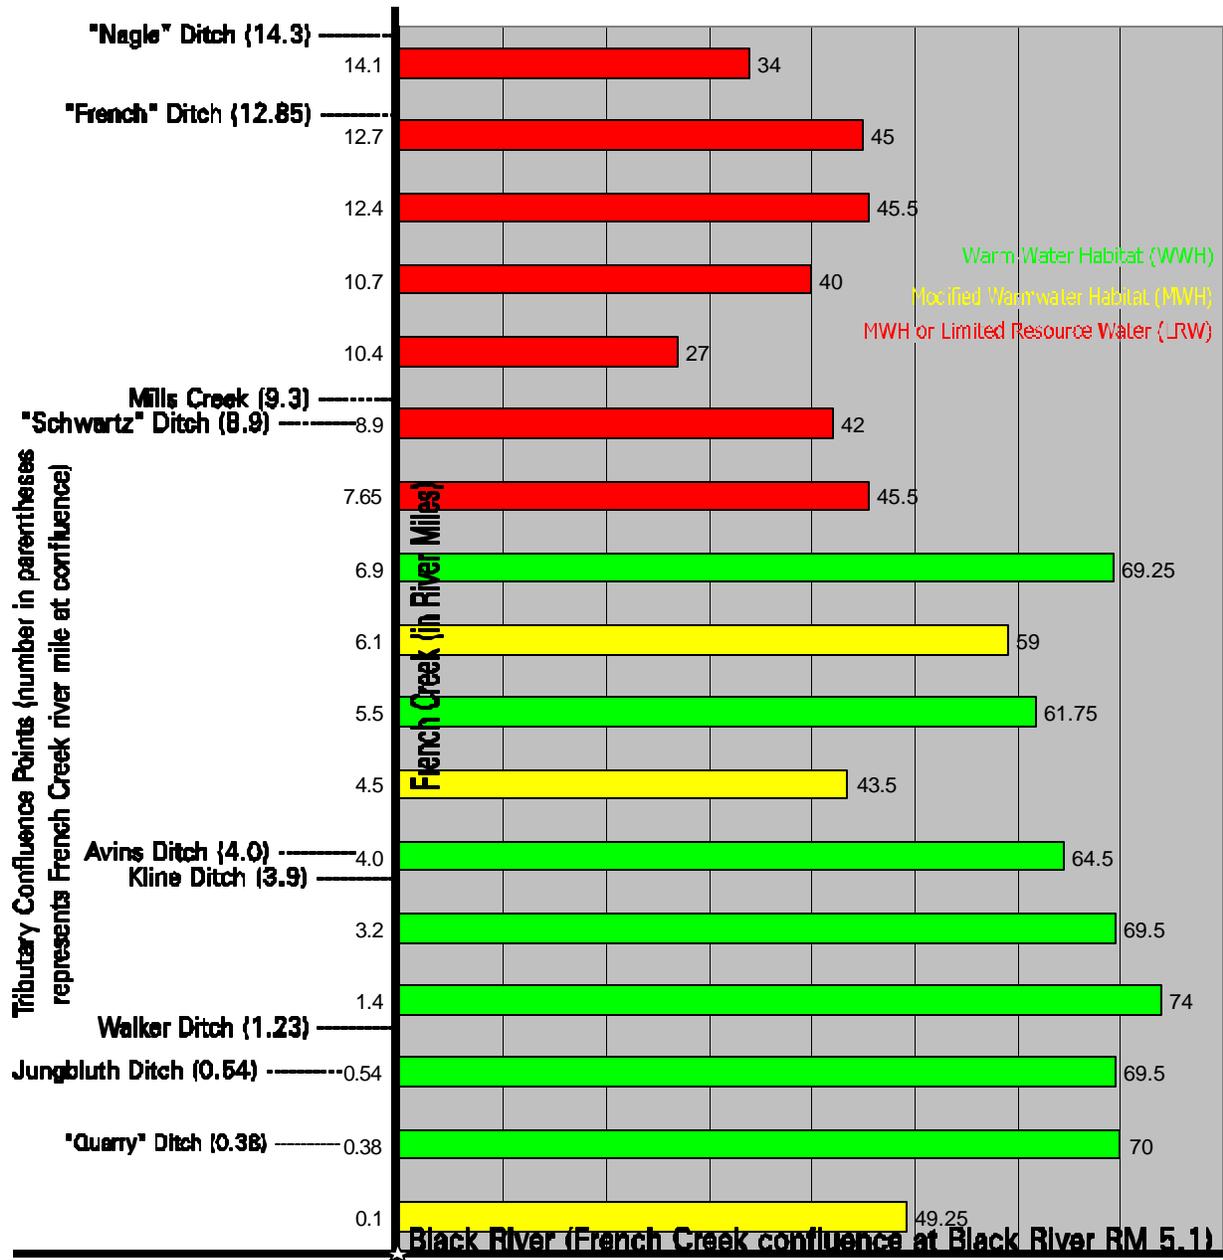
Figure 2: Schematic of the French Creek Watershed with QHEI Scores.

In general, the QHEI survey conducted on French Creek and its tributaries showed a downward trend in QHEI scores, starting from the mouth and progressing upstream through the headwaters of the creek. The sites within the first section (RM's 0.1 – 6.9) of the creek received on average favorable scores which attained the creek's designation as WWH. The second section of the creek (RM's 7.65 – 14.1) received scores that would put the creek in non-attainment of its WWH designation. Figure 2 depicts a schematic of the French Creek watershed, and indicates the QHEI scores attained at each of the French Creek sites. Sections 2.2.1.1 and 2.2.1.2 include a brief description of the findings and observations derived from the survey in the downstream and upstream portions of French Creek, respectively.

2.2.1.1 River Mile 0.1 through 6.9: With the primary exceptions of the site at the mouth of the creek (RM 0.1) and the site located near the I-90 crossing (RM 4.5), the lower 7 river miles of French Creek received QHEI scores that would be consistent with a designation as WWH, with an average score of 63.3. Figure 3 is an aerial view of the lower 7 miles of French Creek. The site at the mouth of the creek received a low score due to several factors. First, the substrate at the site, while dominated by gravel, was highly embedded with silt. Amplifying this effect is that this portion of the creek is relatively straight, over 1 meter deep, extremely slow moving (back flow effects were also noted from the Black River) and

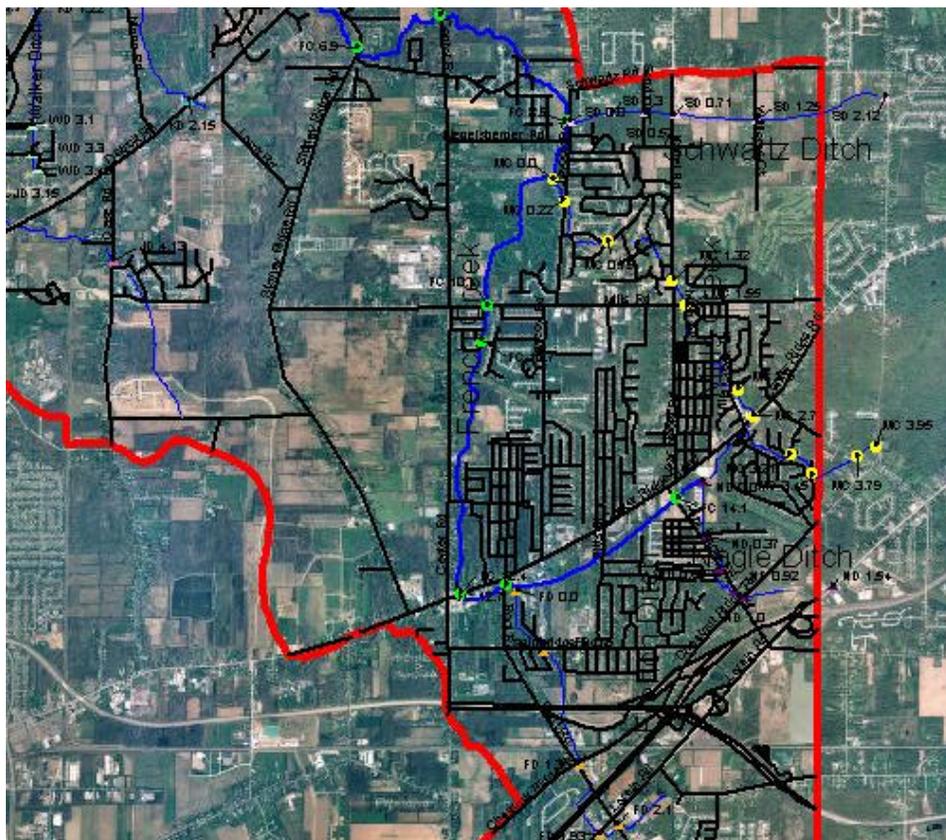
Figure 4: French Creek River Miles 7– 14.

2.2.1.2 River Mile 7.65 through 14.3: The sites on the main stem of French Creek investigated in this portion of the watershed all received scores that indicates non-attainment of its WWH designation. The average QHEI score of the sites in this portion of French Creek was 39.9. These scores indicate that this portion of the creek has scores representing MWH, or in some cases limited resource waters (LRW). This portion of the watershed is developed to a greater extent than the downstream portions, and is dominated by residential and commercial uses. Figure 4 is an aerial view of RMs 7 - 14 of French Creek.

Due to the residential and commercial nature of this portion of the watershed, the primary water quality and river habitat problem noted was the lack of riparian buffers. In most cases, riparian buffers measured less than 5 meters in width, and in many cases no buffer was present. The lack of adequate buffers leads to very flashy storm flows, increased riverbank erosion and increased run-off and sedimentation, which were noted in substrate evaluations. While some moderate amounts of cobble, gravel, and bedrock were present at many of the sites, a predominance of silt and sand substrates was evident. Also attributable to the lack of riparian buffers was a general lack of high quality in-stream cover in this portion of the creek. Most sites investigated within the creek also were channelized, re-routed, or otherwise altered to accommodate residential and commercial development, which has impacted the creek's sinuosity and development of riffle/pool complexes. Riffles and pools tended to be much shallower in this portion of the watershed, also.

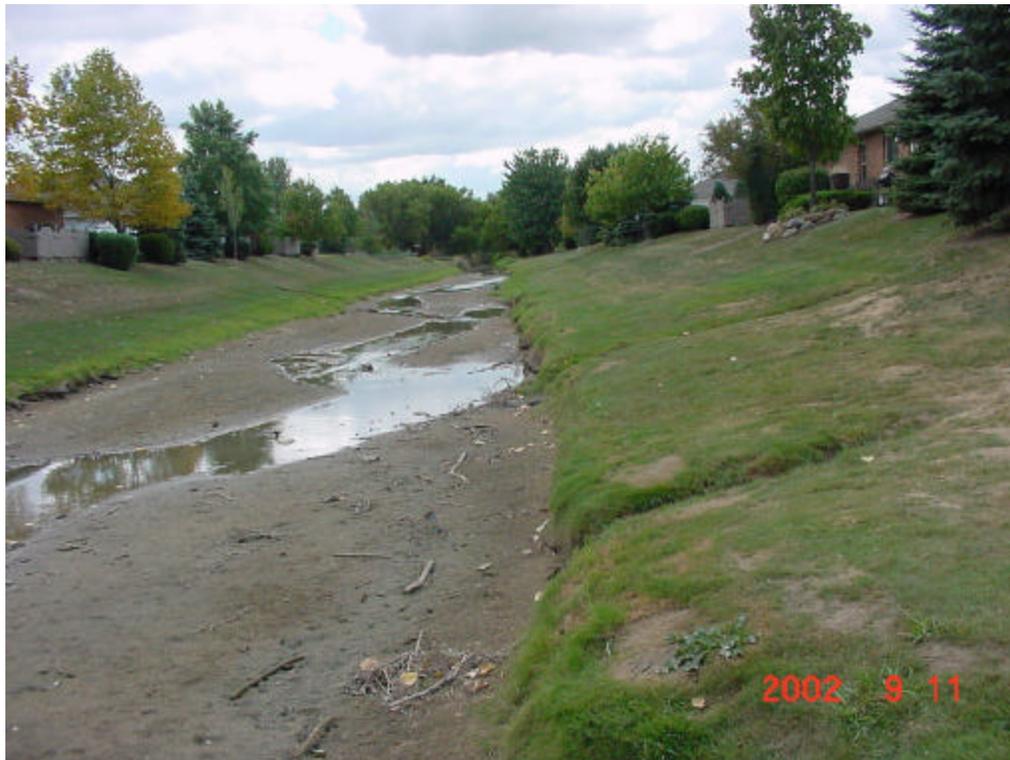
The impairments noted within the stretch from Riegelsberger Road to Mills Road stem from a rapid expansion of residential development in the community of Avon, including numerous subdivisions and condominium developments. This stretch of the creek also flows through a golf course. The primary impairments noted in this area include a significant lack of riparian buffers, heavy streambank erosion, channel modifications, poor riffle/pool development, and severe overland runoff from adjacent developments and the golf course. Photograph 1 below depicts a view of French creek typical of this stretch. Recommended restoration measures for this stretch of French Creek are outlined in Section 3.1.8.

Photograph 1: French Creek at RM 10.4 (Mills Road).

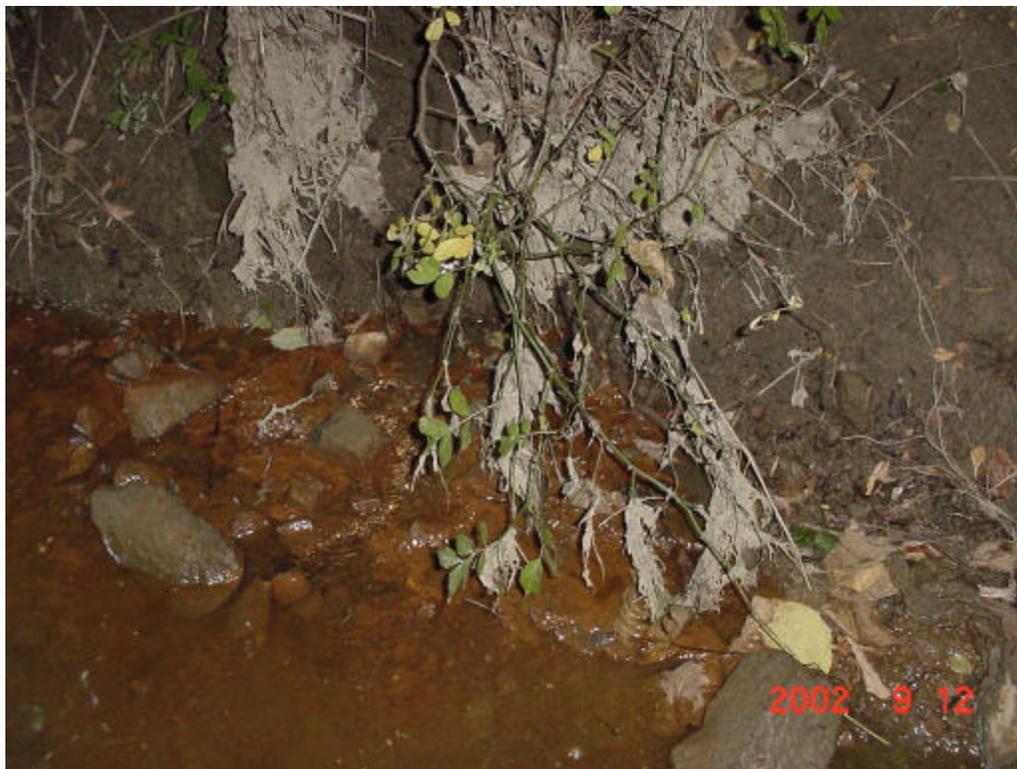
The stream stretch from Mills Road to Center Ridge Road is undergoing similar development pressure to that described above, causing the same concerns. However, this stretch of the creek is additionally impacted by commercial/industrial/municipal development with a series of associated discharges from various culverts and PVC drains from adjacent properties on either side of the creek. These discharges are evidently the cause of a rust-colored sheen in the water column near the upstream portion of this stretch of the creek closest to Center Ridge Road. Photograph 2 below depicts this rust colored discharge. Recommended restoration measures for this stretch of French Creek are outlined in Section 3.1.9.

Photograph 2: Rust-colored discharge noted near RM 12.4 (Center Ridge Road).

3.1.9 Mills Road to Center Ridge Road (RMs 10.4 - 12.4) – This stretch of the creek is undergoing similar development pressure as listed in Section 3.1.8, causing similar concerns. In addition, the upstream portion of this stretch (closest to Center Ridge Road) is bordered by commercial/industrial/municipal development with a series of associated discharges from various culverts and PVC drains from adjacent properties on either side of the creek, causing a rust-colored sheen in the creek. Recommendations for improvement, in addition to those recommended in Section 3.1.8, include investigation of the discharges and enforcement of existing regulations.

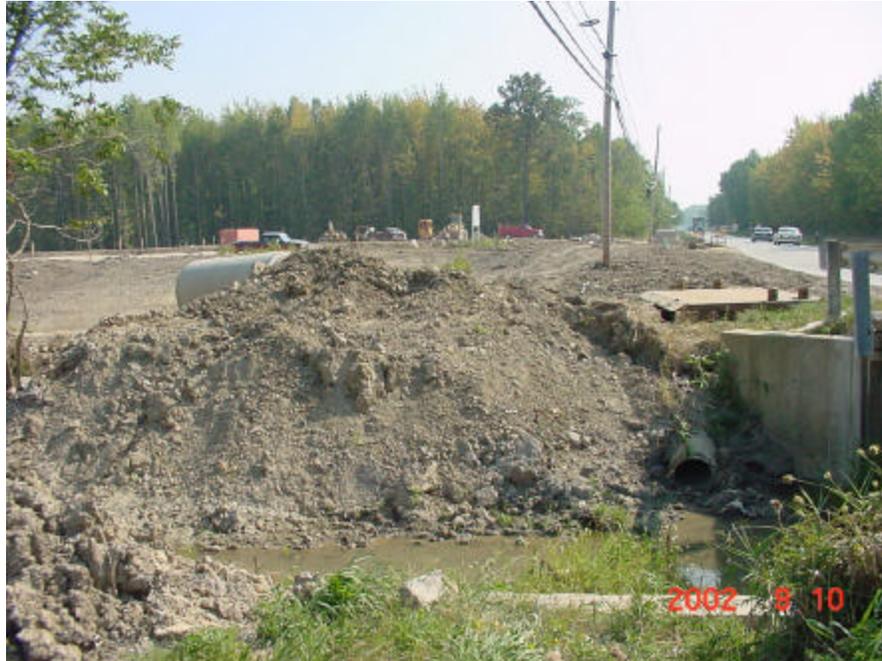
Schwartz Ditch offers examples of some of the most severe impairment in the French Creek watershed. An expansion of residential subdivisions is incurring dramatic impacts to the creek. Impairments include total removal of riparian buffer zones, heavy sedimentation caused by lack of erosion control on construction sites, and channel modification. Photograph 3 depicts some of the construction impacts that were noted along Schwartz Ditch. Section 3.2.6 outlines recommended restoration measures for Schwartz Ditch.

Photograph 3: Construction impacts along Schwartz Ditch.

3.2.6 Schwartz Ditch – Schwartz Ditch offers examples of some of the most severe impairment in the French Creek watershed. A rapid expansion of residential subdivisions is having dramatic impacts to the creek. Impairments include total removal of riparian buffer zones, heavy sedimentation caused by lack of erosion control on construction sites and channel modification.

Recommendations include enforcement of N/SPDES regulations (i.e. installation of silt fences, etc.). Preservation of remaining riparian buffer zones is imperative and creation/enhancement of buffer zones in other areas is strongly recommended. Installation of deflectors is additionally recommended to restore sinuosity.

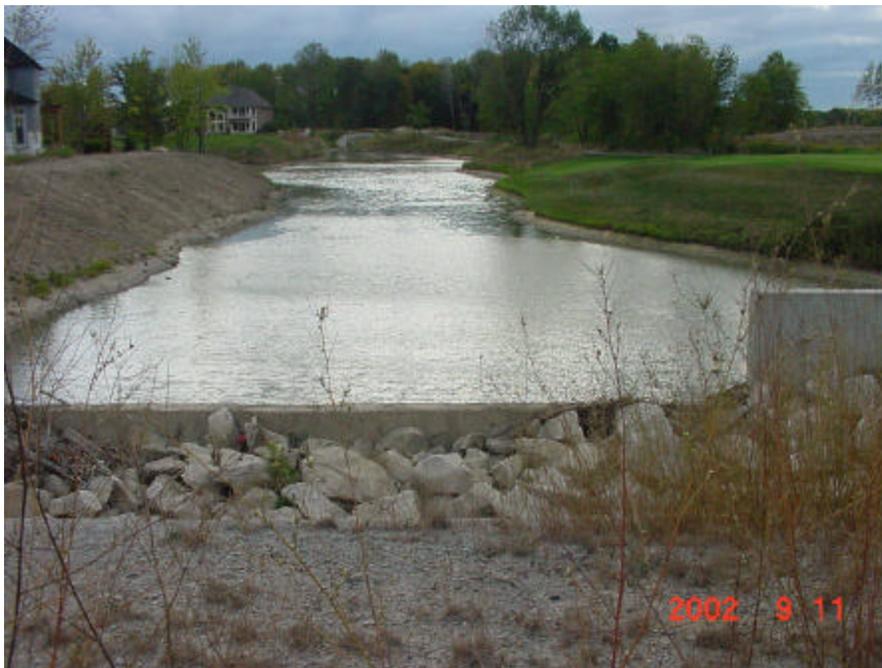
Downstream stretches of Mills Creek have similar impairments to those listed for Schwartz Ditch. Portions have been so impaired that the creek channel is no longer present. Retention ponds have been built within the former channel, portions have been re-routed, culverted and re-shaped. Photograph 4 depicts some of these impacts. Upstream impairments in Mills Creek include a lack of riparian buffer zones and channel modifications (primarily for bank stabilization). Section 3.2.7 outlines recommended restoration measures for Mills Creek.

Photograph 4: Detention Basin/Ponding within Mills Creek.

3.2.7 Mills Creek – Downstream stretches of Mills Creek have similar impairments to those listed in Section 3.2.6 in Schwartz Ditch. Portions of the creek have been so impaired that the creek channel is no longer present. Retention ponds have been built within the former channel, portions have been re-routed, culverted and re-shaped. Upstream, impairments include lack of riparian buffer zones and channel stabilization. Recommendations include enforcement of N/SPDES regulations (i.e. installation of silt fences, etc.), preservation of remaining riparian buffer zones, creation/enhancement of buffer zones and installation of deflectors to restore sinuosity.

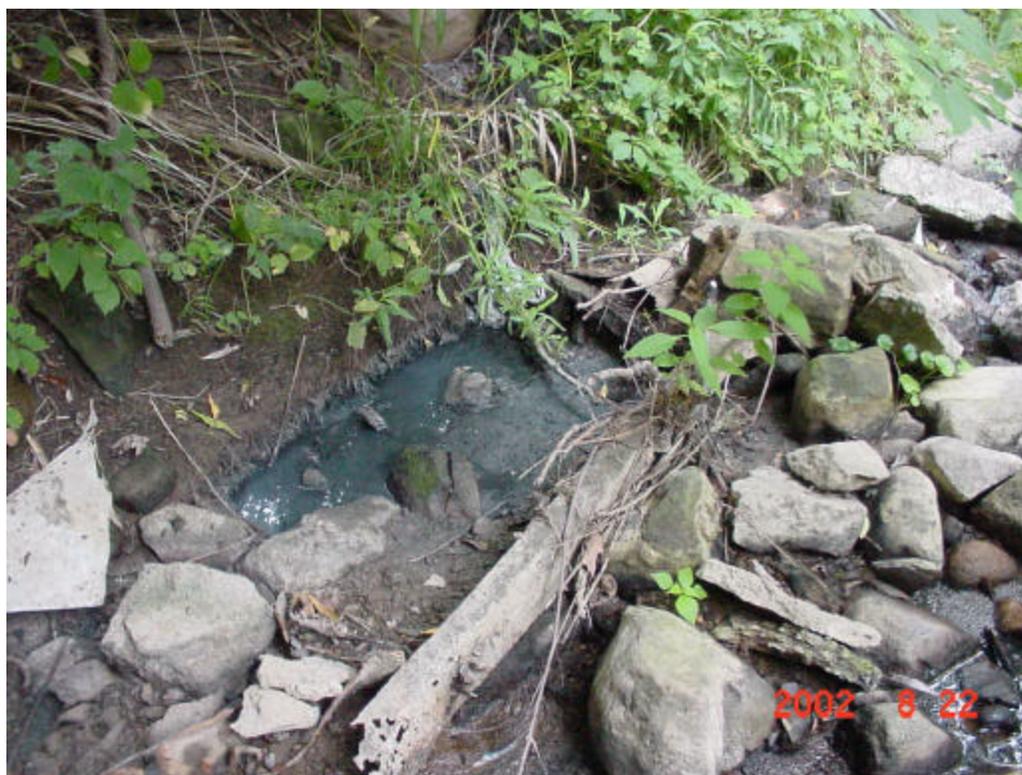
The primary impairments identified within Kline Ditch include significant channelization through/around residential developments, and an associated lack of riparian buffers. Several portions of the ditch flow adjacent to active agricultural fields with little buffer area, increasing the potential for agricultural runoff. Sites investigated in the upstream portions of the ditch exhibited signs of possible contamination from failing HSDS's. These portions of the ditch had little flow and the exposed substrate had a blackish staining. Several PVC discharge pipes and some isolated contaminant pools were also noted. Photograph 5 depicts one of these contaminant pools. Section 3.2.4 includes recommendations for restoration within Kline Ditch.

Photograph 5: Black contaminant pool located along Kline Ditch.

3.2.4 Kline Ditch – Lack of riparian buffers and channel modification are concerns along the entire length of Kline Ditch. In the upstream portions, runoff from agricultural fields contributes to bedload concerns. Upstream of Detroit Road, it appears that the ditch has been contaminated with effluent from failing septic systems. Recommendations include expansion and preservation of riparian buffer zones. Installation of deflectors is recommended to correct channel modifications. Inspection of septic systems and enforcement of health codes is strongly recommended in order to reduce the influx of effluent into the ditch.
