February 2010

## White Oak Creek Watershed TMDL Report

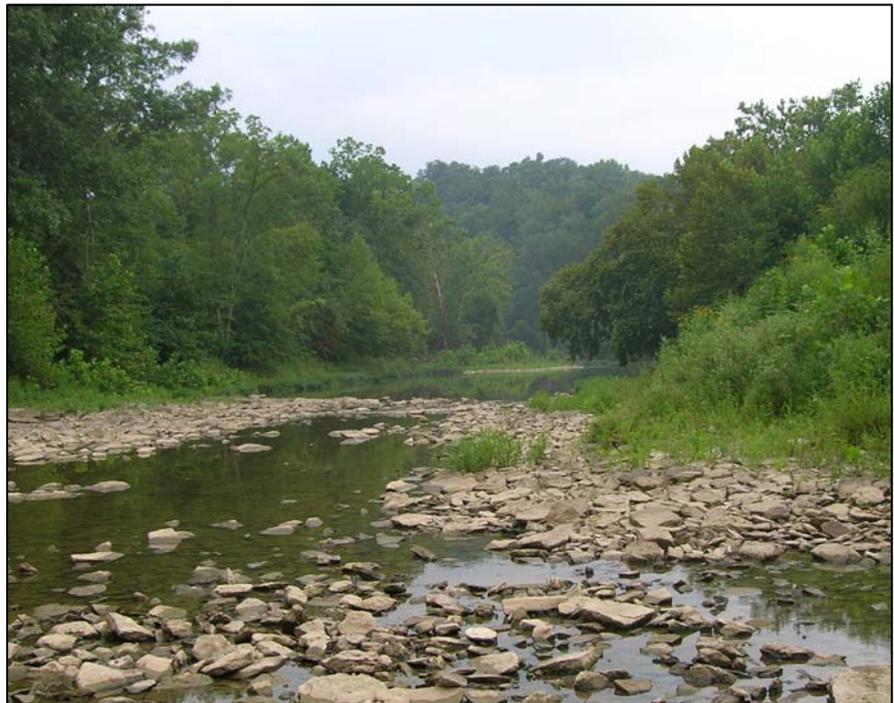
To focus its work, Ohio EPA divided the watershed into two areas: the headwaters of White Oak Creek and Sterling Run – White Oak Creek (see map).
