COMBINED PRELIMINARY ASSESSMENT/SITE INSPECTION REPORT

DAYTON WAREHOUSE
CITY OF DAYTON
MONTGOMERY COUNTY, OHIO

REVISION 3
SEPTEMBER 2005

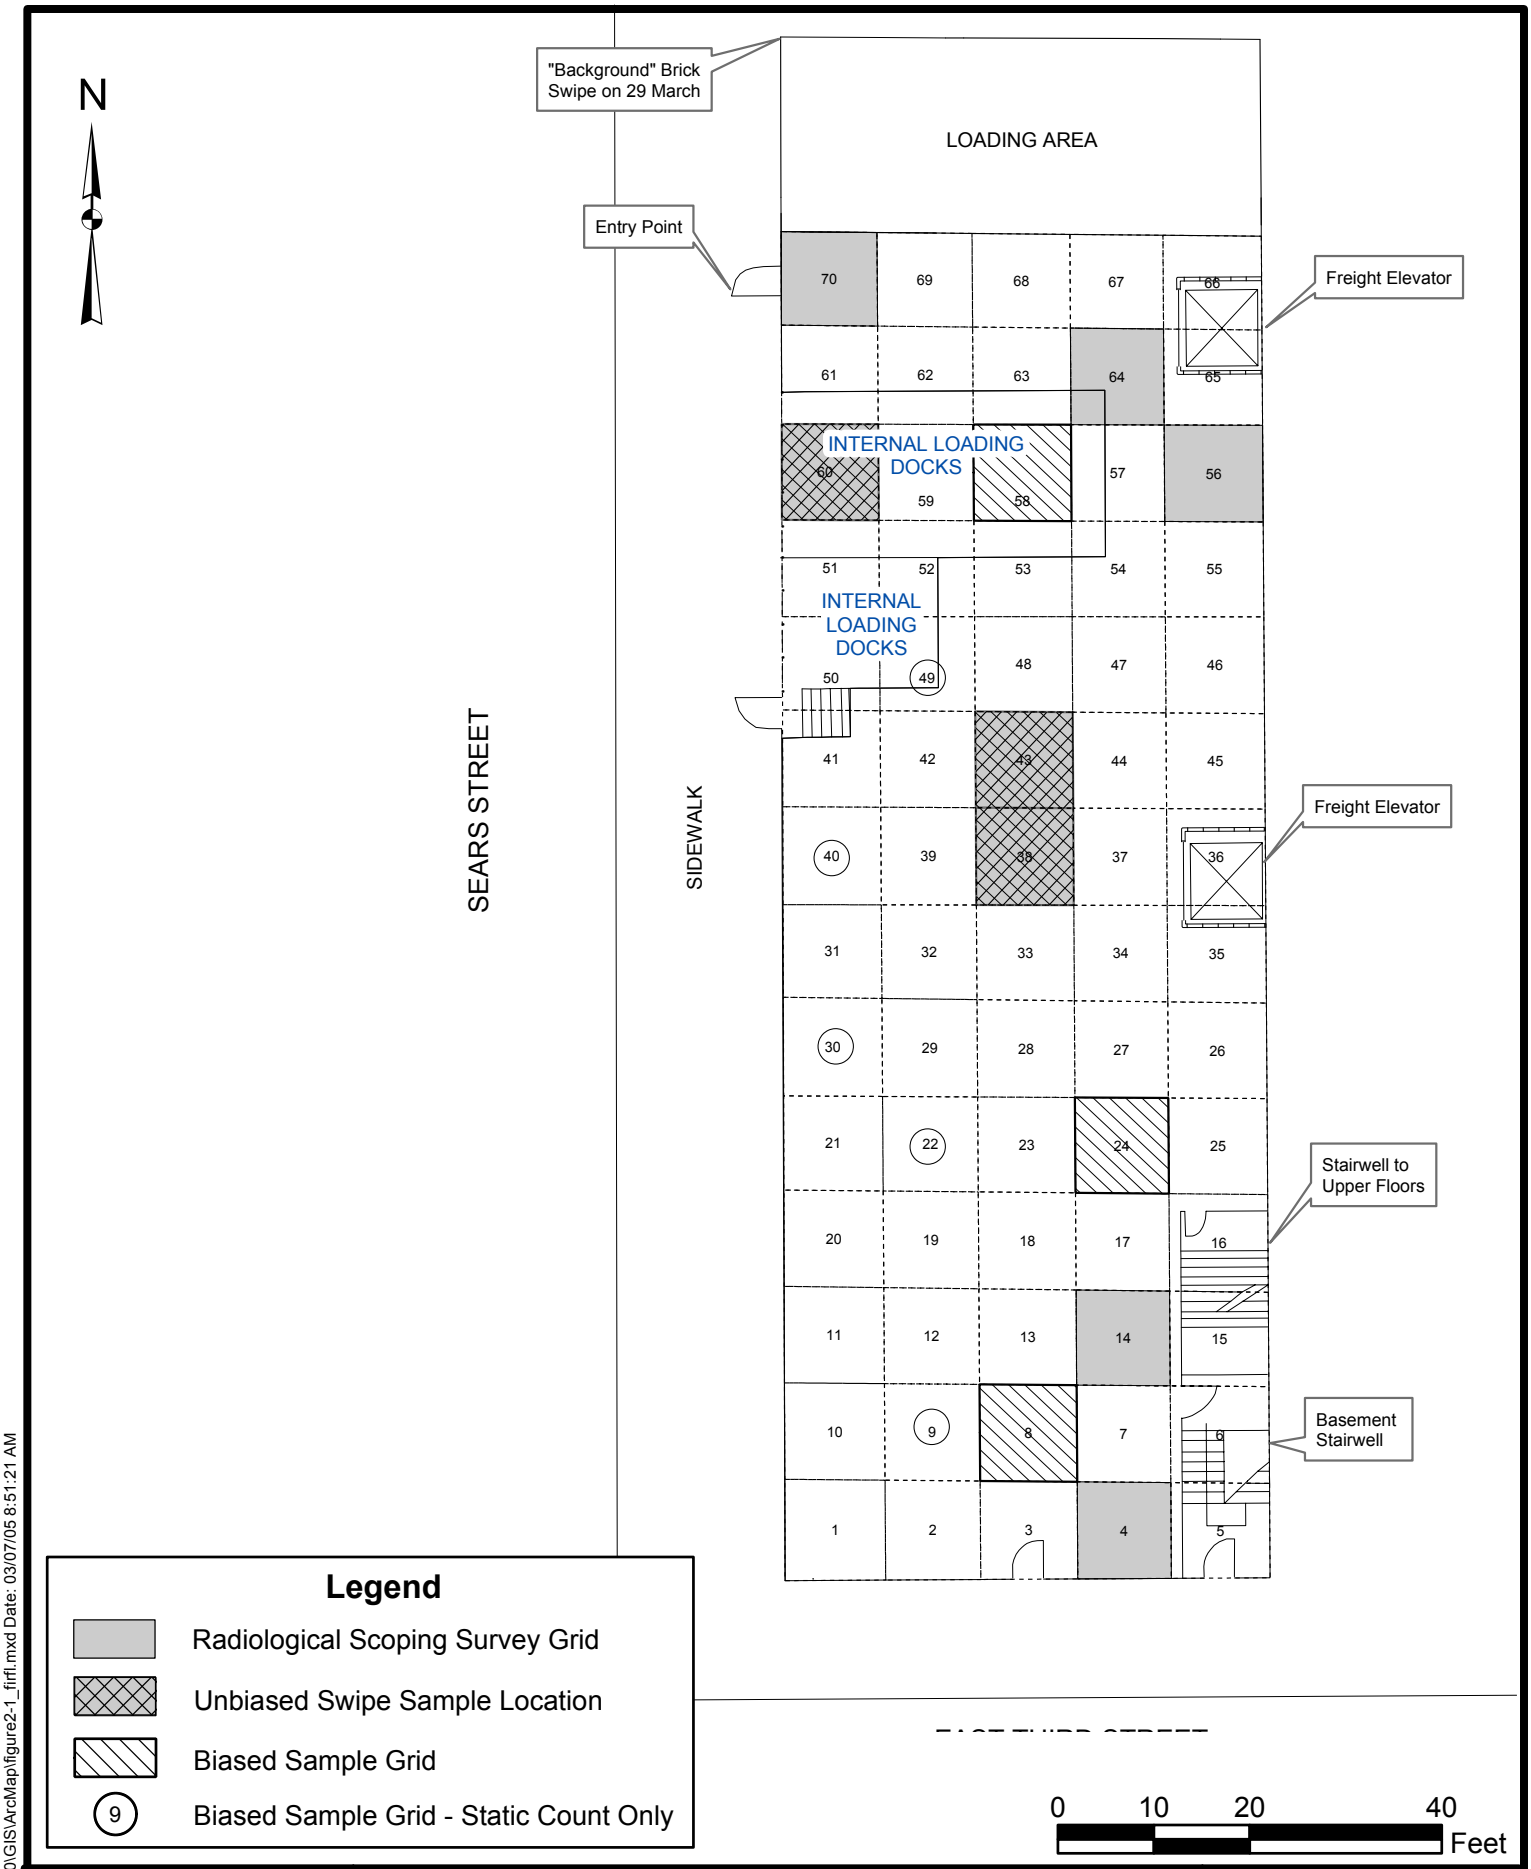
FIGURE 2-1

As shown on Figure 2-1, the biased and unbiased survey grids on the first floor were generally located in the center and along the east side of the building. Five additional survey grids were selected in the field along the west side (9, 22, 30, 40, and 49) for more complete coverage. Because of obstructions, only static measurements were made in these locations.

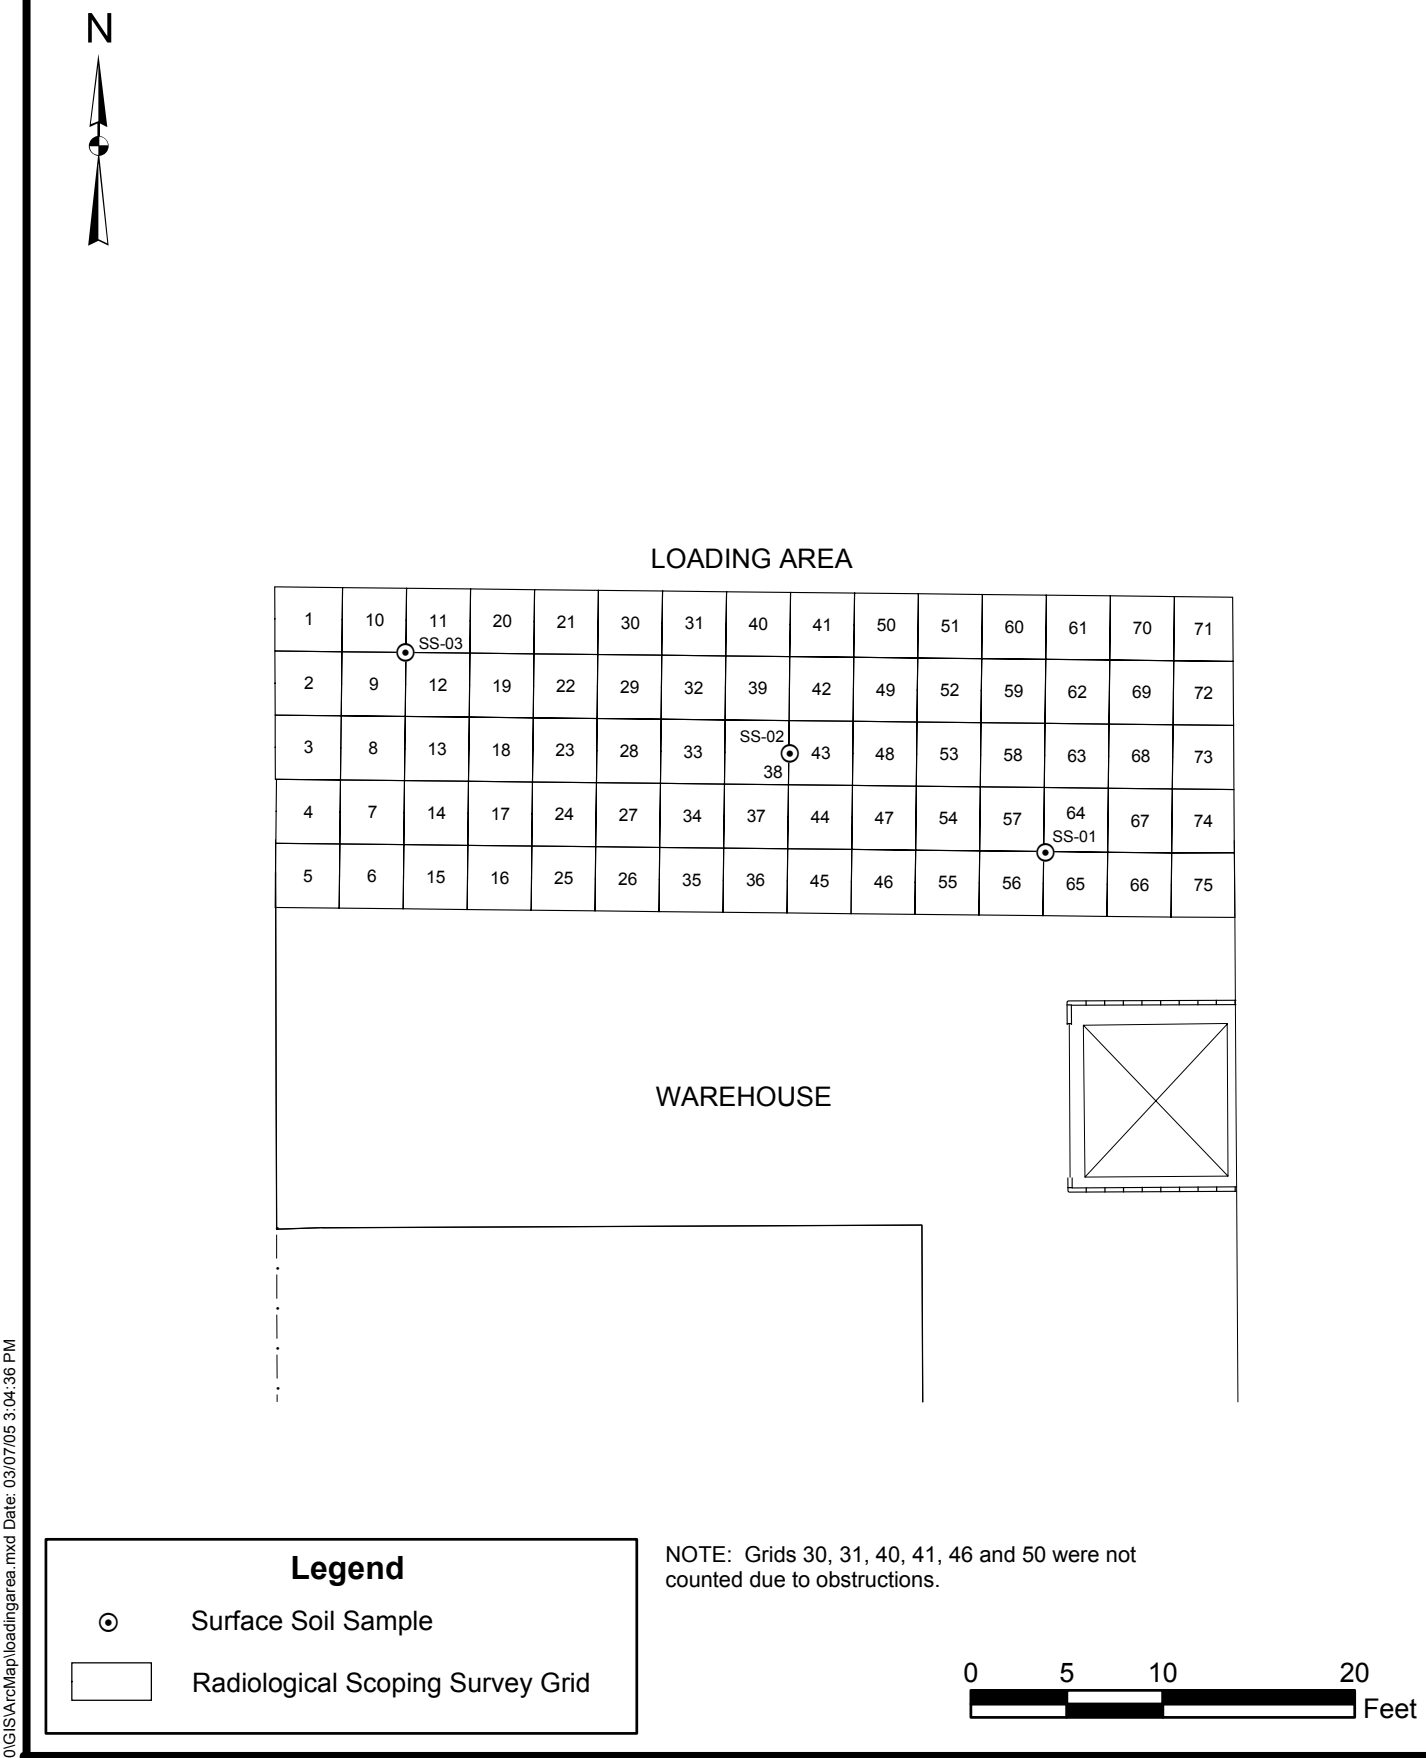
FIGURE 2-2

The loading area was divided into 75 squares measuring about three feet by three feet (See Figure 2-2). Each square was scanned for one minute, except for squares 30, 31, 40, 41, 46, and 50, which could not be scanned because of obstructions. The square size was selected as the largest size that could easily be scanned by the operator kneeling and/or squatting on the ground (see photograph 31, Appendix A).

The objective of the loading dock survey was to select the location of three surface soil samples required by the *Sampling and Analysis Plan.* The three samples, taken from zero to six inches at the locations of the highest beta radiation counts (Figure 2-2), were sent off site for laboratory analysis of Ra-226, Pb-210, and beryllium.

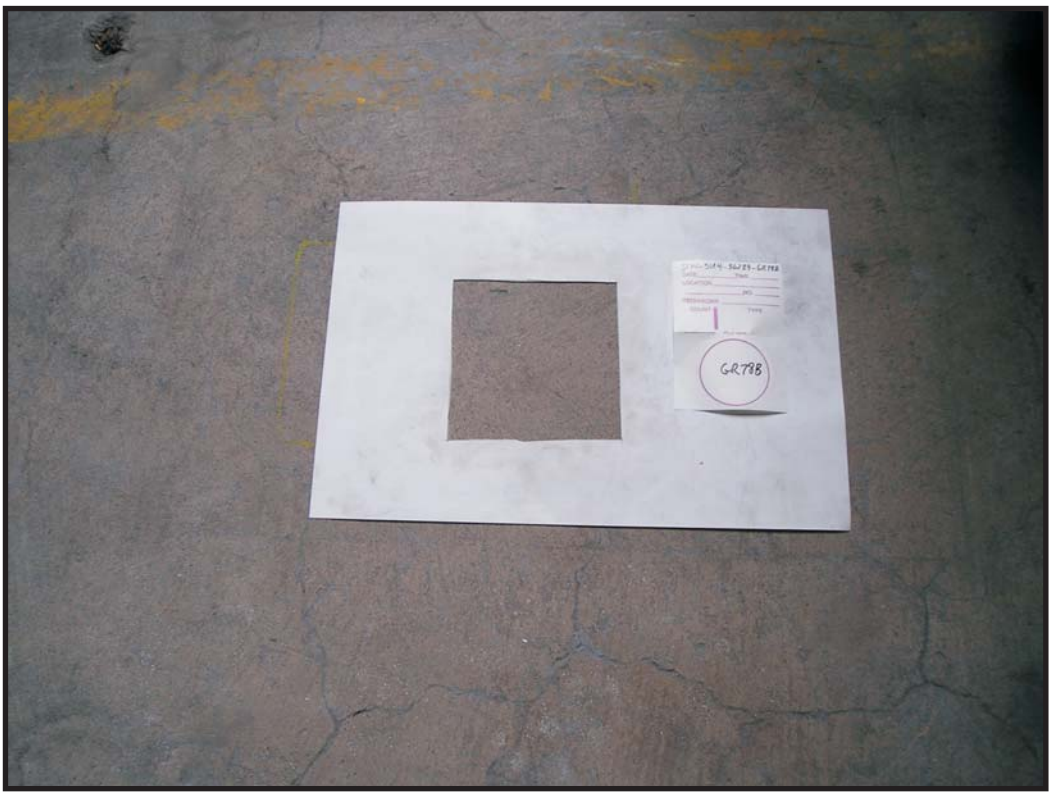
Photo 19 - Swipe sample template at fourth floor survey grid 78.

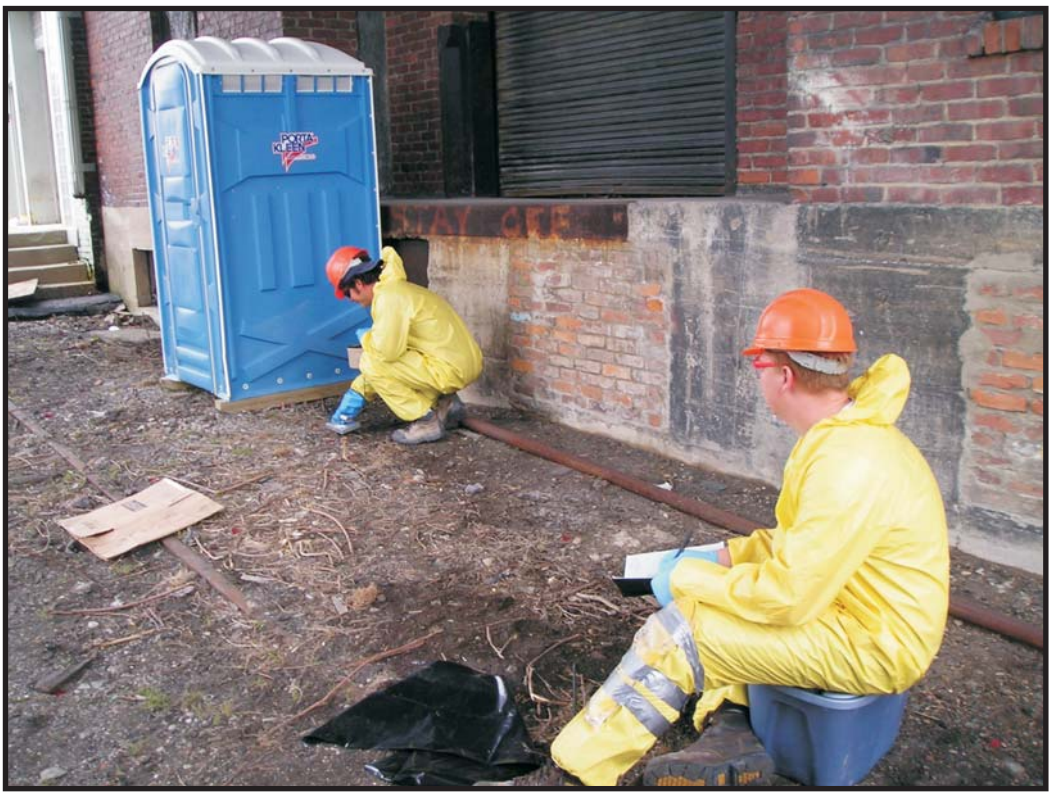
Photo 31 - Performing radiological scoping survey of loading area using Ludlum Model 2360 Alpha/Beta Data Logger with Model 43-68 Gas Proportional Detector.

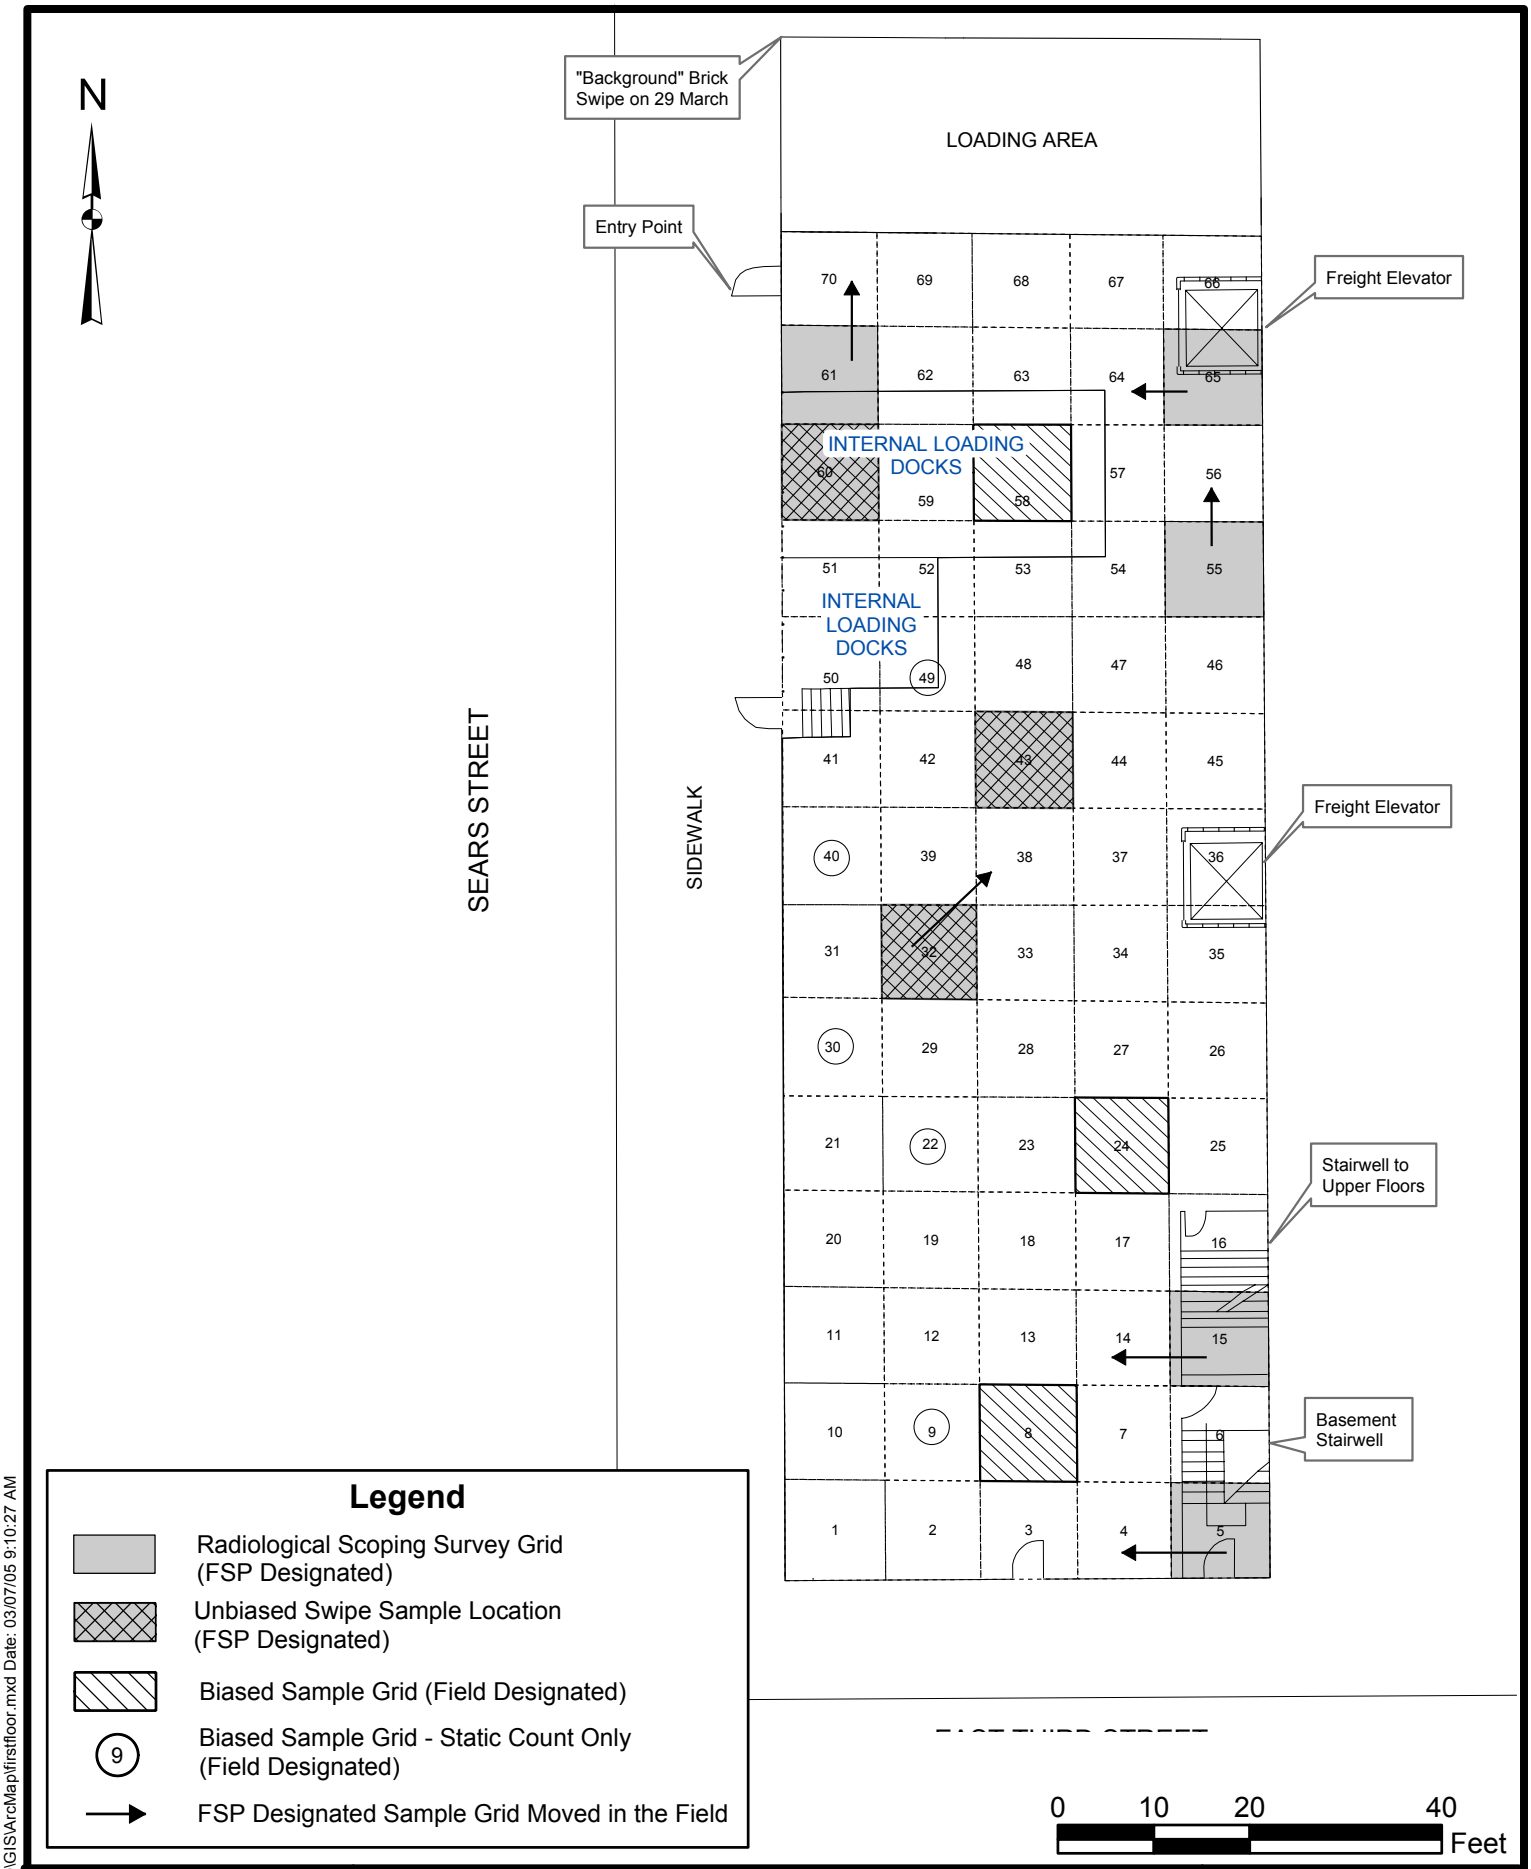
FIGURE 1

The first floor, SU-1, had many immovable objects that prevented the complete scanning of some of the selected survey grids using the floor monitor. Consequently, six of the original eight randomly selected, unbiased survey grids were shifted in the field to adjacent grids because of the debris (see Figure 1, Appendix C).
