# **Illicit Discharge Detection and Elimination Workshop for MS4s**

Case Study – Deteriorating Infrastructure

City of Seven Hills  
Mark K. Papke, P.E.  
City Engineer

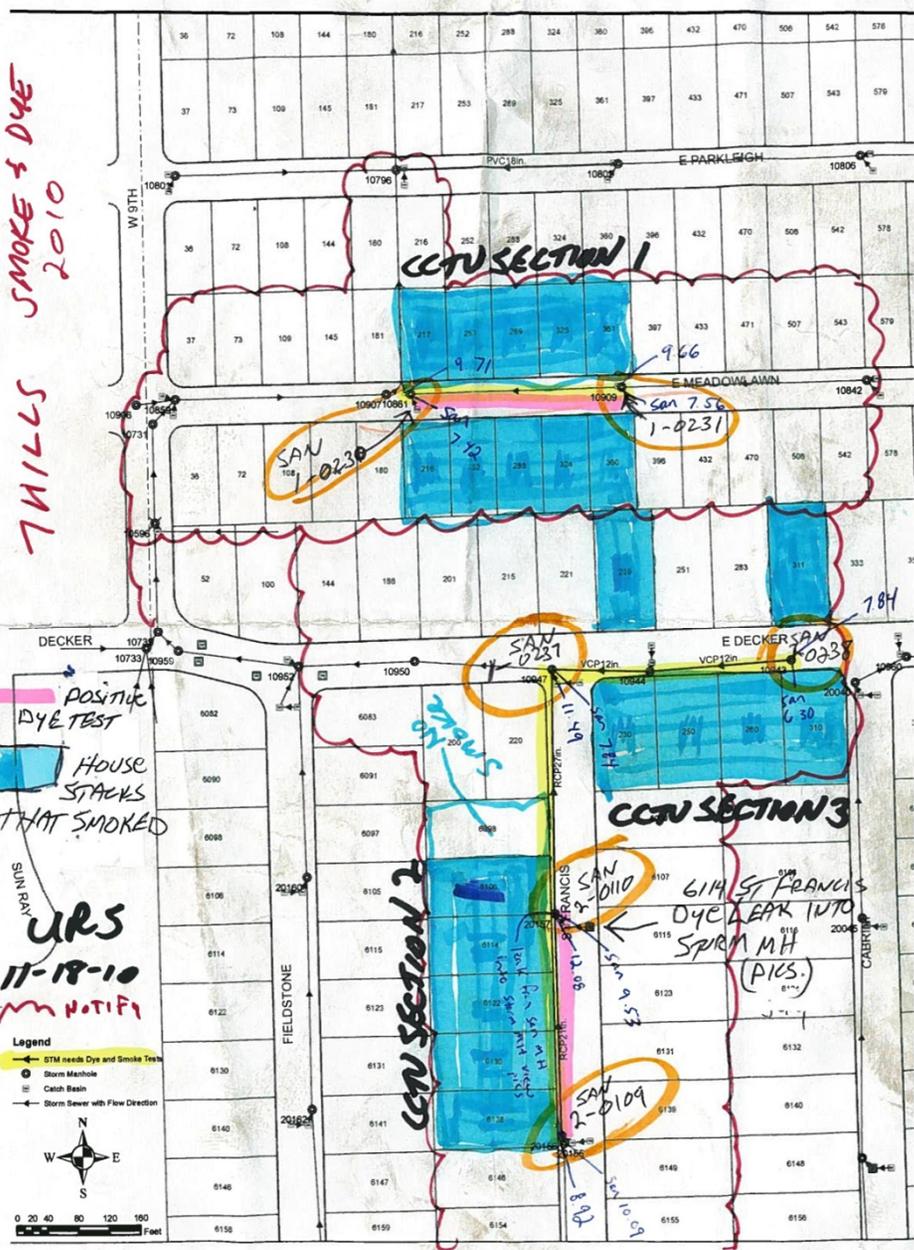
## Seven Hills Smoke and Dye Test Results

Address: 6114 St. Francis  
MH Section: 2-0109 to 2-0110

Smoke Test Results	
Smoke Induction Point:	STM1518
Source Description:	San-2-0110
Smoke Source Type:	Manhole
Test Date:	11/18/2010
Dye Test Results	
Dye Induction Point	SAN-2-0109 to San-2-0110
Source Description:	STM MH walls
Location of Observed Dye:	STM MH 1518
Estimated Flow:	1-3 gpm
CCTV Section Number:	2
Test Results:	Positive
Test Date:	11/18/2010
