## BROWNFIELD INVESTIGATION

Whittier Peninsula  
Columbus, Ohio

U.S. EPA ID: OHB000001706

November 6, 1998

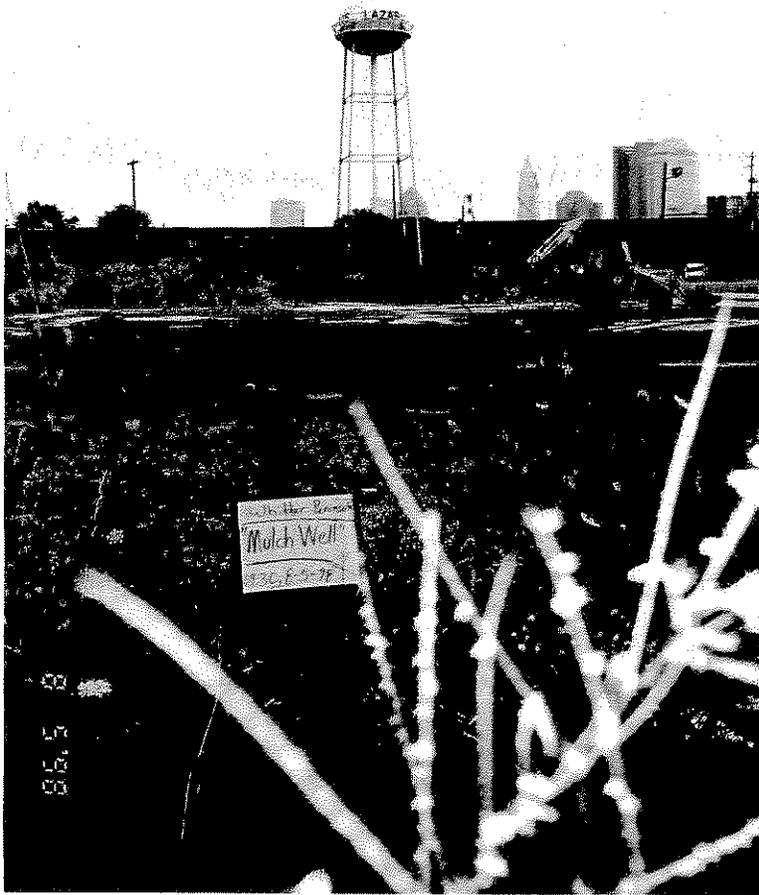
Photo No: 11  
Sample No. ECGS/MEBKG 1  
Date: August 5, 1998  
Orientation: North  
Description: Universal Concrete MW1. Close up of monitoring well sample "Mulch Well".

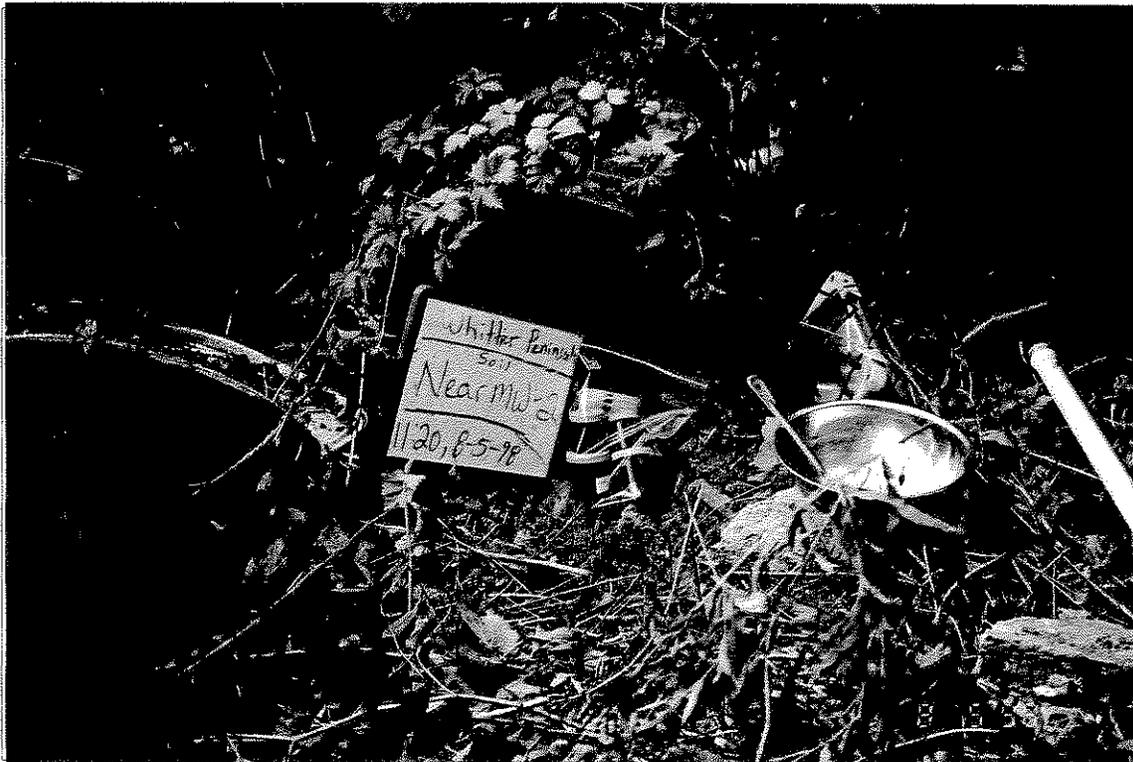
Photo No: 12  
Sample No: ECGT/MEBKH 1  
Date: August 5, 1998  
Orientation: South  
Description: Closeup of soil sample Near MW-2 collected near drum and electrical equipment.

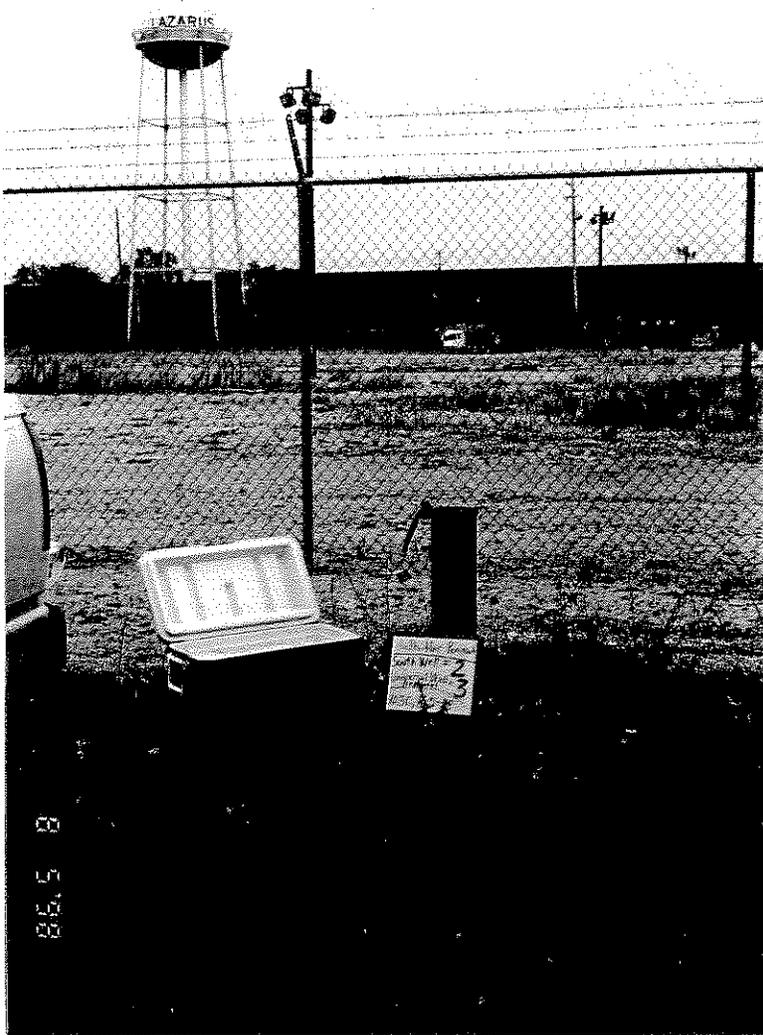
**Photo No: 13**  
**Sample No.** ECGS/MEBKG 2  
and ECGS/MEBKG 3 (dup)  
**Date:** August 5, 1998  
**Orientation:** North  
**Description:** Universal Concrete  
MW2. Close up of monitoring  
well samples "South Well" and  
"Universal Well".

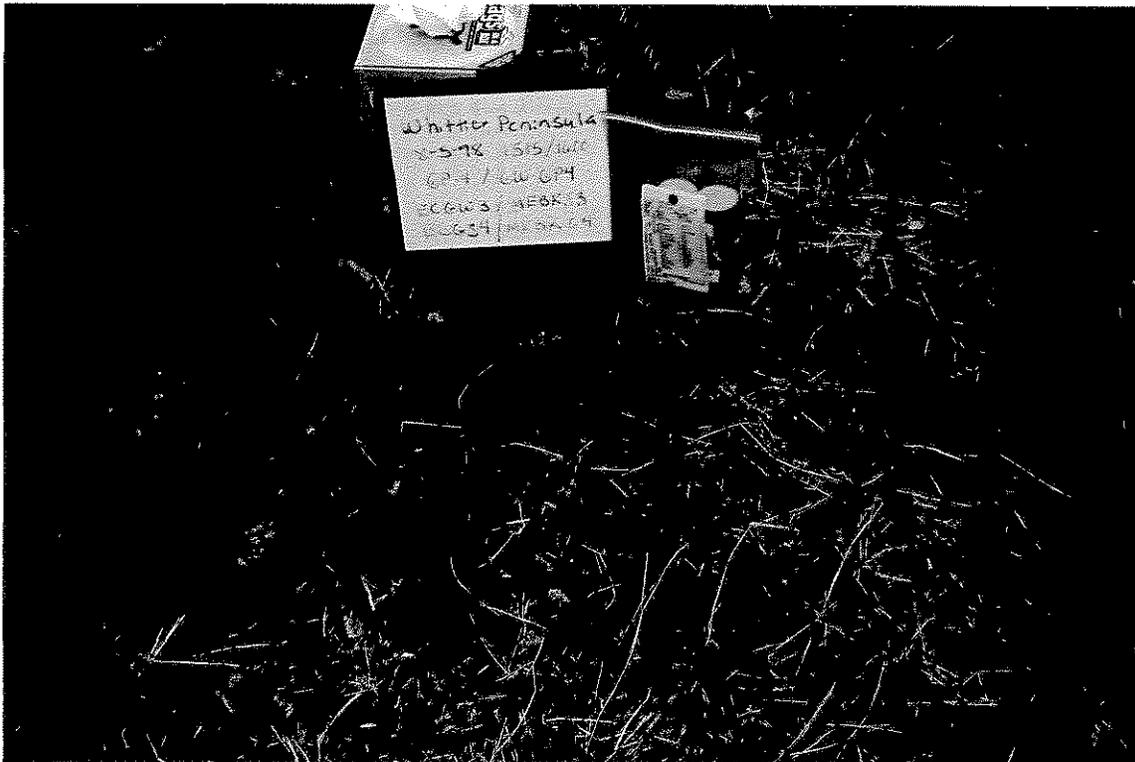
**Photo No: 18**  
**Sample No: ECGW/MEBKJ 3 & ECGS/MEBKJ 4**  
**Date: August 5, 1998**  
**Orientation: North**  
**Description: Close up of Geoprobe soil and groundwater samples GP4 and GW-GP4 collected from burn area of lower impound lot.**

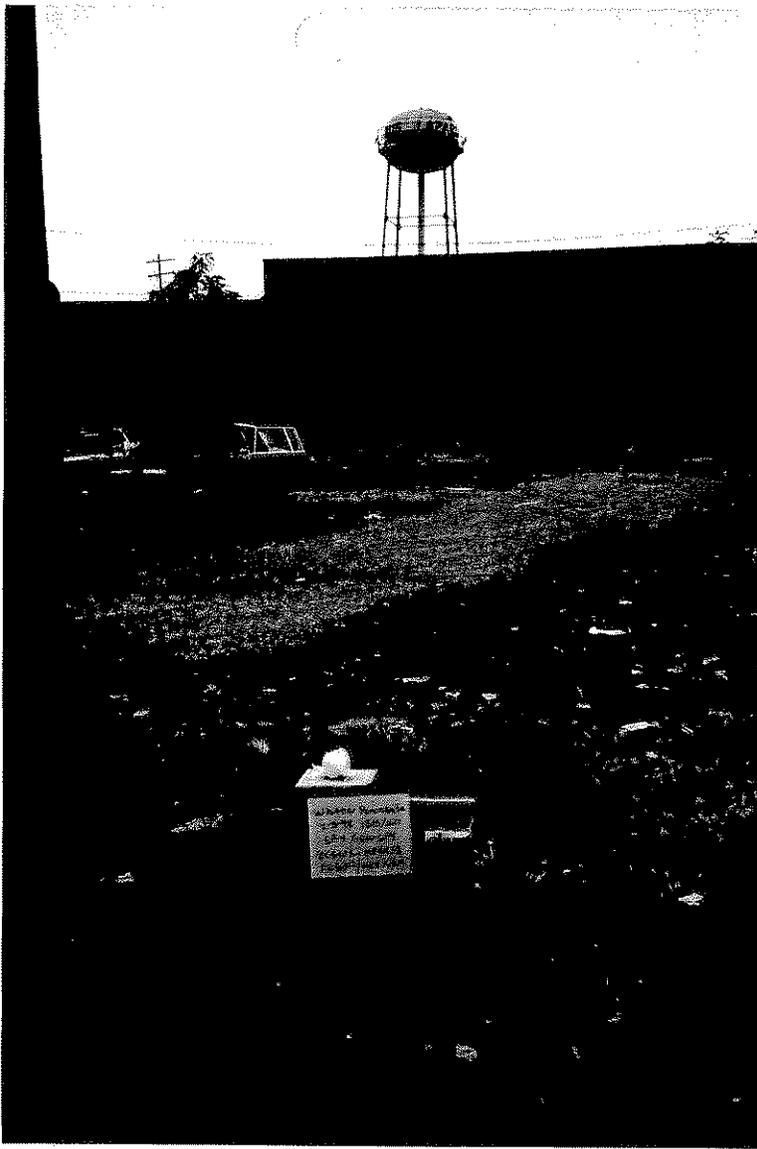
**Photo No: 19**  
**Sample No. ECGW/MEBKJ 3**  
**& ECGS/MEBKG 4**  
**Date: August 5, 1998**  
**Orientation: West**  
**Description: Perspective of**  
**Geoprobe soil and groundwater**  
**sample GP4 and GW-GP4**  
**collected from burn area of**  
**lower upper impound lot.**

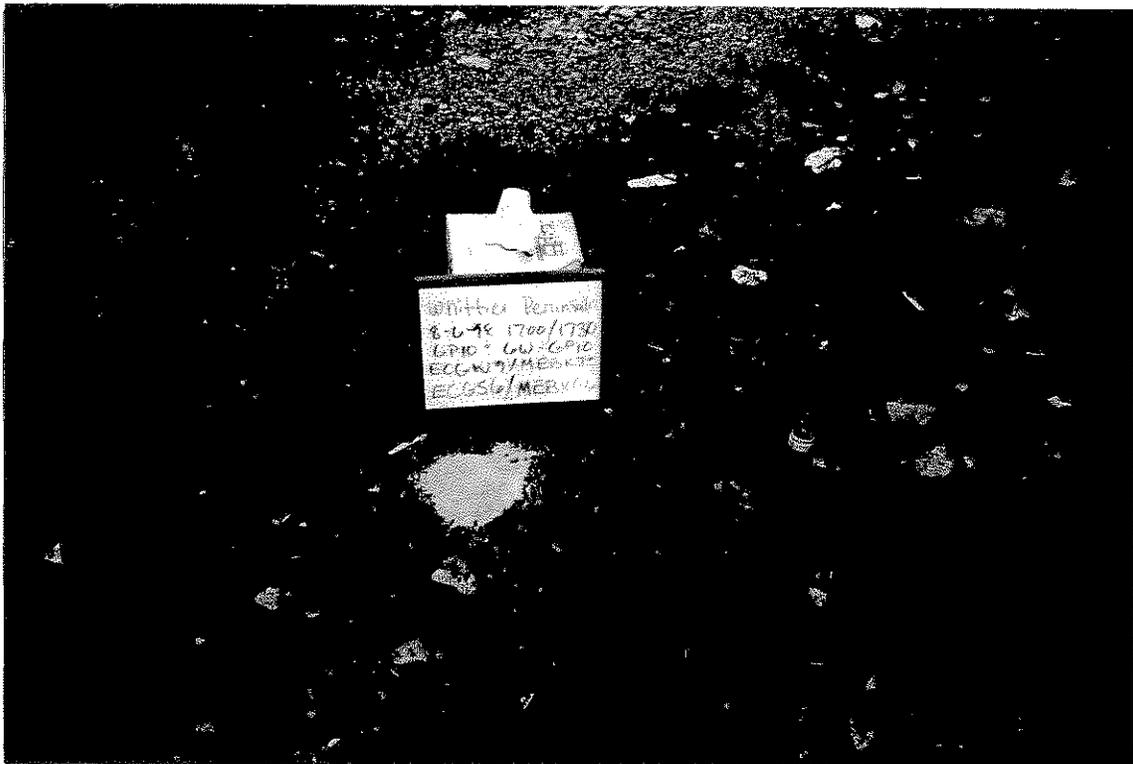
**Photo No:** 30  
**Sample No:** ECGW/MEBKJ 9 & ECGS/MEBKG 6  
**Date:** August 5, 1998  
**Orientation:** Northwest  
**Description:** Closeup of Geoprobe soil and groundwater samples GP10 and GW-GP10 collected from stained area on west side of site between Maier Place Road. and a storage shed.

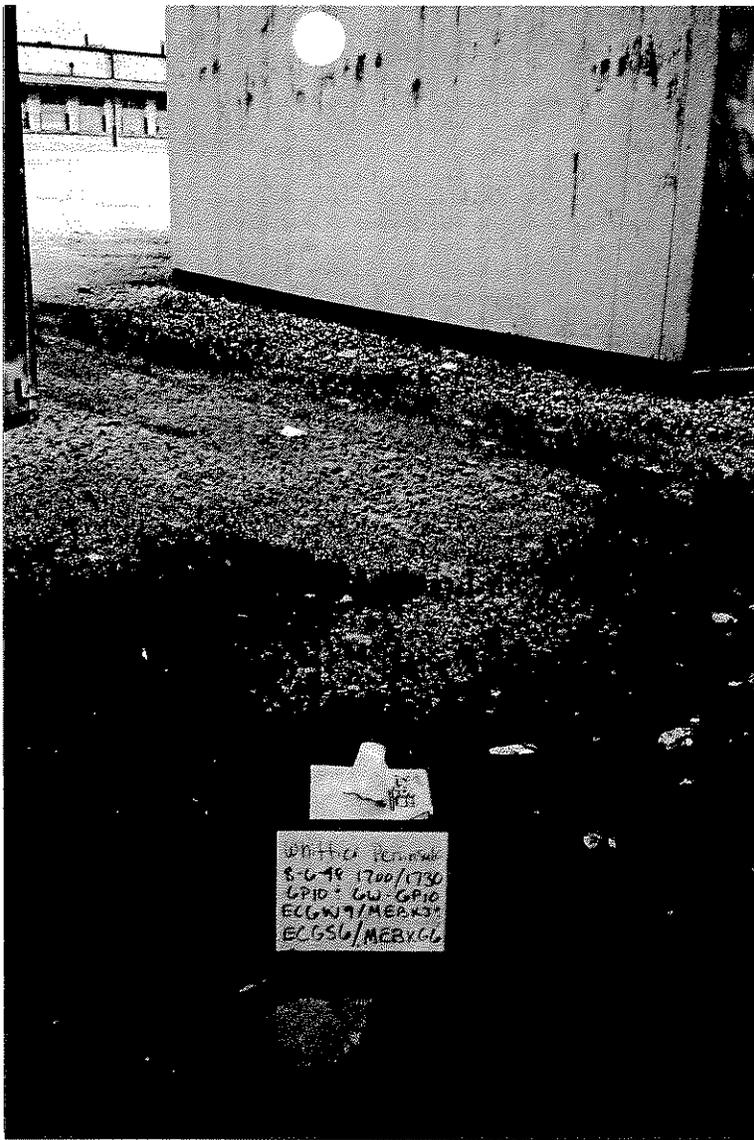
**Photo No:** 31  
**Sample No.** ECGW/MEBKJ 9 & ECGS/MEBK6  
**Date:** August 5, 1998  
**Orientation:** Northwest  
**Description:** Perspective of Geoprobe soil and groundwater samples GP10 and GW-GP10 collected from stained area on west side of site between Maier Place Road, and a storage shed.

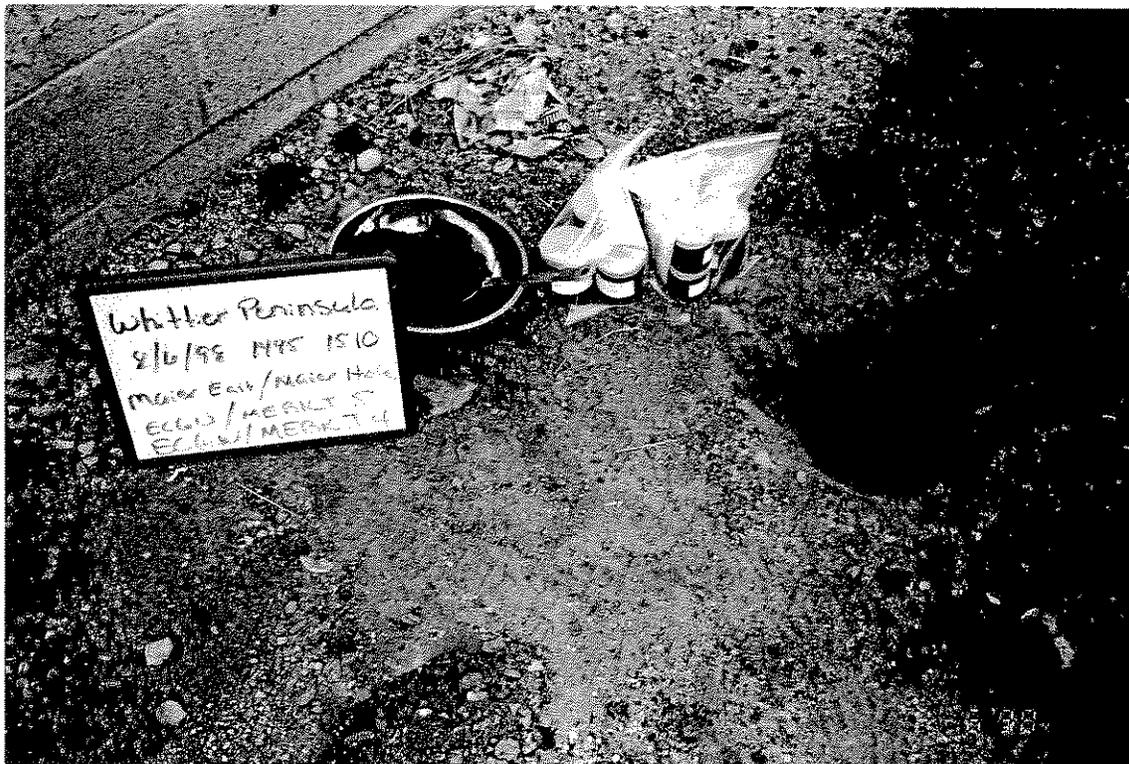
**Photo No:** 32  
**Sample No:** ECGW/MEBKJ 5 & ECGW/MEBKJ 4 (Dup)  
**Date:** August 5, 1998  
**Orientation:** West  
**Description:** Closeup of surficial soil sample Maier East/Maier Hole collected on the east side of the Maier building.

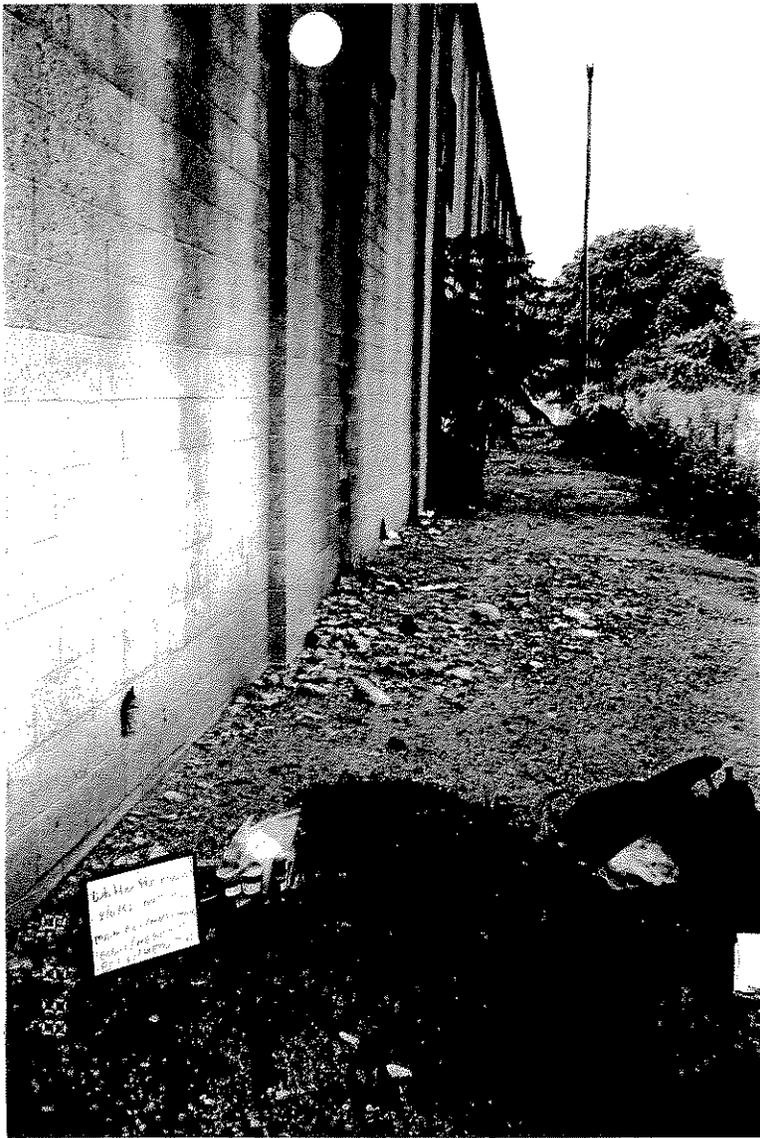
**Photo No:** 33  
**Sample No.** ECGW/MEBKJ 5 &  
ECGW/MEBKJ 4 (Dup)  
**Date:** August 5, 1998  
**Orientation:** North  
**Description:** Perspective of  
surficial soil samples Maier East  
and Maier Hole collected on the  
east side of the Maier building.
