**Integrated Assessment Report- Combined Preliminary Assessment Site Inspection**

**Town Run**

**Marysville, Union County, Ohio**

EPA I.D. No. : OHN000508114

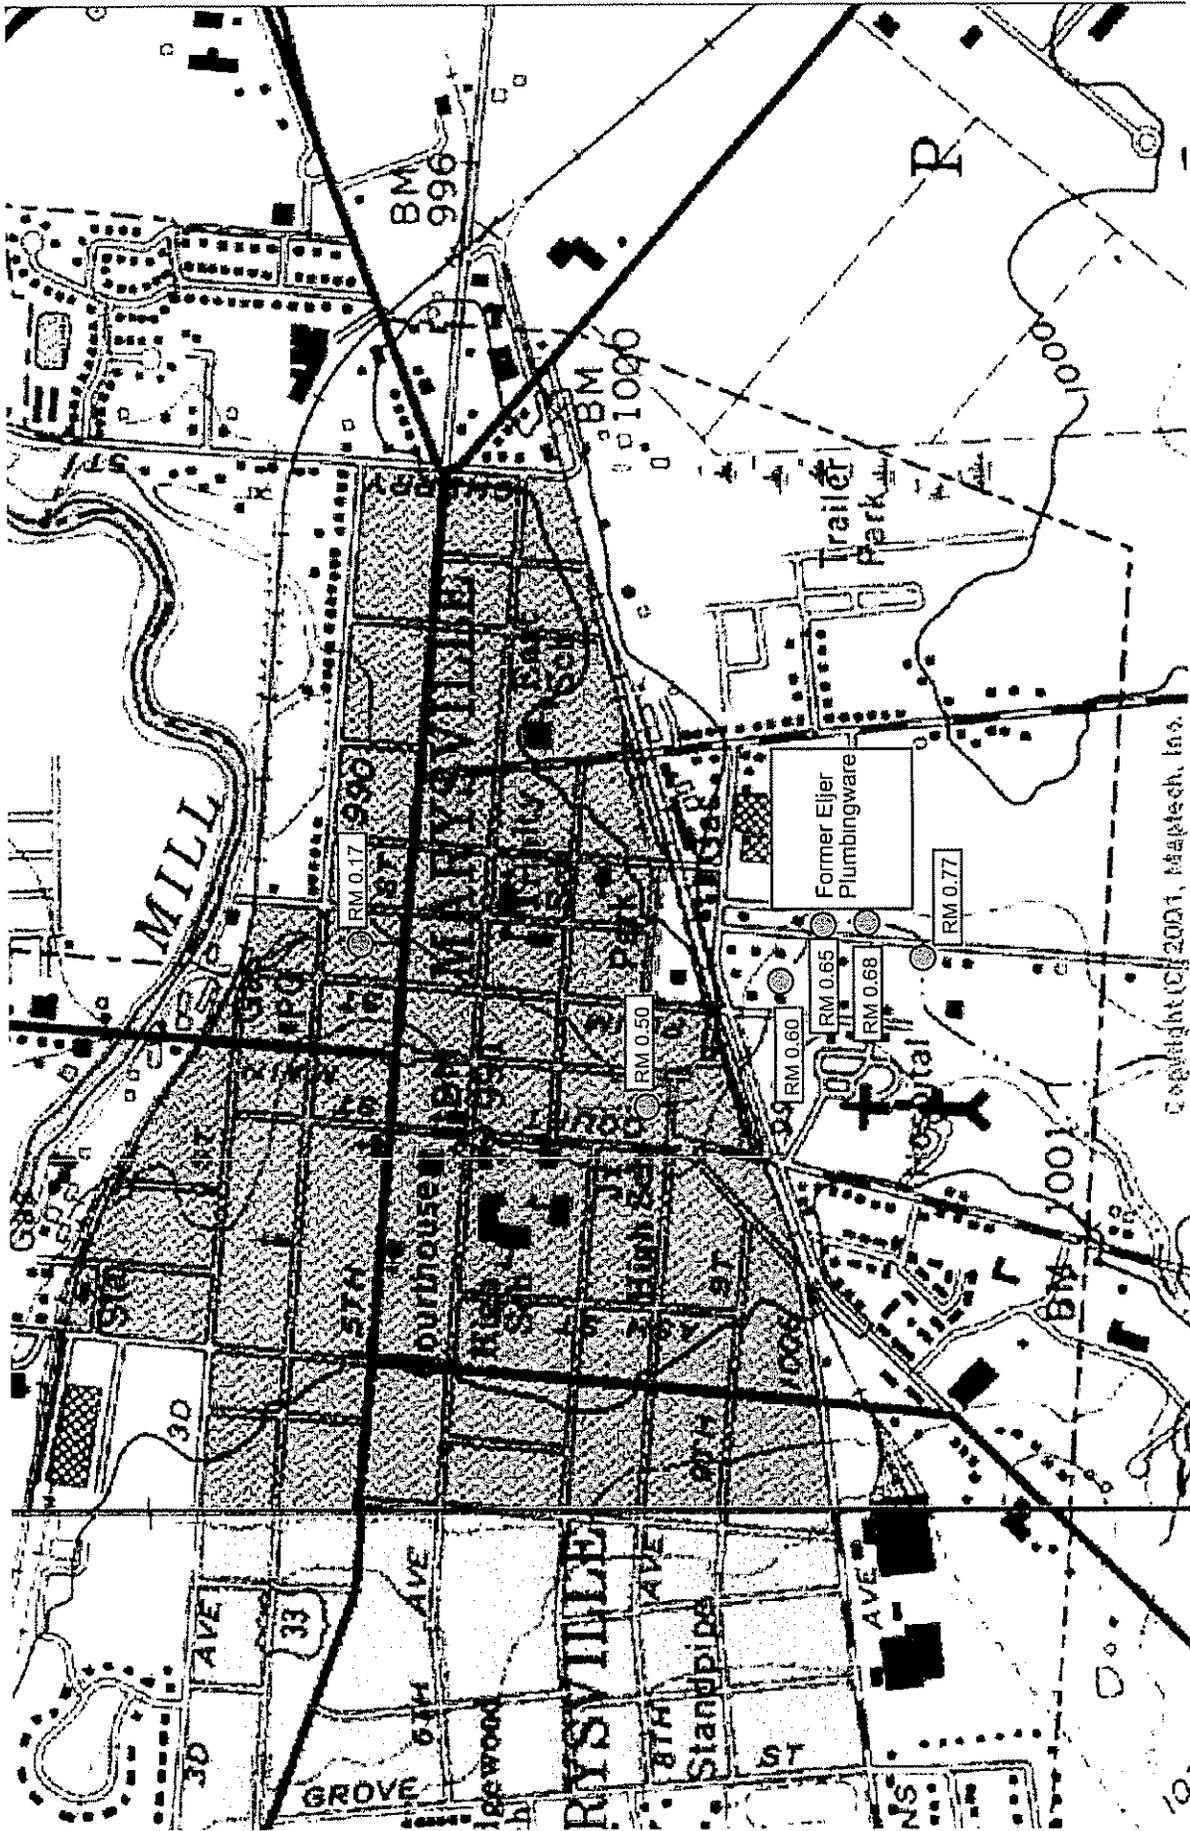
Figure 1. Map of sediment/surface water sampling locations in Town Run.

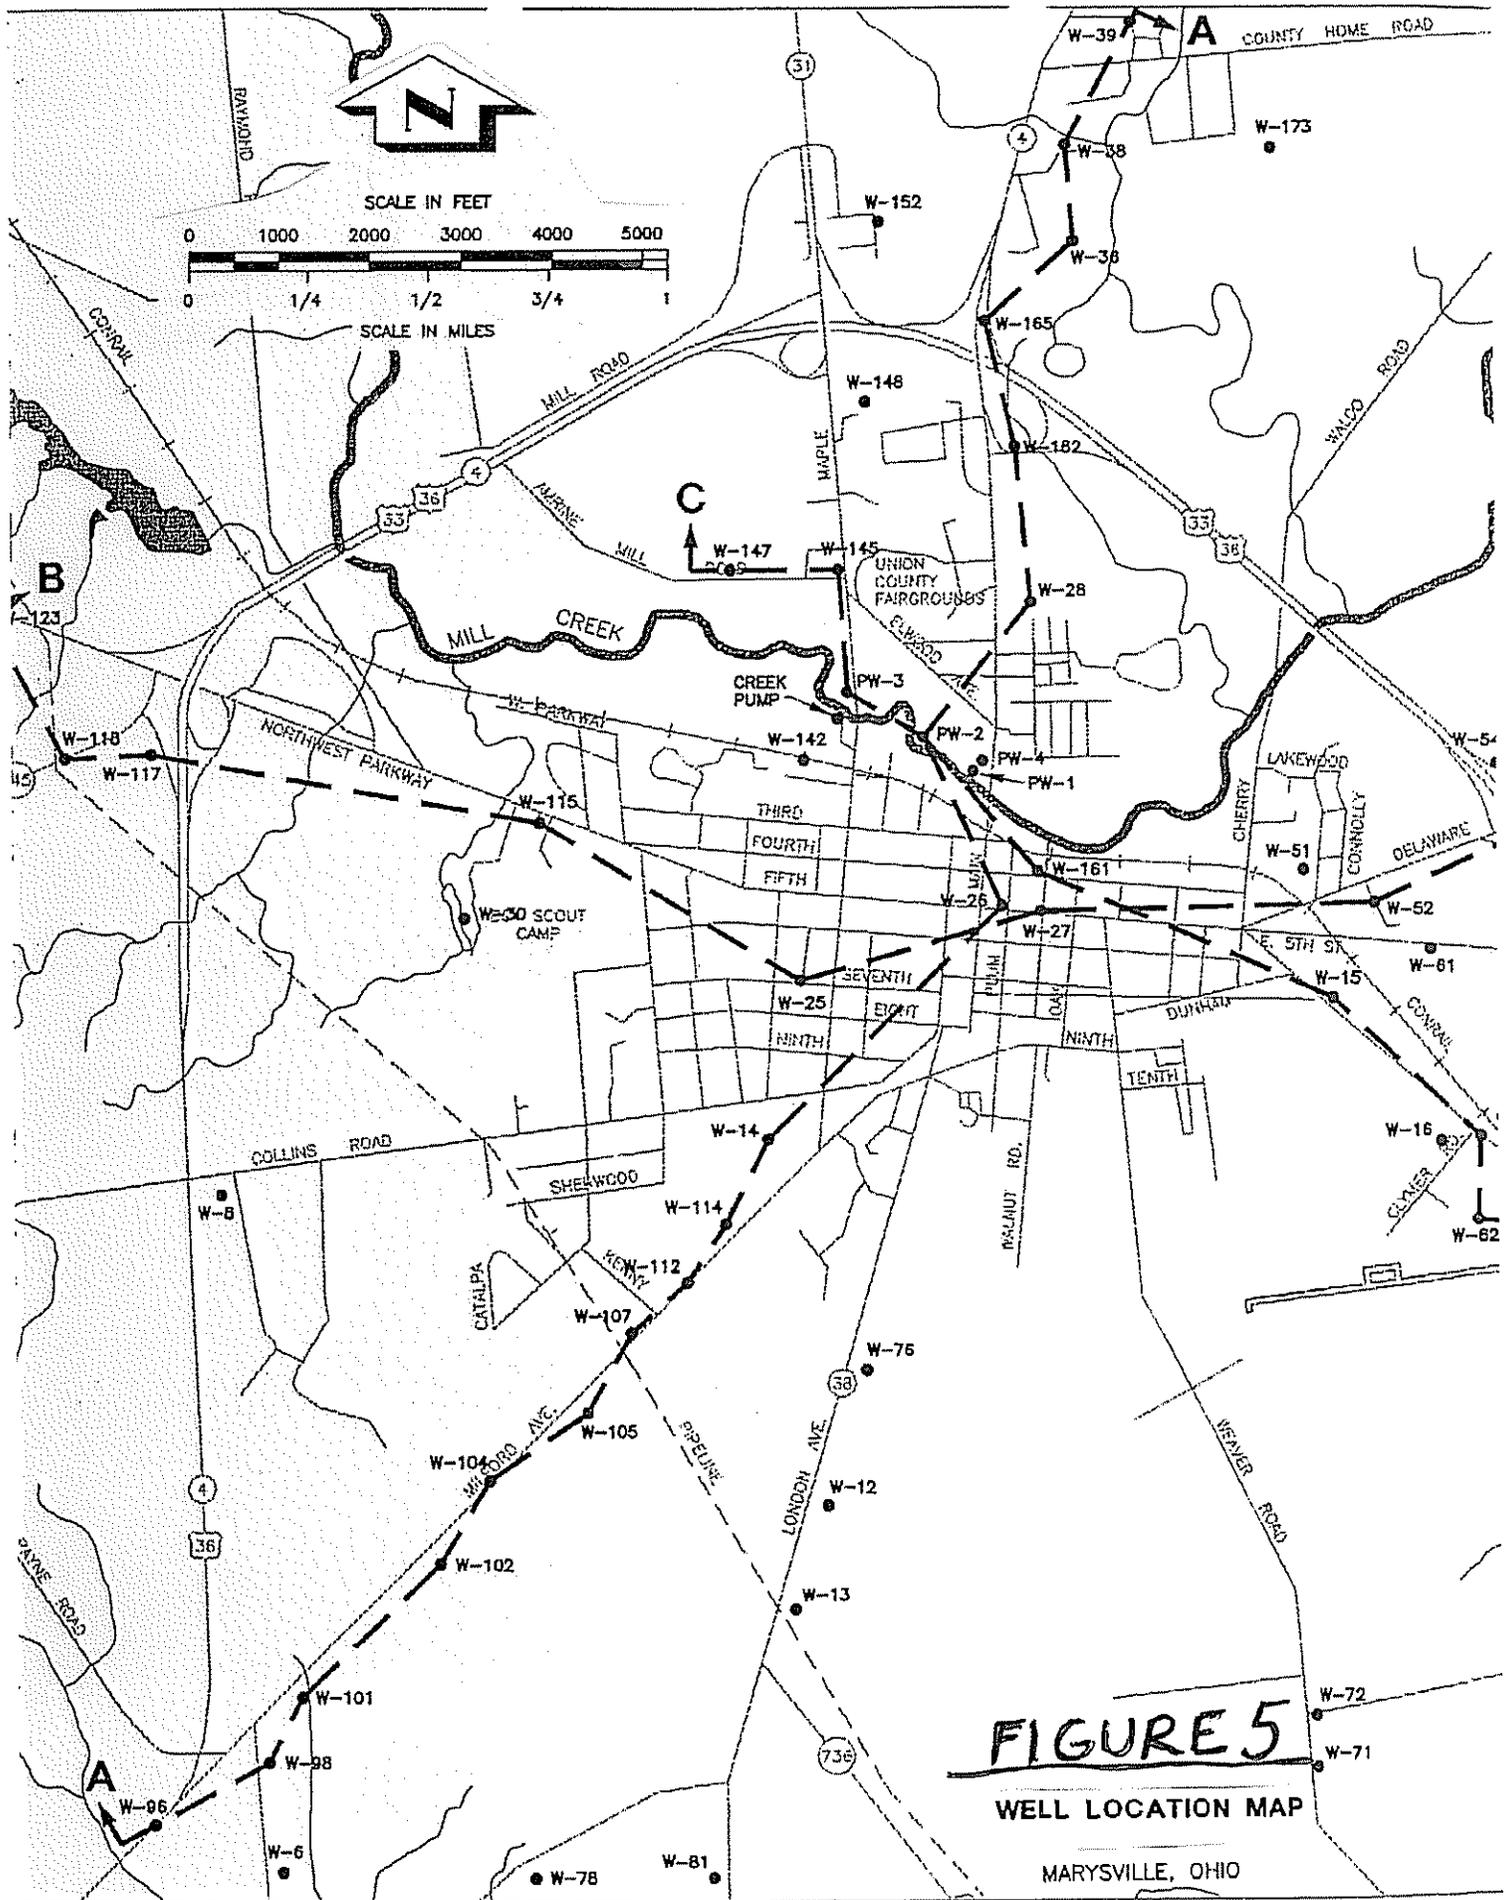
# FIGURE 5

The well field for Marysville's public water supply is located approximately one mile northwest of Town Run. Four private water wells were identified within ½ mile of the site, shown in **Figure 5** as W-26, W-27, W-76 and W-161. These four wells were installed in the early 1950s and it is not known if the wells are still in existence or are being used because the City of Marysville requires connection to the public water supply within the city's limits. Two of the municipal wellfield system's wells are located about 800 feet (PW-1) to 1,500 feet (PW-2) northwest (upstream) of the Town Run and Mill Creek confluence. The construction date for Water Well PW-1 is unknown, but it was rehabilitated in 1989 with a 16-inch casing and screen installed to a depth of 75 feet. Water Well PW-2 was constructed in 1975 with a total depth of 206 feet, into the limestone bedrock.
