## **2.0 Watershed Overview and Assessment**

The Big Darby Creek watershed covers 555 square miles of central Ohio just west of the Columbus metropolitan area (see Figure 2.1.1) Big Darby Creek originates in Logan County and flows more than 80 miles before joining the Scioto River near Circleville, Ohio. Land use is predominately row crop agricultural, except for the watershed's suburbanizing eastern edge along the border of Madison and Franklin counties, and in Union County (see Figure 2.1.2).

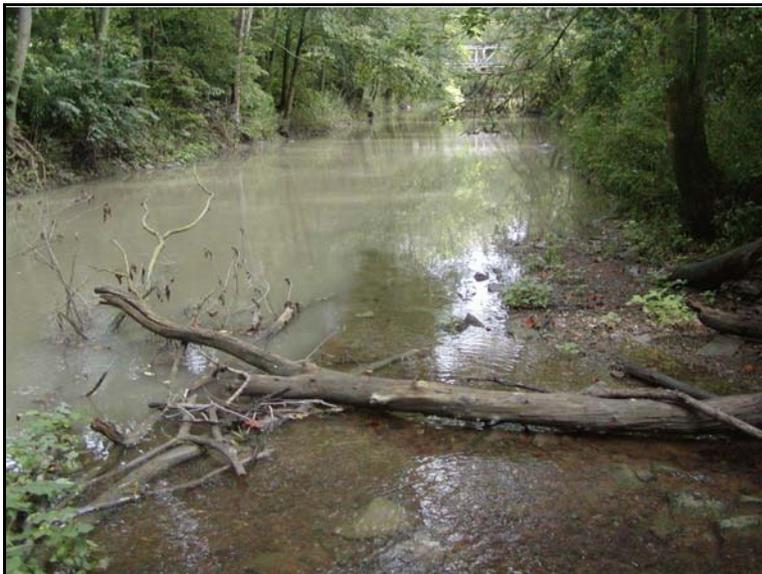
Figure 2.2.2.2 Confluence of Big Darby Creek (right) with Flat Branch (left). Notice that Flat Branch's turbidity overwhelms the clear water from Big Darby Creek.

Water emanating from Flat Branch is generally very turbid, and has a marked visual influence on the water quality downstream of its confluence with Big Darby Creek (see Figure 2.2.2.2). Flat Branch also experiences violations of the MWH dissolved oxygen (DO) standard, and causes DO violations in Big Darby Creek downstream of the confluence of Flat Branch and Big Darby Creek.

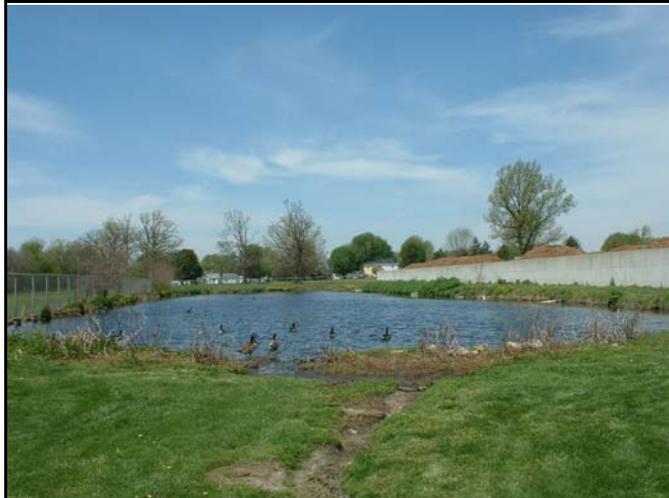
**Figure 2.2.4.2.** A storm water pond at Select Sires in Unionville Center. Grass in the swale is burned by high strength influent. Note manure piles on right.

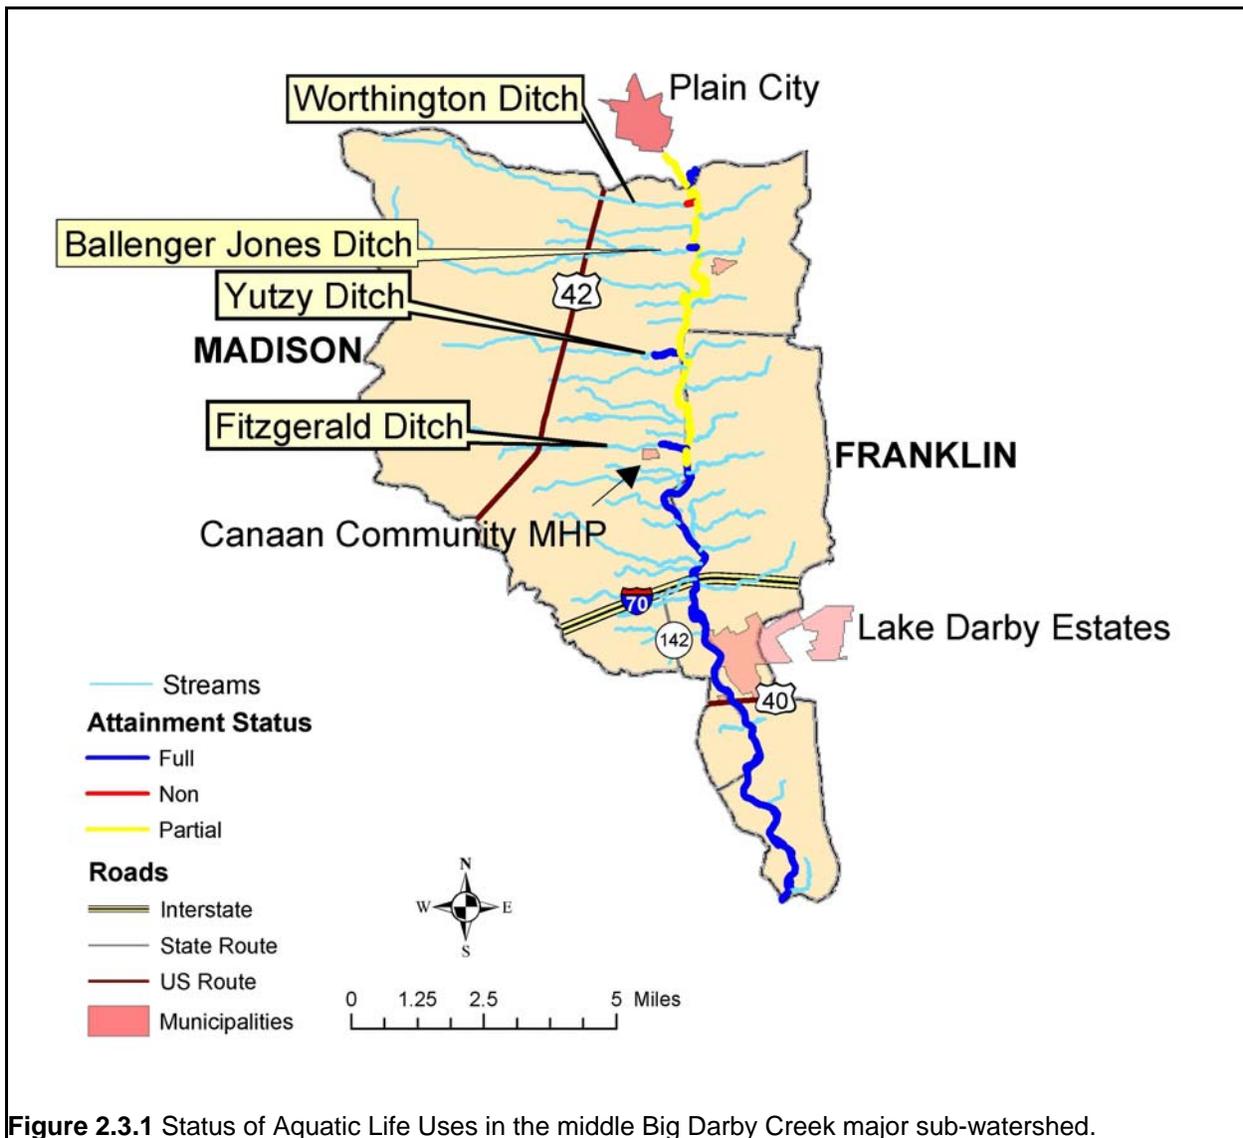
**Figure 2.3.1** Status of Aquatic Life Uses in the middle Big Darby Creek major sub-watershed.

Aquatic life uses in middle Big Darby Creek are impaired. Status of aquatic life uses is shown in Figure 2.3.1. The condition of the riparian corridor in this major sub-watershed is shown in Figure 2.3.2.

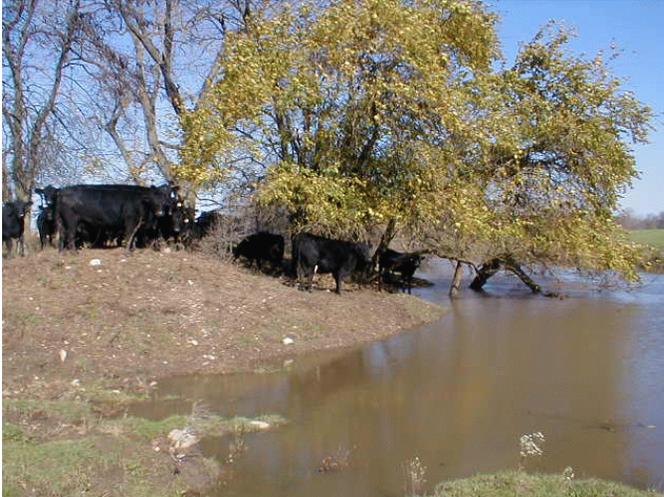
**Figure 2.4.4.2.** Unrestricted livestock access to lower Treacle Creek.

Treacle Creek, currently designated EWH its entire length, partially met criteria in its headwaters and is in non-attainment towards its mouth. A wide variety of stressors were adversely affecting biological communities towards the mouth of Treacle Creek. Poor habitat resulting from channelization and free access livestock pasturage (Figure 2.4.4.2) has resulted in all native substrates being covered in a thick layer of soft, unconsolidated clays and silts. High fecal coliform bacteria and elevated nutrients also contributed to the decline which extended its reach into Little Darby Creek.
